## **WINDSOR-ESSEX PARKWAY**

# **Subsurface Conditions Interpretation Report**

**Report Number:** 07-1130-207-0-R02 / 05-1140-003

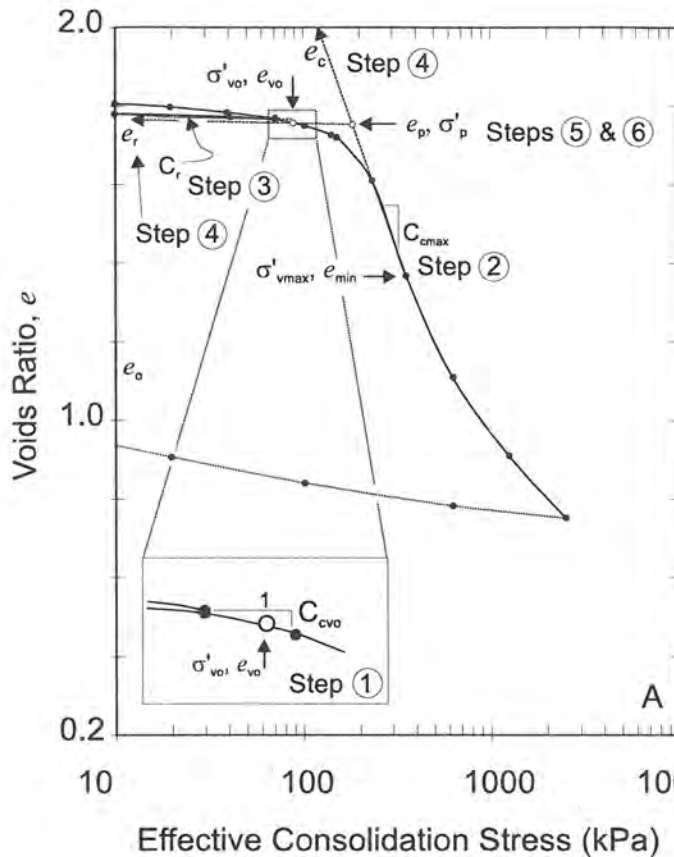
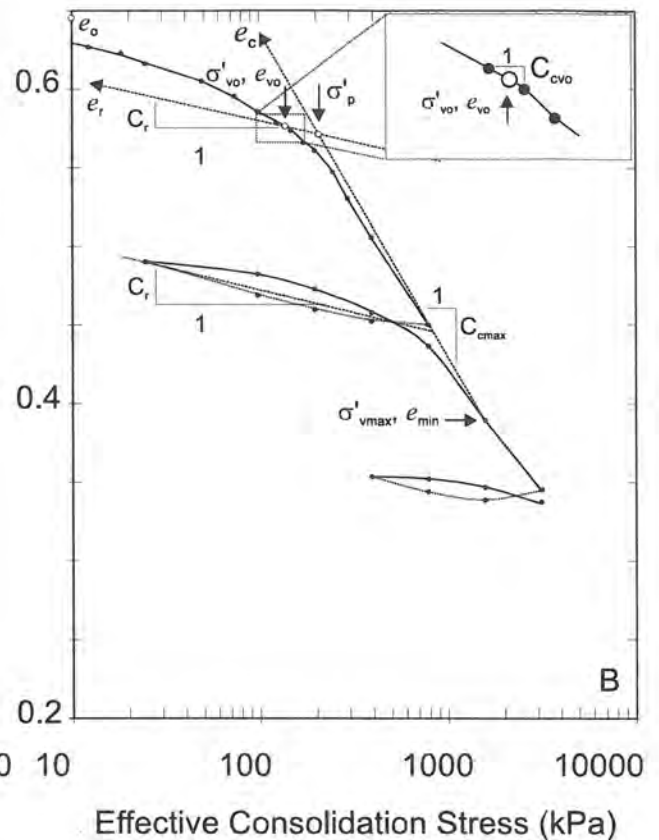
PROJECT			
SUBSURFACE CONDITIONS INTERPRETATION REPORT			
WINDSOR-ESSEX PARKWAY			
WINDSOR, ONTARIO			
TITLE			
INTERPRETATION OF			
OEDOMETER TEST DATA			
PROJECT No.		07-1130-2070	FILE No.
			0711302070-R02065
CADD		SJB	DEC 09
CHECK		RY	DEC 09
			SCALE AS SHOWN REV. 1
			6.5

- $C_c$  = virgin compression index  
 $C_r$  = recompression index  
 $C_{cvo}$  = compression index at in situ vertical effective stress  
 $\sigma'_{vo}$  = in situ vertical effective stress  
 $\sigma'_p$  = preconsolidation pressure  
 $\sigma'_{vmax}$  = maximum vertical effective stress at end of load increment producing largest value of  $C_c$   
 $e_{min}$  = minimum voids ratio at end of load increment producing largest value of  $C_c$   
 $e_r$  = voids ratio axis intercept value at an effective consolidation stress of 1 kPa based on projection of recompression index line  
 $e_c$  = voids ratio axis intercept value at an effective consolidation stress of 1 kPa based on projection of virgin compression index line  
 $e_p$  = voids ratio at the preconsolidation pressure

1. THIS FIGURE IS TO BE READ WITH THE REPORT TITLED "SUBSURFACE CONDITIONS INTERPRETATION REPORT, WINDSOR-ESSEX PARKWAY"
2. THIS FIGURE SUMMARIZES THE METHODOLOGY USED TO ESTIMATE THE PRECONSOLIDATION PRESSURE FROM OEDOMETER TESTS ON SAMPLES OF THE CLAYEY SILT TO SILTY CLAY DEPOSITS

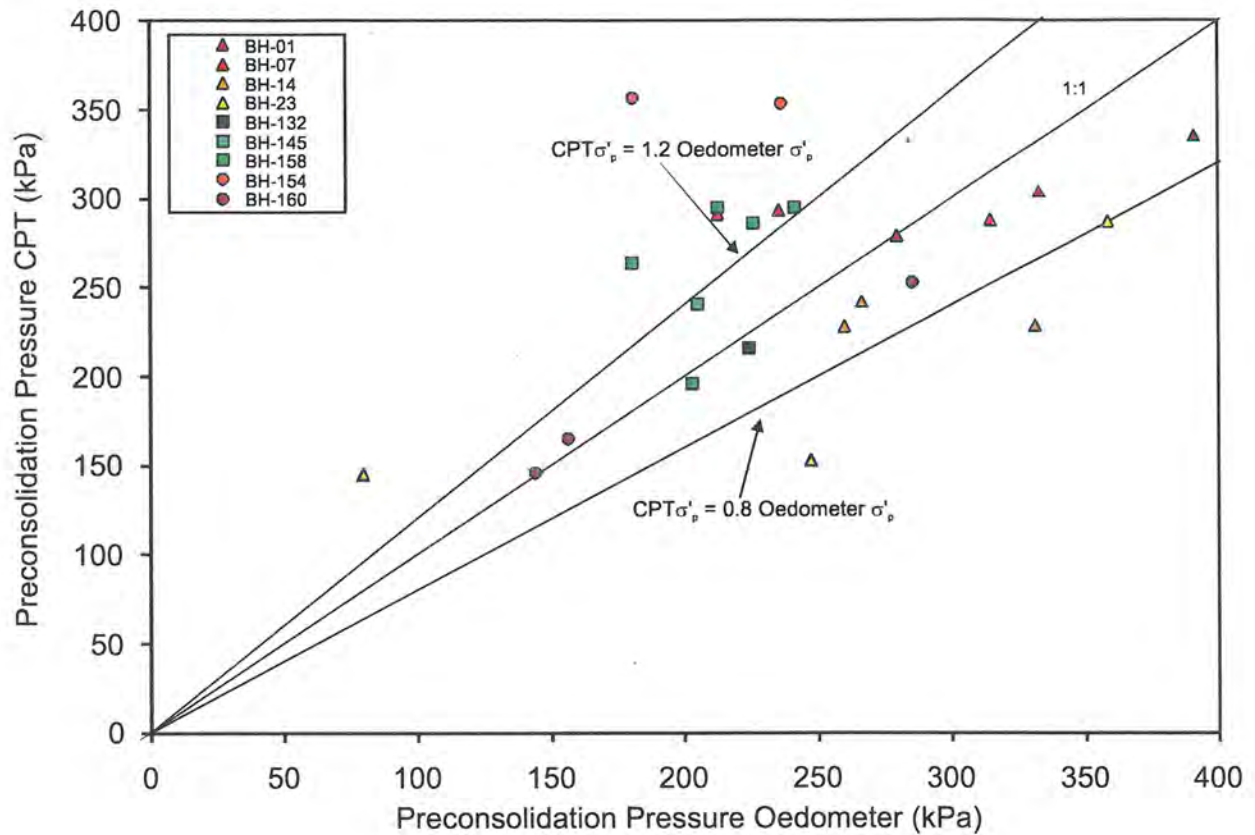
1. THIS FIGURE IS TO BE READ WITH THE REPORT TITLED "SUBSURFACE CONDITIONS INTERPRETATION REPORT, WINDSOR-ESSEX PARKWAY"
2. THIS FIGURE REPRESENTS A SUMMARY OF FIELD AND AS DISCUSSED IN THE TEXT OF THE REPORT REFERENCED ABOVE.

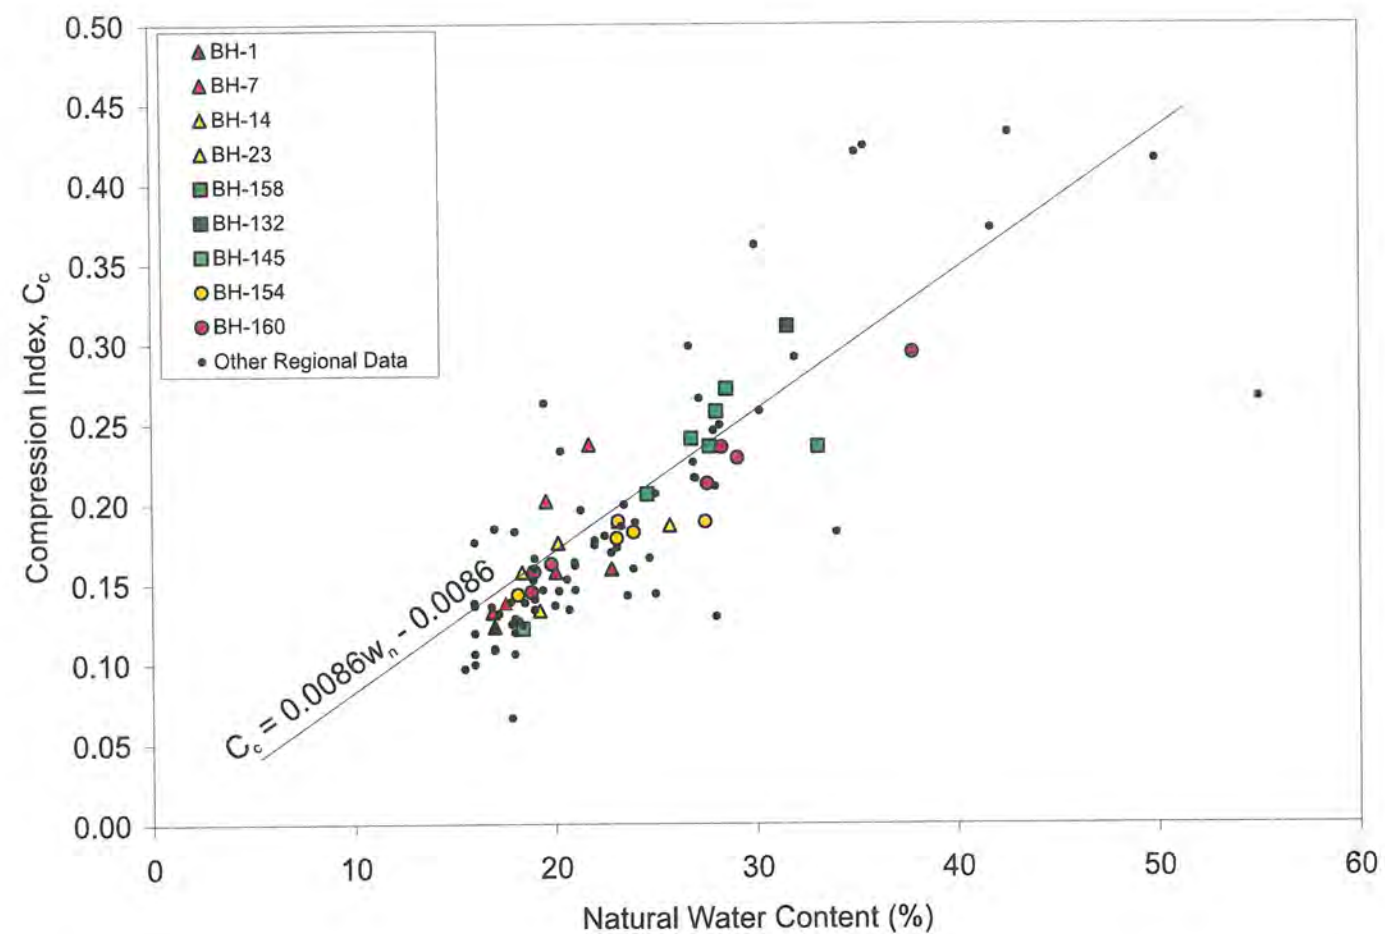
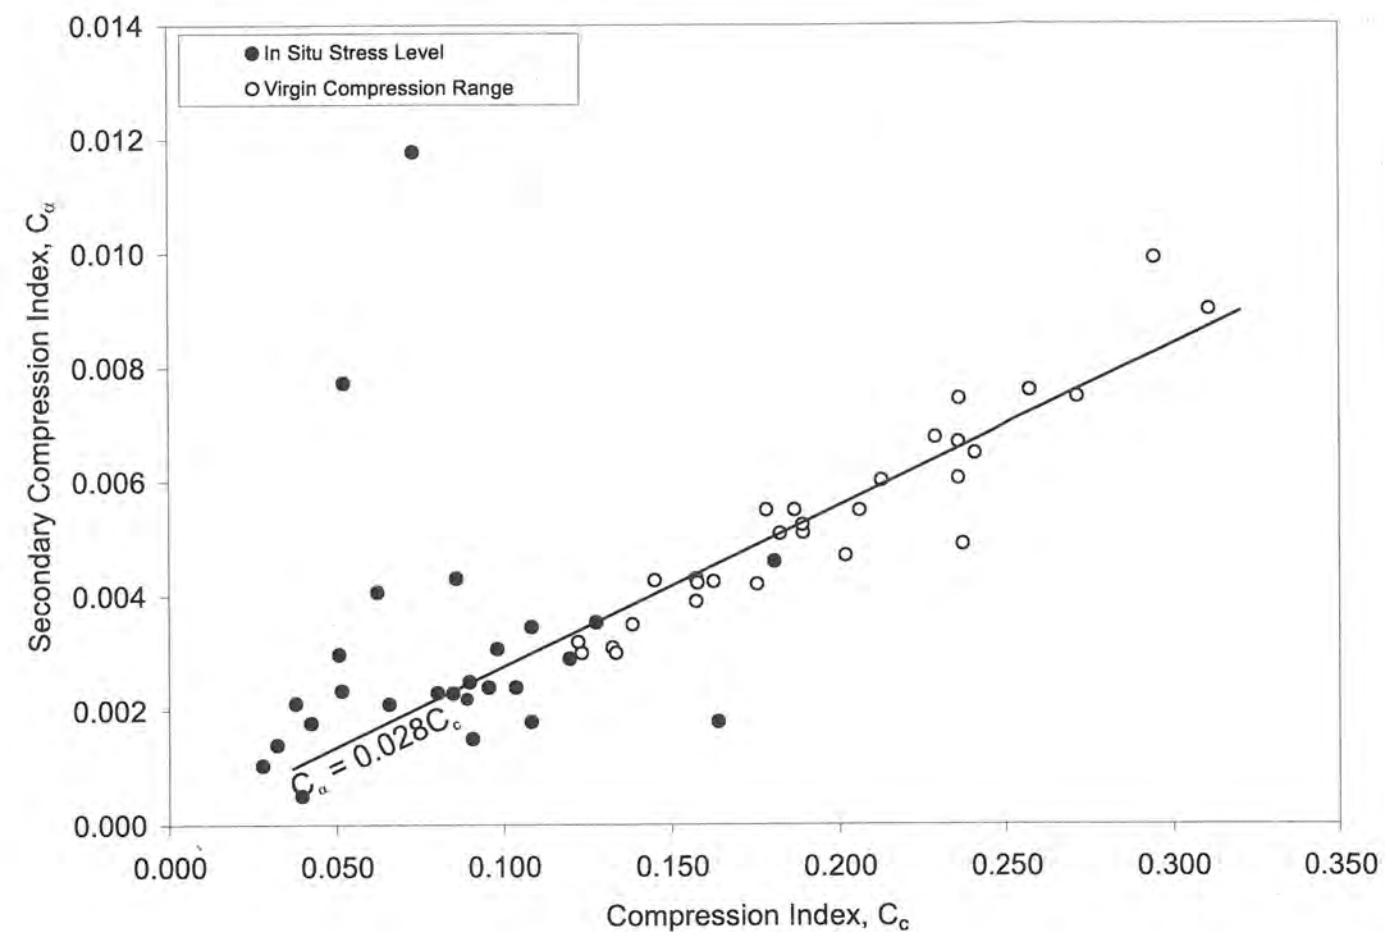
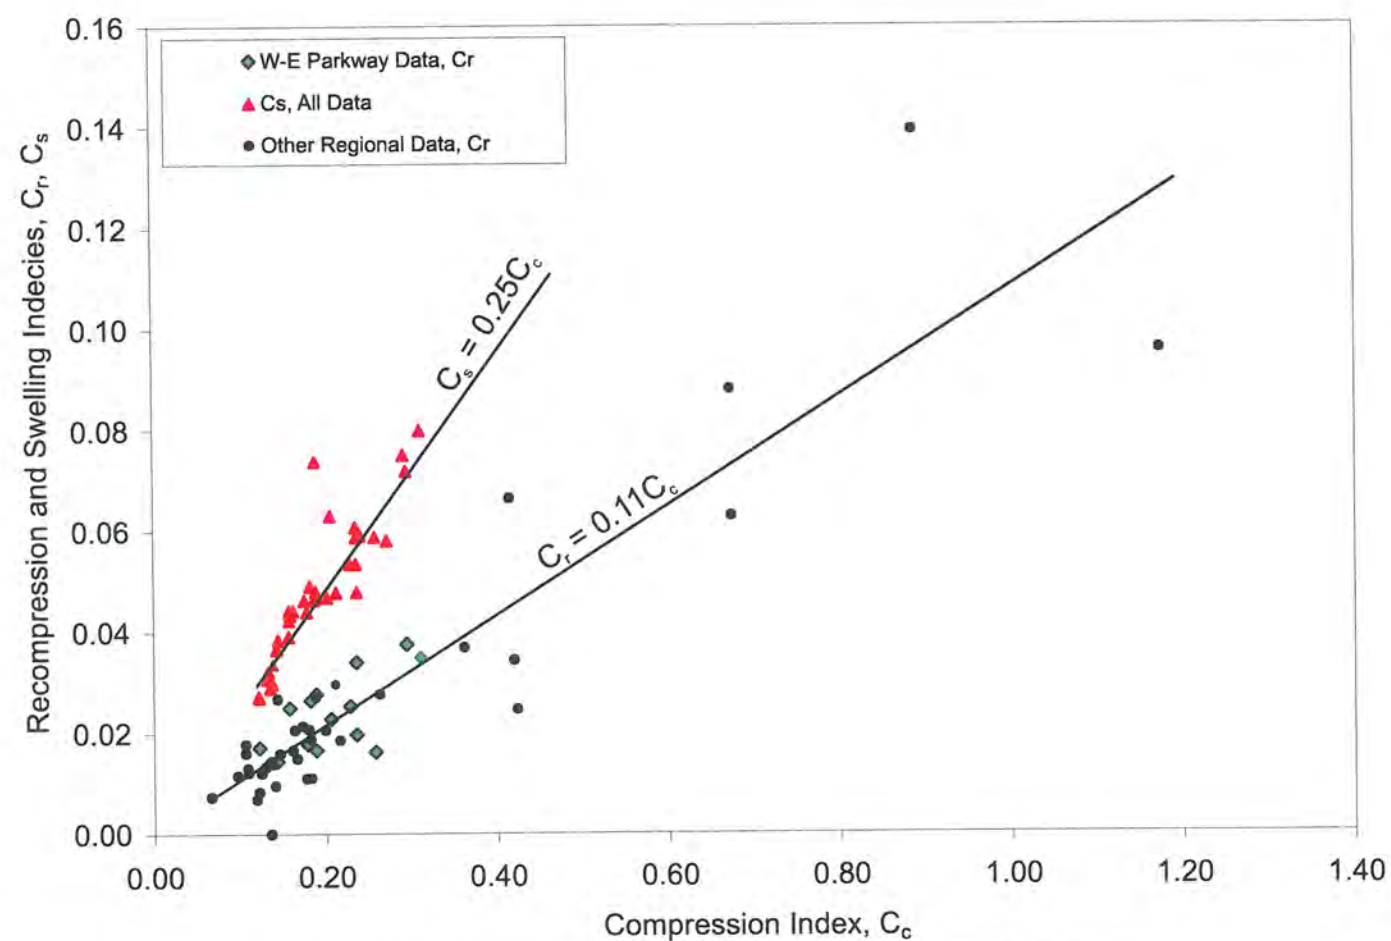
PROJECT			
SUBSURFACE CONDITIONS INTERPRETATION REPORT WINDSOR-ESSEX PARKWAY WINDSOR, ONTARIO			
TITLE			
DATA SUMMARY COMPRESSION INDICES			
PROJECT No. 07-1130-2070		FILE No. 0711302070-R02066	
CADD	SUB	DEC 09	SCALE AS SHOWN
CHECK			6.7

1. THIS FIGURE IS TO BE READ WITH THE REPORT TITLED "SUBSURFACE CONDITIONS INTERPRETATION REPORT, WINDSOR-ESSEX PARKWAY"
2. THIS FIGURE REPRESENTS A SUMMARY OF LABORATORY TESTING DATA AS DISCUSSED IN THE TEXT OF THE REPORT REFERENCED ABOVE AND ON SEPARATE FIGURES.

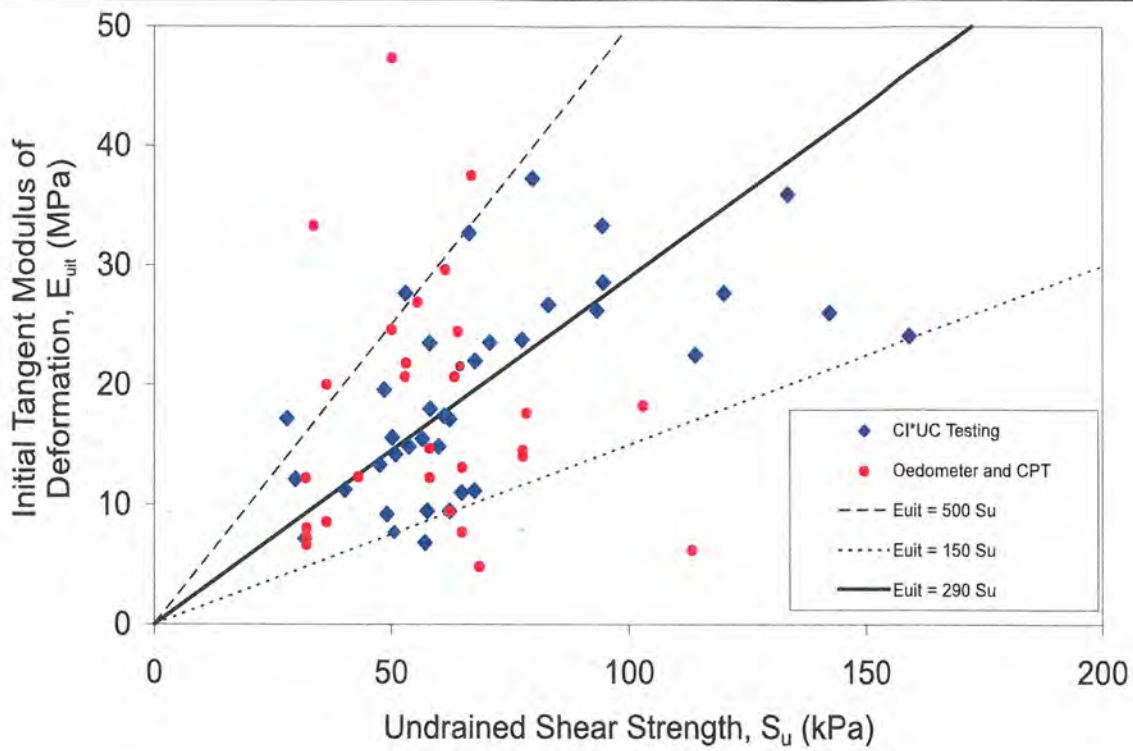
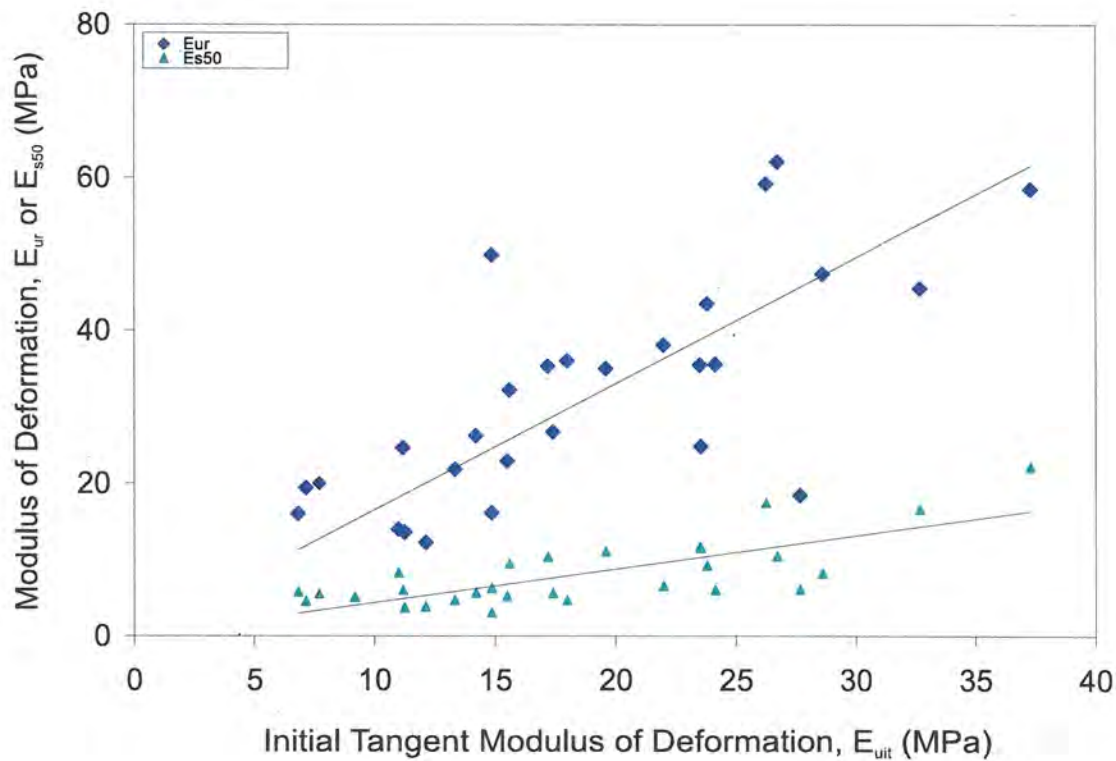
1. THIS FIGURE IS TO BE READ WITH THE REPORT TITLED "SUBSURFACE CONDITIONS INTERPRETATION REPORT, WINDSOR-ESSEX PARKWAY"
2. THIS FIGURE REPRESENTS A SUMMARY OF FIELD AND LABORATORY TESTING DATA AS DISCUSSED IN THE TEXT OF THE REPORT REFERENCED ABOVE.

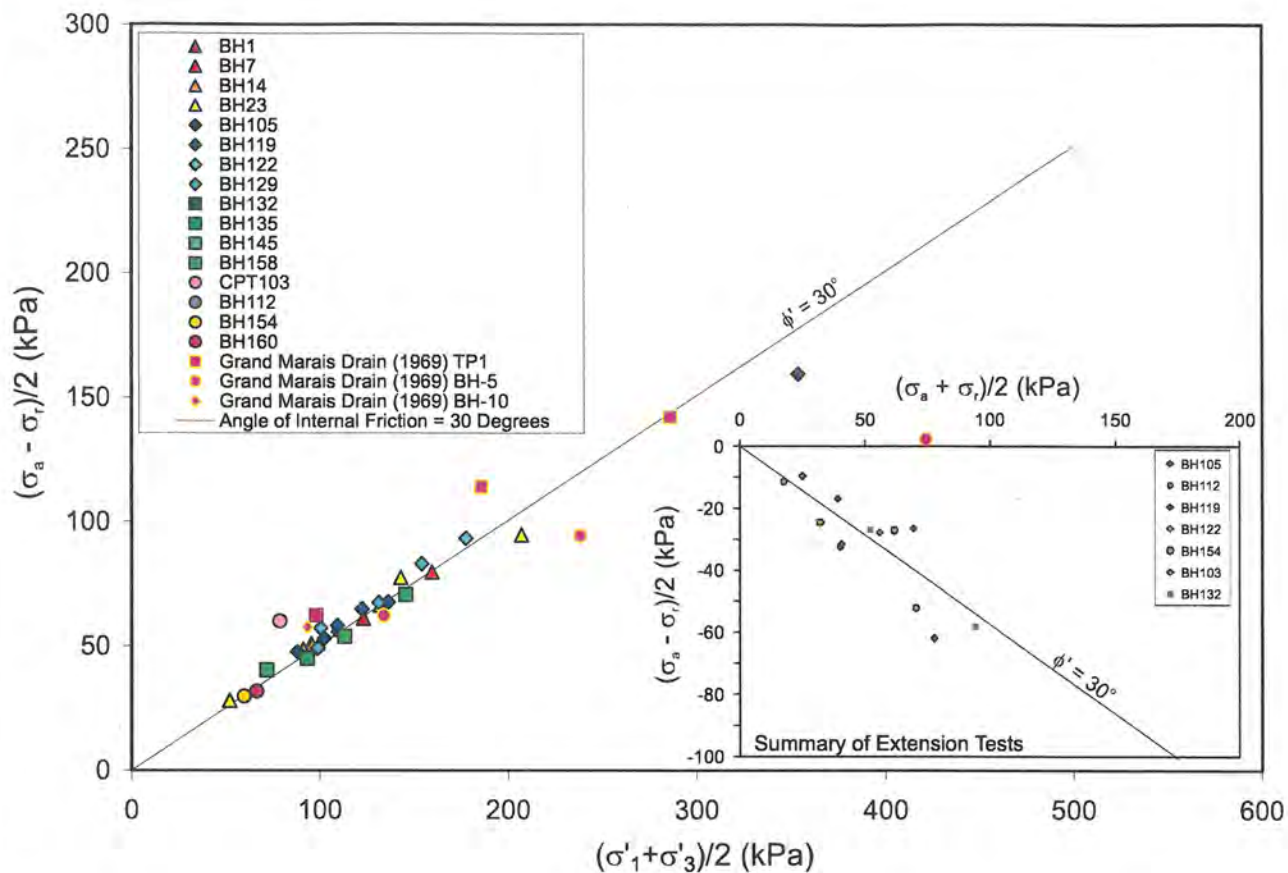
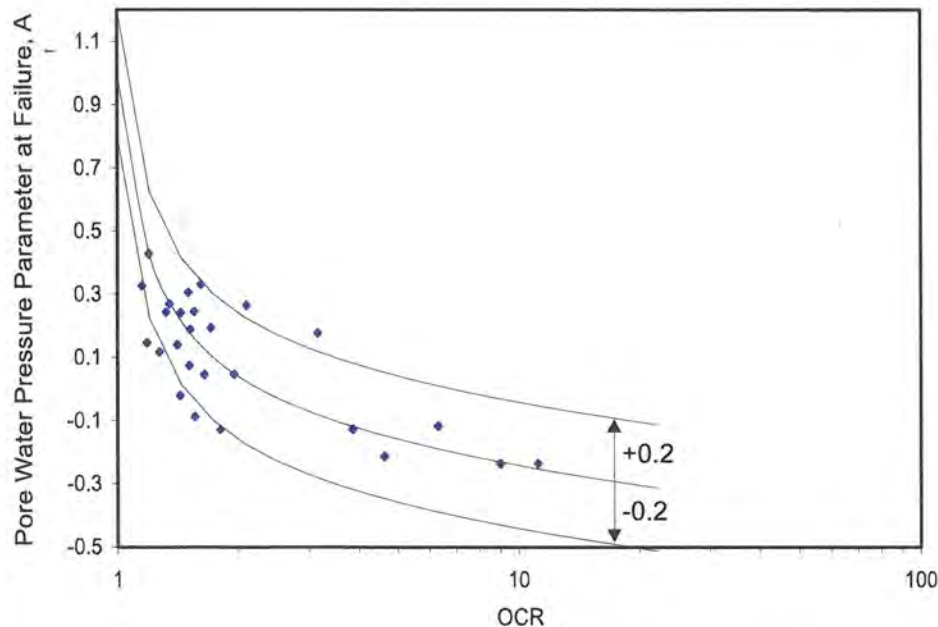
PROJECT No. 07-1130-2070		FILE No. 0711302070-R02088	
CADD	SJB	DEC 09	SCALE AS SHOWN REV. 1
CHECK	my	Dec 09	6.9

$\sigma'_a$  = axial effective stress at failure  
 $\sigma'_r$  = radial effective confining stress at failure  
 OCR = overconsolidation ratio  
 $A_v$  = pore water parameter at failure

1. THIS FIGURE IS TO BE READ WITH THE REPORT TITLED "SUBSURFACE CONDITIONS INTERPRETATION REPORT, WINDSOR-ESSEX PARKWAY"
2. THIS FIGURE REPRESENTS A SUMMARY OF LABORATORY TESTING DATA AS DISCUSSED IN THE TEXT OF THE REPORT REFERENCED ABOVE.

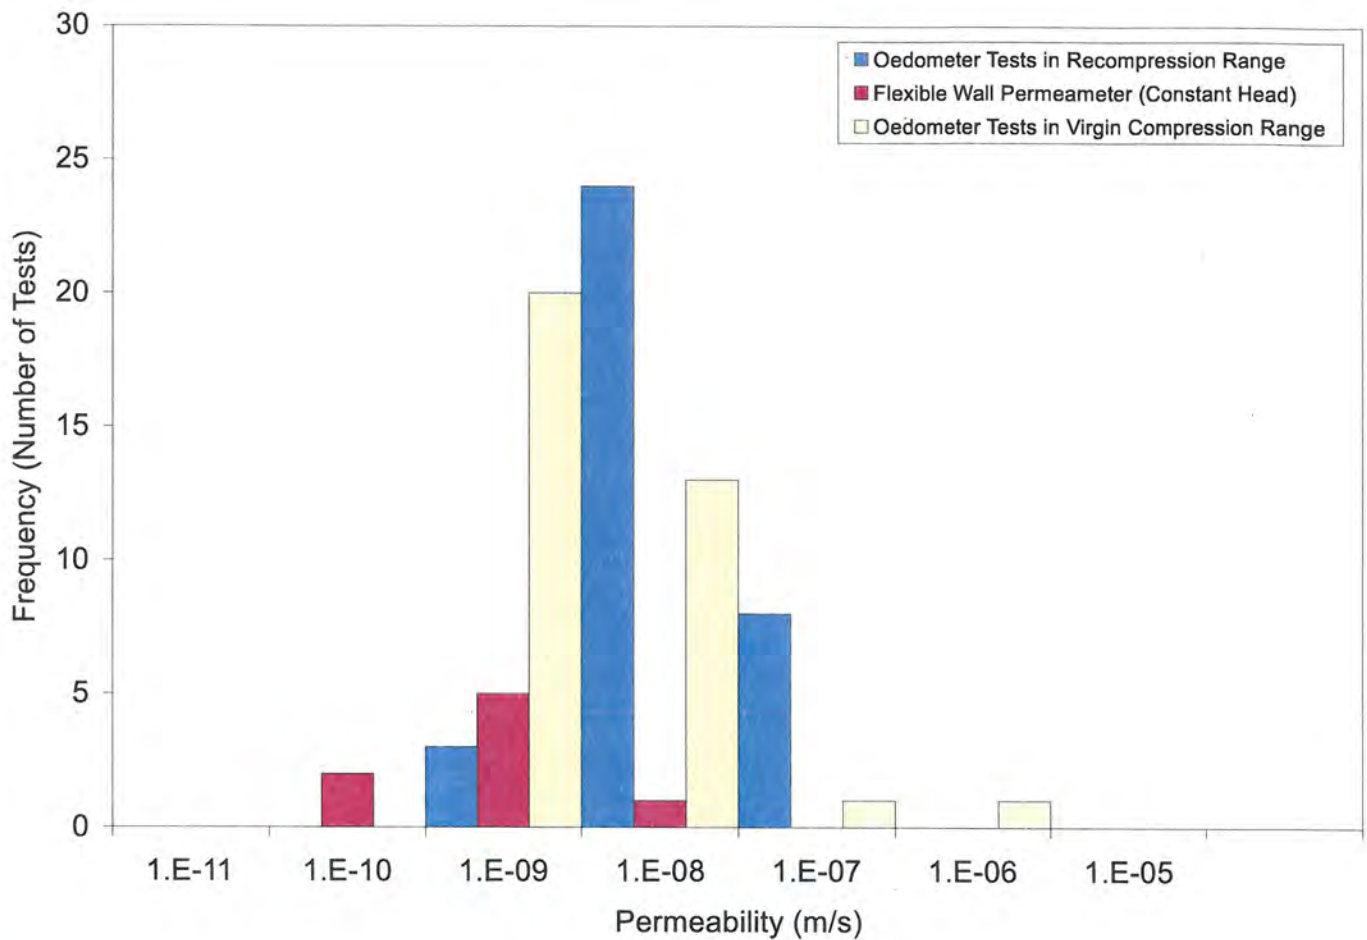
1. THIS FIGURE IS TO BE READ WITH THE REPORT TITLED "SUBSURFACE CONDITIONS INTERPRETATION REPORT, WINDSOR-ESSEX PARKWAY"
2. THIS FIGURE REPRESENTS A SUMMARY OF LABORATORY TESTING DATA AND DOES AS DISCUSSED IN THE TEXT OF THE REPORT REFERENCED ABOVE.

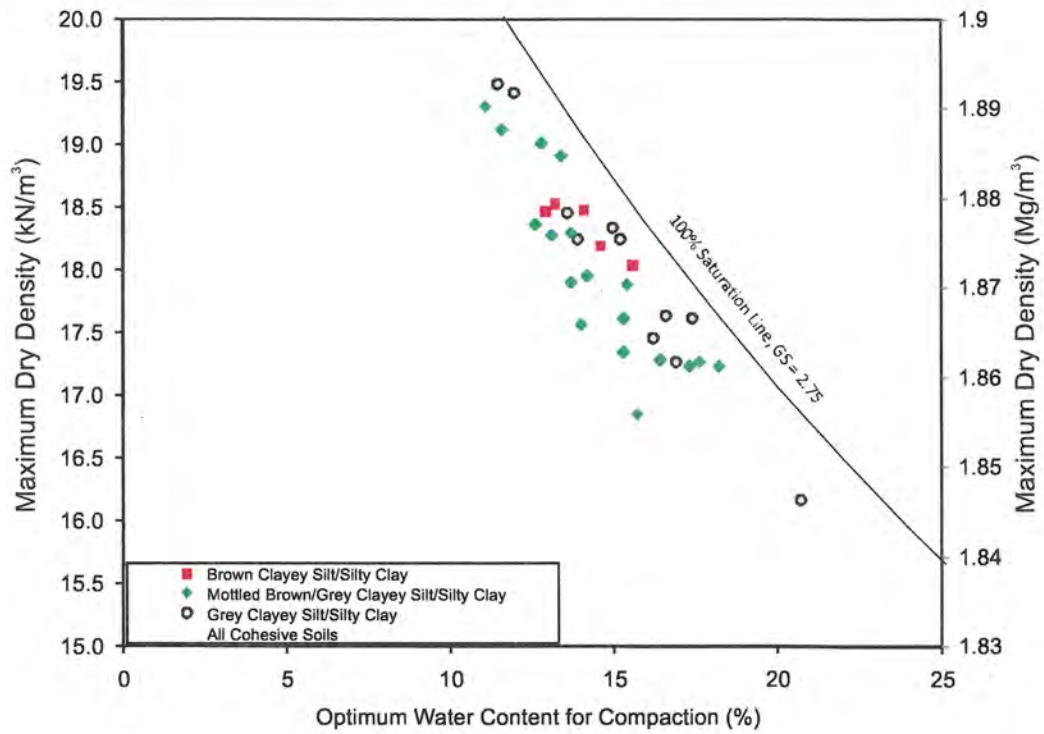
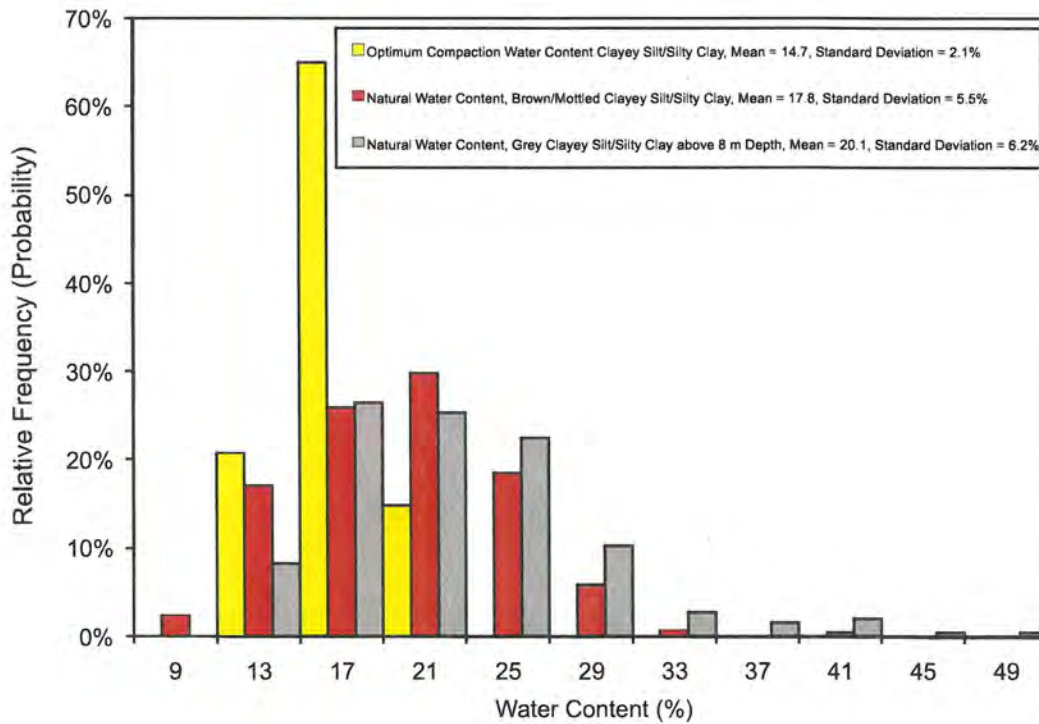
PROJECT			
SUBSURFACE CONDITIONS INTERPRETATION REPORT			
WINDSOR-ESSEX PARKWAY			
WINDSOR, ONTARIO			
TITLE			
DATA SUMMARY			
MAXIMUM DRY DENSITY AND OPTIMUM			
COMPACTION WATER CONTENT			
PROJECT No.		07-1130-2070	FILE No. 0711302070-R020611
CADD	SJB	DEC 09	SCALE N/A REV 1
CHECK	MY	Dico	6.11

1. THIS FIGURE IS TO BE READ WITH THE REPORT TITLED "SUBSURFACE CONDITIONS INTERPRETATION REPORT, WINDSOR-ESSEX PARKWAY"
2. THIS FIGURE REPRESENTS A SUMMARY OF LABORATORY TESTING DATA AS DISCUSSED IN THE TEXT OF THE REPORT REFERENCED ABOVE

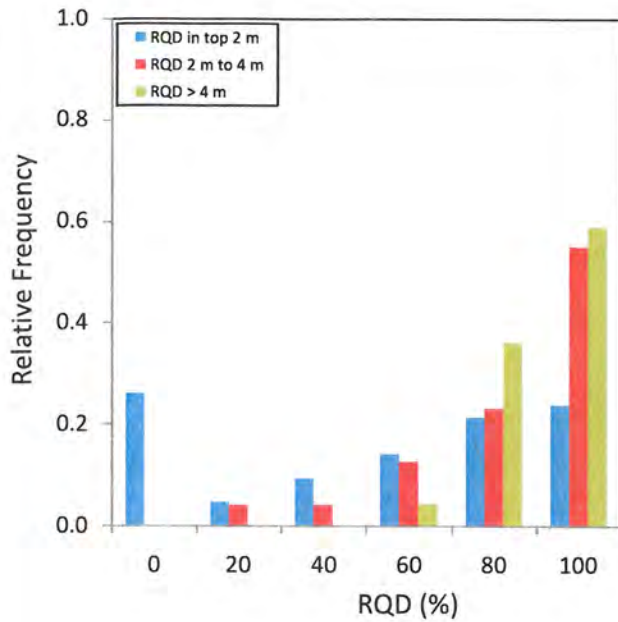
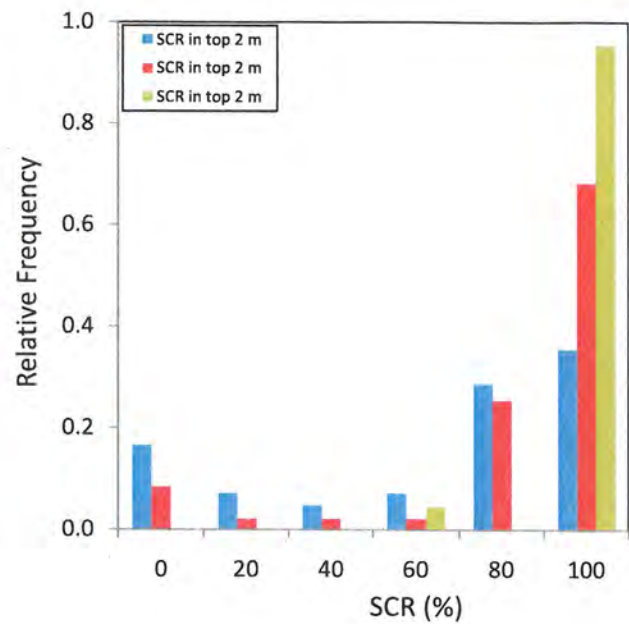
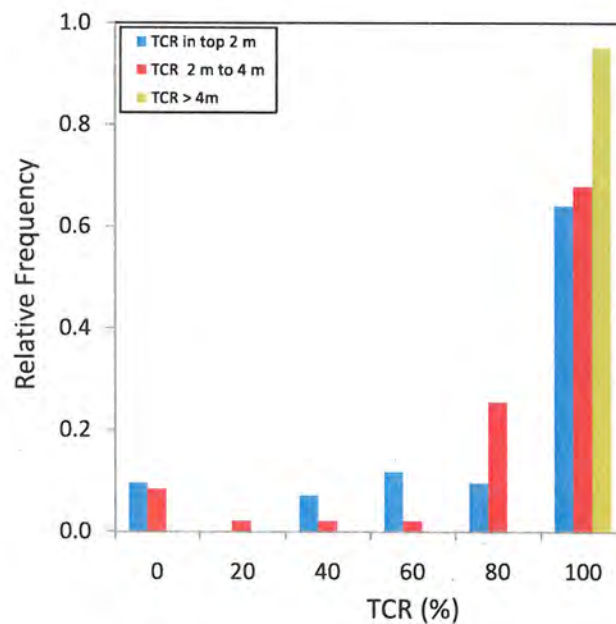
PROJECT <b>SUBSURFACE CONDITIONS INTERPRETATION REPORT WINDSOR-ESSEX PARKWAY WINDSOR, ONTARIO</b>			
TITLE <b>DATA SUMMARY ROCK CORING</b>			
PROJECT No. 07-1130-2070		FILE No. 0711302070-R020613	
CADD	SJB	DEC 09	SCALE AS SHOWN
CHECK	MY	JULIA	<b>6.13</b>

1. THIS FIGURE IS TO BE READ WITH THE REPORT TITLED "SUBSURFACE CONDITIONS INTERPRETATION REPORT, WINDSOR-ESSEX PARKWAY"
2. THIS FIGURE REPRESENTS A SUMMARY OF LABORATORY TESTING DATA AS DISCUSSED IN THE TEXT OF THE REPORT REFERENCED ABOVE

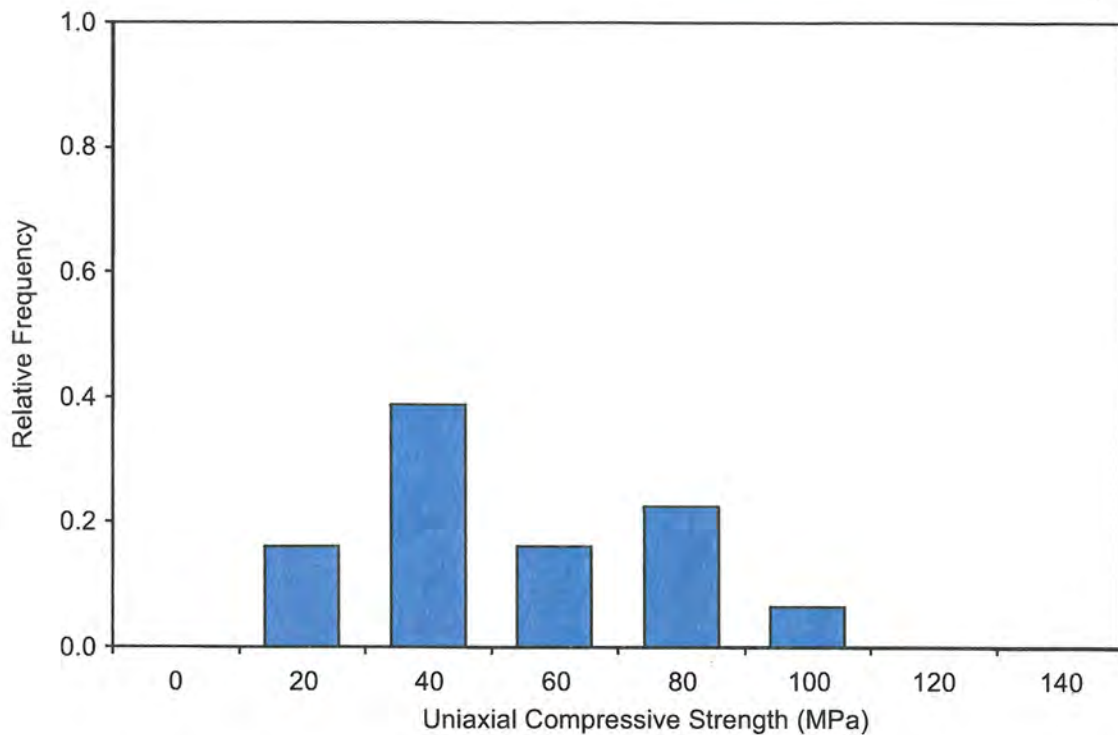
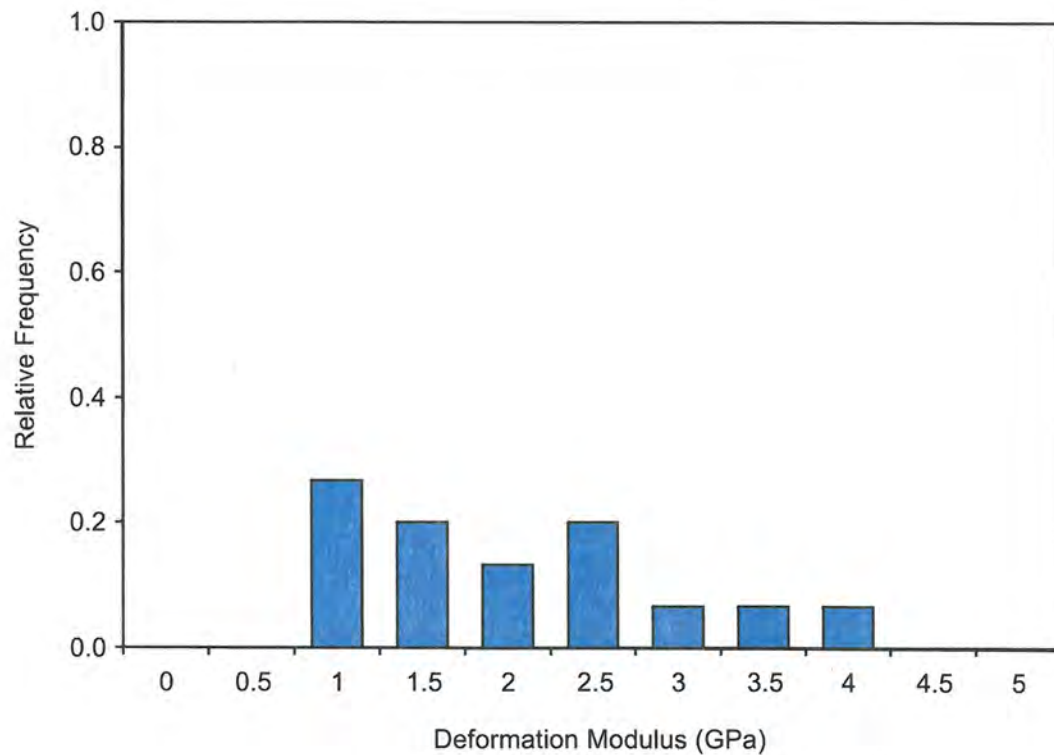
1. THIS FIGURE IS TO BE READ WITH THE REPORT TITLED "SUBSURFACE CONDITIONS INTERPRETATION REPORT, WINDSOR-ESSEX PARKWAY"
2. THIS FIGURE REPRESENTS A SUMMARY OF LABORATORY TESTING DATA AS DISCUSSED IN THE TEXT OF THE REPORT REFERENCED ABOVE
