FINAL REPORT FOUNDATION INVESTIGATION AND DESIGN

**BONNECHERE RIVER BRIDGE REHABILITATION
HIGHWAY 60
DEACON, ONTARIO
MINISTRY OF TRANSPORTATION
W.P. 247-99-01**

Report Number: 09-1111-6062

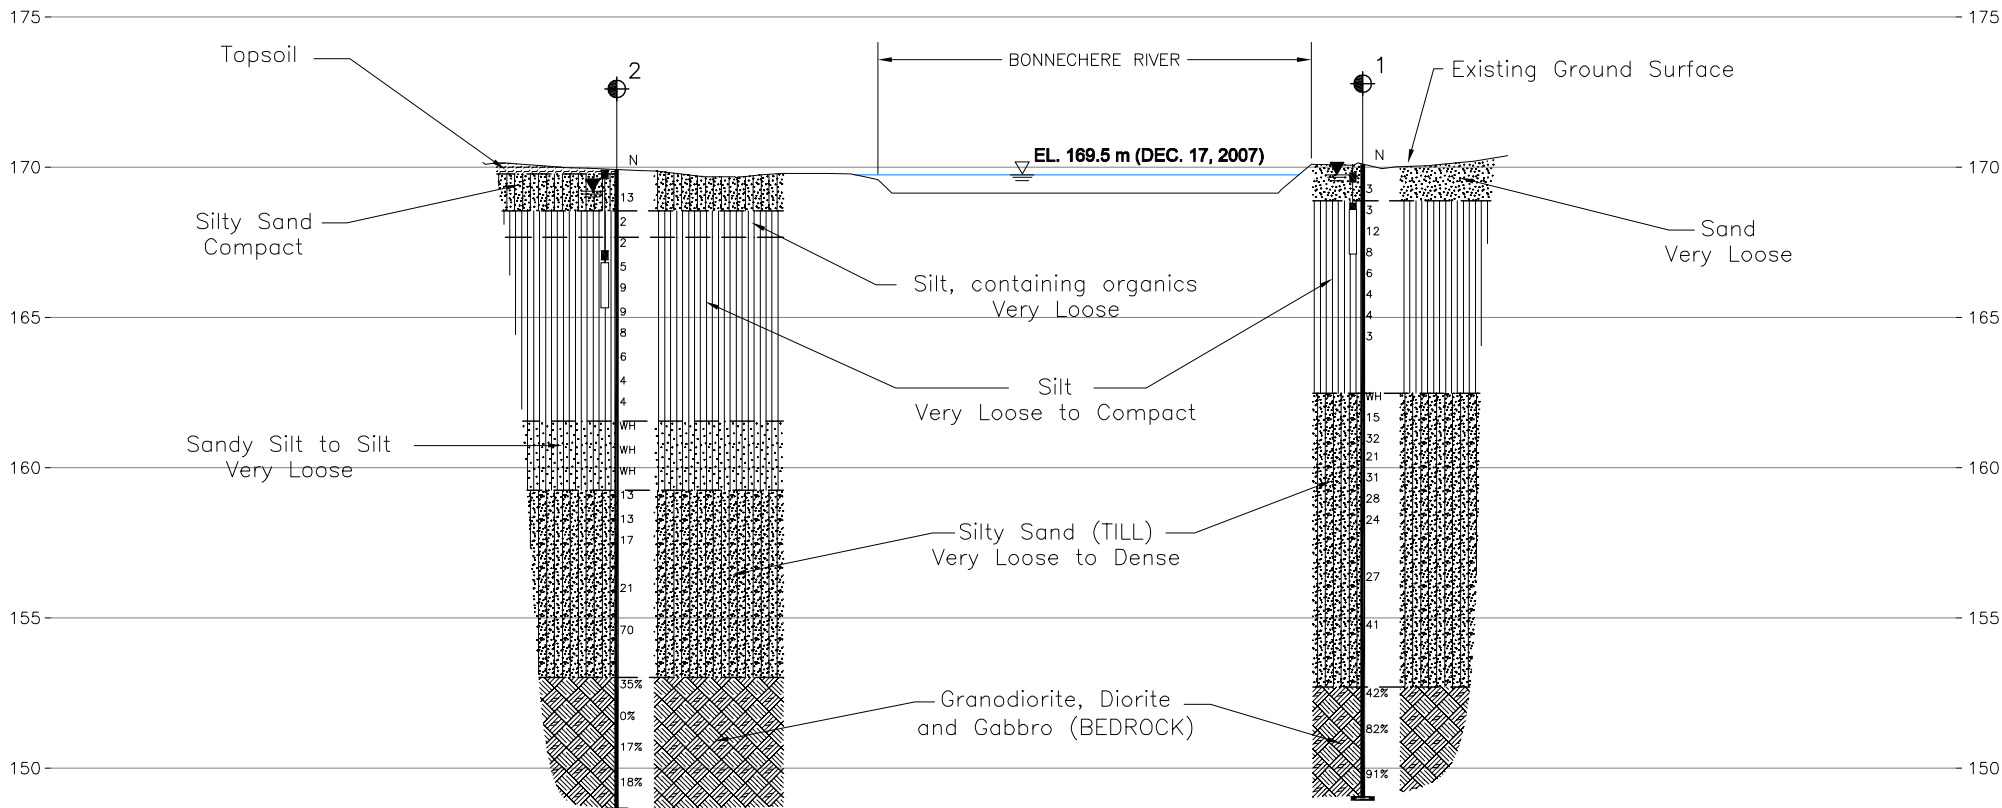
A-A'

PROFILE

Attachments: Drawing 1 – Borehole Location and Soil Strata
Appendix A – Record of Borehole Logs and Laboratory Test Results from Houle Chevrier Engineering Ltd. Report titled, "Geotechnical Investigation, Proposed Bridge Rehabilitation, Bonnechere River, Highway 60, Deacon, Ontario", dated January 2008

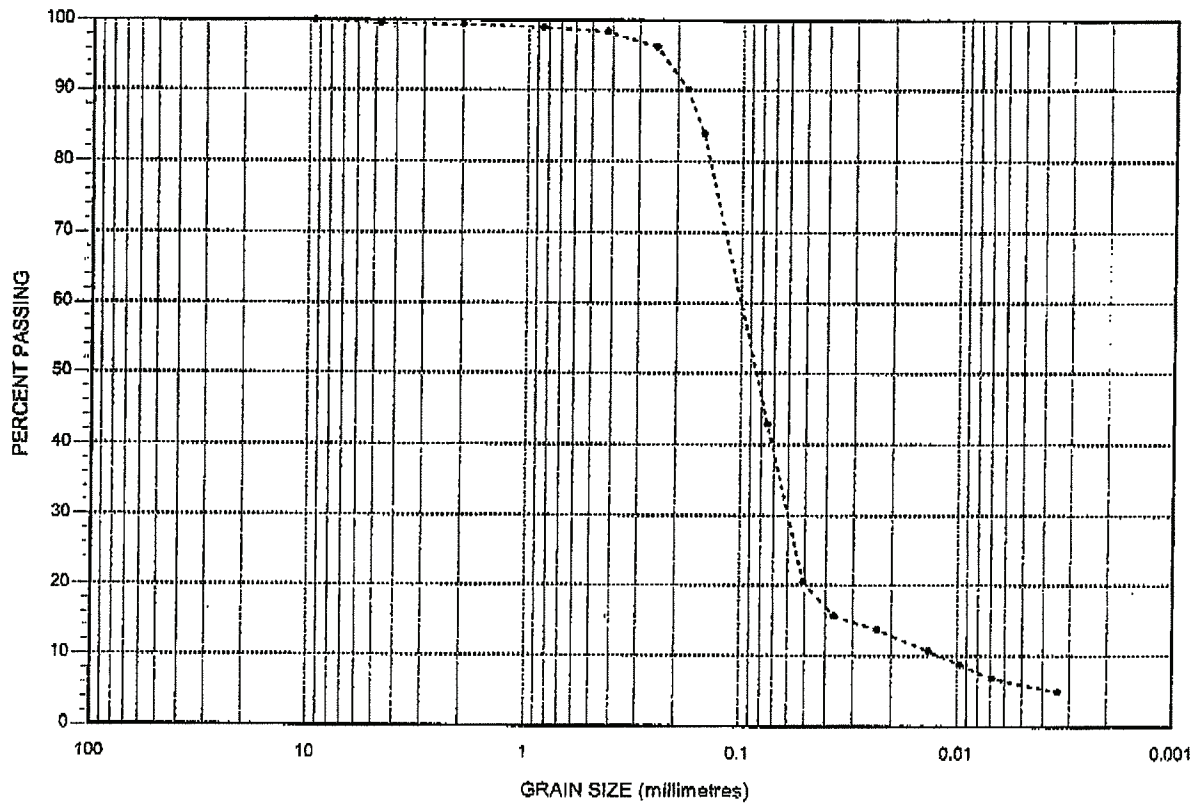
FIGURE 3

GRAIN SIZE DISTRIBUTION - NATIVE SILTY SAND -

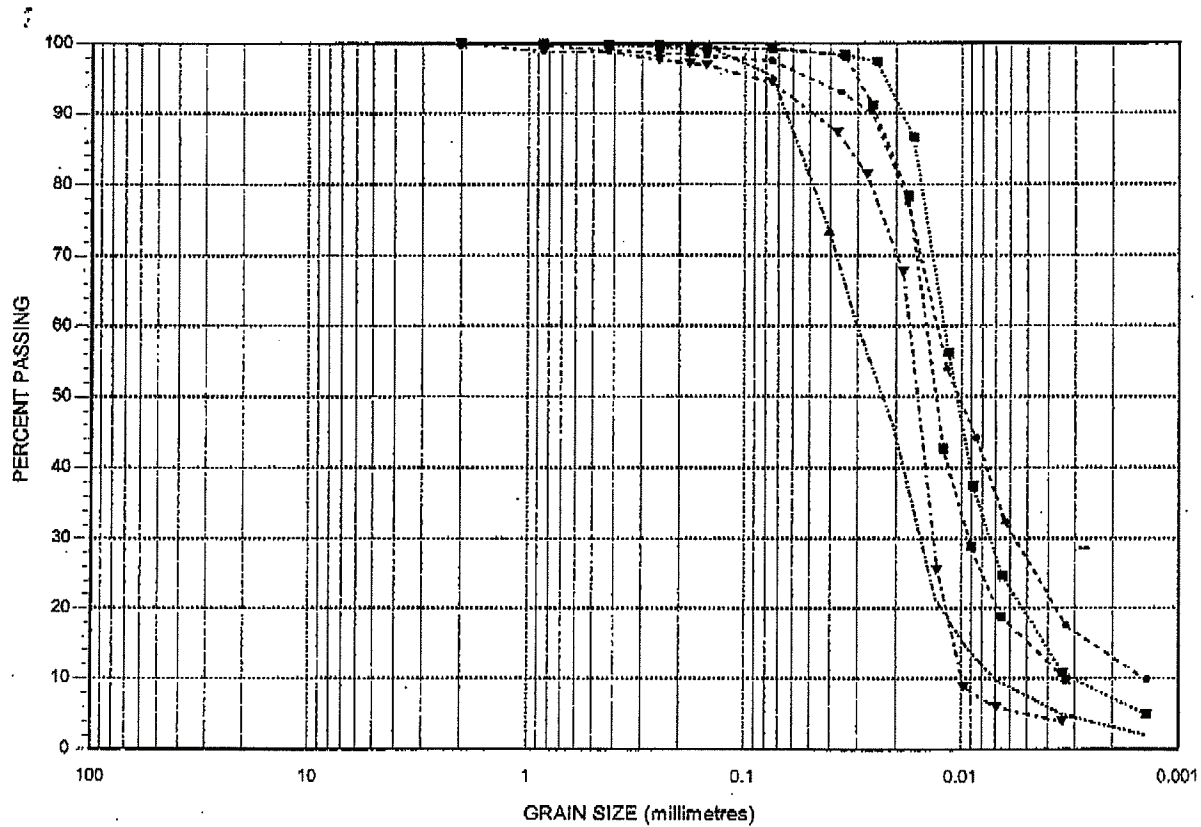
FIGURE 4

GRAIN SIZE DISTRIBUTION - NATIVE SILT -

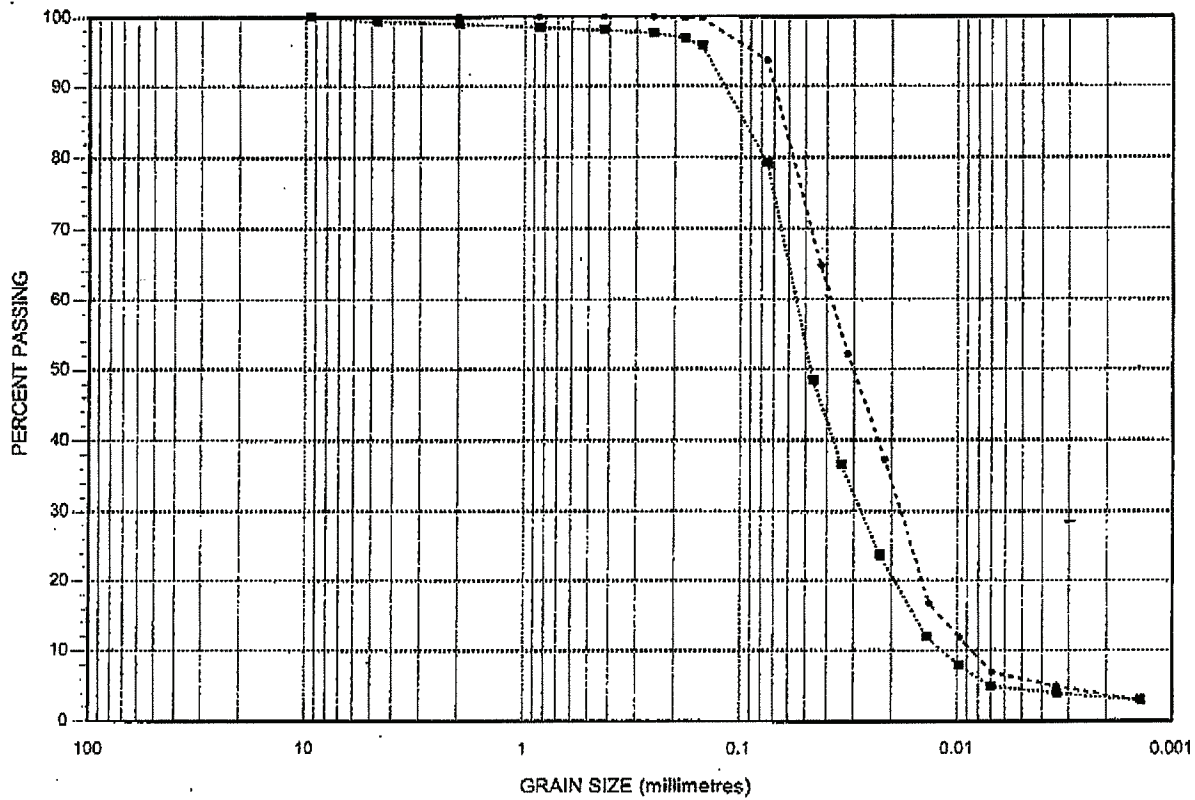
FIGURE 5

GRAIN SIZE DISTRIBUTION - NATIVE SANDY SILT AND SILT -

LEGEND
 - - - BH 2 SA 11
 - ■ - BH 2 SA 13

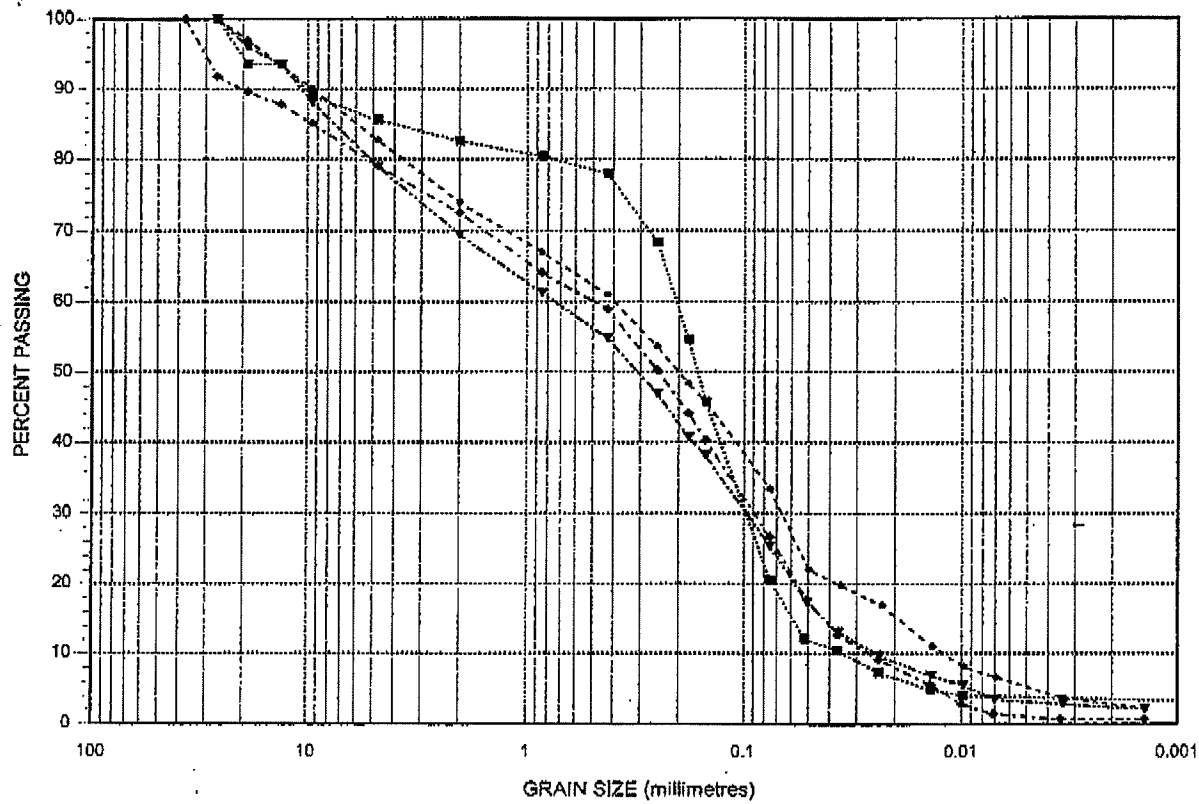
FIGURE 6

GRAIN SIZE DISTRIBUTION - GLACIAL TILL -
