**Bridge Rehabilitation – Hawk Creek Bridge  
Highway 547  
Stations 13+727 to 13+758 – Township of Esquega  
Site No. 38C-016  
GWP 5377-11-00**

## **FINAL FOUNDATION INVESTIGATION AND DESIGN REPORT**

Date: August 12, 2015  
Ref. N°: 15/04/15026-F1

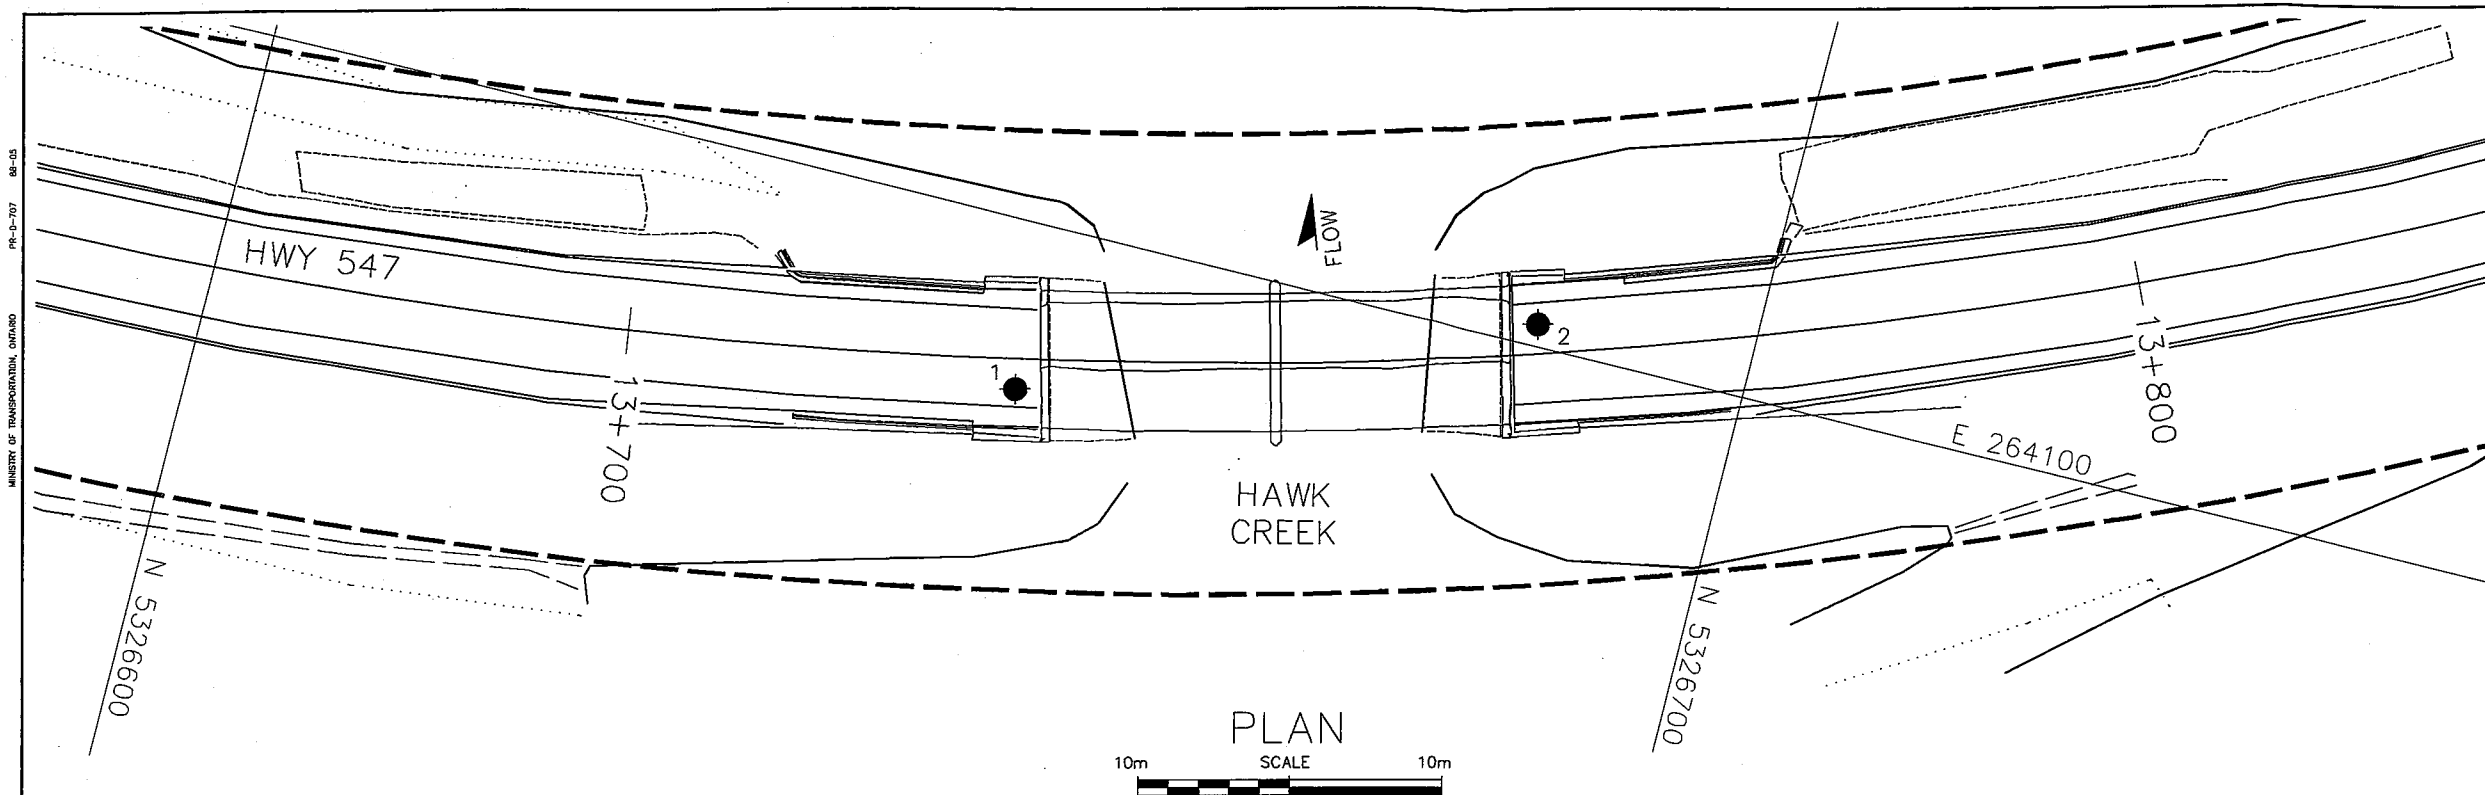
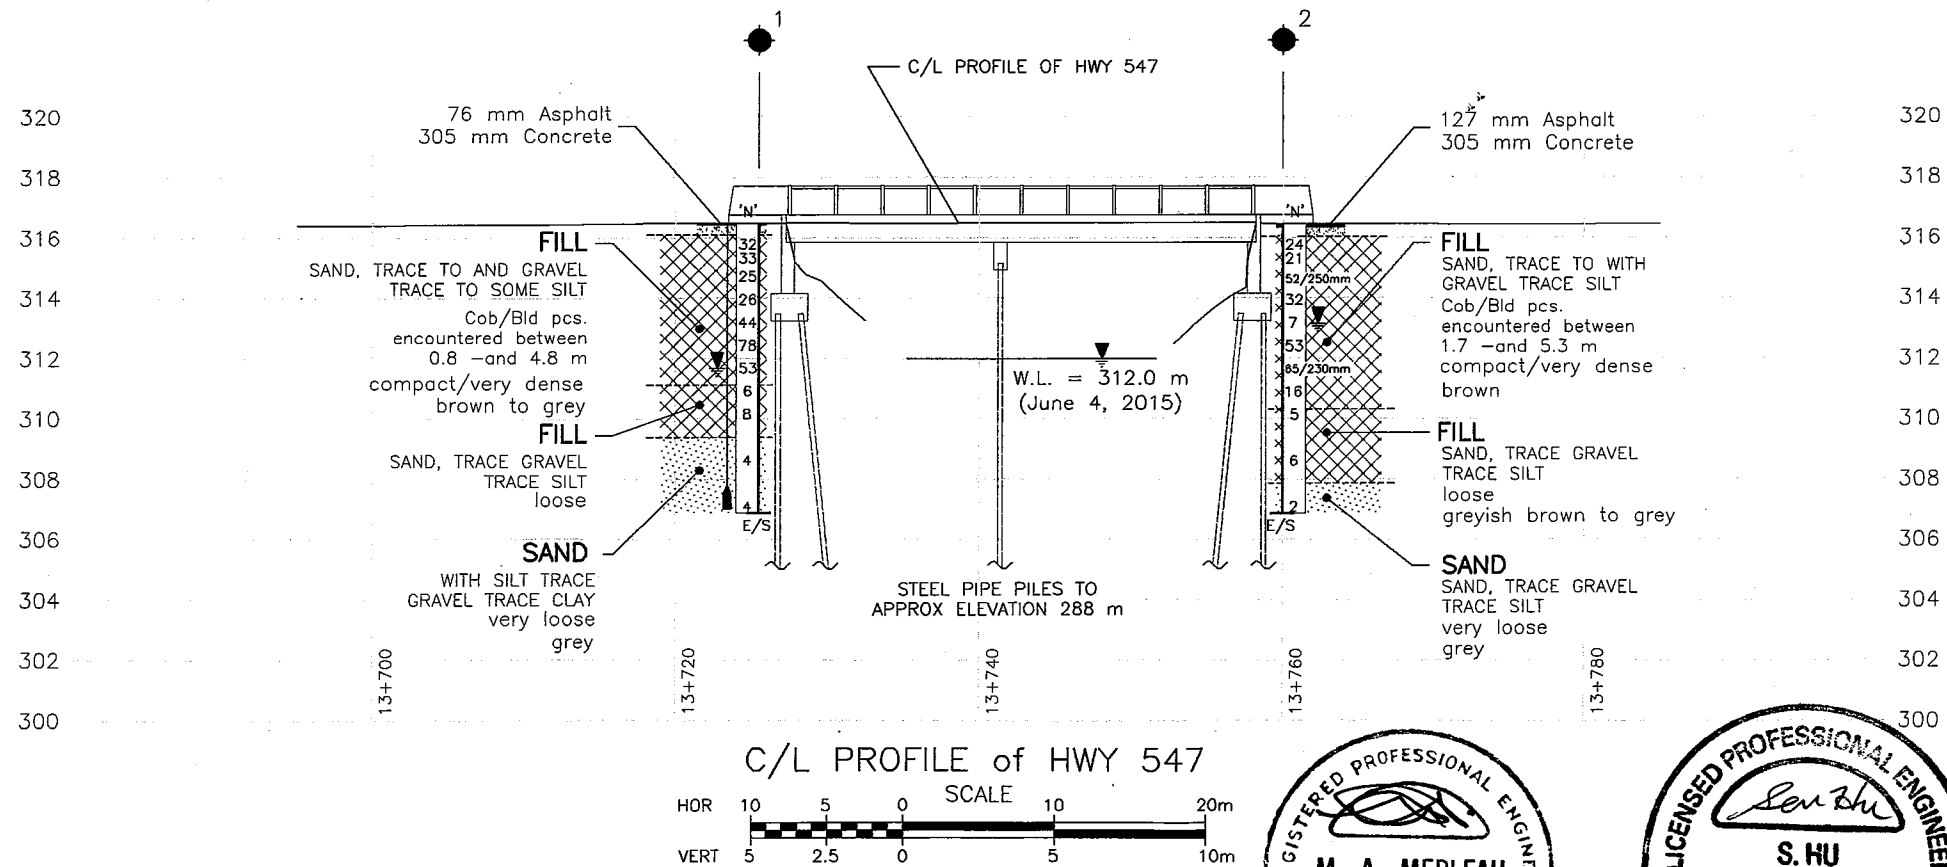
SHEET  
2

This drawing is for subsurface information only. Surface details and features are for conceptual illustration. The proposed structure location is shown for illustration purposes only and may not be consistent with the final design configuration as shown elsewhere in the Contract Documents.

HWY 547  
HAWK CREEK BRIDGE  
SITE NO. 38C-016  
BOREHOLE LOCATIONS  
AND SOIL STRATIGRAPHY

Details of the subsurface conditions revealed by the investigation program are presented on the enclosed Records of Borehole Logs (Appendix 2) and on Drawing No. 2 (Appendix 3). Please note that stratigraphic delineations presented on the borehole logs and soil strata plot are the results of non-continuous sampling, response to drilling progress, the results of SPT, plus field observations. Typically such boundaries represent transitions from one zone to another and are not an exact demarcation of specific geological unit. Additional consideration should be given to the fact that subsurface conditions may vary markedly between adjacent boreholes and beyond any specific boring location, and are shown on the drawings for illustration purposes only.

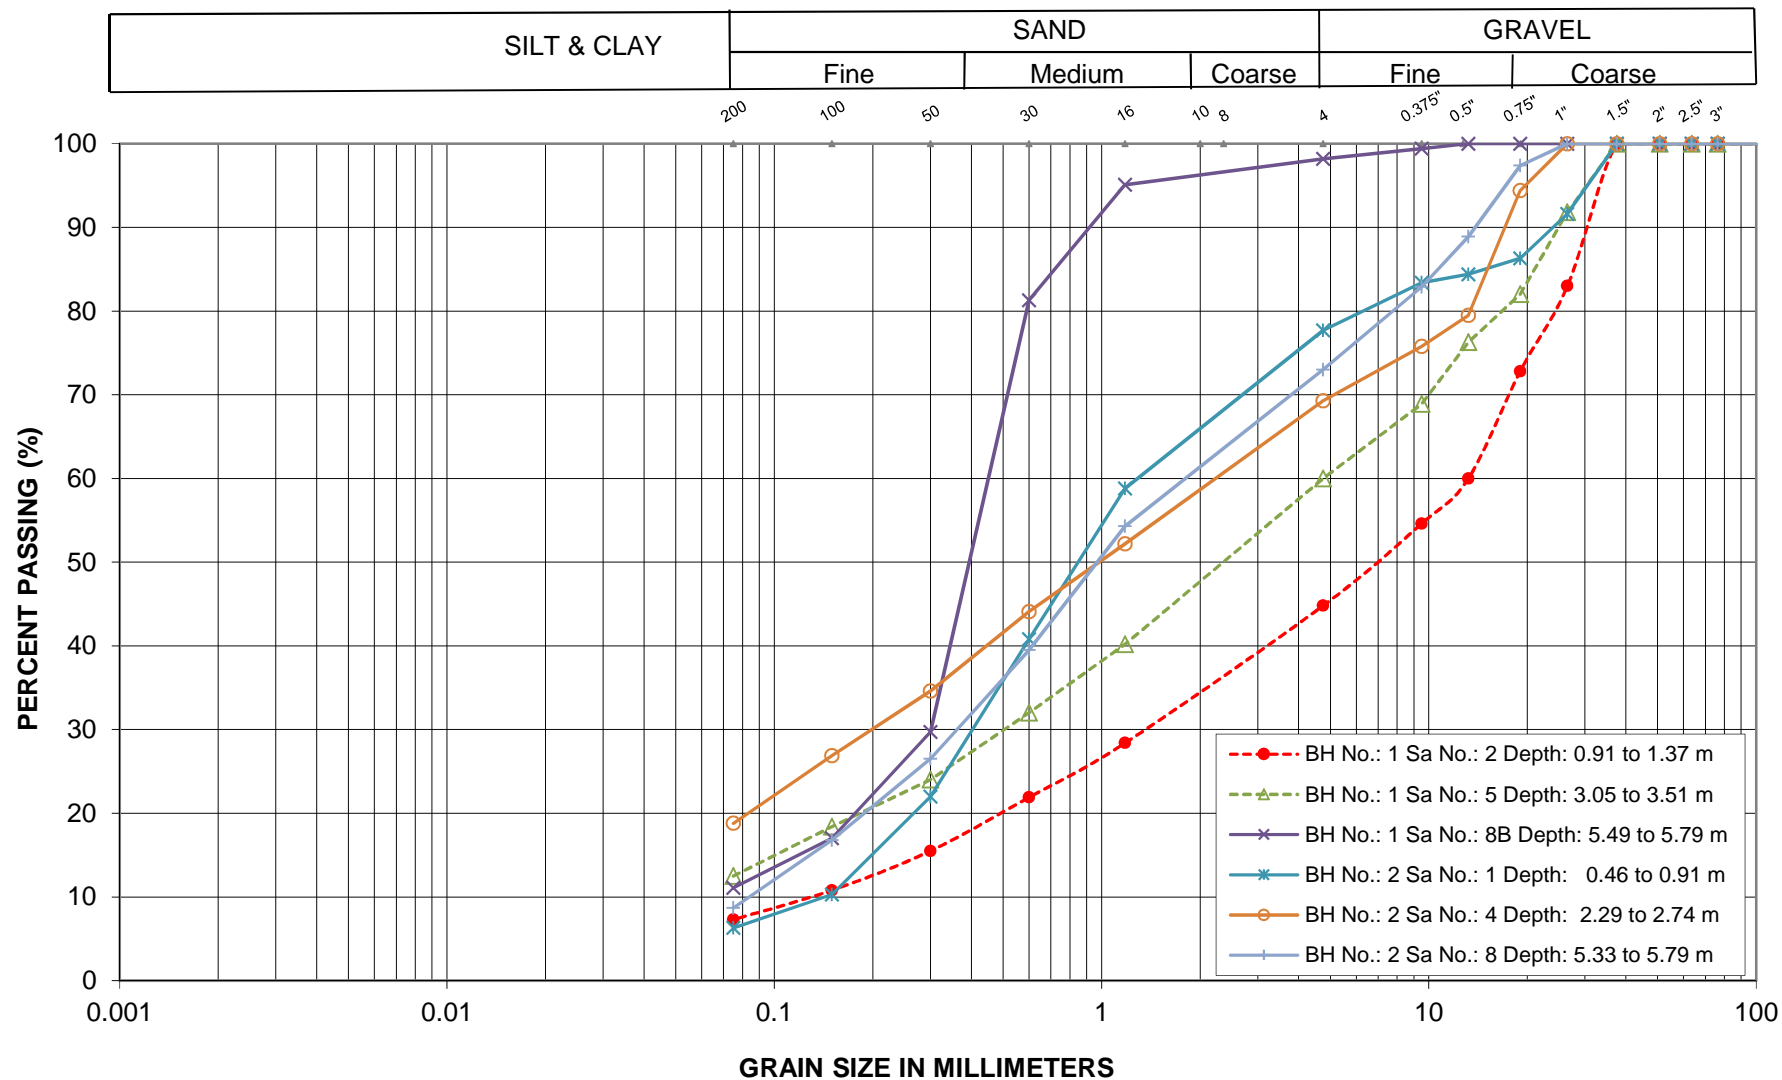
**FIGURE L-1**  
**GWP 5377-11-00**

**GRAIN SIZE ANALYSIS**

LOCATION: Hwy 547, Hawk Creek Bridge

Sand Fill

plus overall drill supervision. All samples received a visual confirmatory inspection in our laboratory. Laboratory testing of select samples included routine testing for natural moisture content determination and particle size analysis. The results of the laboratory testing are presented on the individual Record of Borehole Sheets (Appendix 2), with a summary of results presented on the laboratory sheets in Appendix 3 (Figures Nos. L-1 to L-2 and Table No. L-3).

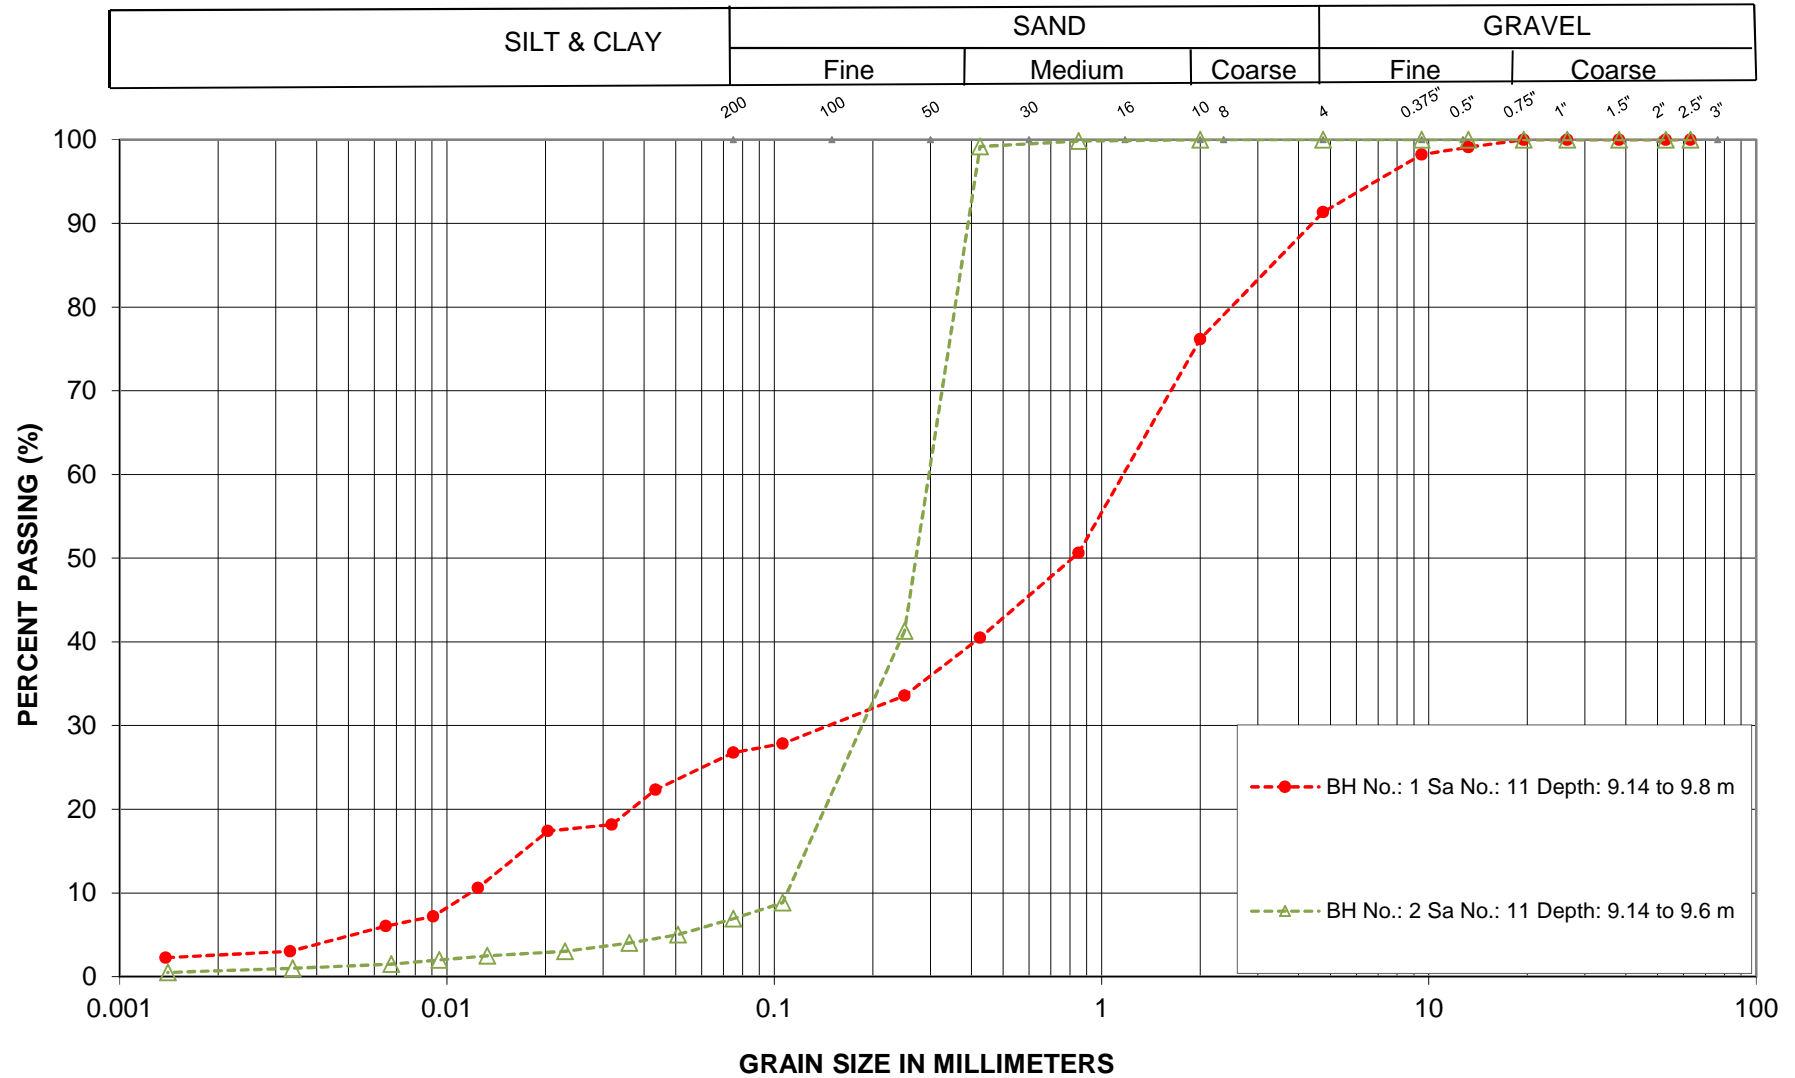
## GRAIN SIZE ANALYSIS

LOCATION: Hwy 547, Hawk Creek Bridge

SAND to SAND with SILT

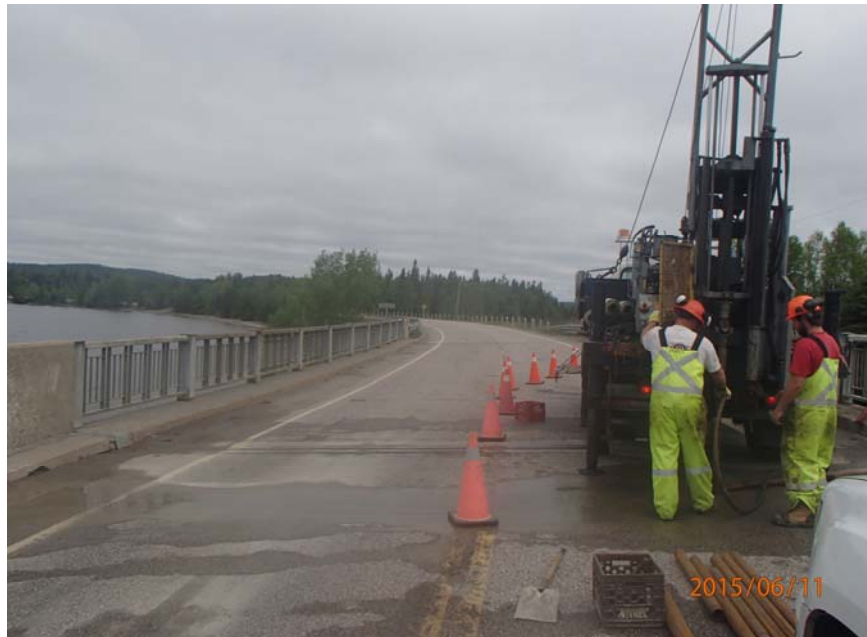
Photo: 1

Bridge South side– Looking North

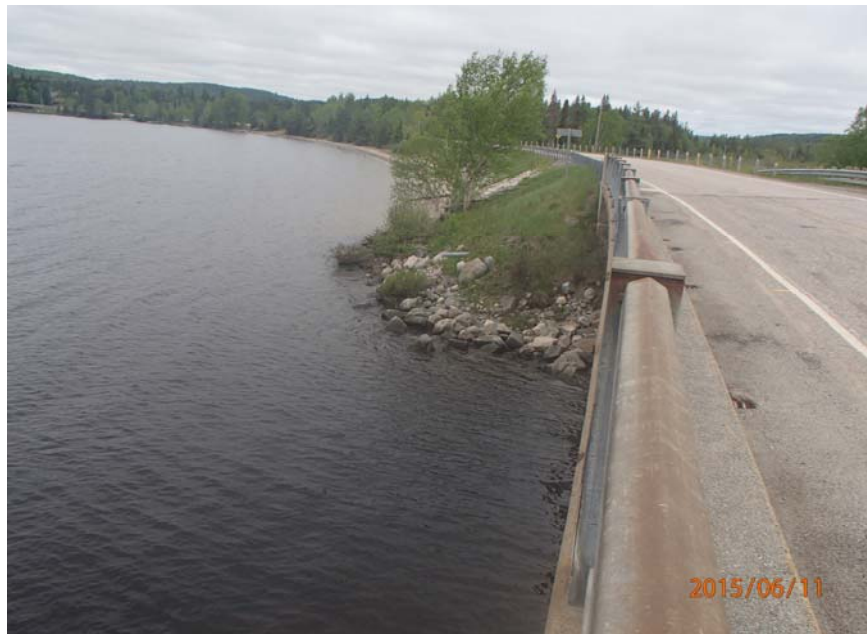
Photo: 2

Bridge North Approach Embankment – Looking Northwest

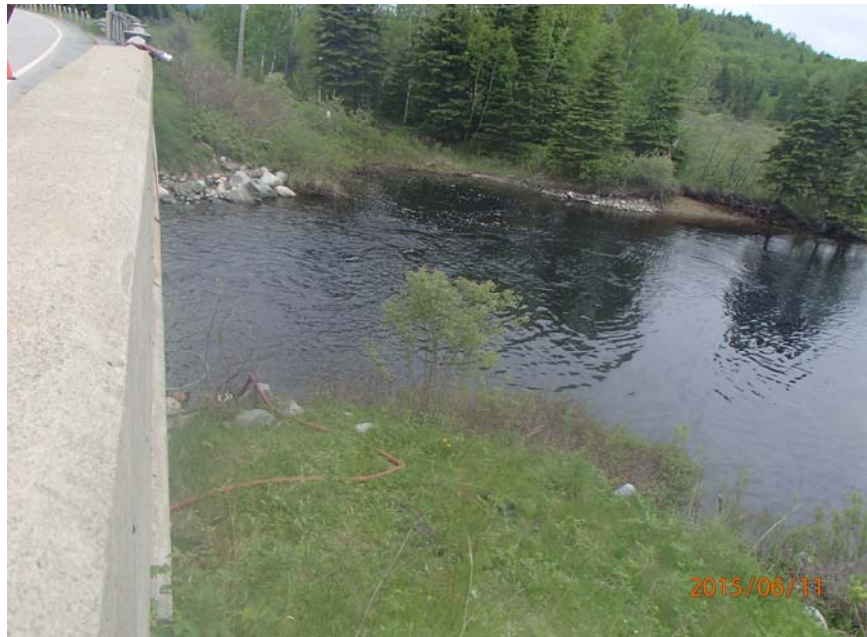
Photo: 3

Upstream of Creek– Looking Northeast

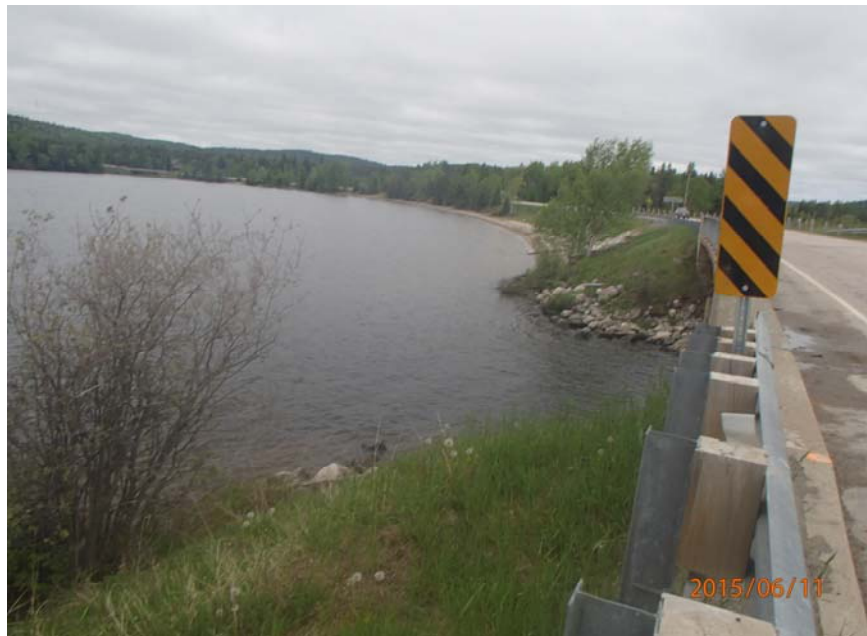
Photo: 4

Downstream of Creek to Hawk Lake – Looking Northwest

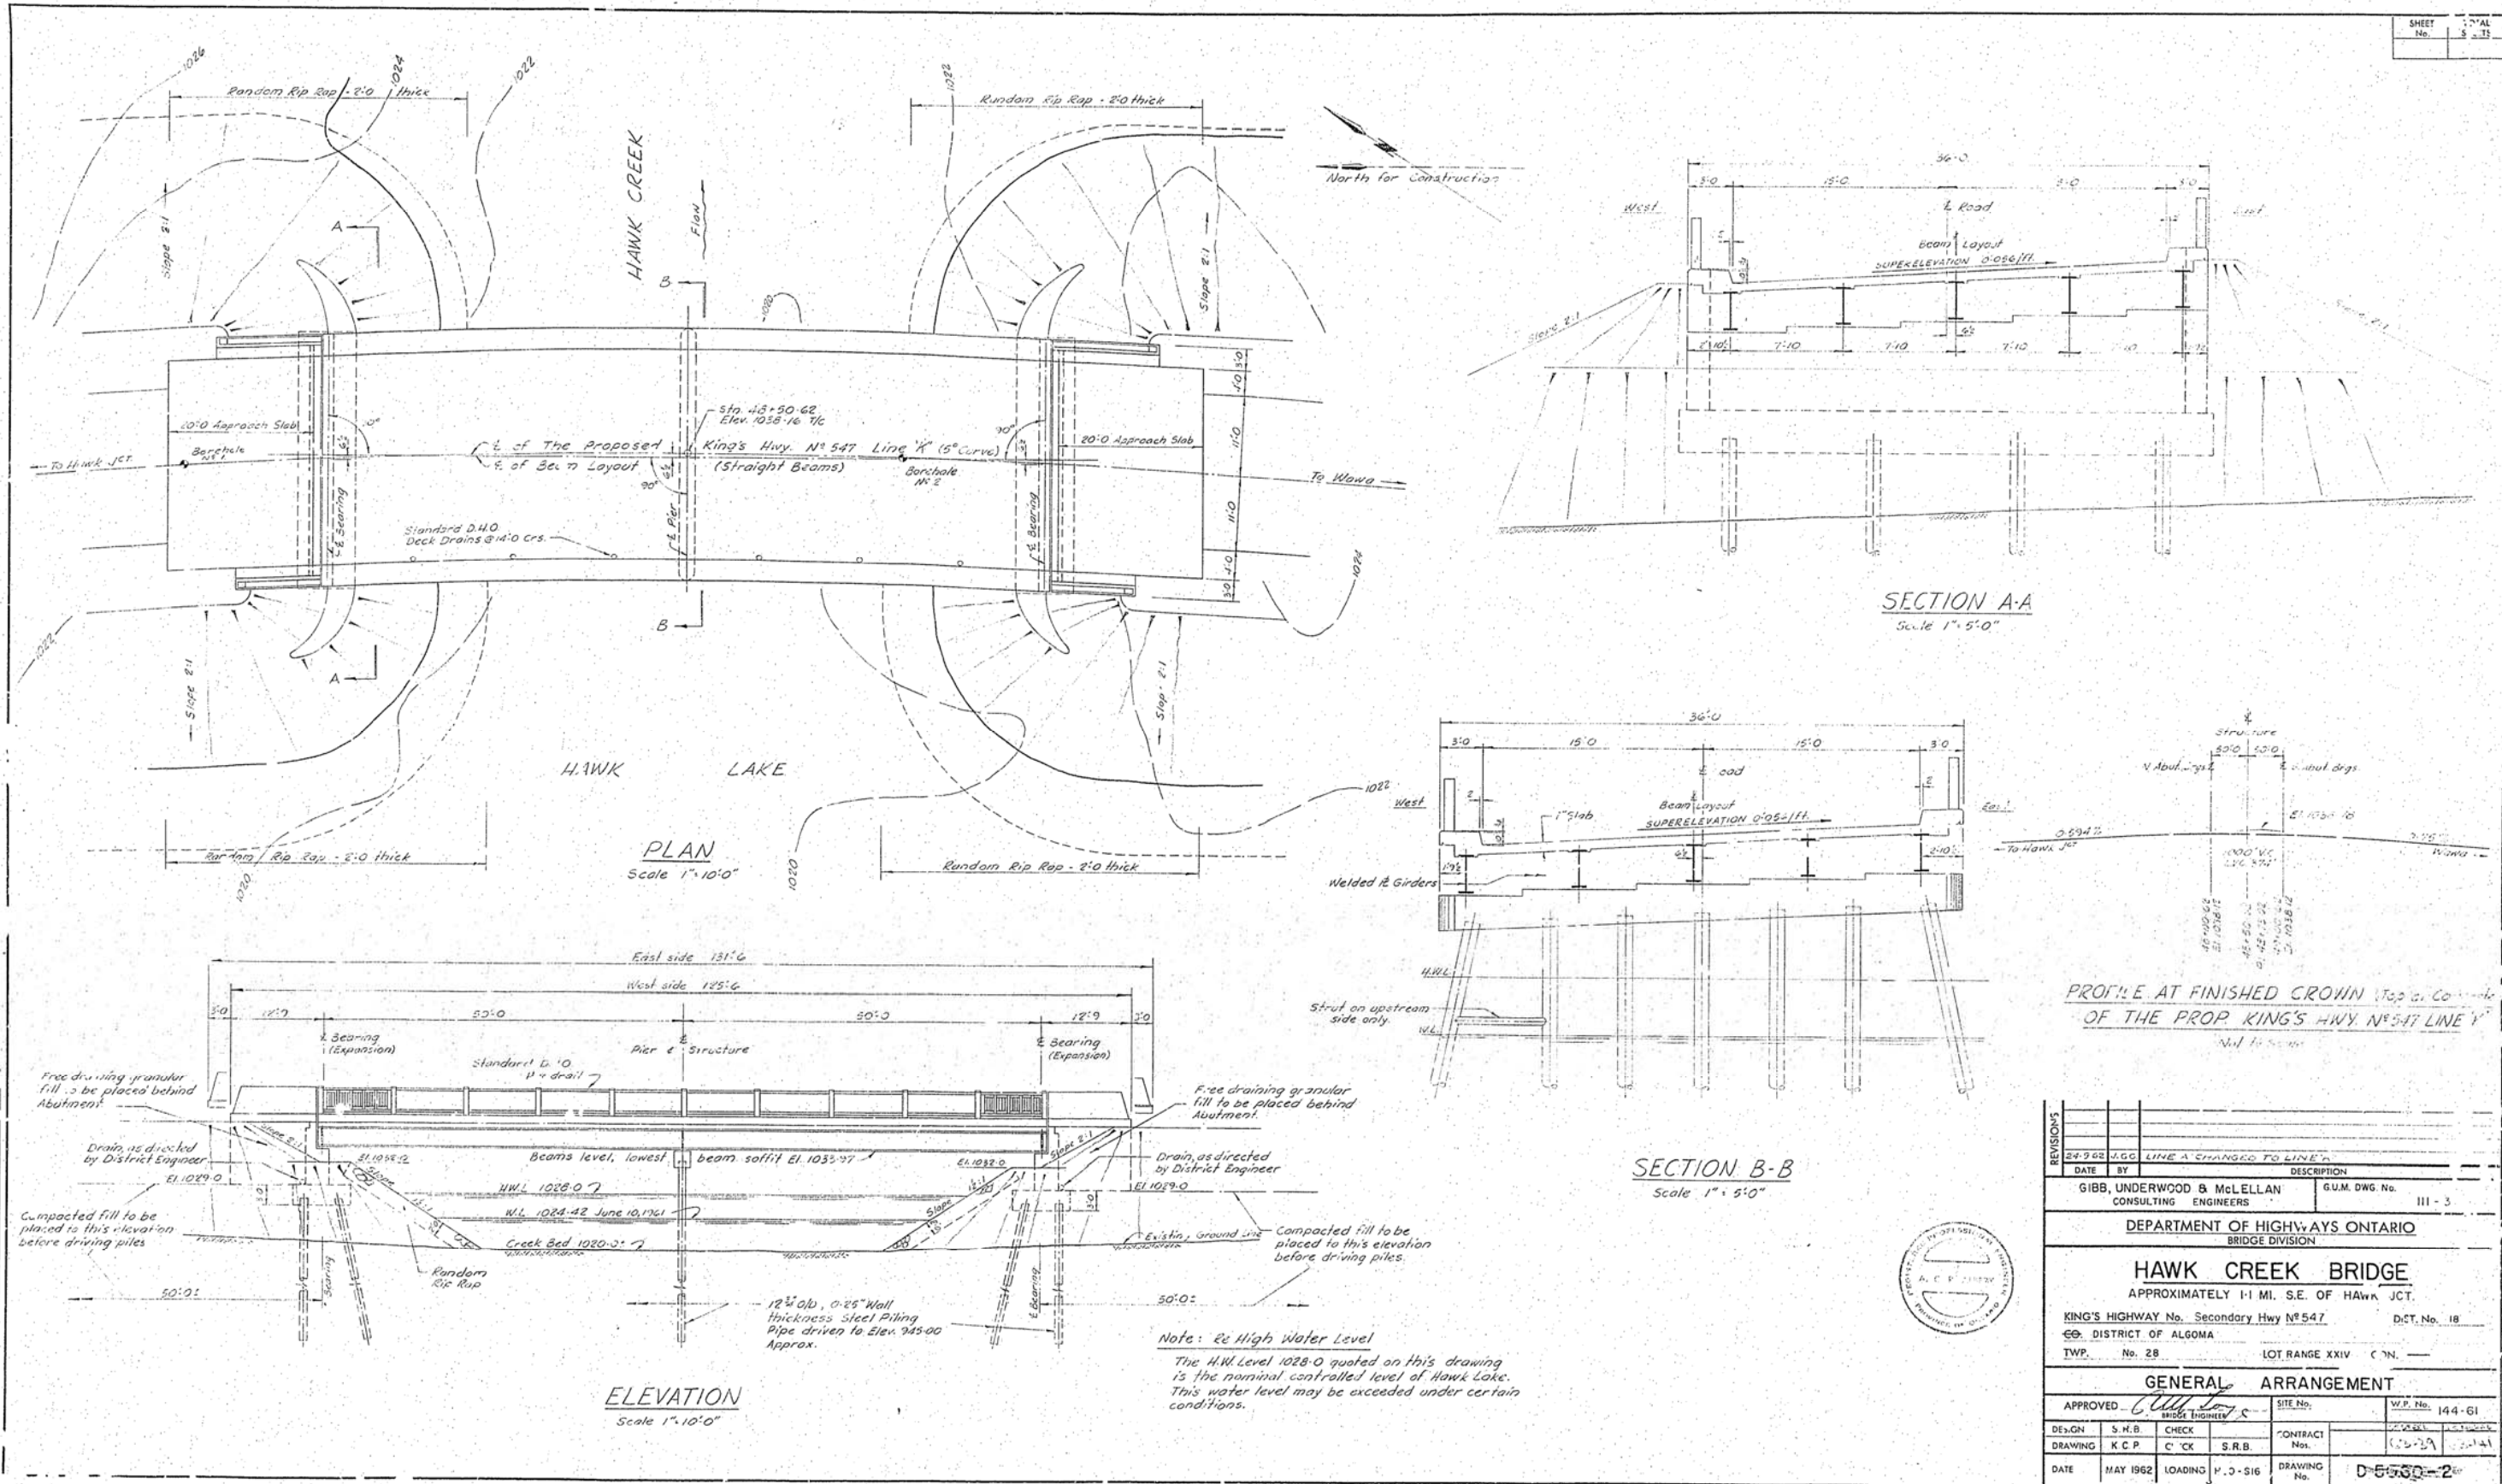
PROFILE AT FINISHED CROWN (Top of Center) OF THE PROPOSED KING'S HWY. NO. 547 LINE 1

REVISIONS					
24.9.62	J.G.C.	LINE A CHANGED TO LINE 1			
DATE	BY	DESCRIPTION			
GIBB, UNDERWOOD & McLELLAN		G.U.M. DWG. No.		III - 3	
CONSULTING ENGINEERS					
DEPARTMENT OF HIGHWAYS ONTARIO					
BRIDGE DIVISION					
HAWK CREEK BRIDGE					
APPROXIMATELY 1.1 MI. S.E. OF HAWK JCT.					
KING'S HIGHWAY No. Secondary Hwy No 547				D.C.T. No. 18	
CO. DISTRICT OF ALGOMA					
TWP. No. 28		LOT RANGE XXIV C.N. —			
GENERAL ARRANGEMENT					
APPROVED		SITE No.		W.P. No. 144-61	
DESIGN		CHECK		CONTRACT	
DRAWING		S.R.B.		Nos.	
DATE		LOADING		DRAWING	
MAY 1962		J.C. - S16		No. D-550-2

5, Appendix 5). Based on a Drawing No. TWP 682-16-2-A of Contract No. 63-39, the existing bridge was founded on deep foundations (324 mm diameter steel pipe piles driven to refusal at approximate elevation 288 m) at both of the north and the south abutments and the central pier (Enclosure No. 6, Appendix 5).

Based on the Contract No. 63-39, the existing bridge is founded on deep foundations (324 mm diameter steel pipe piles driven to refusal at approximate elevation 288 m) at both of the north and the south abutments and the central pier (Enclosure No. 6, Appendix 5). The conversion to semi integral abutments will require the removal of the ballast walls. It is anticipated that, to carry out the bridge rehabilitation and convert the Hawk Creek Bridge to a semi integral abutment, an excavation some 1.2 m deep of will be required behind the existing abutments. As such, a protection system will be required at the north and south abutments of the bridge to support an excavation some 1.2 m deep behind the abutments and maintain an active lane of traffic. Based on data from this foundation investigation, the embankment fill behind the abutments supporting the approach slabs and pavement structure generally consists of sand and gravel fill to sand fill, mixed with rock pieces of the cobble and boulder sizes encountered at depths ranging from 0.8 m to 5.3 m below ground surface, at locations of Borehole Nos. 1 and 2.
