**Bridge Rehabilitation
Highway 11
Oro Line 7 UP (Simcoe Road 27)
Site No 30-471
GWP 2087-15-00**

FINAL FOUNDATION INVESTIGATION REPORT

Date: February 20, 2018
Ref. Nº: P-0014012-0-00-100-01-F2

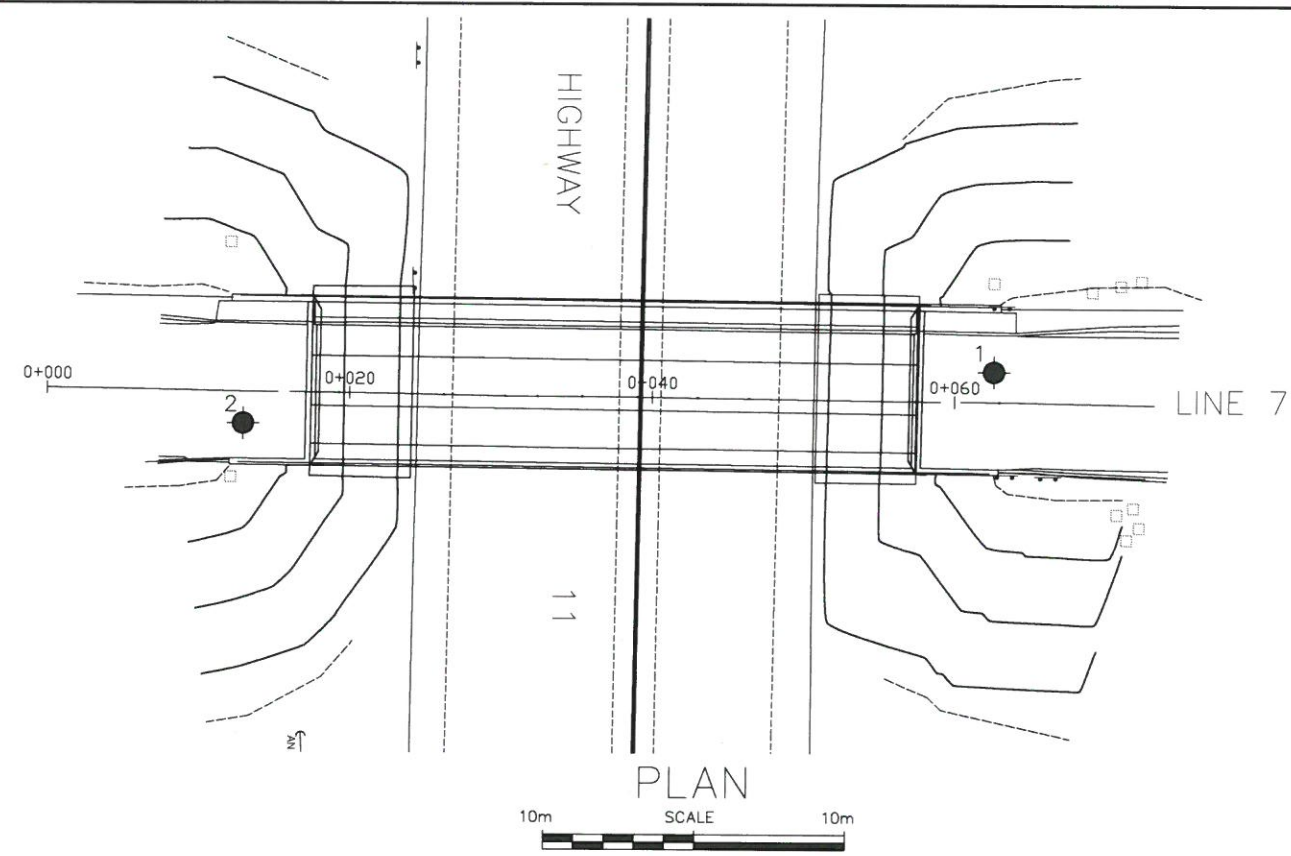
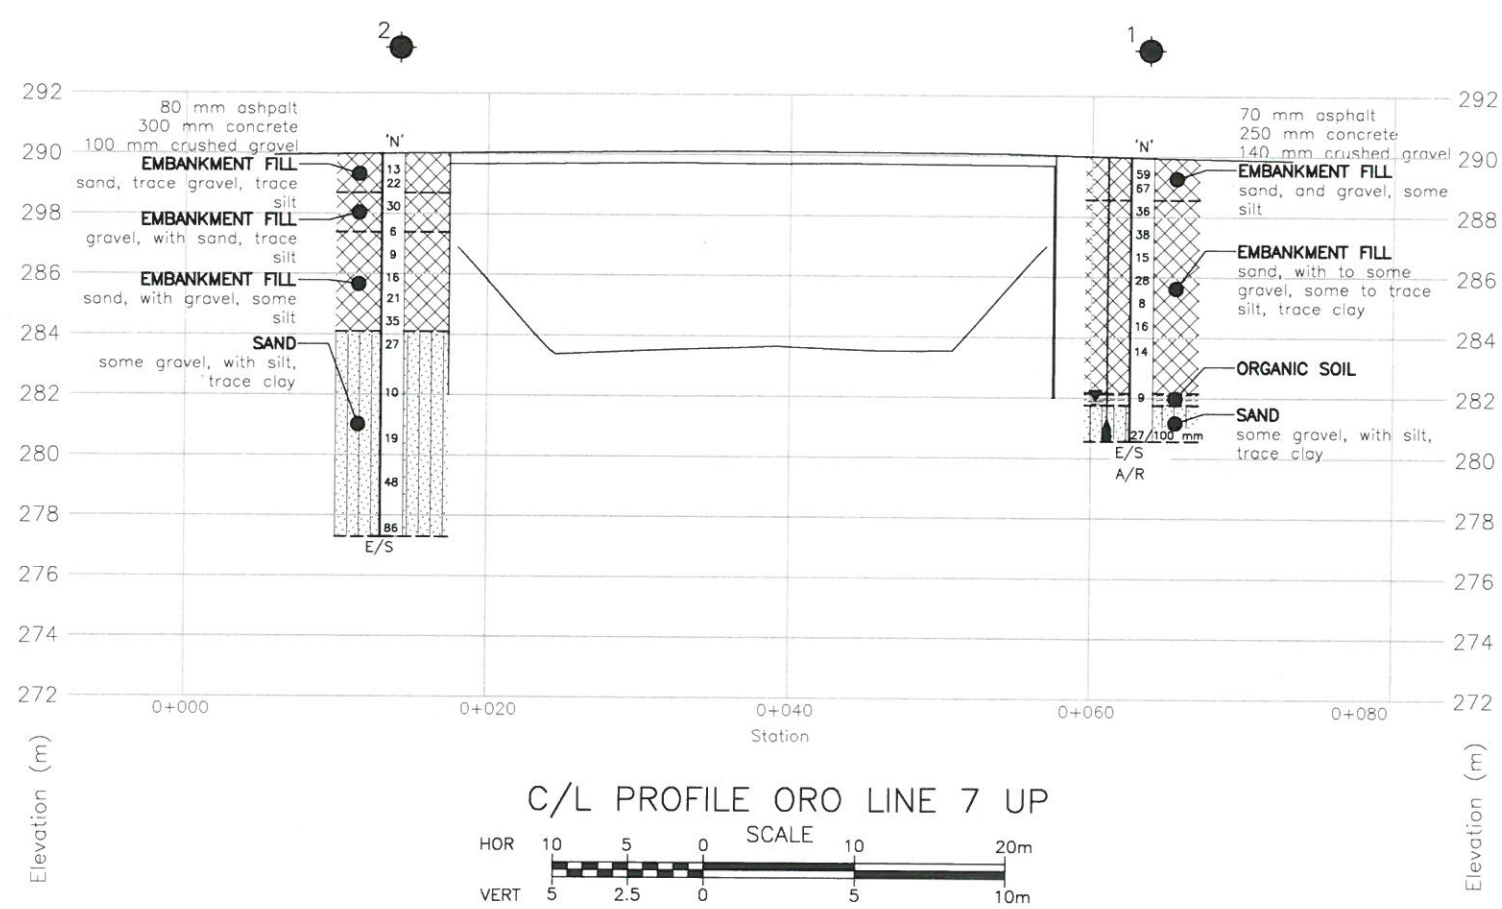
This drawing is for subsurface information only. Surface details and features are for conceptual illustration. The proposed structure location is shown for illustration purposes only and may not be consistent with the final design configuration as shown elsewhere in the Contract Documents.

Details of the subsurface conditions revealed by the investigation program are presented on the enclosed Records of Borehole Logs (Enclosure Nos. 2 and 3, Appendix 2) and on Drawing No. 2 (Appendix 3). Please note that stratigraphic delineation presented on the borehole logs and soil strata plot are the results of non-continuous sampling, response to drilling progress, the results of SPT, plus field observations. Typically such boundaries represent transitions from one zone to another and are not an exact demarcation of specific geological unit. Additional consideration should be given to the fact that subsurface conditions may vary markedly between adjacent boreholes and beyond any specific boring location, and are shown on the drawings for illustration purposes only.

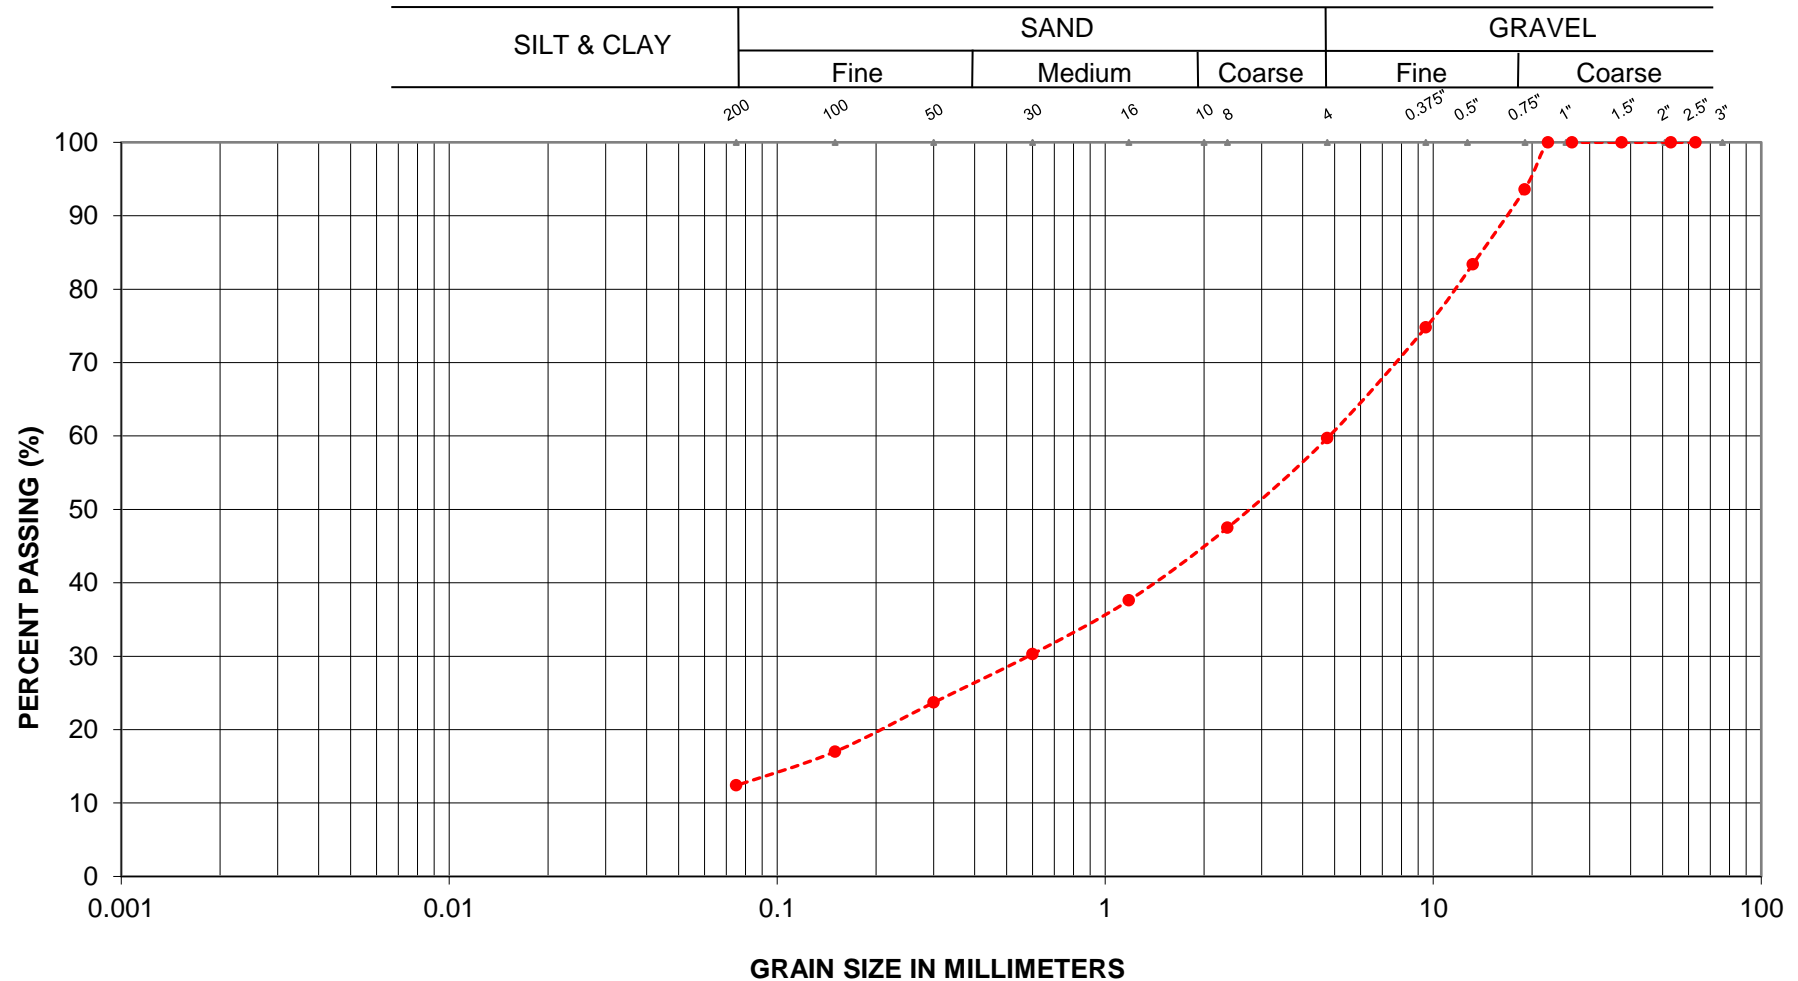
FIGURE L-1

GRAIN SIZE ANALYSIS

---●--- BH No.: 1 Sa No.: 2 Depth: 0.8 - 1.2 m

EMBANKMENT FILL, sand and gravel

Underlying the pavement structure at Borehole No. 1, a layer of embankment fill described as sand and gravel, some silt was penetrated. The natural moisture content measured on samples retrieved from this layer was generally in the order of 4 to 5%. A gradation (sieve) analysis was carried out on one (1) sample of this deposit and the testing results indicated 40% gravel size particles, 48% sand size particles, and 12% silt and clay size particles (Figure No. L-1, Appendix 3). Based on SPT 'N' values of 59 to 67 blows per 300 mm penetration, the compactness of this layer was described as very dense. This layer was encountered to a depth of 1.4 m below grade at Borehole No. 1 (Elevation 288.6 m).

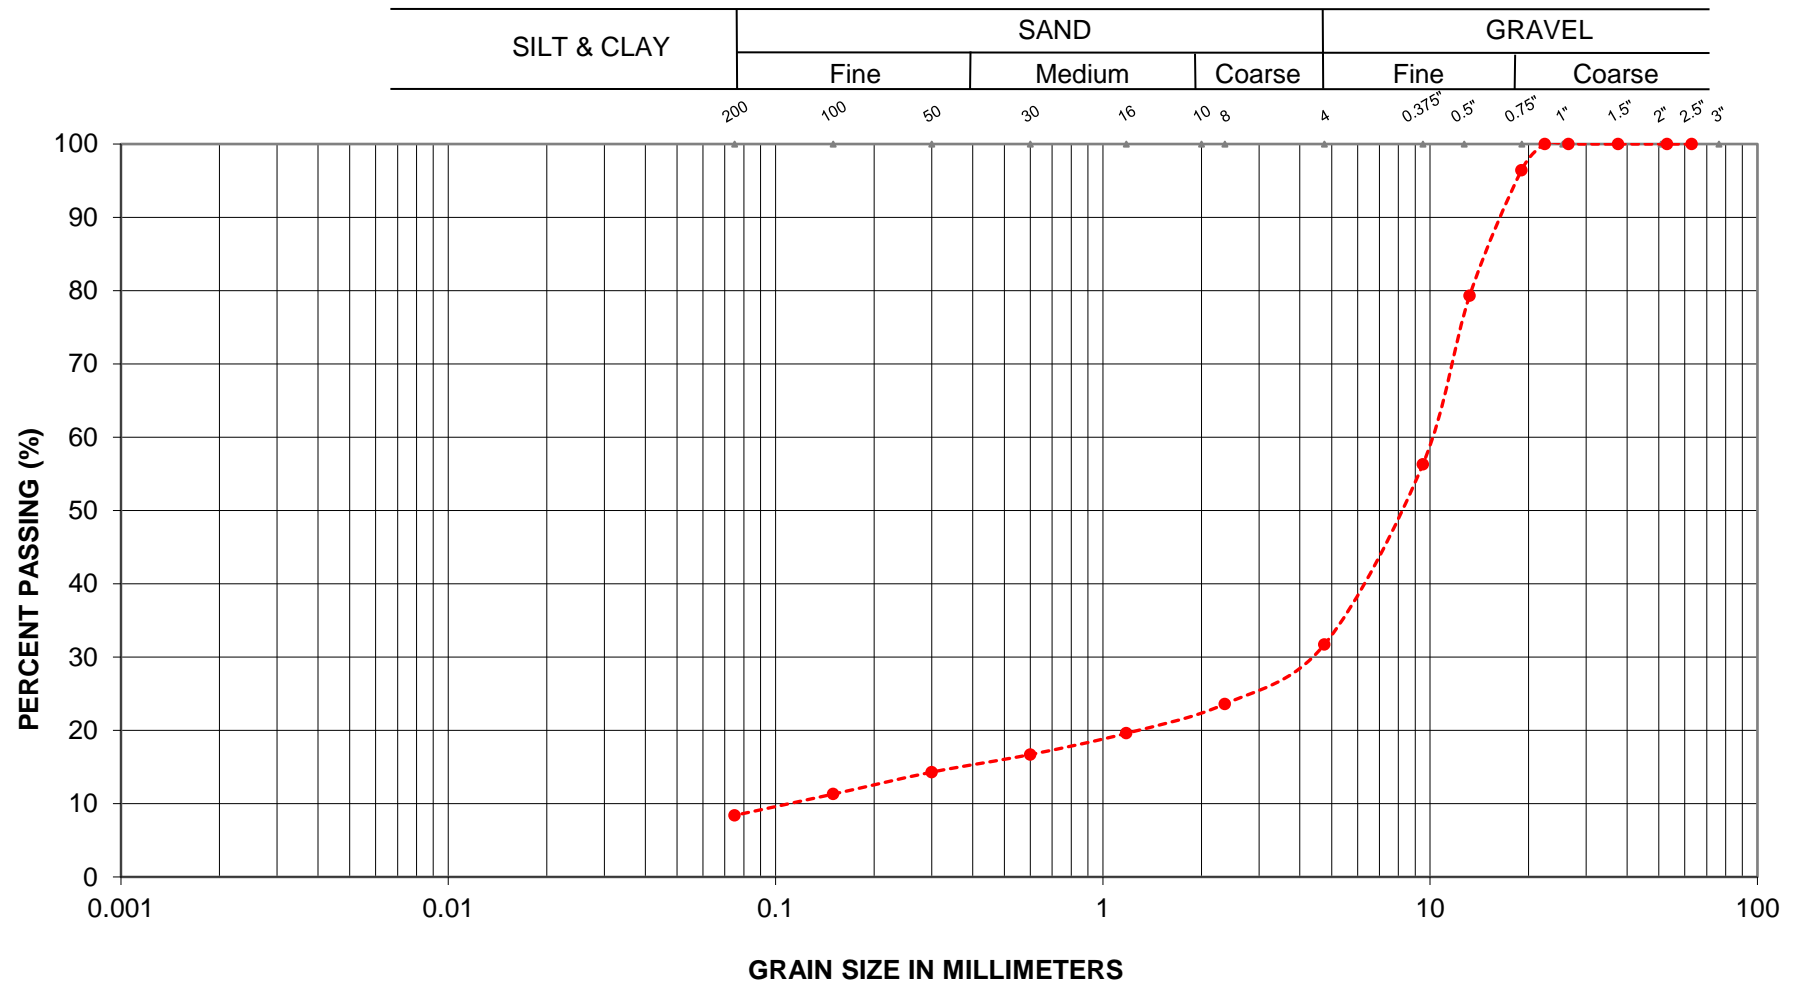
FIGURE L-2

GRAIN SIZE ANALYSIS

---●--- BH No.: 2 Sa No.: 3 Depth: 1.5 - 2.0 m

EMBANKMENT FILL, gravel with sand

Underlying the sand fill at Borehole No. 2, a layer of embankment fill described as gravel, with sand, trace silt was penetrated. The natural moisture content measured on samples retrieved from this layer was generally in the order of 3 to 5%. A gradation (sieve) analysis was carried out on one (1) sample of this deposit and the testing results indicated 68% gravel size particles, 24% sand size particles, and 8% silt and clay size particles (Figure No. L-2, Appendix 3). Based on SPT 'N' values of 30 to 6 blows per 300 mm penetration, the compactness of this layer was described as compact to loose. This layer was encountered to a depth of 2.6 m below grade at Borehole No. 2 (Elevations 287.4 m).

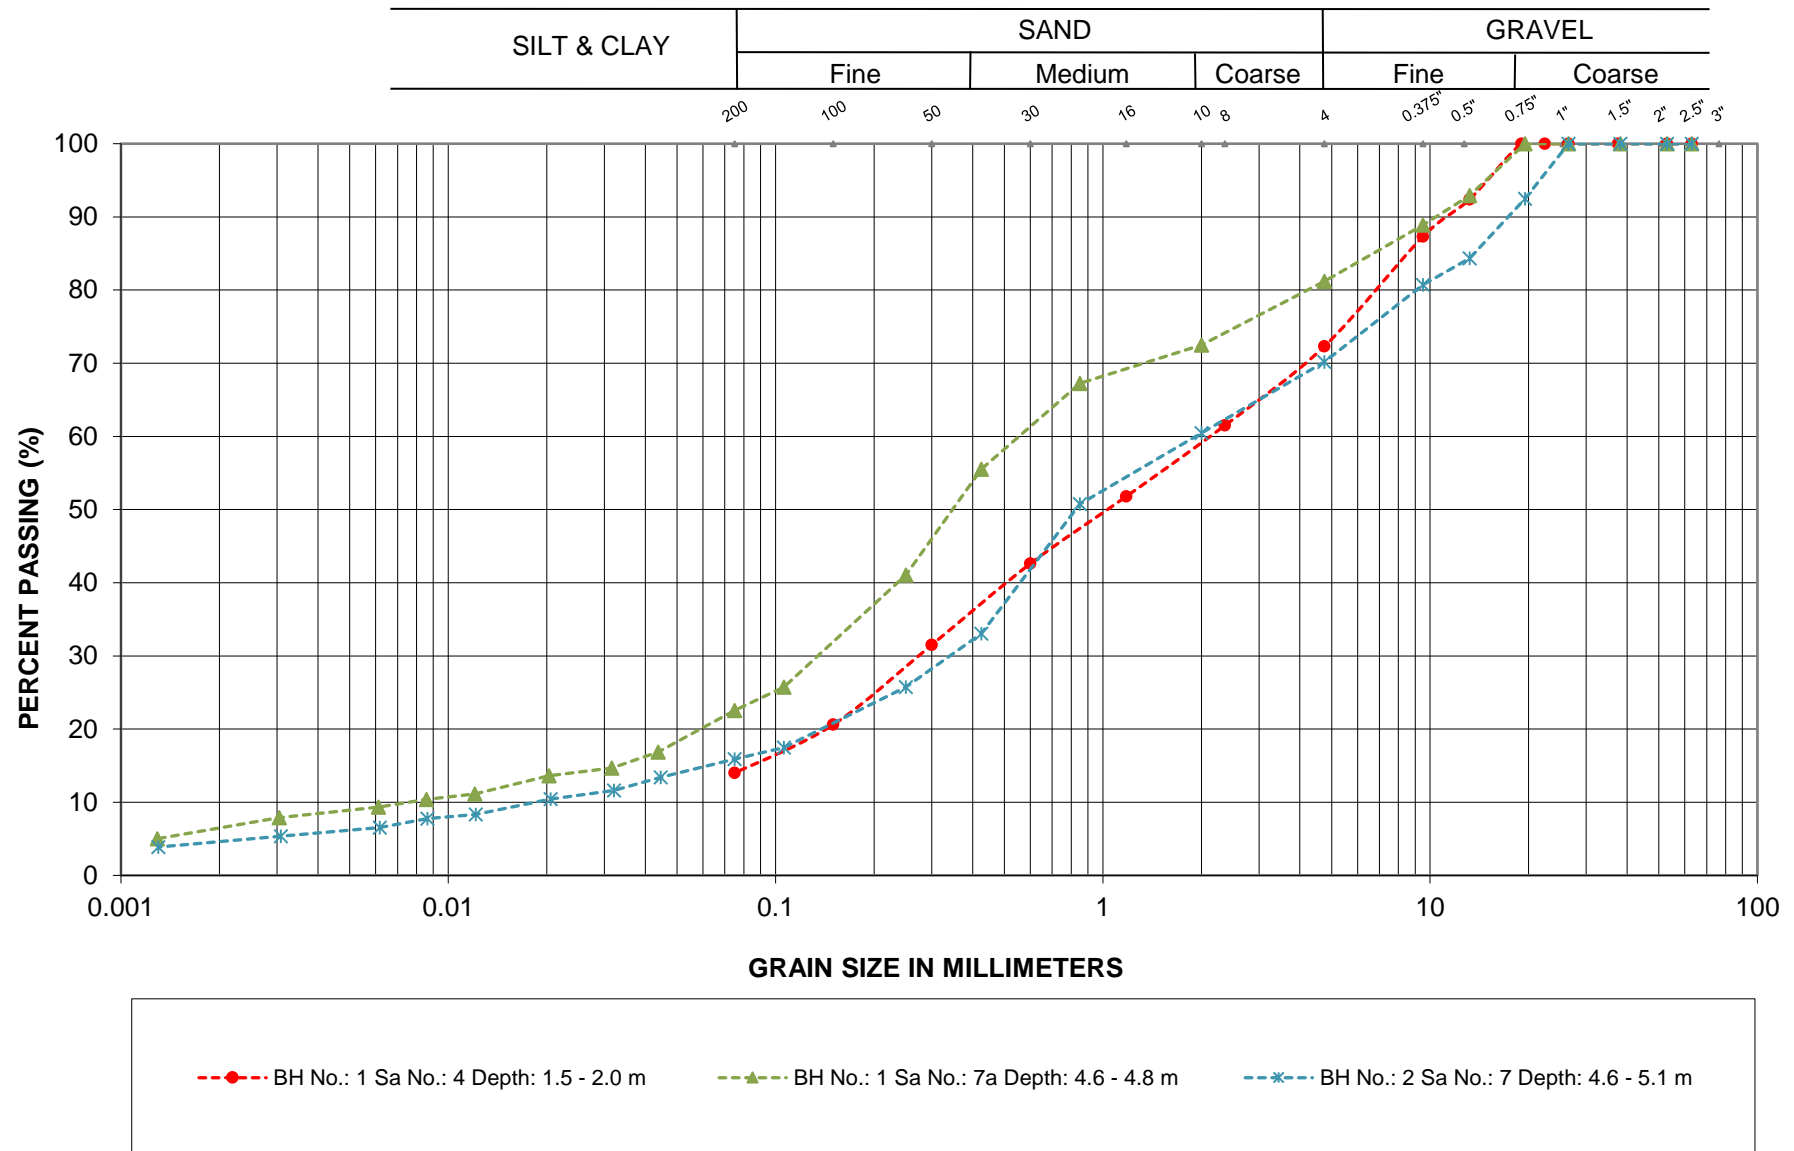
FIGURE L-3

GRAIN SIZE ANALYSIS

EMBANKMENT FILL, sand with to some gravel

LOCATION: Hwy 11
Oro Line 7 UP

Underlying the sand and gravel fill at Borehole No. 1, and underlying the gravel fill at Borehole No. 2, a layer of embankment fill described as sand, with to some gravel, some to trace silt, trace clay was penetrated. Layers of silty sands approximately 50 mm in thickness and pockets of silt were encountered within this fill layer at Borehole No. 1. The natural moisture content measured on a sample of this deposit was in the order of 4 to 15%. A gradation (sieve) analysis was carried out on one (1) sample of this layer and the testing results indicated 28% gravel size particles, 58% sand size particles, and 14% silt and clay size particles (Figure No. L-3, Appendix 3). In addition, gradation (hydrometer) analyses were carried out on two samples of this layer, and the testing results indicated 19 to 30% gravel size particles, 54 to 58% sand size particles, 11 to 17% silt size particles and 5 to 6% clay size particles (Figure No. L-3, Appendix 3). Based on SPT 'N' values of 6 to 38 blows per 300 mm penetration, the compactness of this layer was described as loose to dense, generally compact on average. This fill layer was encountered to depths of 7.8 and 5.9 m below grade at Borehole Nos. 1 and 2, respectively (Elevations 282.2 and 284.1 m, respectively).

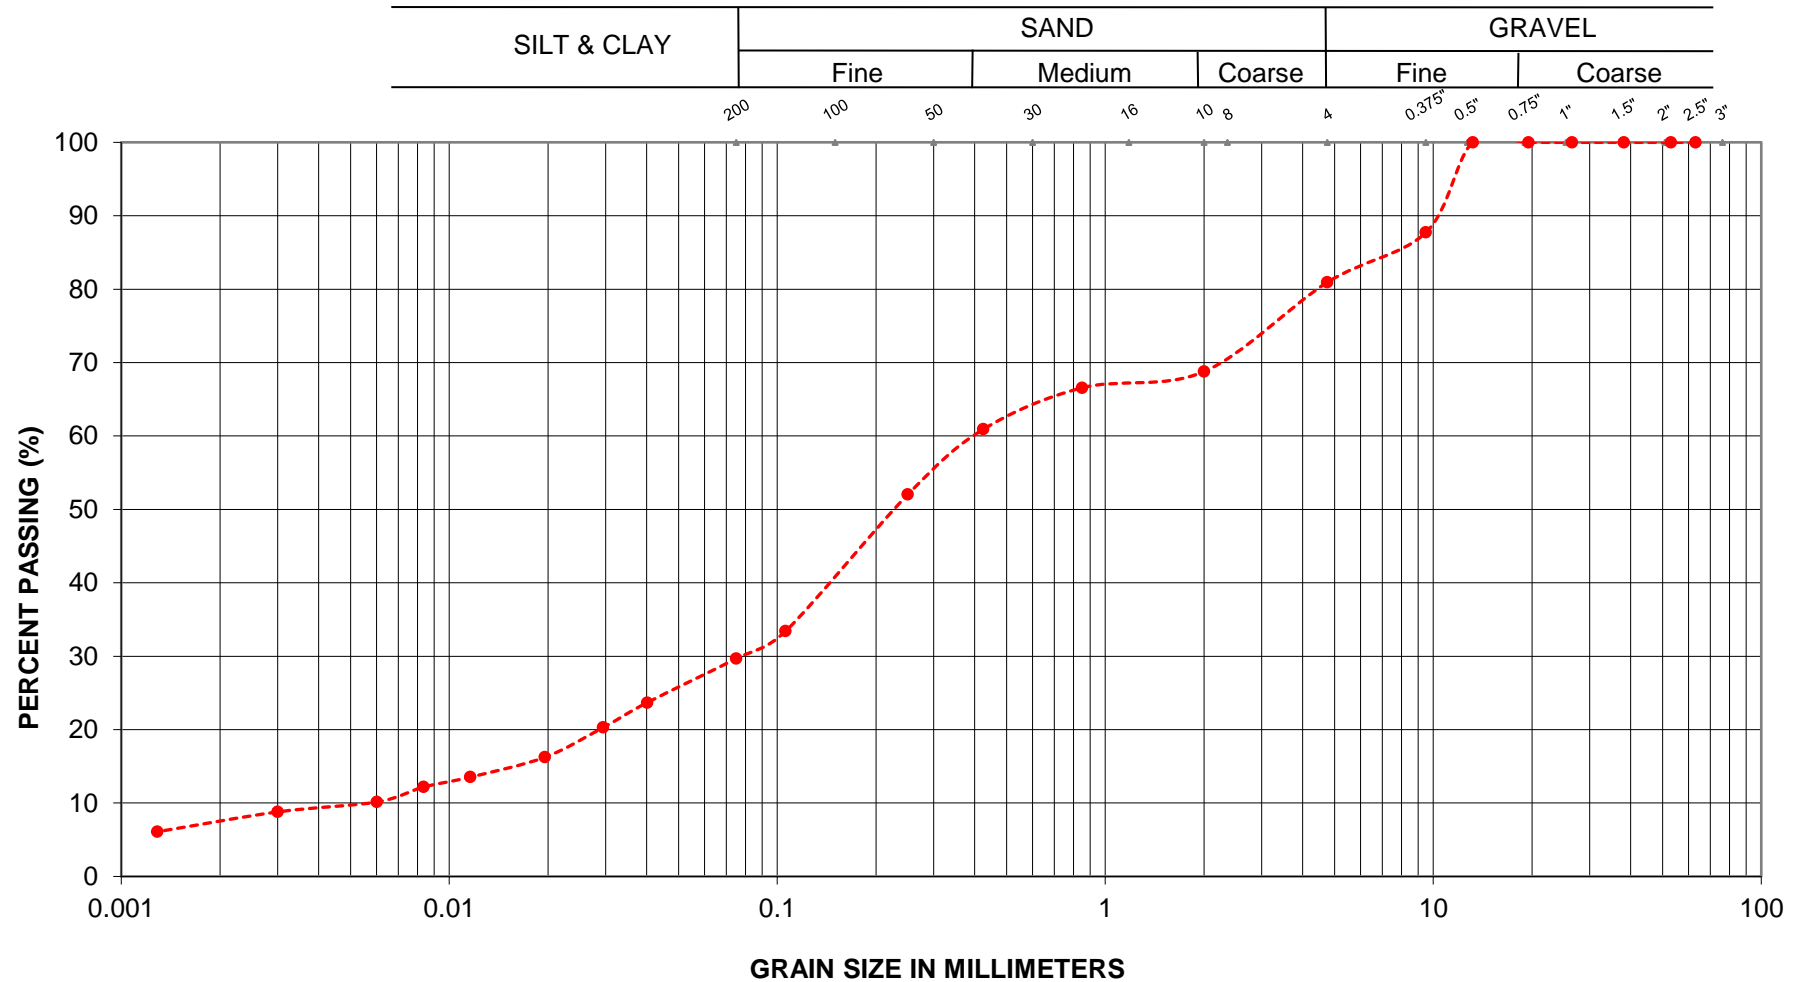
GRAIN SIZE ANALYSIS

---●--- BH No.: 1 Sa No.: 11 Depth: 9.1 - 9.3 m

SAND

The fieldwork for this investigation was under the full time direction of a senior member of the Englobe engineering staff, who was responsible for locating the boreholes, clearing the borehole locations of underground services, in-situ sampling and testing operations, logging of the boreholes, labeling and preparation of samples for transport to our North Bay laboratory, plus overall drill supervision. All samples received a visual confirmatory inspection in our laboratory. Laboratory testing of select samples included routine geotechnical testing for natural moisture content determination and particle size analyses. The results of the laboratory testing are presented on the individual Record of Borehole Sheets (Appendix 2), with a summary of testing results presented on the laboratory sheets in Appendix 3 (Figures Nos. L-1 to L-4 and Table No. L-5).

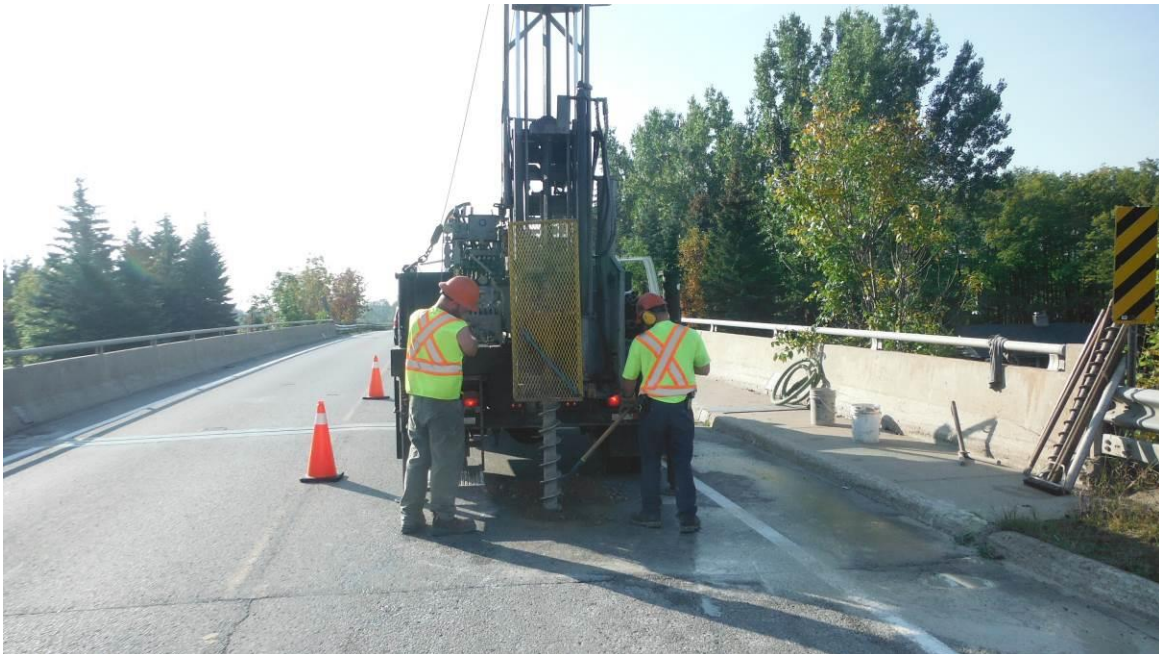
Photo: 1

Existing Bridge, North Approach – Looking South

The existing bridge underpass is located approximately between Stations 0+017 and 0+058 on Oro Line 7 and crosses over Highway 11, in the Township of Oro-Medonte. The existing Oro Line 7 Underpass embankment currently supports two undivided lanes, locally running in a south-north direction. A visual review of the roadway to the north and the south of the bridge approaches indicates that, in general, the approaches are in fair to good condition (see Photo Essay in Appendix 4).
