REPORT ON

Preliminary Foundation Investigation and Design No Name Creek (Rimington) Culvert Replacement Site No. 11-329c 11.2 km North of Madoc Highway 62, Hastings County, Ontario W.P. 4149-10-01

**PRELIMINARY FOUNDATION DESIGN REPORT
NO NAME CREEK (RIMINGTON) CULVERT REPLACEMENT
SITE 11-329C
11.2 KM NORTH OF MADOC
HIGHWAY 62
W.P. 4149-10-01**

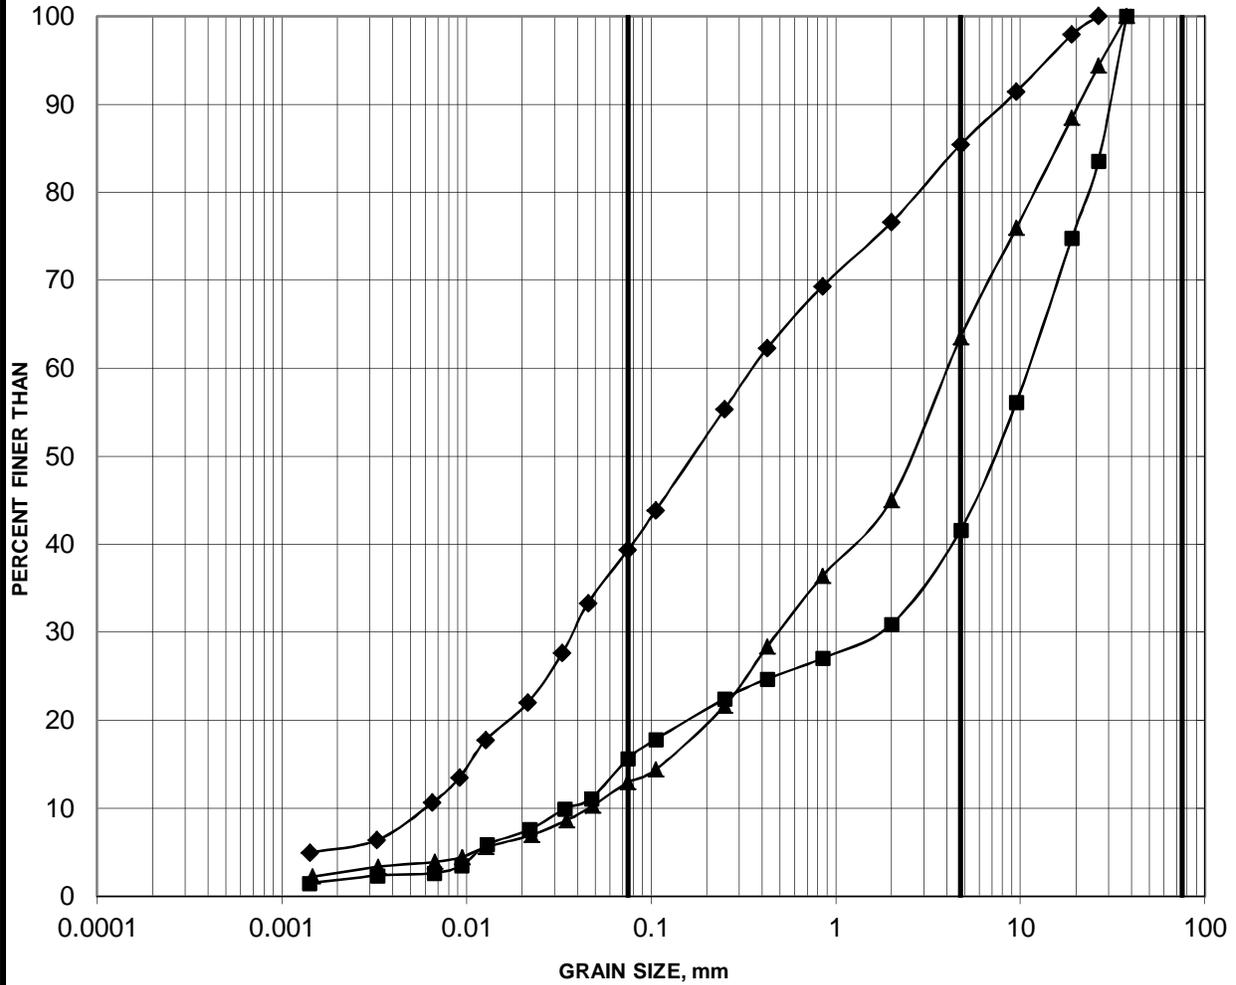
EMBANKMENT FILL

SILT AND CLAY	FINE	MEDIUM	COARSE	FINE	COARSE	COBBLE SIZE
	SAND SIZE			GRAVEL SIZE

Borehole	Sample	Depth (m)
—■—	12-112	3
—◆—	12-113	3
—▲—	12-114	1

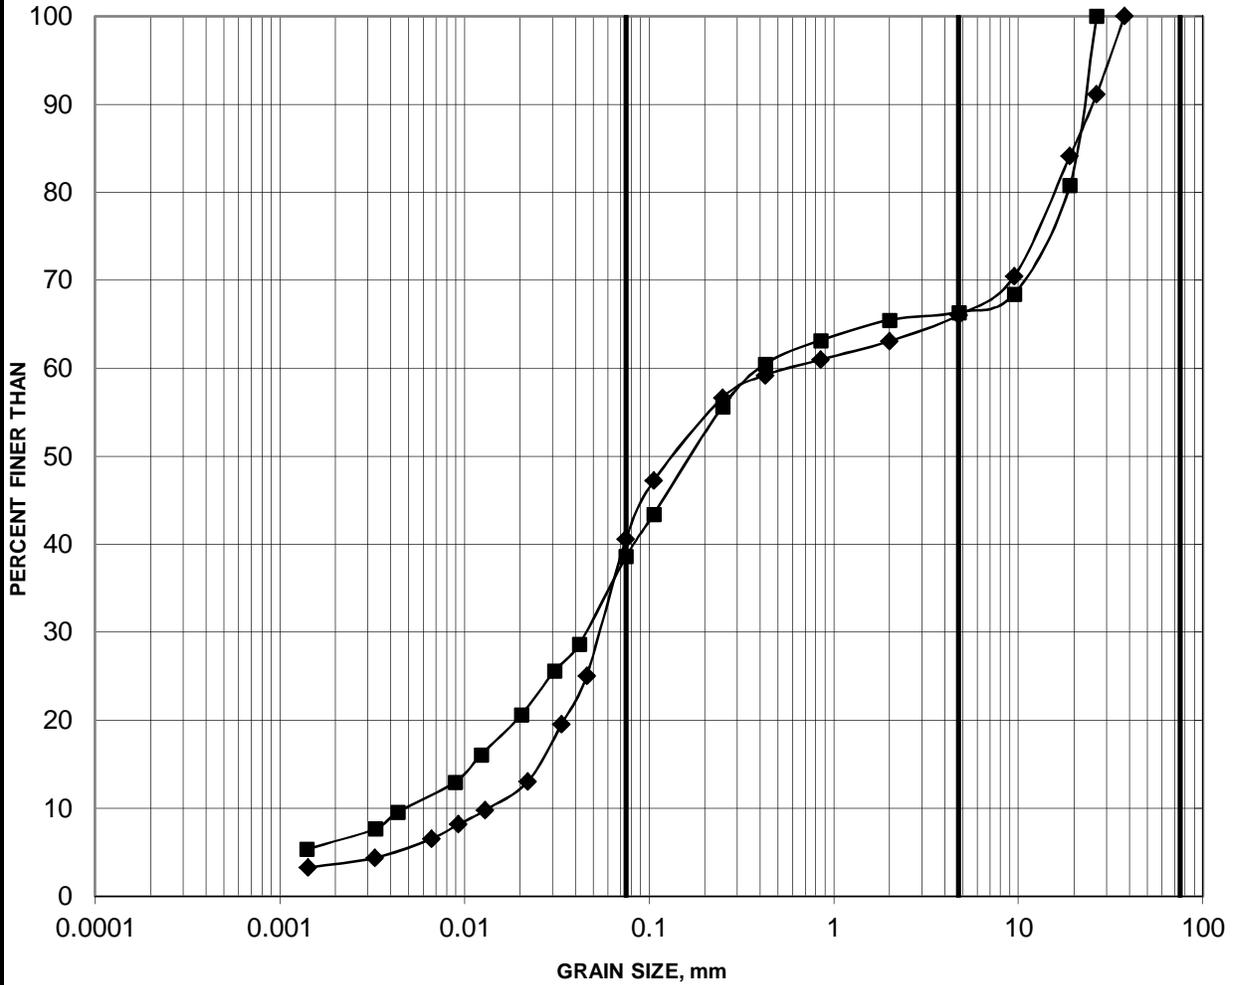
Sandy SILT and GRAVEL

SILT AND CLAY	FINE	MEDIUM	COARSE	FINE	COARSE	COBBLE SIZE
	SAND SIZE			GRAVEL SIZE

Borehole	Sample	Depth (m)
12-111	1	0.00-0.61
12-111	3	1.22-1.83

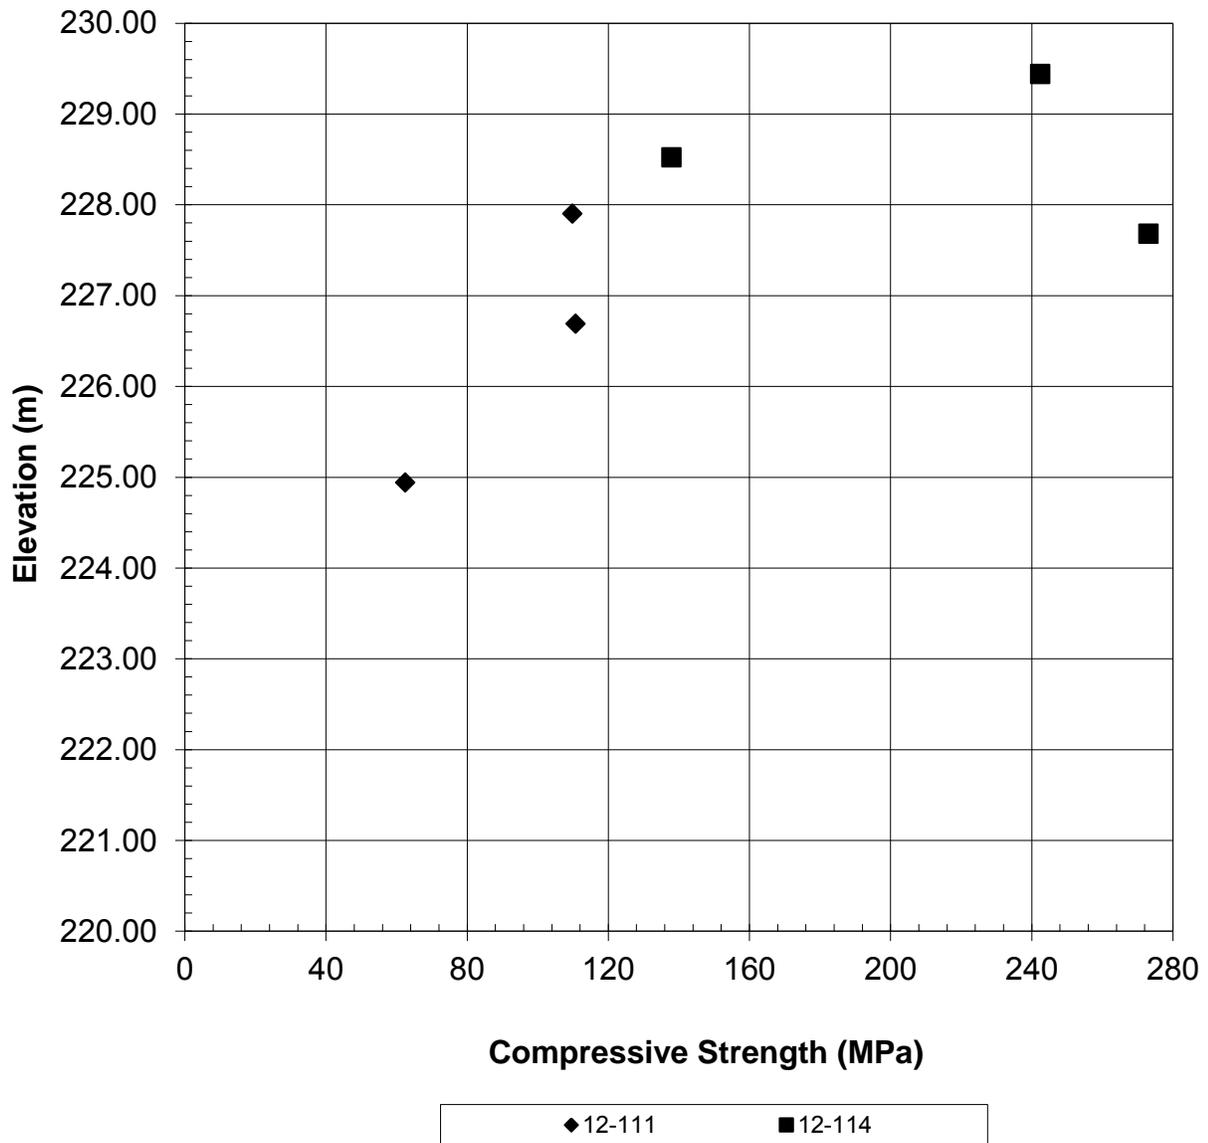
FIGURE B3

**SUMMARY OF LABORATORY COMPRESSIVE STRENGTH
POINT LOAD TESTING**

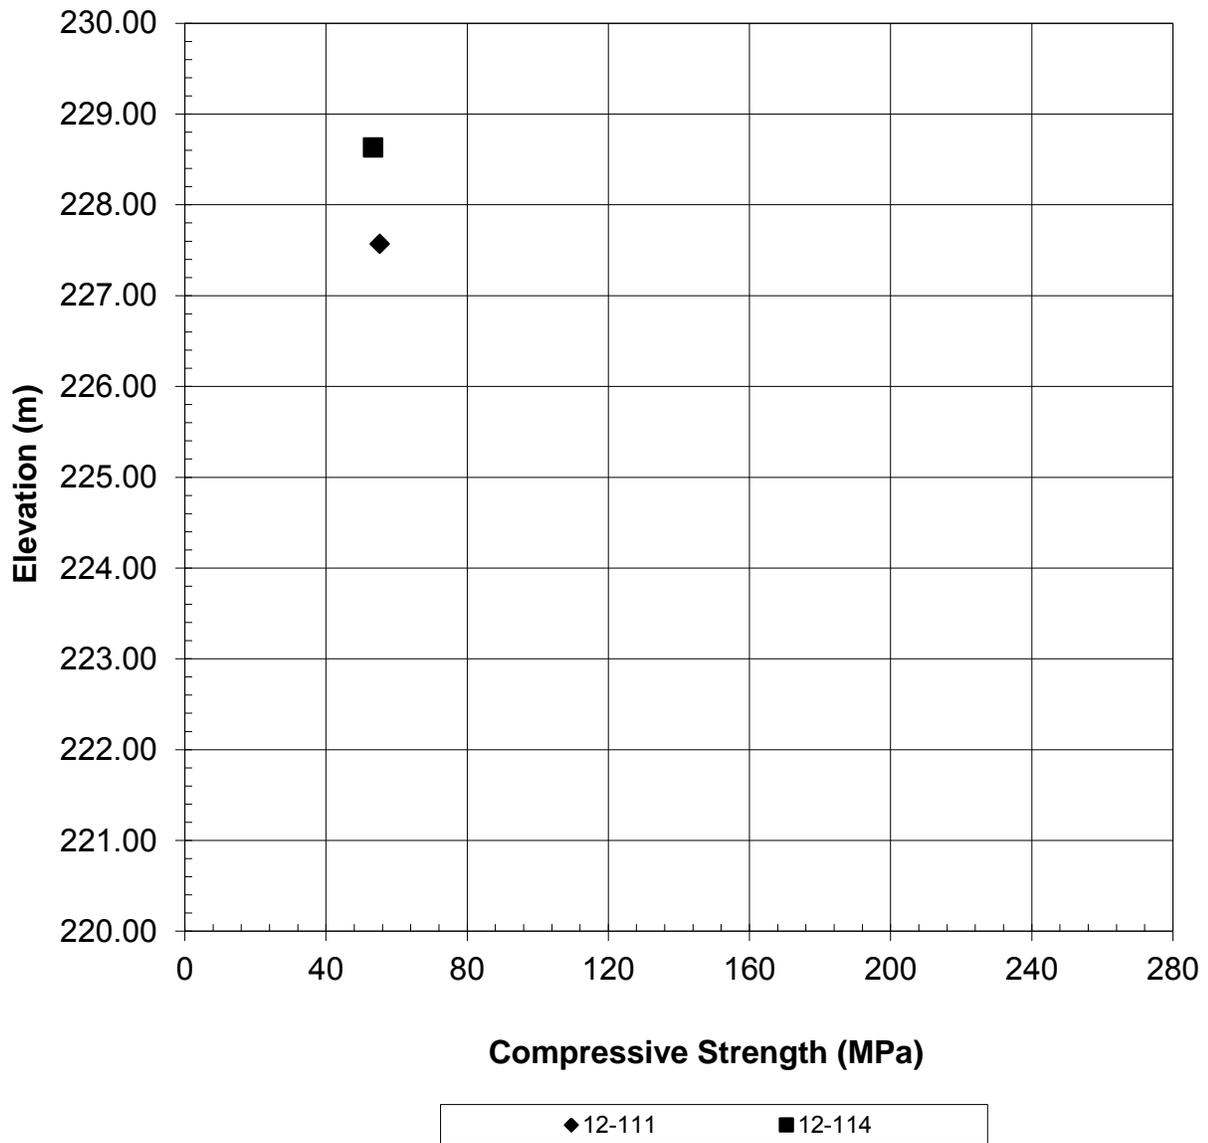
FIGURE B4

**SUMMARY OF LABORATORY COMPRESSIVE STRENGTH
UNCONFINED COMPRESSION TESTS**
