Foundation Investigation
and Design Report

Embankment Widening

Stn. 19+770 to 10+040

**Highway 129, Birch and Langlois
Townships, District of Sudbury**

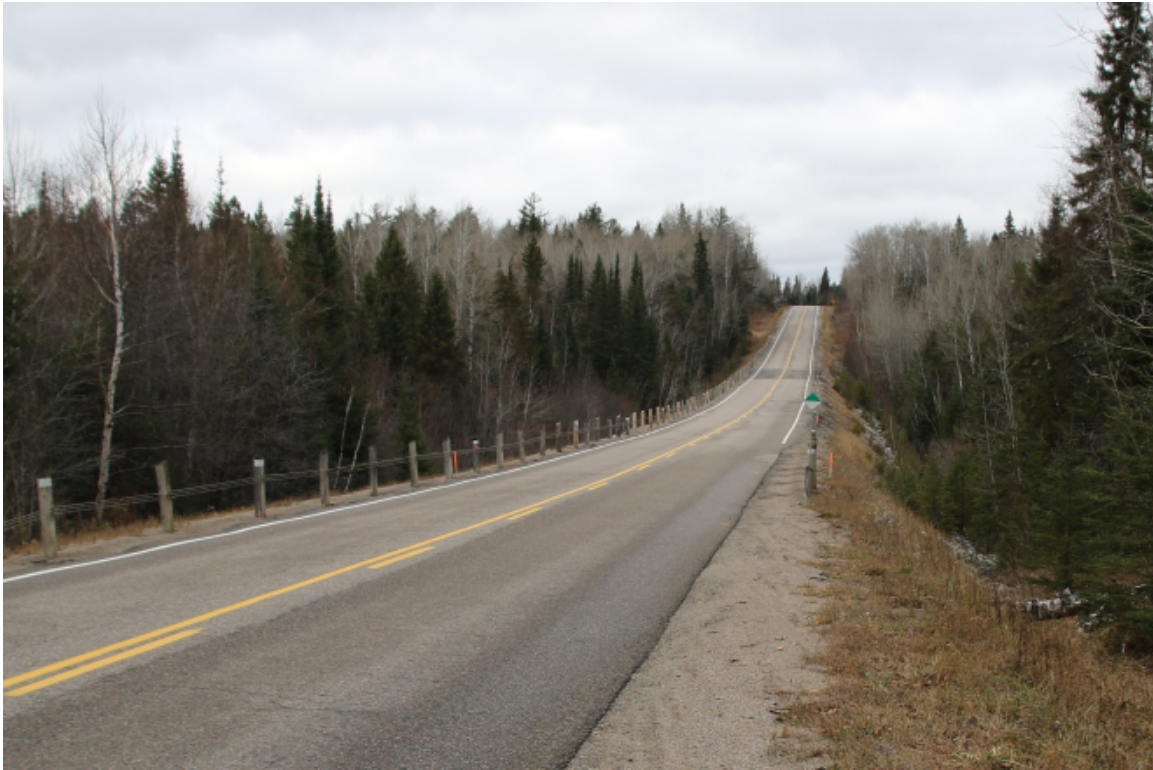
Photograph No. 1 – Highway 129 at Proposed Embankment Widening (Facing Up Chainage)

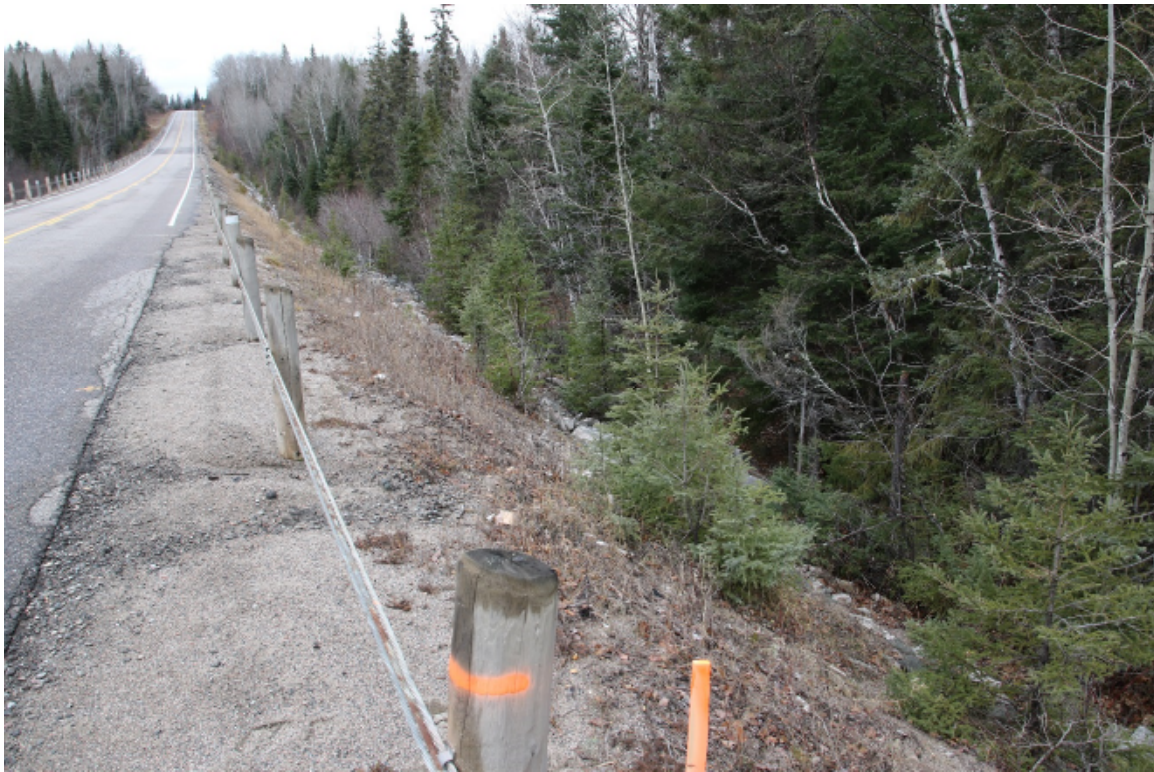
Photograph No. 3 – East Embankment from Start of Widening, Stn. 19+770 (Facing Up Chainage)

The general site conditions were assessed on November 16, 2016. The side slopes of the highway embankment are covered with grass and light vegetation, as well as large boulder rip-rap for slope protection. The toe of the embankment is forested with large coniferous and deciduous trees. Guardrails at the top of the embankment and trees near the embankment toe all appeared to generally be standing vertically, suggesting there is not likely any stability issues with the current embankment. A small creek is located near the toe of the embankment around Stn. 19+830, flowing from west to east through an existing 1.2 m diameter corrugated steel pipe (CSP) culvert within the embankment at Stn. 19+829. The highway travels through a large bedrock

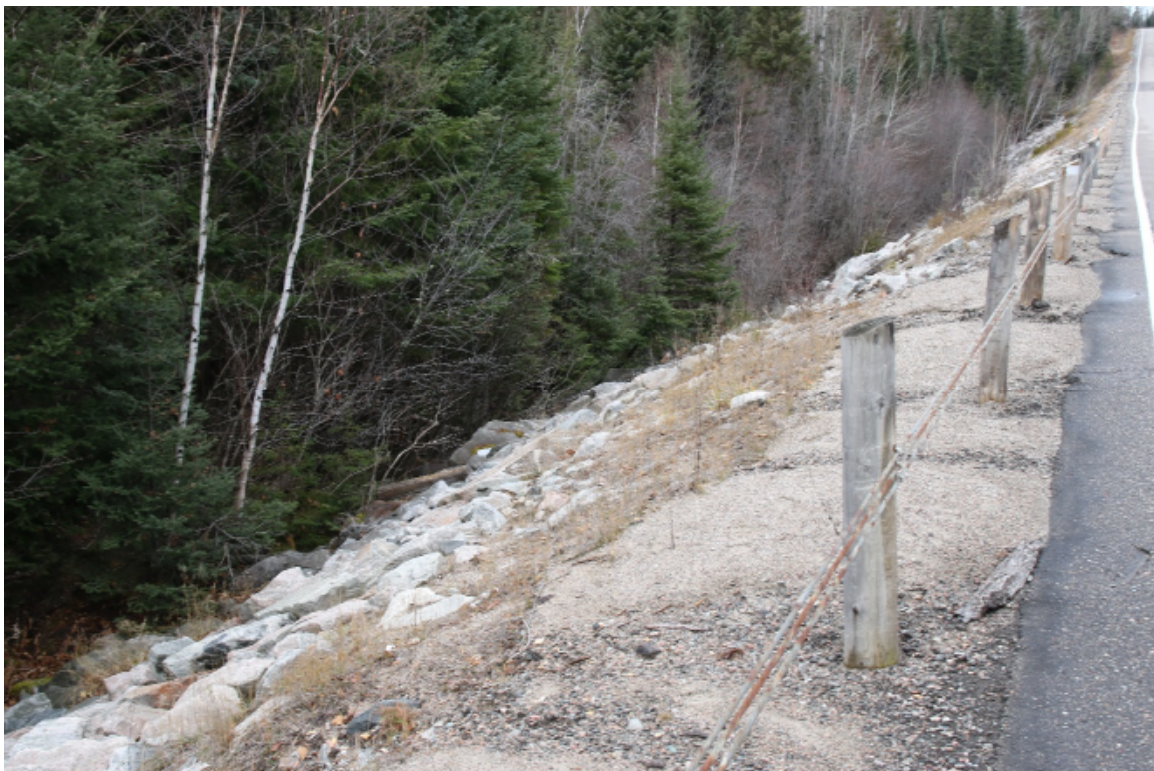
Photograph No. 4 – West Embankment from Start of Widening, Stn. 19+770 (Facing Up Chainage)

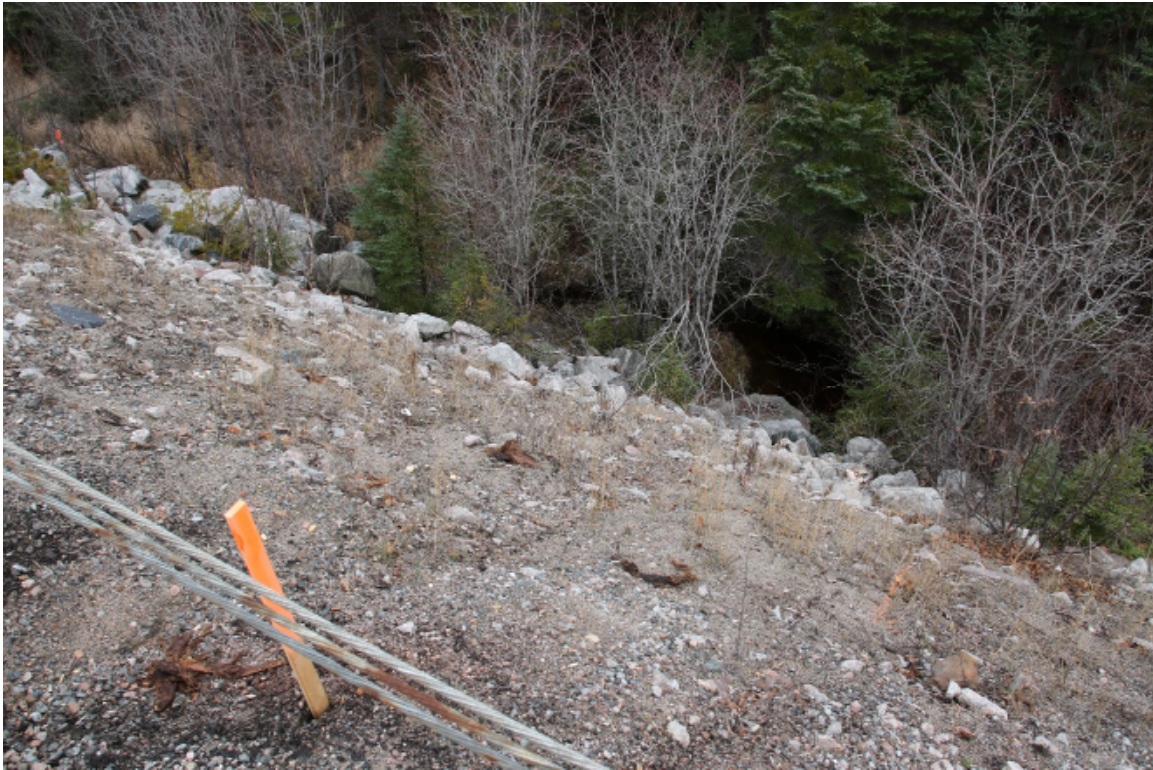
Photograph No. 11 – Existing Creek at Culvert 19+829 Outlet (Facing East)

The watercourse crossing through the existing culvert at Station 19+829 turns parallel to the toe of the embankment near the culvert outlet (refer to Photographs 11 and 12 in Appendix B). If the proposed embankment widening footprint approaches or extends over the existing creek, the creek will likely need to be permanently diverted to accommodate the widening. In addition, a culvert extension will also be required.

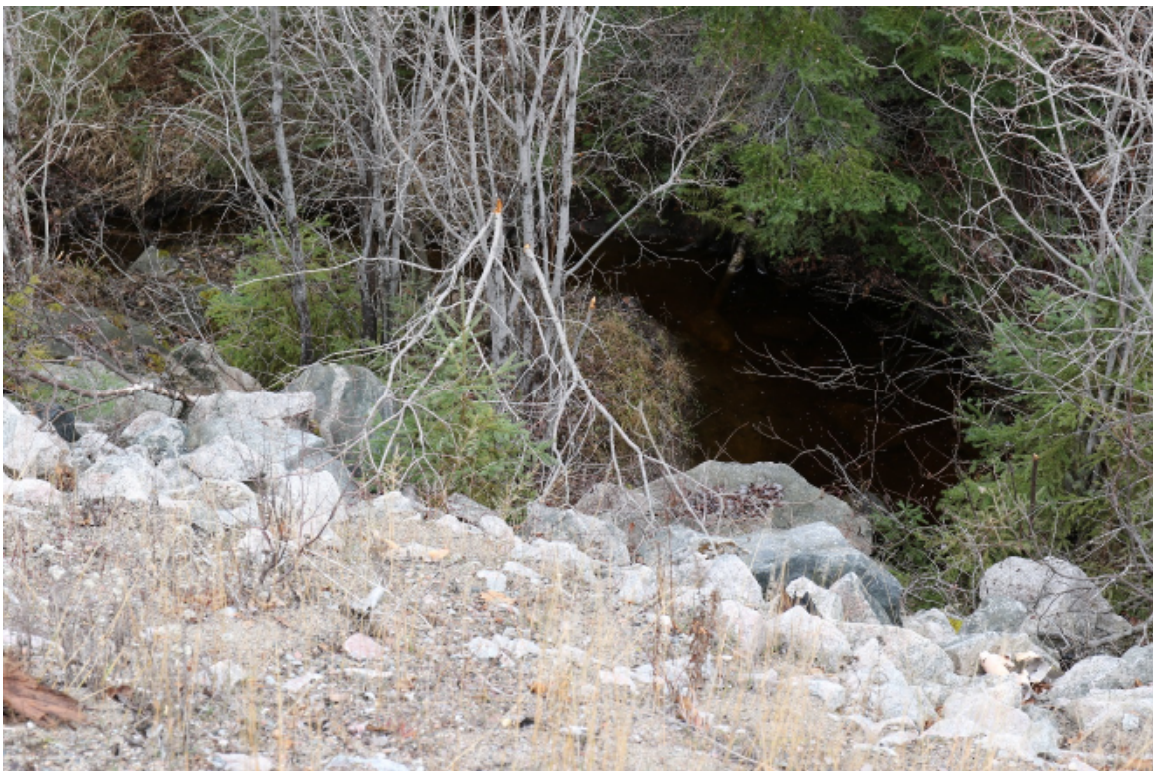
Photograph No. 12 – Existing Creek at Culvert 19+829 Outlet (Facing East)

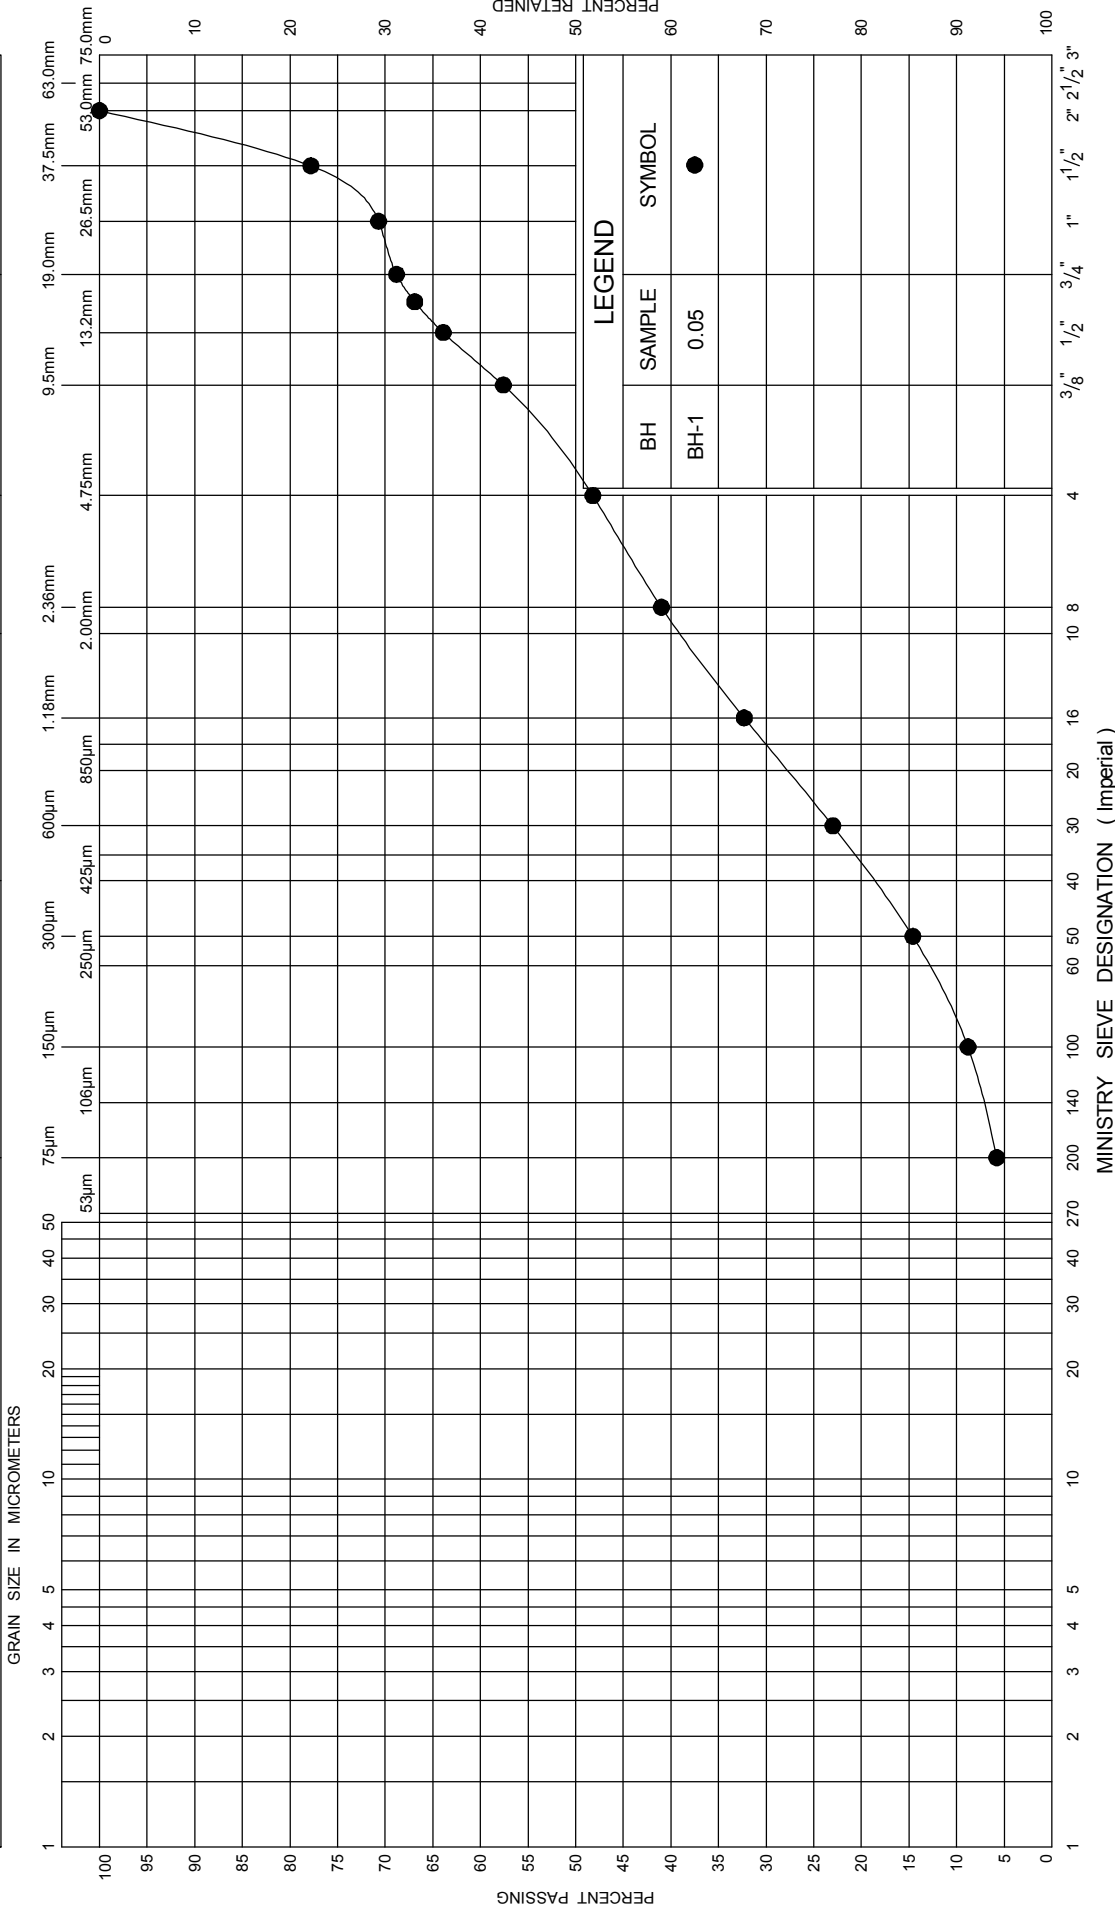
FIG No 1

GRAIN SIZE DISTRIBUTION
GRAVEL AND SAND FILL

The results of the moisture content and grain size distribution tests are provided on the Record of Borehole Sheet for BH-1 in Appendix C. The result of the grain size distribution test is also provided on Figure 1 in Appendix D.

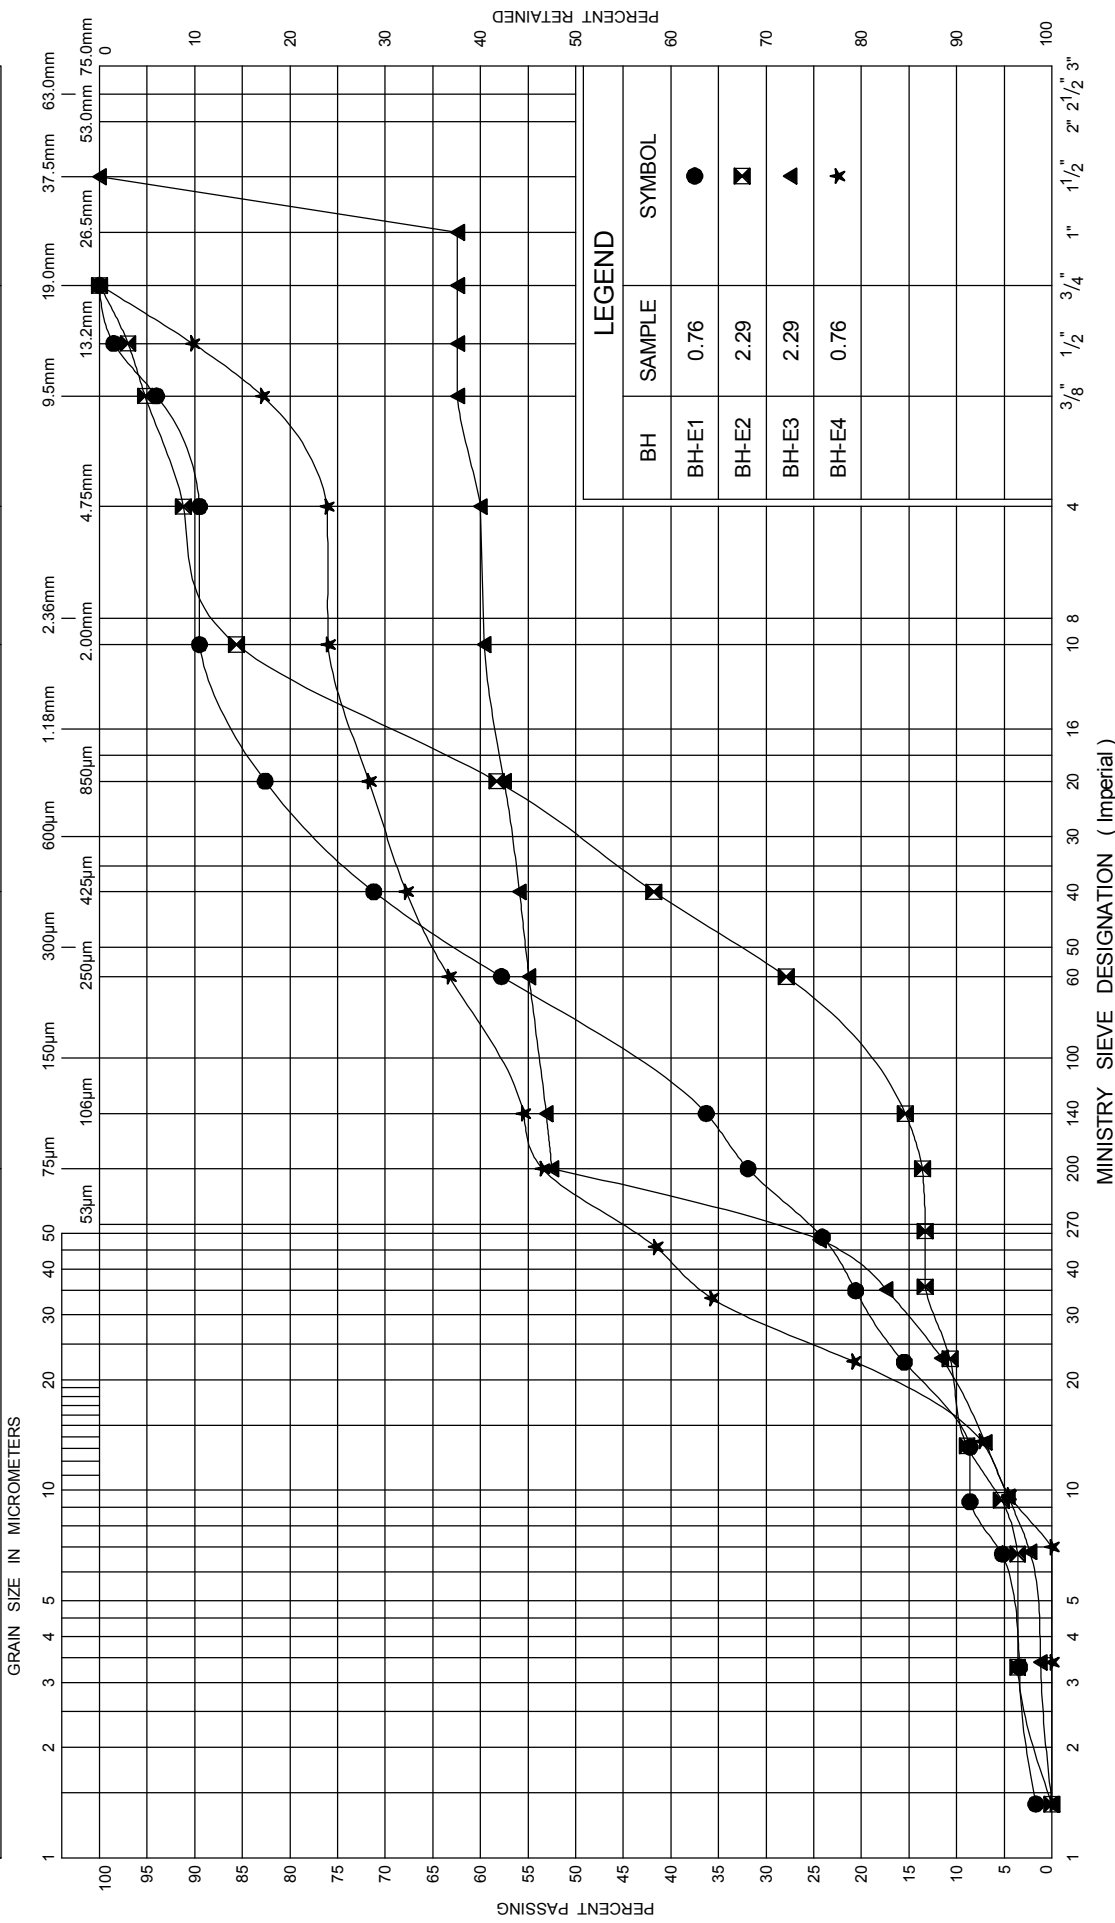
FIG No 3

GRAIN SIZE DISTRIBUTION

The results of the moisture content and grain size distribution tests are provided on the Record of Borehole Sheets in Appendix C. The results of the grain size distribution tests are also provided on Figures 2 and 3 in Appendix D.

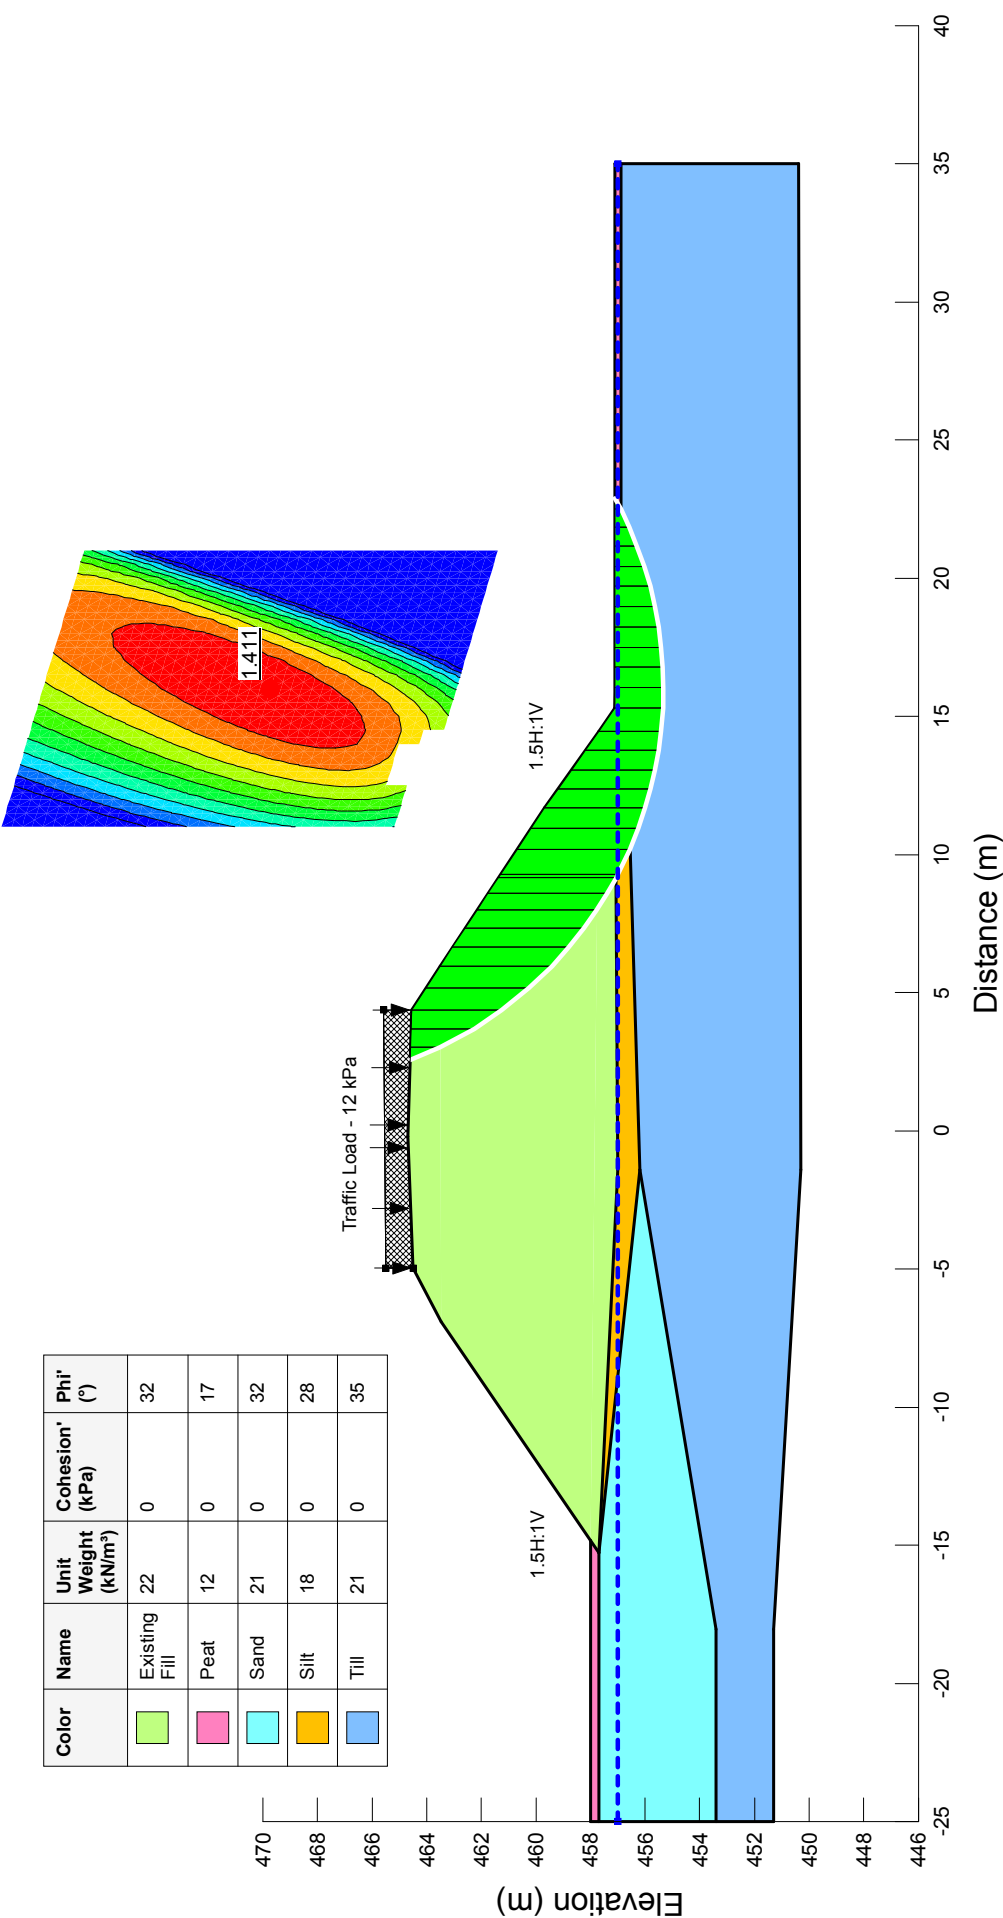
FIGURE E-2 - Existing Embankment Stability - Stn. 19+950
Highway 129, Birch Township
Drained Conditions

Color	Name	Unit Weight (kN/m³)	Cohesion* (kPa)	Phi* (°)
<div></div>	Existing Fill	22	0	32
<div></div>	Till	21	0	35
<div></div>	Topsoil	12	0	15

Stability analyses were performed near the location of Borehole BH-1 where existing embankment information is known, and at Station 19+950, where the highest embankment slope is present. The SLOPE/W graphical printout for each analysis is shown on the noted figure in Appendix E.

- Figure E-1 – Existing Embankment Stability – Station 19+825
- Figure E-2 – Existing Embankment Stability – Station 19+950
- Figure E-3 – Proposed Widened Embankment Stability – Station 19+825
- Figure E-4 – Proposed Widened Embankment Stability – Station 19+950

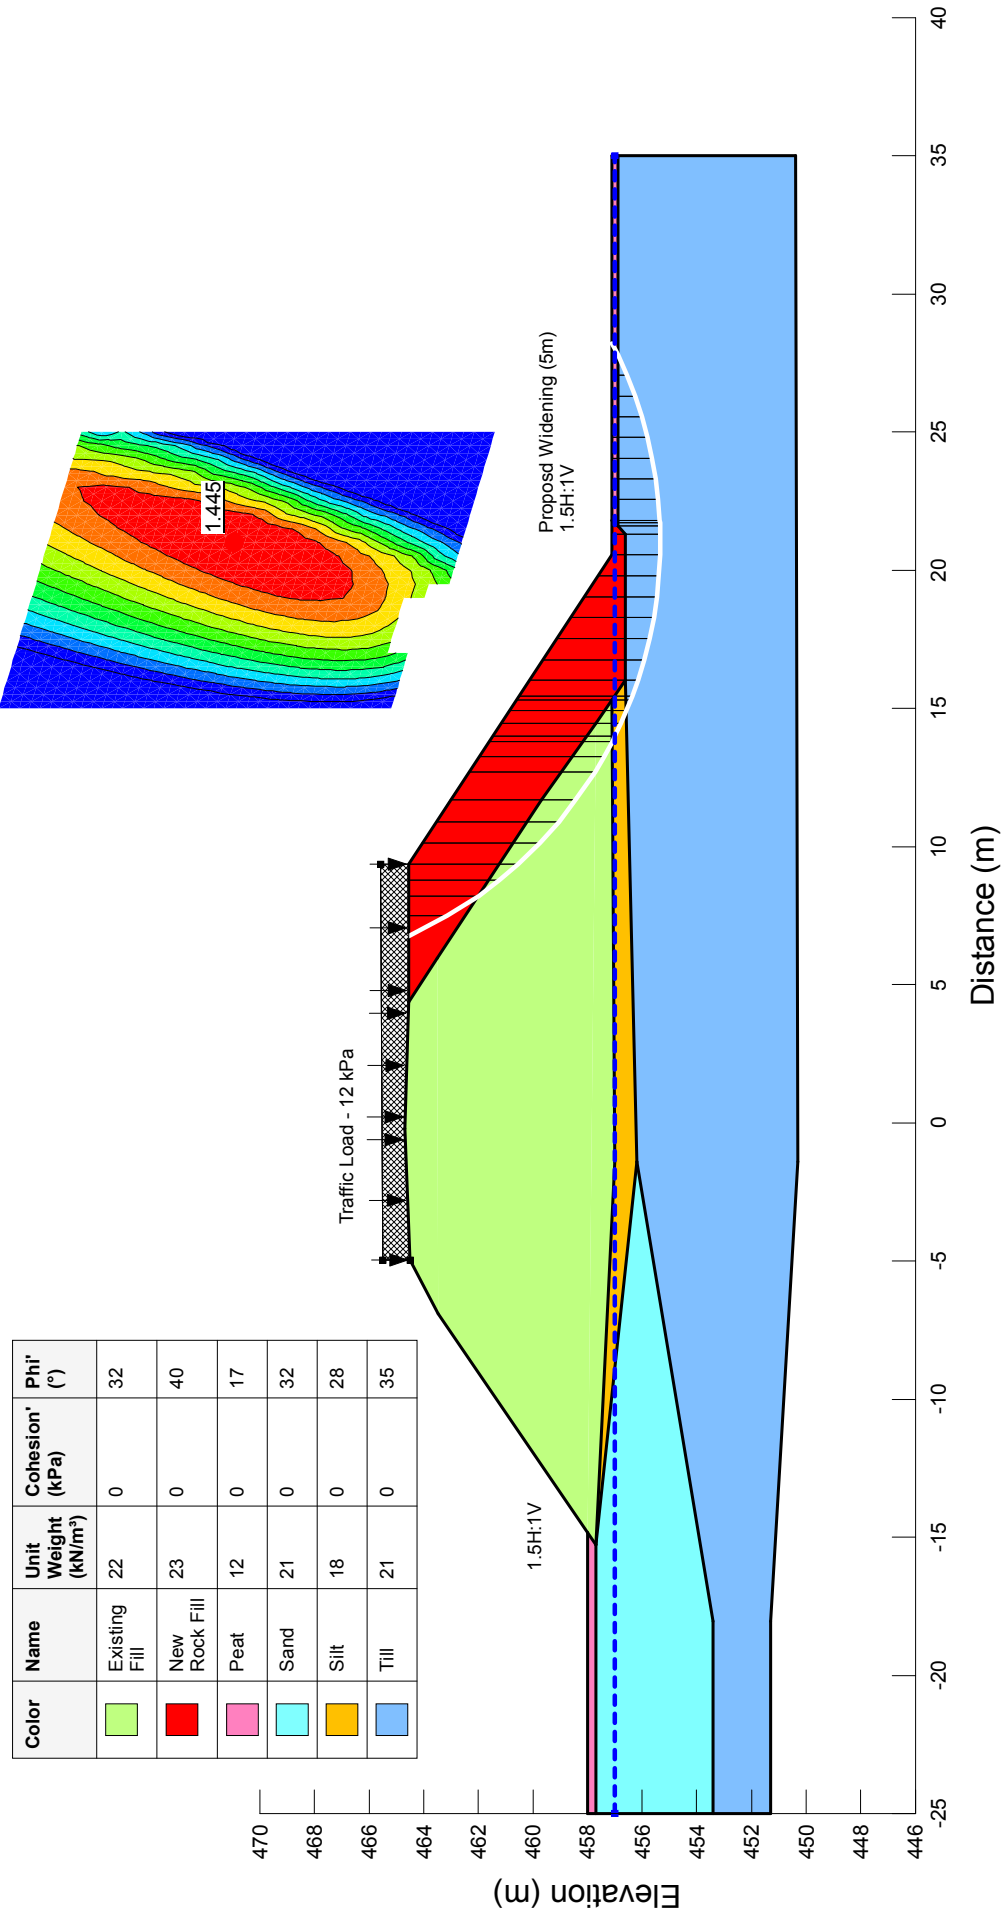
FIGURE E-4 - Proposed Widened Embankment Stability - Stn. 19+950
Highway 129, Birch Township
Drained Conditions

Color	Name	Unit Weight (kN/m³)	Cohesion* (kPa)	Phi* (°)
<div></div>	Existing Fill	22	0	32
<div></div>	New Rock Fill	23	0	40
<div></div>	Till	21	0	35
<div></div>	Topsoil	12	0	15

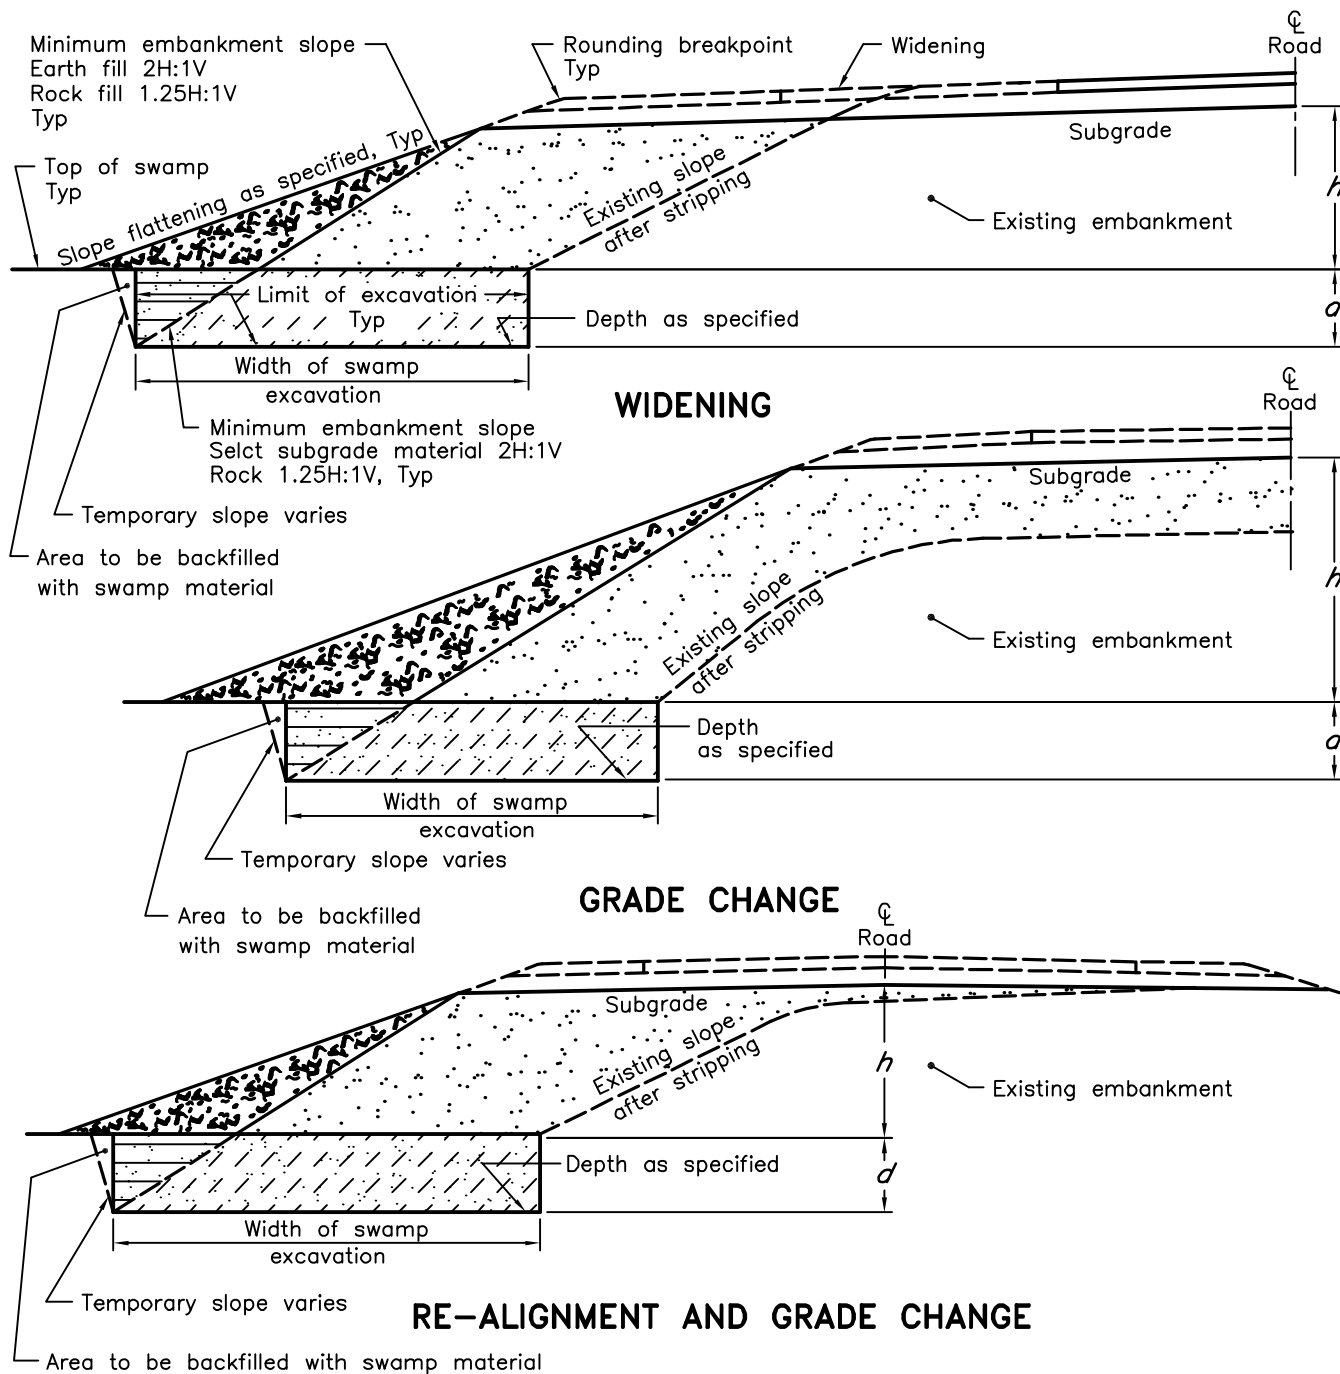
OPSD 203.030

- A For this OPSD, $h \leq 4.5\text{m}$ and $d \leq 6.0\text{m}$.
- B Topsoil shall be stripped from existing slopes.
- C Height of fill is the vertical difference between subgrade and top of swamp measured at new road centreline.
- D Widening of existing earth embankments shall be benched according to OPSD 208.010.

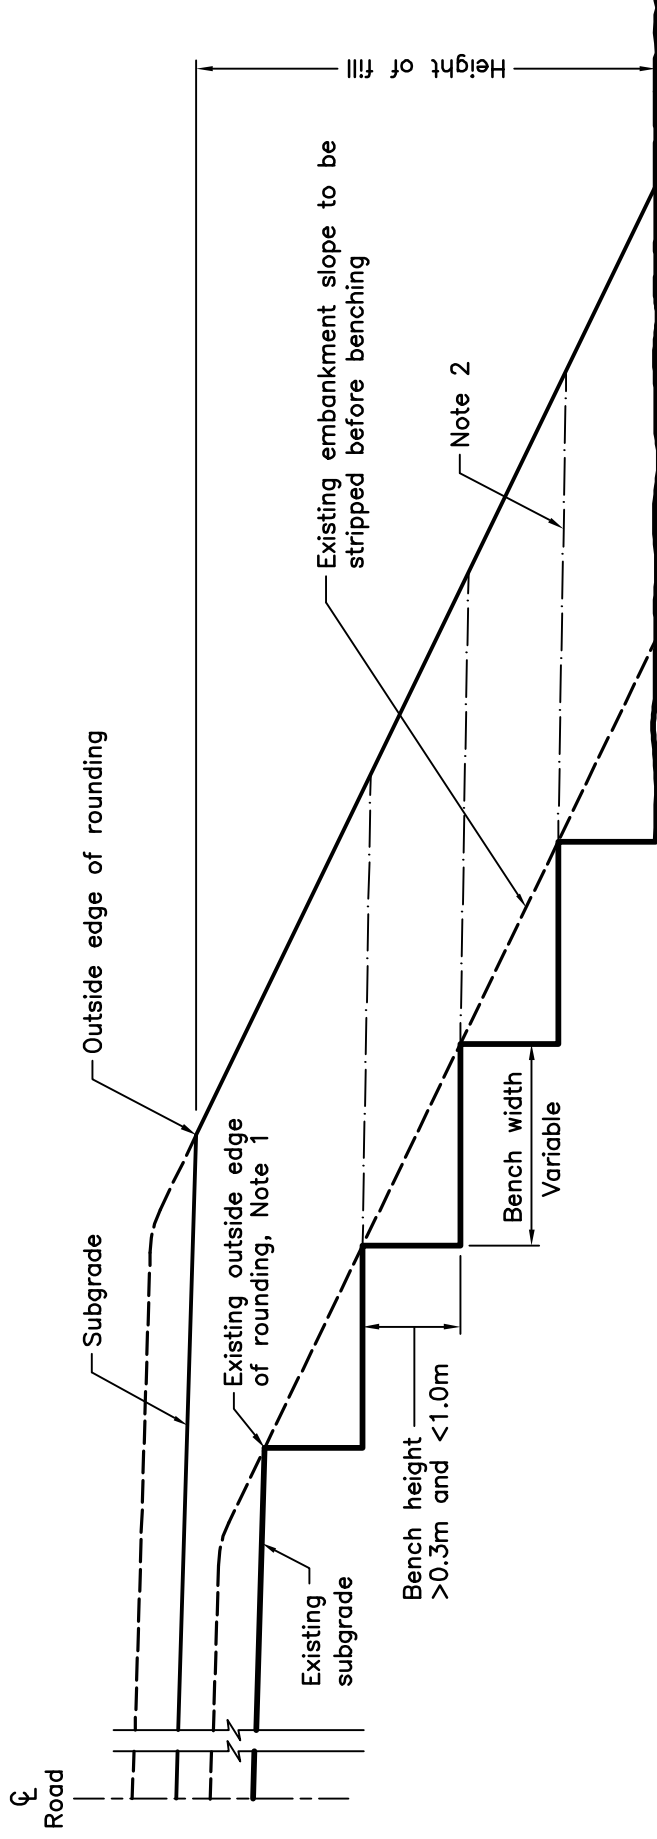
OPSD 208.010

- 1 When the subgrade is below the existing outside edge of rounding, benching shall be carried out below the point where the subgrade intersects the existing slope.
- 2 Benches shall be excavated one level at a time and the fill placed and compacted before the next bench is excavated.
- A Benchings is not required on existing slopes flatter than 3H:1V.
- B All dimensions are in metres unless otherwise shown.
