**Foundation Investigation and  
Design Report  
Two Overhead Sign Supports**

Highway 417 near Harmer  
Avenue, City of Ottawa

City Contract # ISD16-7043

Prepared by:  
Stantec Consulting Ltd.  
400 – 1331 Clyde Avenue  
Ottawa, ON K2C 3G4

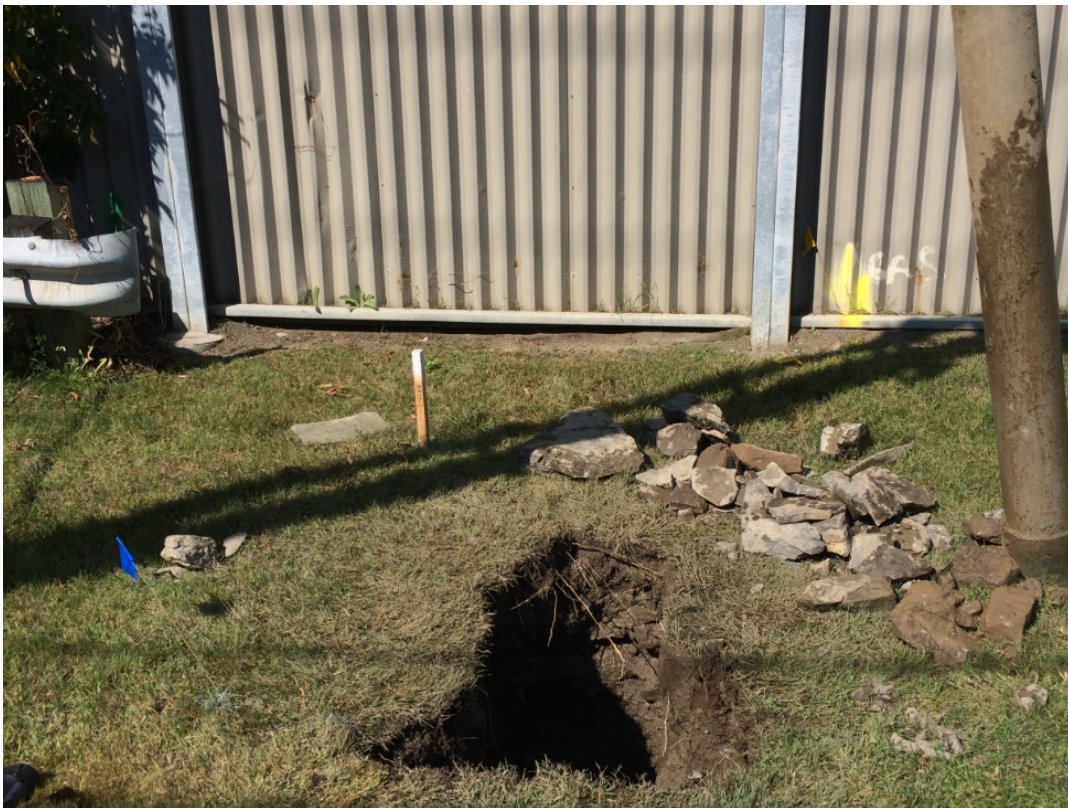
**Photograph 1 – Cobbles and Boulders Excavated During Hydro-Vac Activities**

The fill materials encountered at borehole BH17-7 (Eastbound Sign location) consisted of a mixture of sandy silt and sandy silty clay and contained silty sand seams/zones as well as frequent cobbles and boulders. The following photographs, taken during the hydro-vacuuming operations to expose the watermain, display cobbles and boulders retrieved from within the fill during the hydro-vac activities (Photograph 1) and a larger boulder within the hydro-vac excavation (Photograph 2).

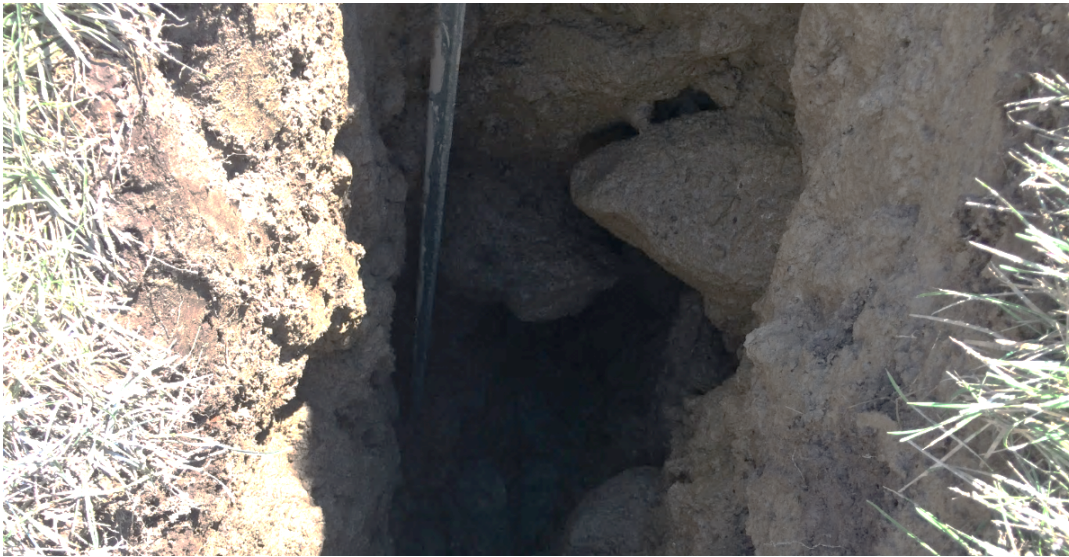
**Photograph 2 – Boulders Within Hydro-Vac Excavation**

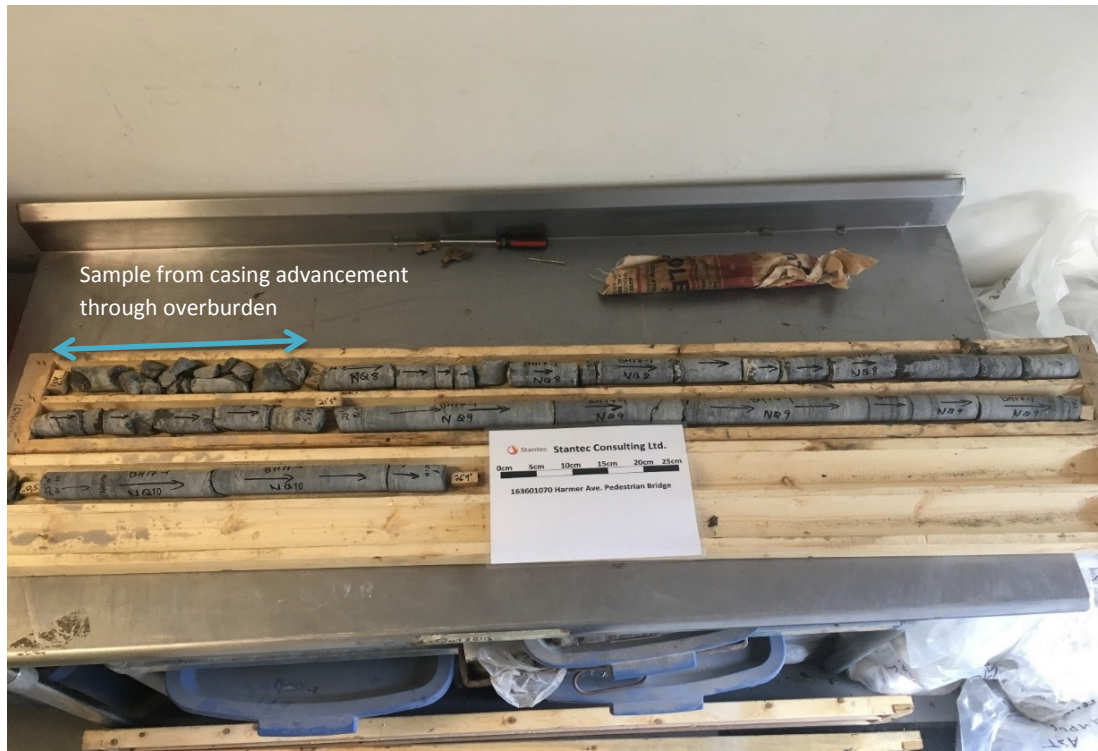
Rock Core Photo No.: 1 Borehole: BH 17-1 (NQ 8 to NQ 10) Depth: 4.7 m to 8.2 m

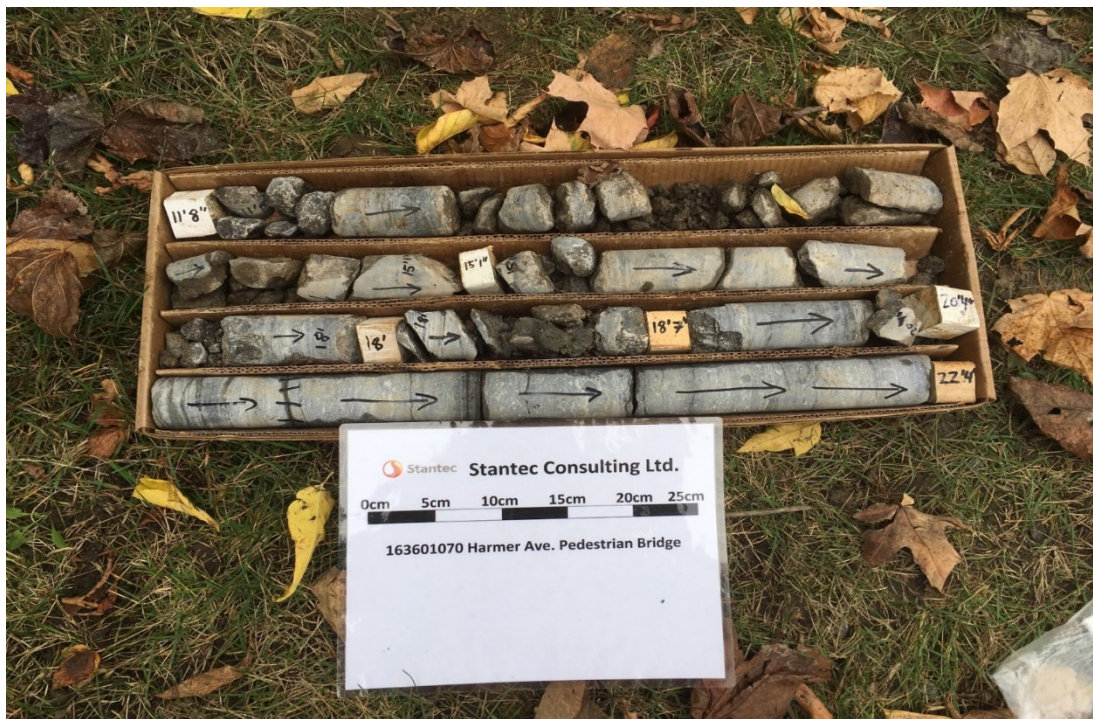
Rock Core Photo No.: 2 Borehole: BH 17-07 (NQ 6 to NQ 10) Depth: 3.5 m to 6.8 m

about 68 m in borehole BH17-7 was highly fractured with RQD values of between 0% and 11%. This is near to the elevation as the invert of the adjacent watermain (~68.5 m) and it is possible that this rock was damaged/fractured (e.g. by blasting) during installation of the watermain.

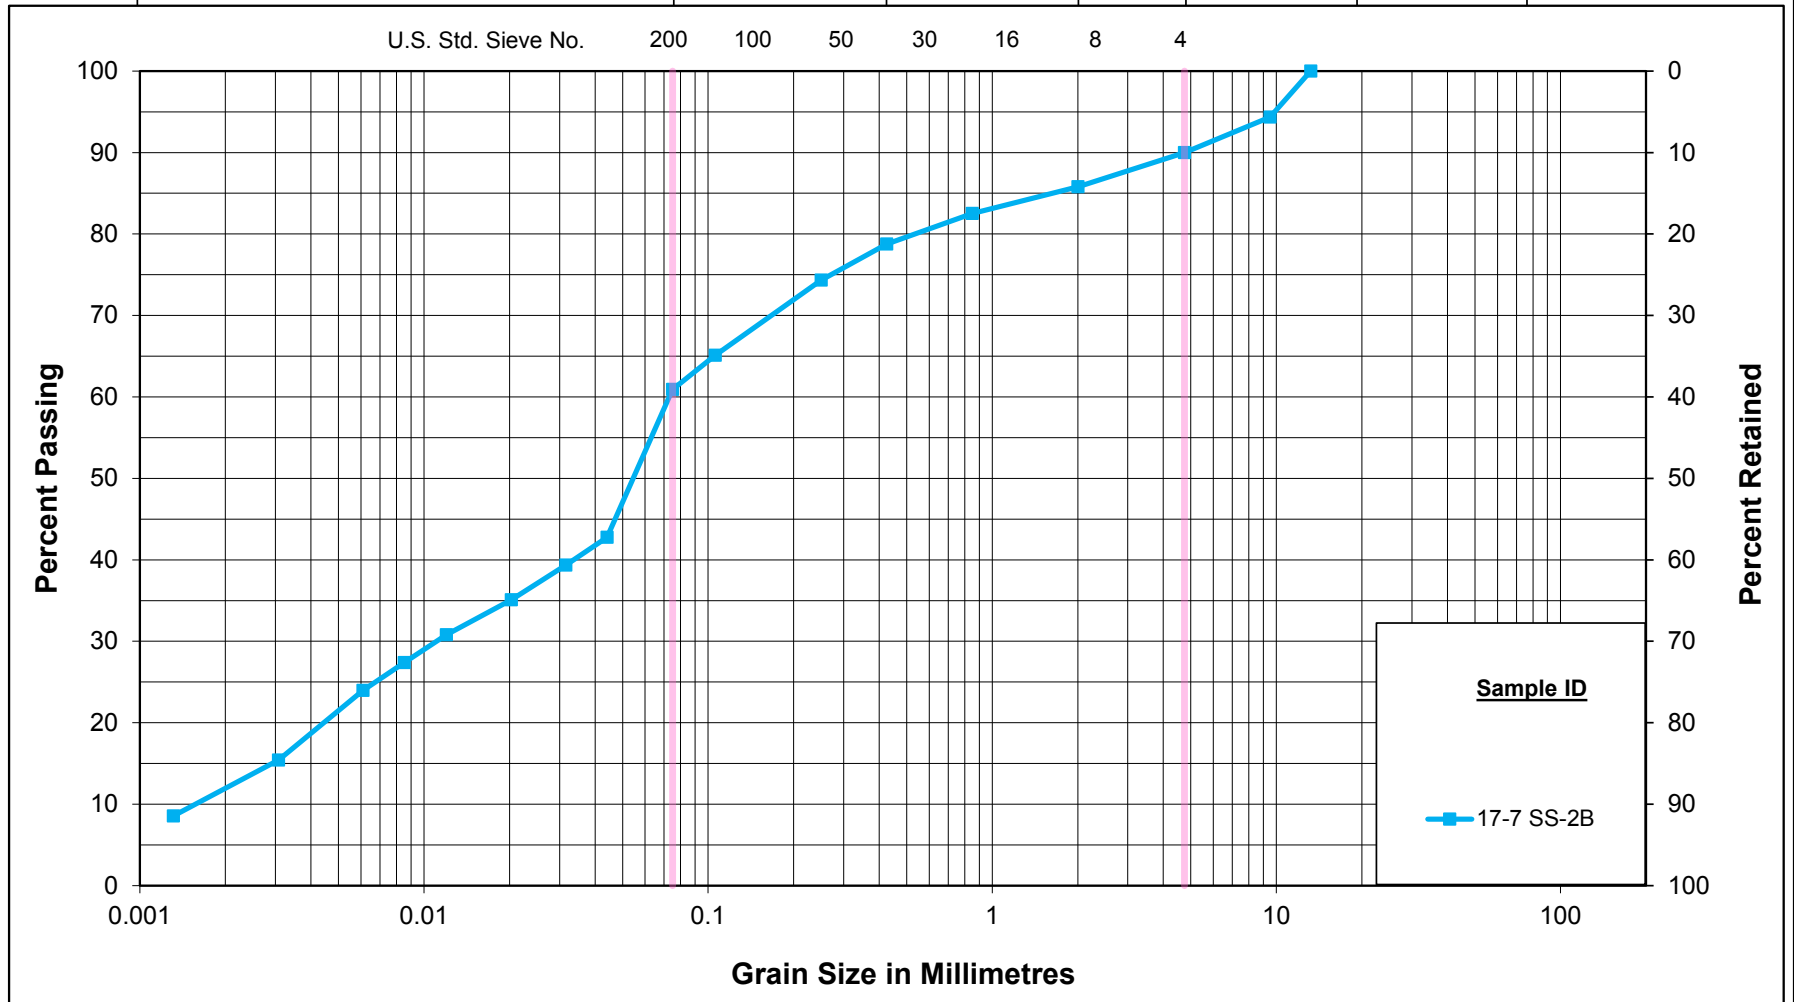
Figure No. C-1

**FILL: SANDY SILT some clay**  
 Harmer Ave. Pedestrian Bridge  
 City of Ottawa

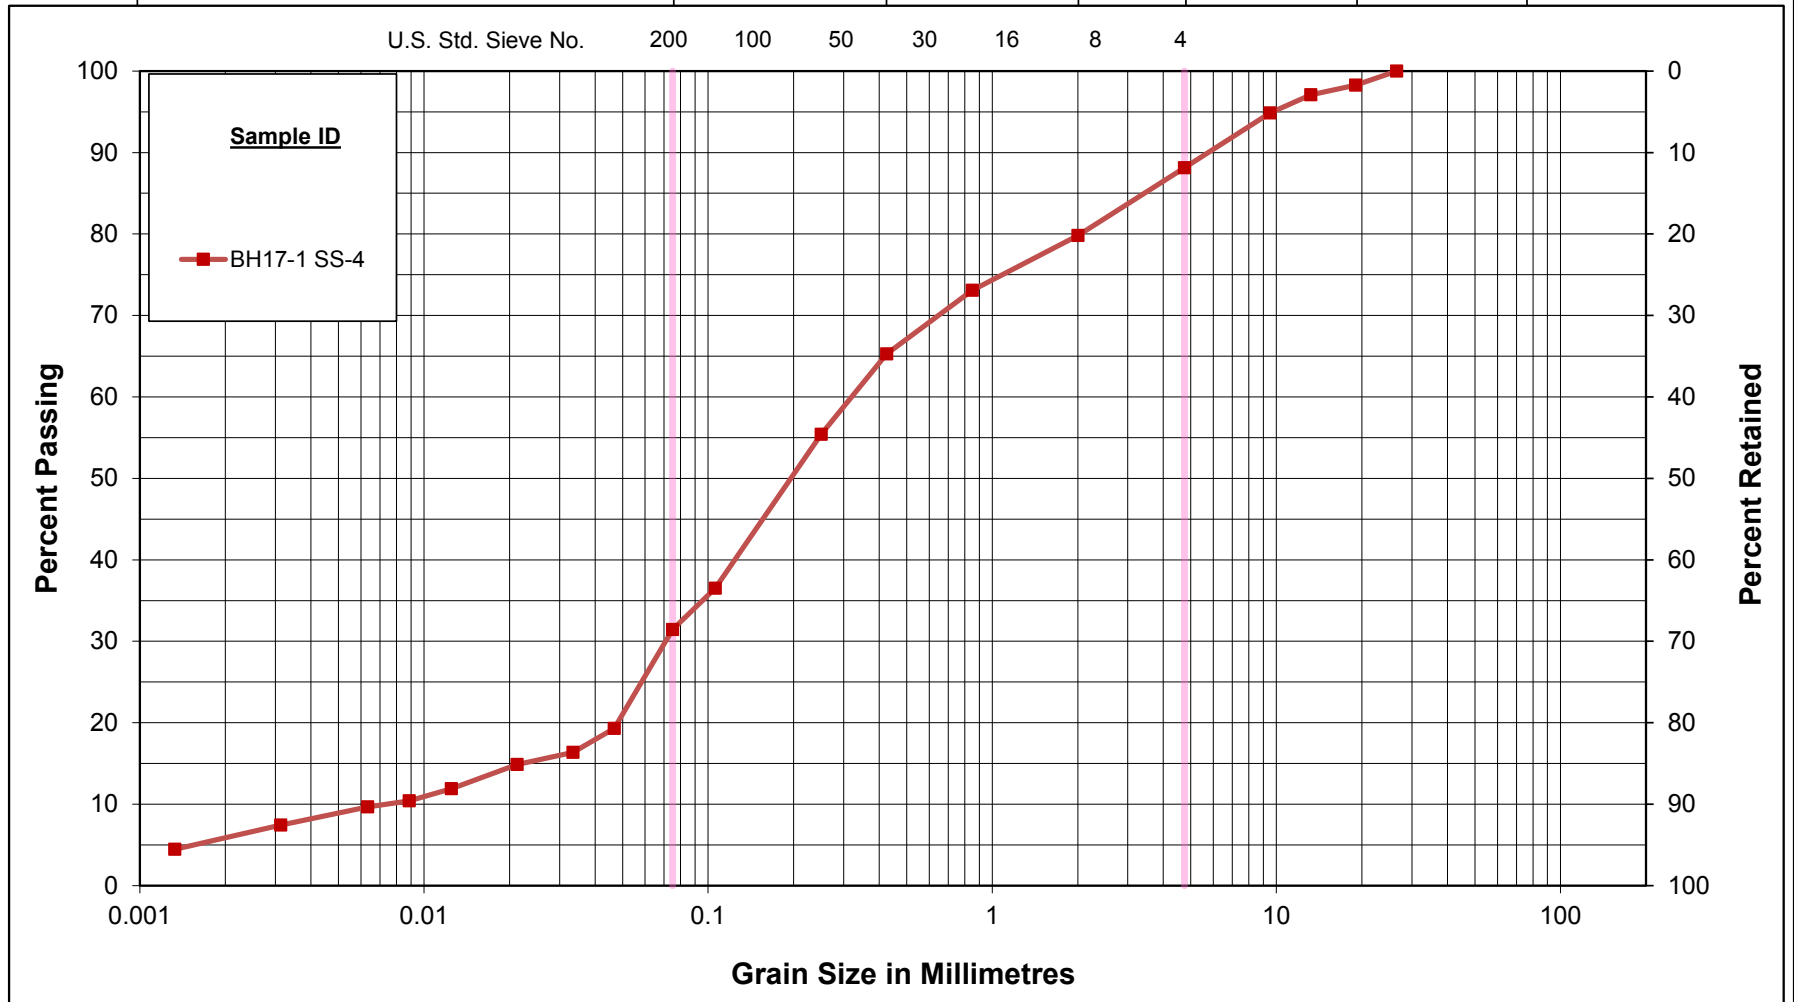
Figure No. C-2

**Till: SILTY SAND some gravel**  
Harmer Ave. Pedestrian Bridge  
City of Ottawa

The moisture content of samples of the till deposit were measured to range from approximately 9% to 11%. The results of grain size distribution testing carried out on a sample of the till from borehole BH17-1 is displayed on Figure C-2.

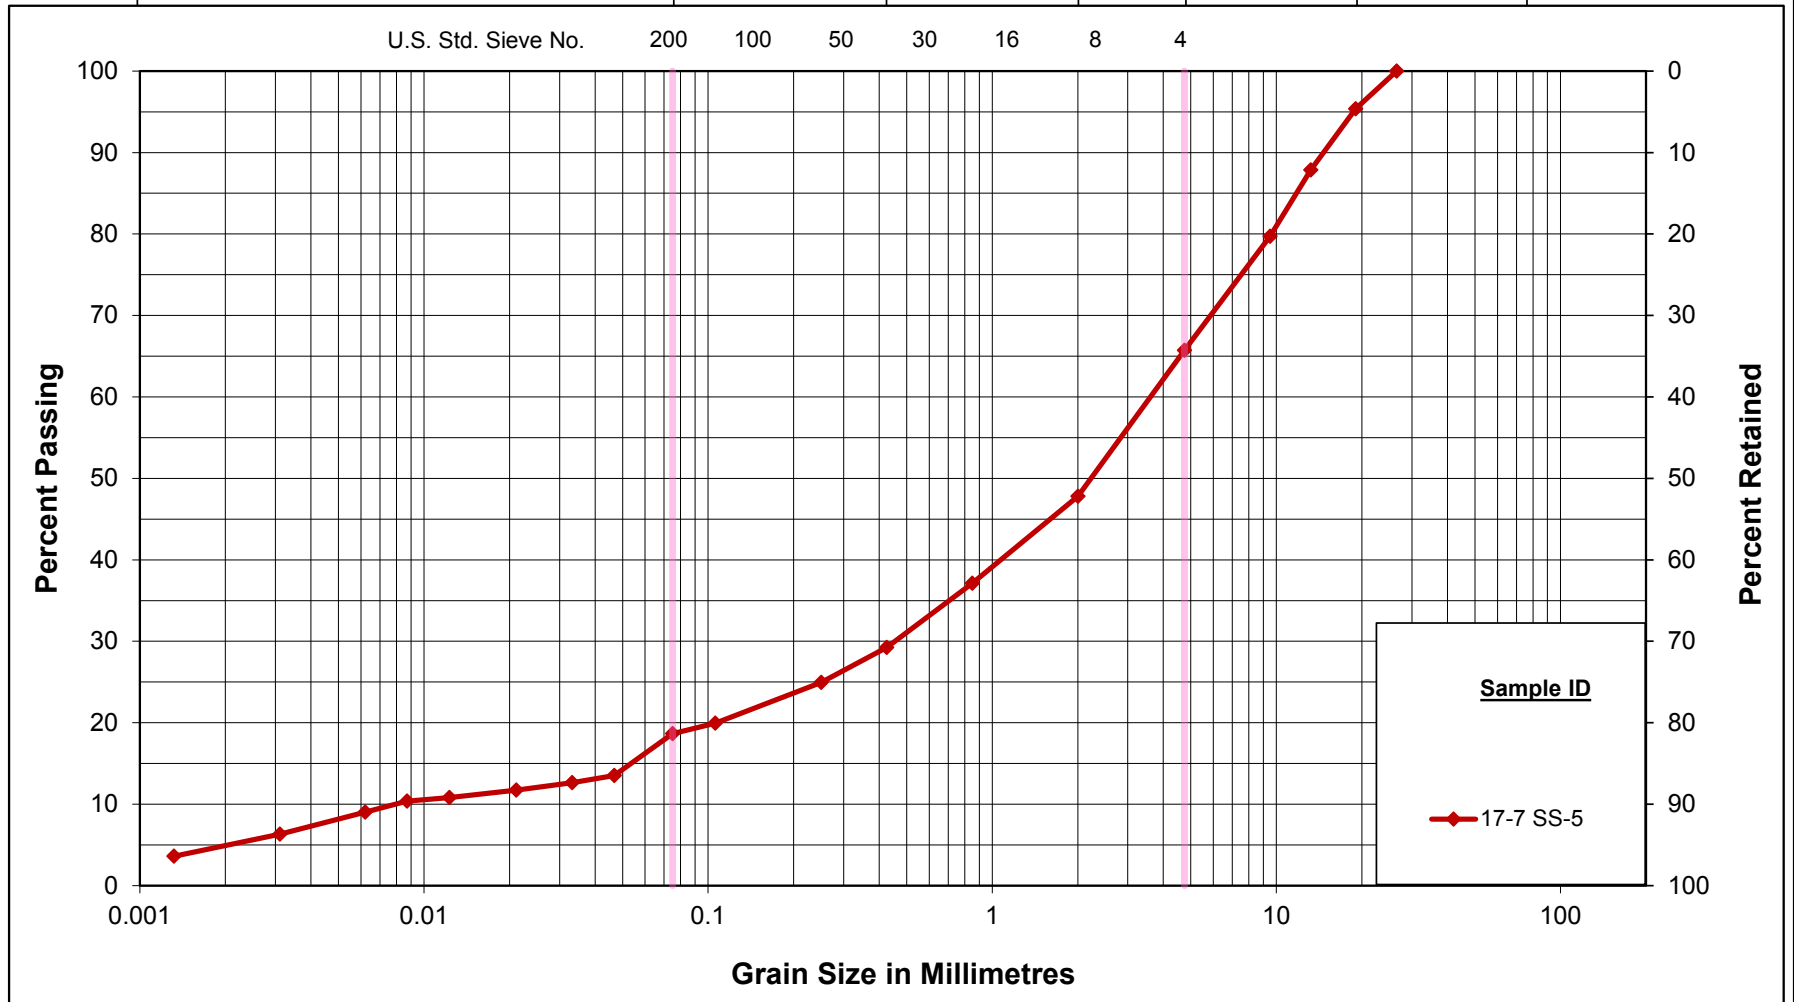
**Gravelly SAND (SW) - Possible FILL**

The moisture content of this material was determined to be approximately 3%. The results of grain size distribution testing carried out on a sample of the gravelly sand is displayed on Figure C-3 in Appendix C.
