**Highway 144 Rehabilitation**  
**Culvert Replacement – Site No. 46-413**  
**Halfway Lake Channel Culvert**  
**Station 22+833 – Twp. Of Antrim**  
**GWP 5046-05-00**

## **FINAL FOUNDATION INVESTIGATION REPORT**

Date: September 21, 2012  
Ref. N<sup>o</sup>: 11/06/11101-F2

**Geocres No. 42I-291**

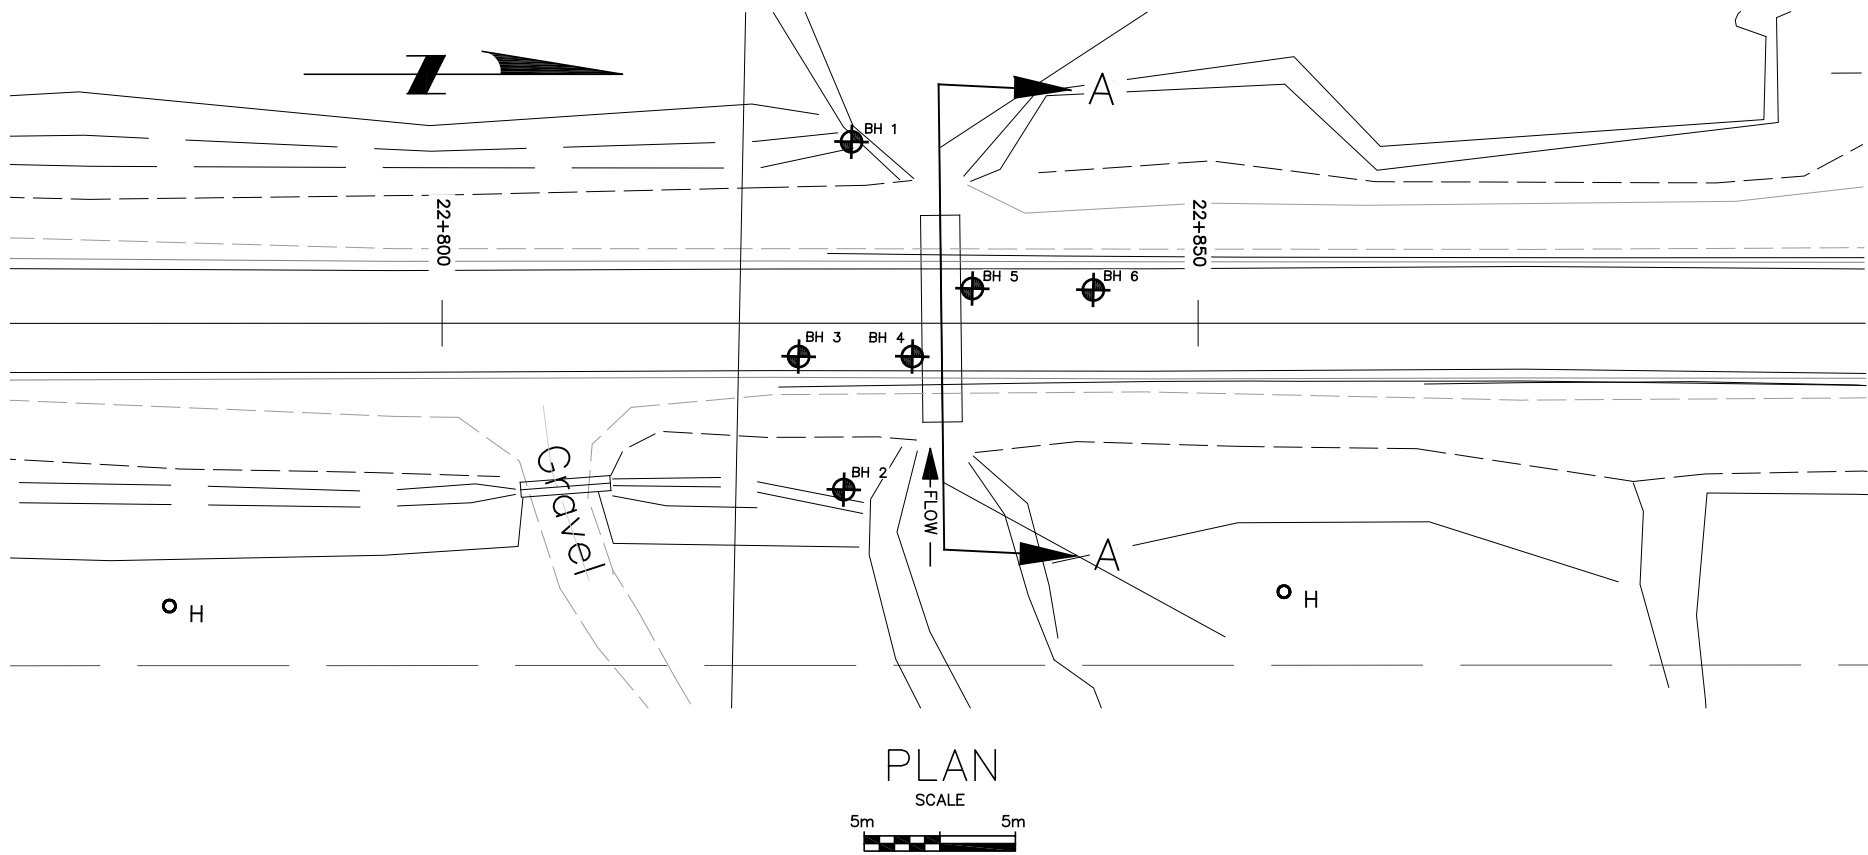
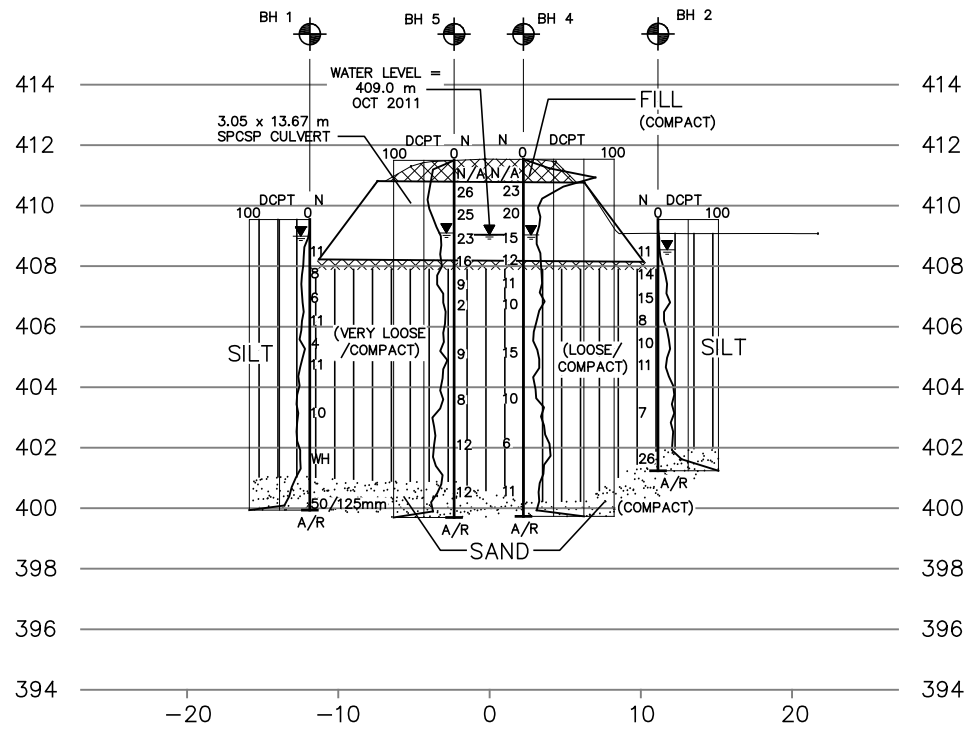
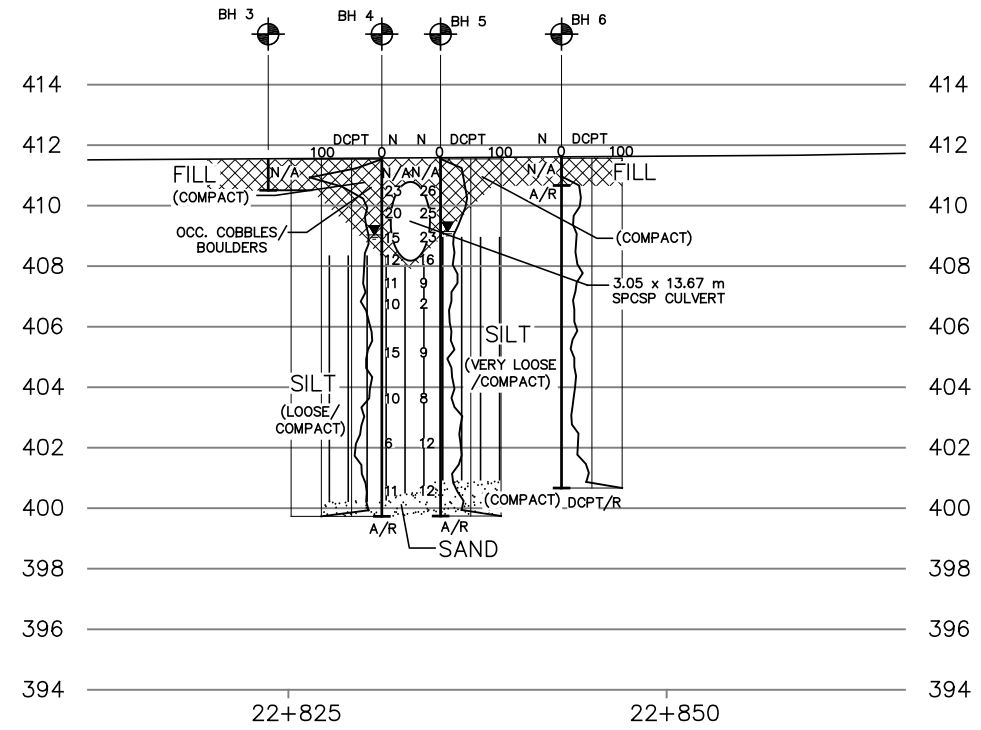
Figure  
2

HWY NO. 144 – Township of Antrim  
Halfway Lake Channel Culvert – Station 22+833  
Culvert Replacement  
BOREHOLE LOCATIONS & SOIL STRATA

SECTION A-A  
SCALE  
5m HOR  
2.5m VER

PROFILE C-C  
SCALE  
5m HOR  
2.5m VER

Details of the subsurface conditions revealed by the investigation program are presented on the enclosed Record of Borehole Logs (Appendix B) and on Figure No. 2 (Appendix C). Please note that stratigraphic delineation presented on the borehole logs and soil strata plot are the results of non-continuous sampling, response to drilling progress, the results of SPT and Dynamic Cone Penetration Test (DCPT) plus field observations. Typically such boundaries represent transitions from one zone to another and are not an exact demarcation of specific geological unit. Additional consideration should be given to the fact that subsurface conditions may vary markedly between adjacent boreholes and beyond any specific boring location, and are shown on the drawings for illustration purposes only.

A plan and profile illustrating the borehole locations and stratigraphic sequences is shown on Figure No. 2, Appendix C. During the course of the exploration program, six (6) sampled boreholes were put down at this site, with Borehole Nos. 1 and 2 advanced off from the ends of the culvert and Borehole Nos. 3 to 6, inclusive, were advanced through the existing embankment. At the time of the subsurface investigation, the ground surface elevations at Boreholes Nos. 1 to 6 inclusive were recorded at 409.5, 409.5, 411.5, 411.5, 411.5, and 411.6 m, respectively.

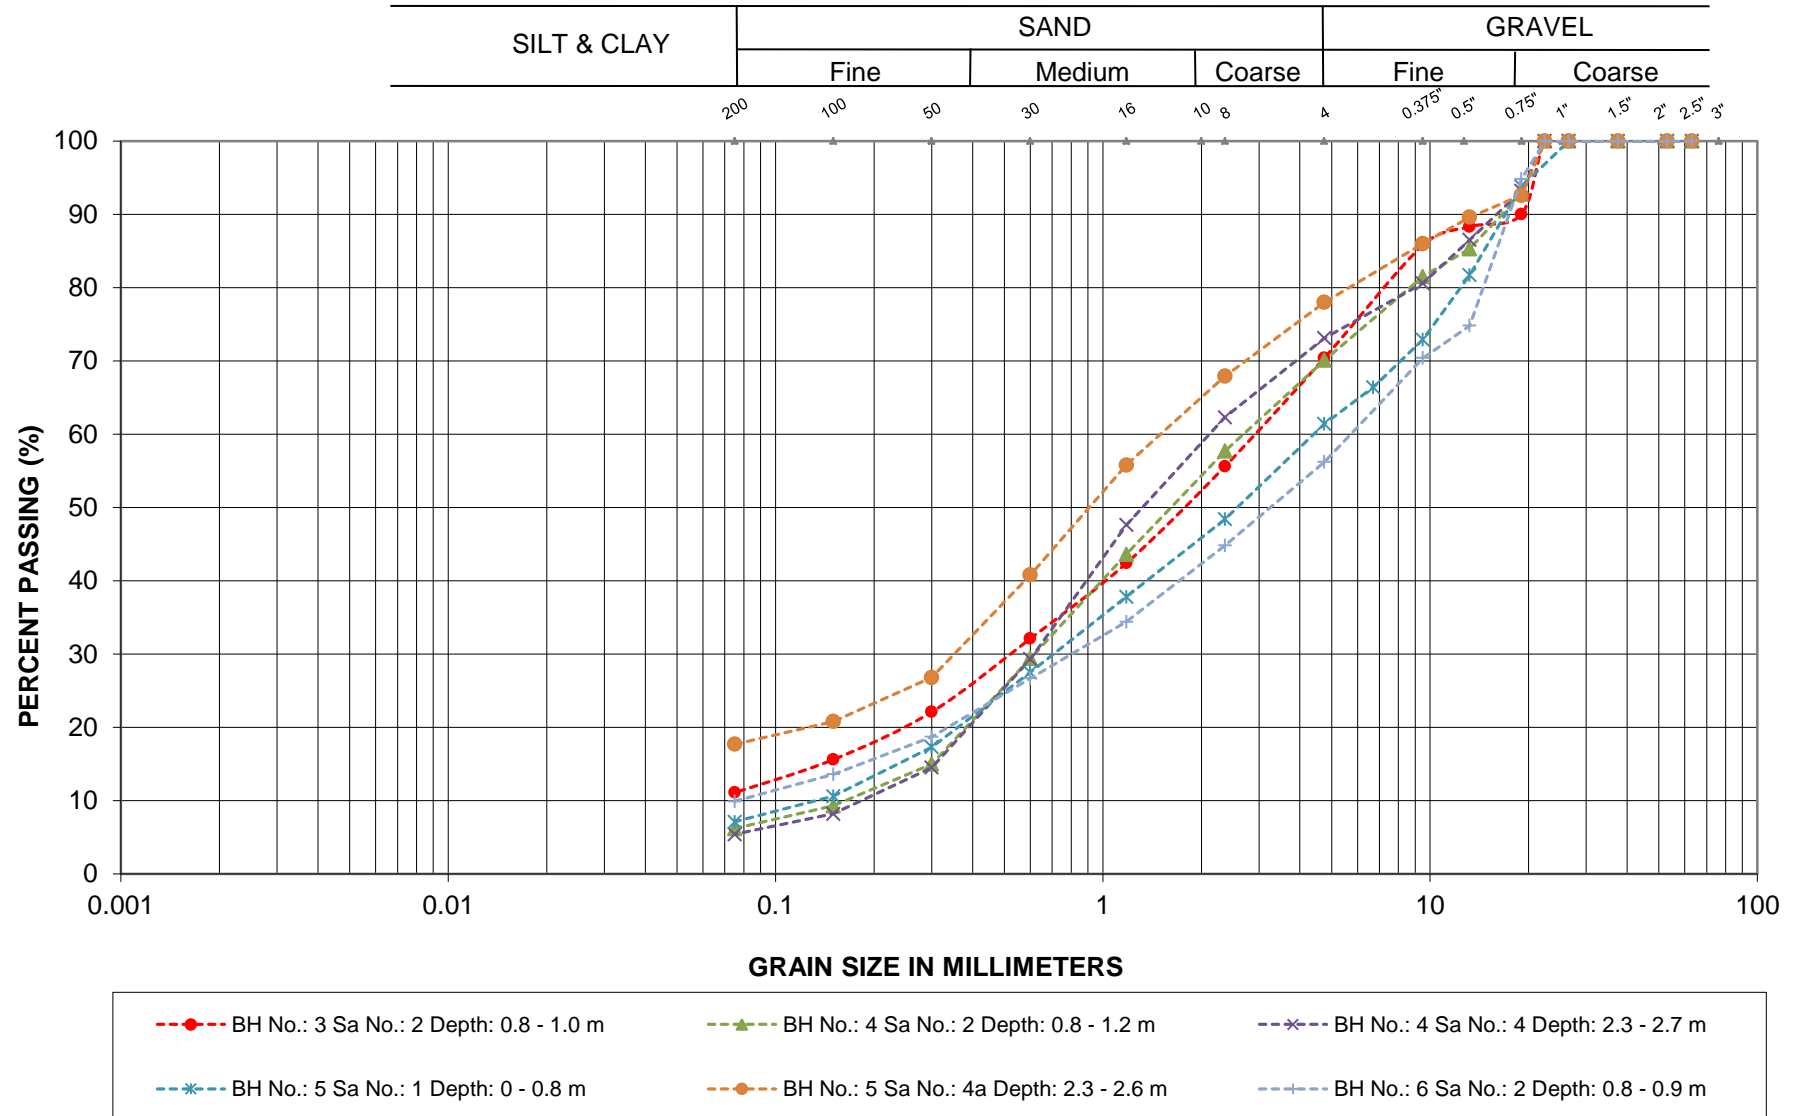
# GRAIN SIZE ANALYSIS

FILL

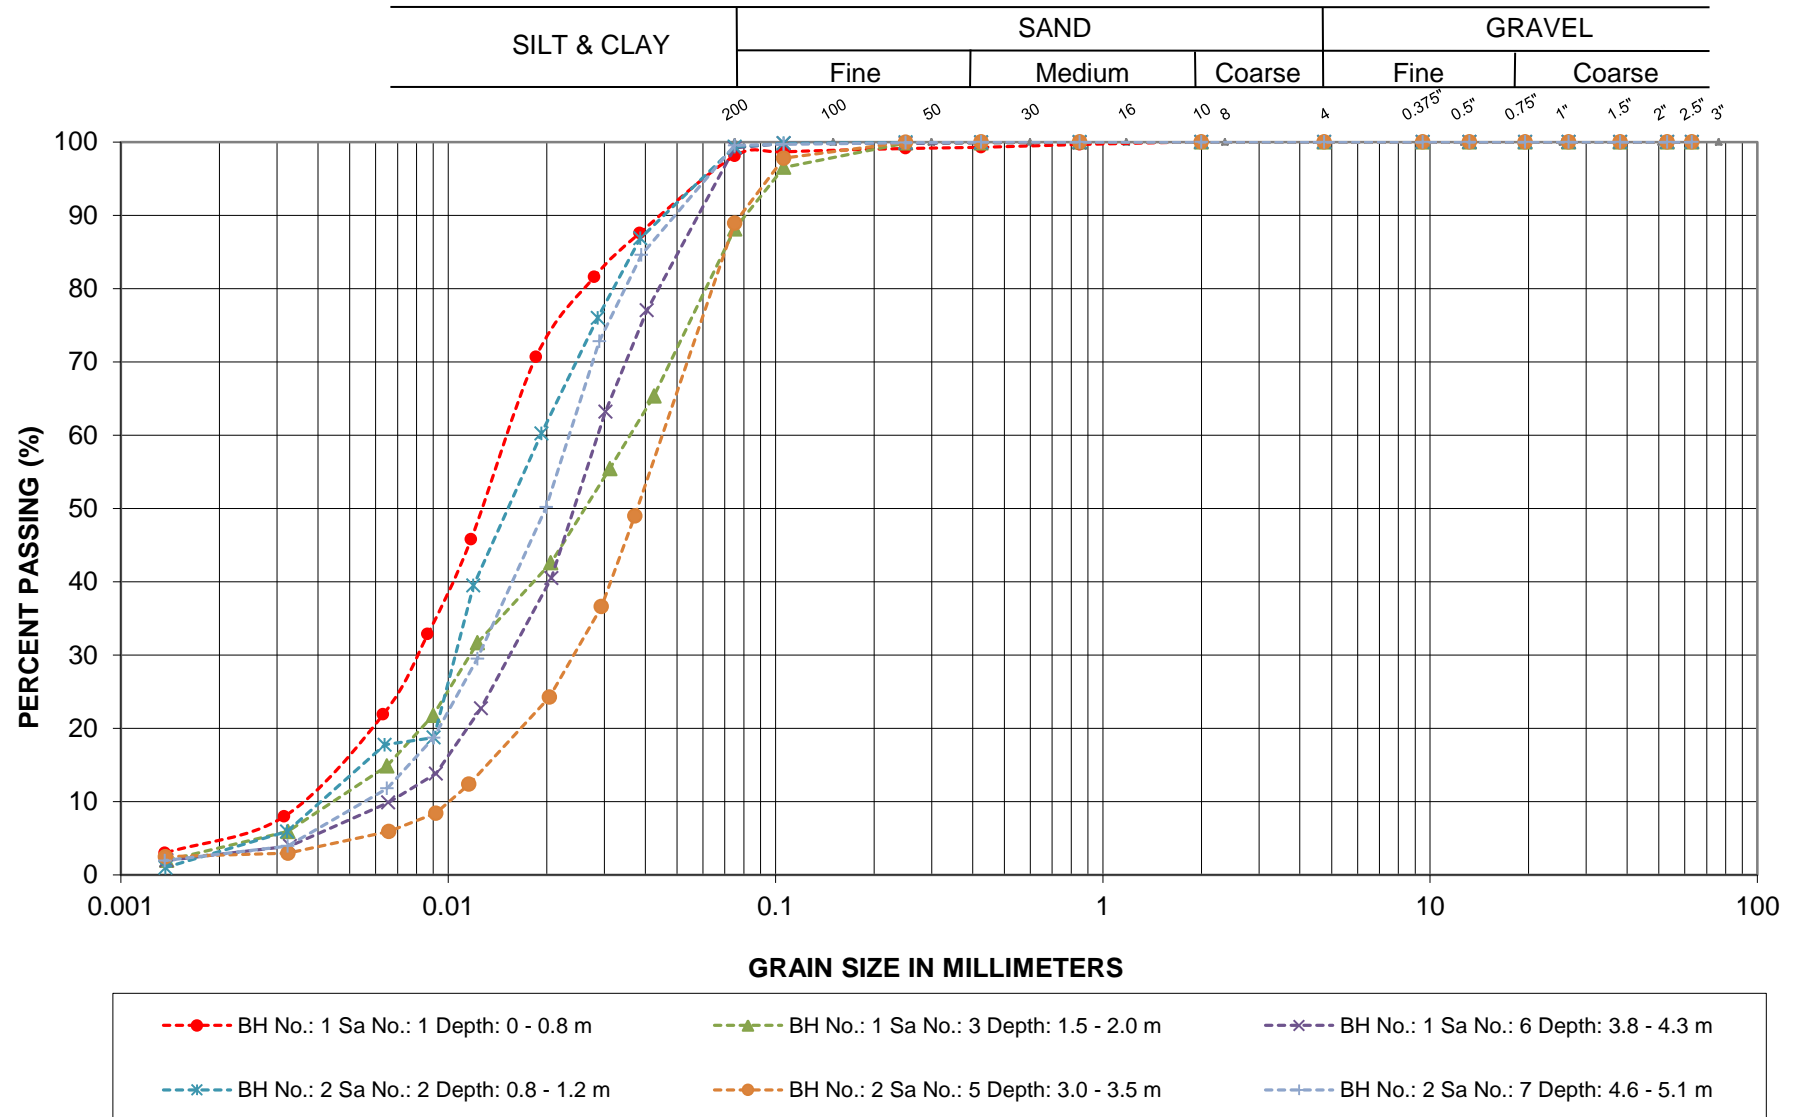
FIGURE L-2

## GRAIN SIZE ANALYSIS

SILT

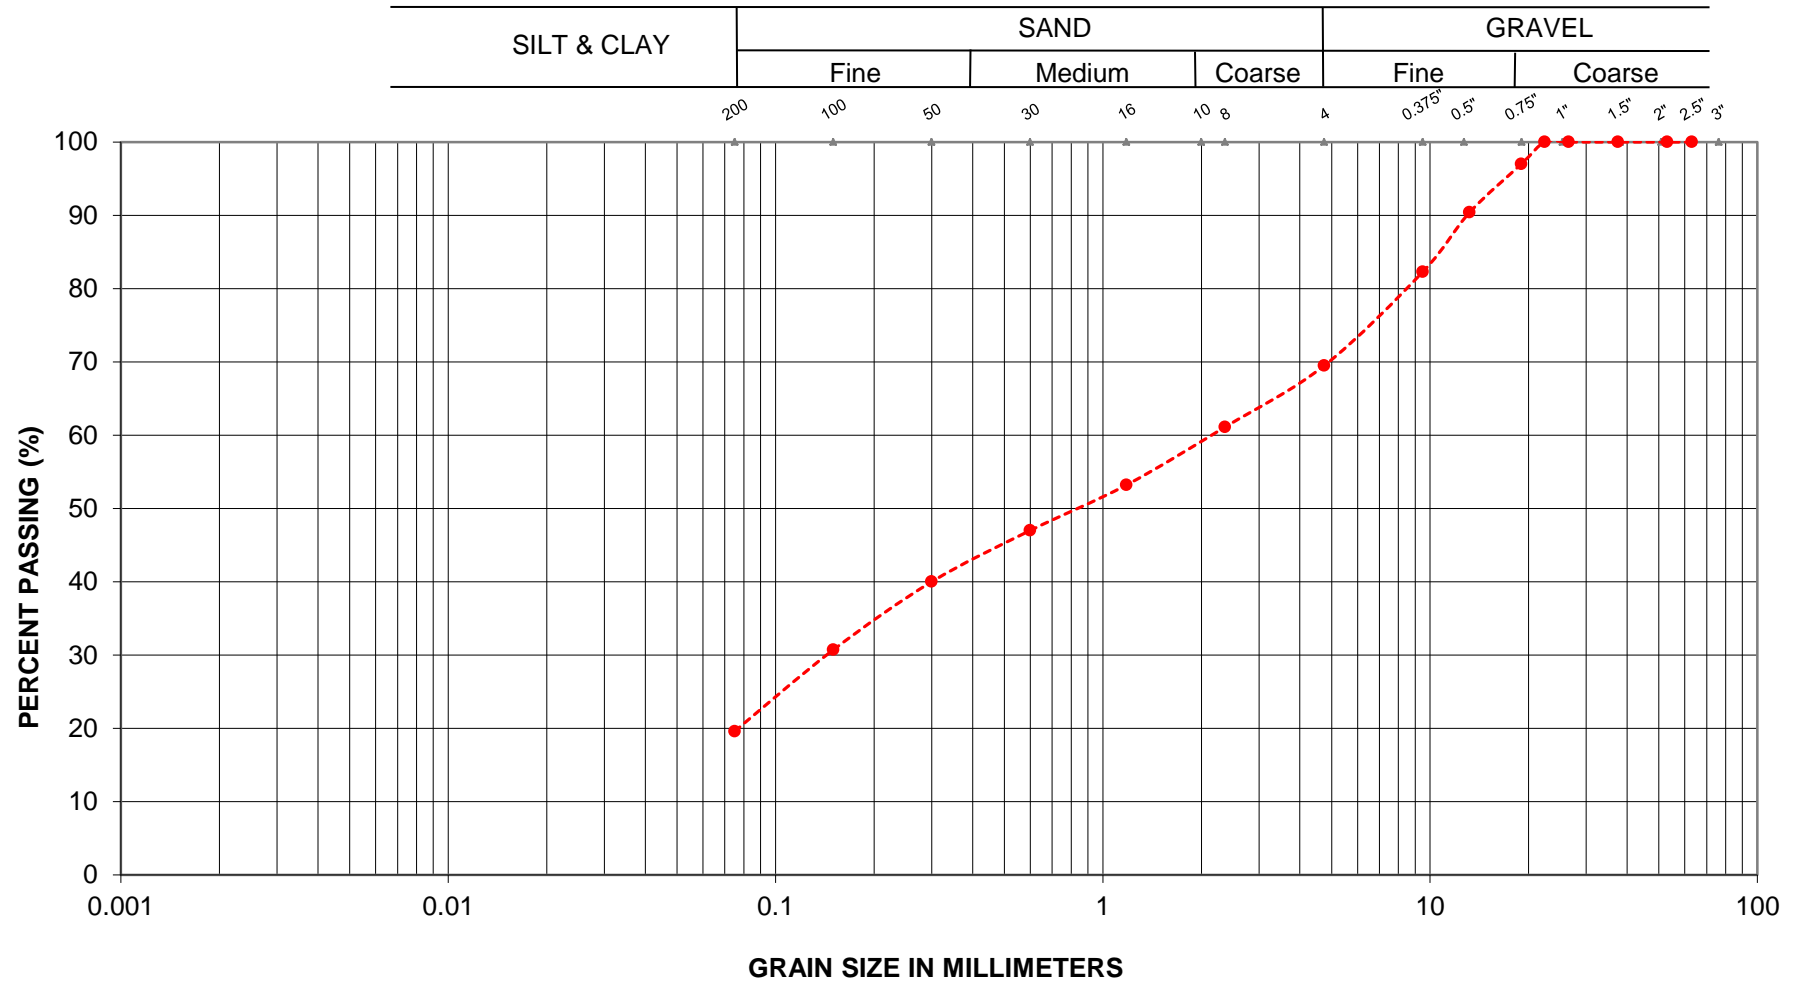
# GRAIN SIZE ANALYSIS

---●--- BH No.: 1 Sa No.: 10 Depth: 9.1 - 9.6 m

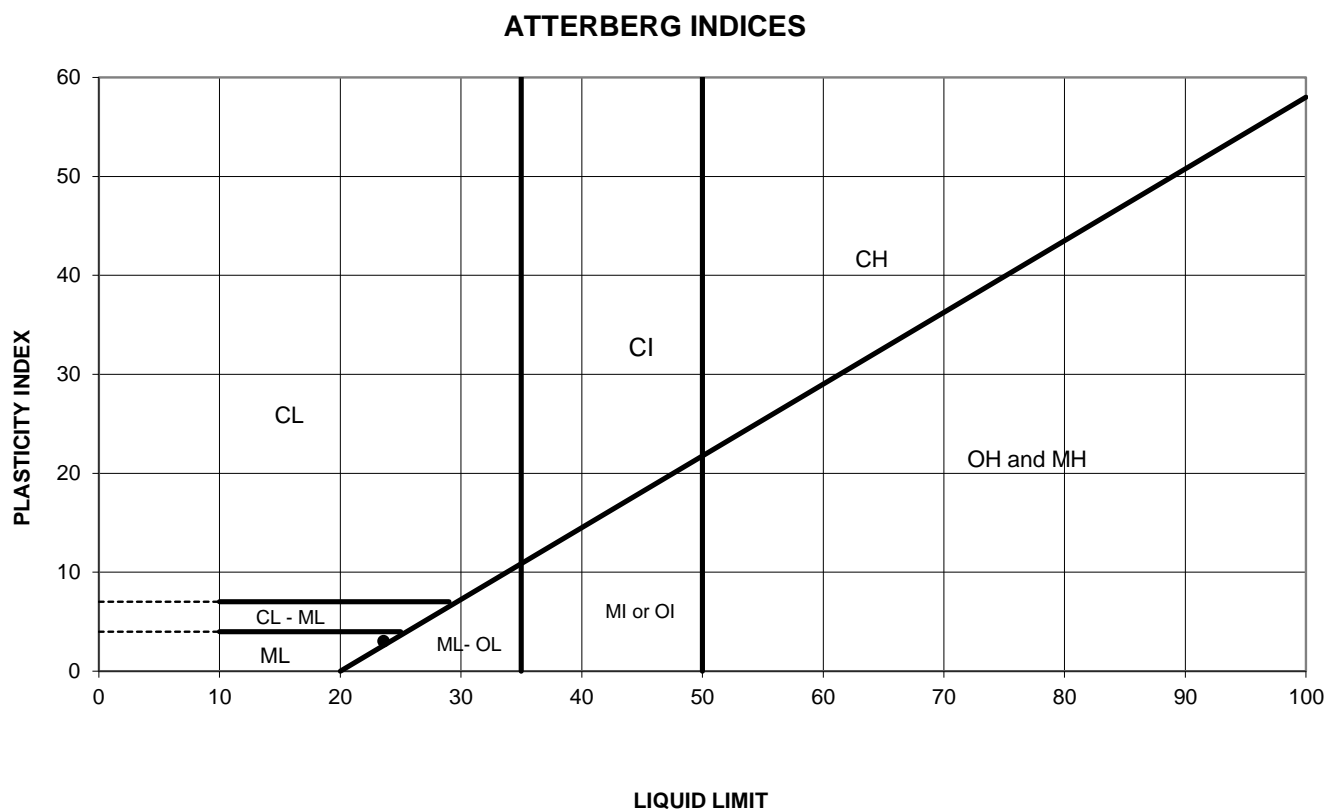
**FIGURE L-4**

## ATTERBERG LIMITS TEST RESULTS

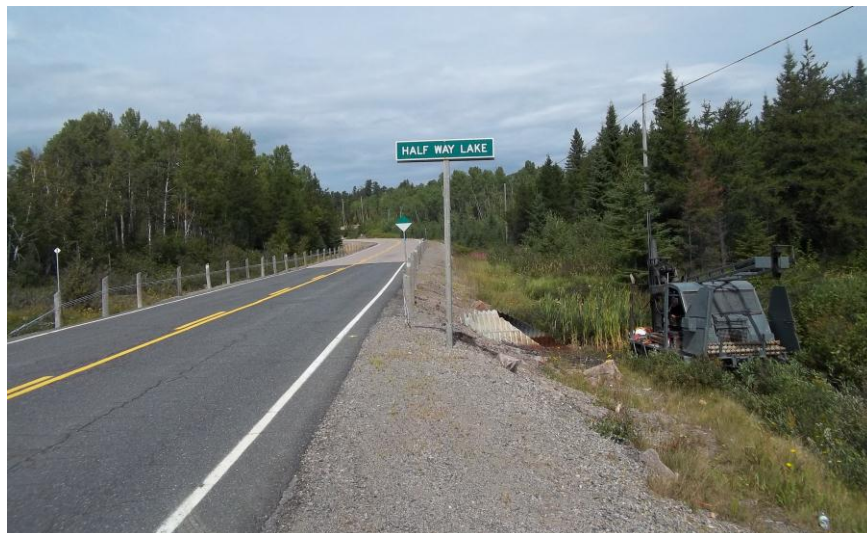
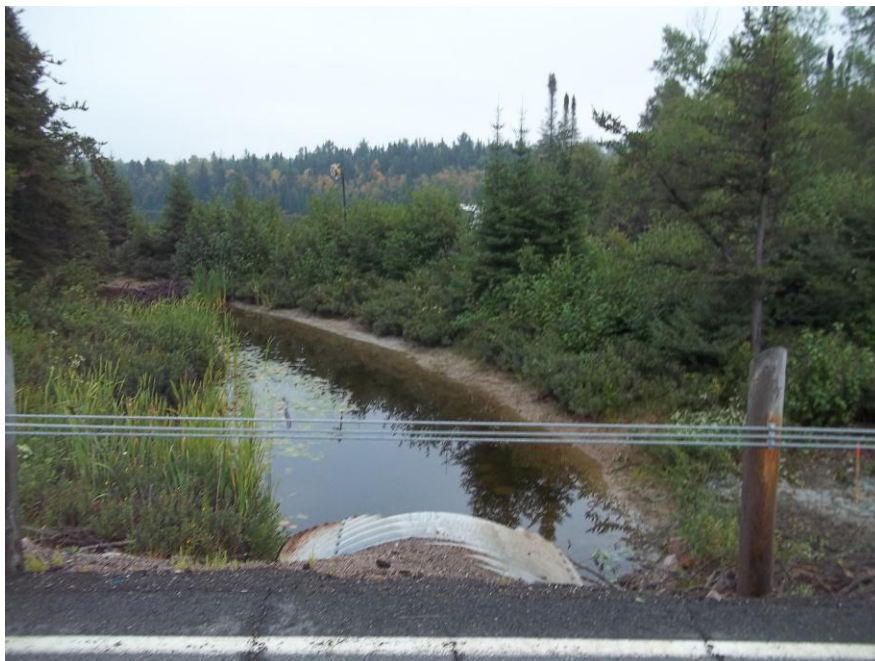
Photo: 1 - 2

Top: Embankment at culvert, looking north  
Bottom: Stream at culvert inlet, looking east

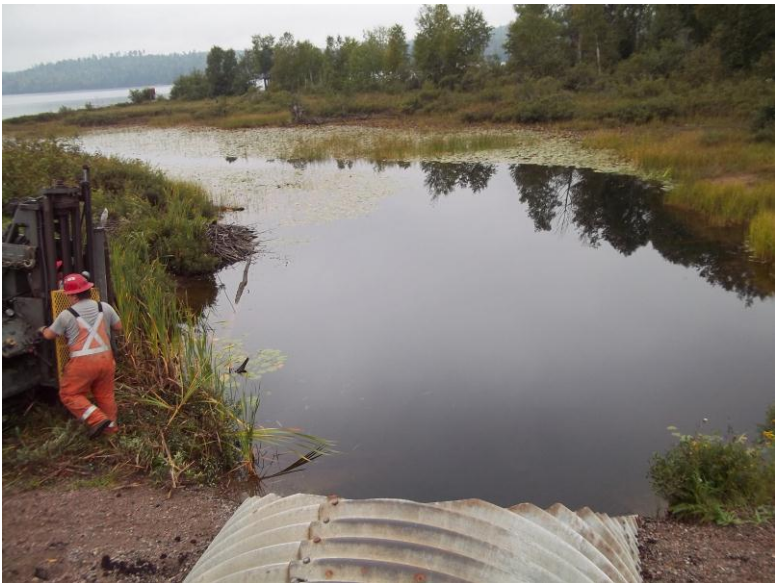
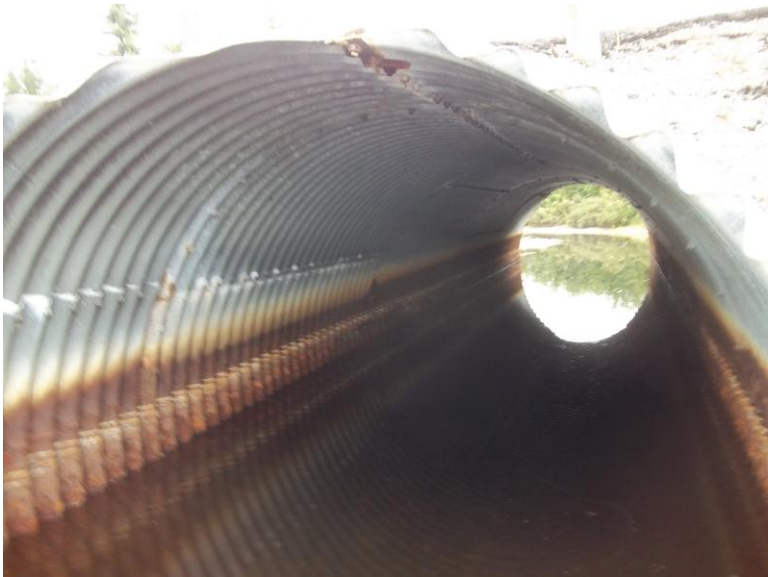
Photo: 3 - 4

Top: Stream at culvert outlet, looking west  
Bottom: Looking through culvert, looking east
