**Unnamed Creek Culvert Replacement
Site No. 47-413C
Stations 17+380 - Township of Boston
GWP 5105-12-00
Highway 112
4.7 km north of Blanche River**

FINAL FOUNDATION INVESTIGATION REPORT

Date: March 31, 2015
Ref. Nº: 13/05/13073-F11

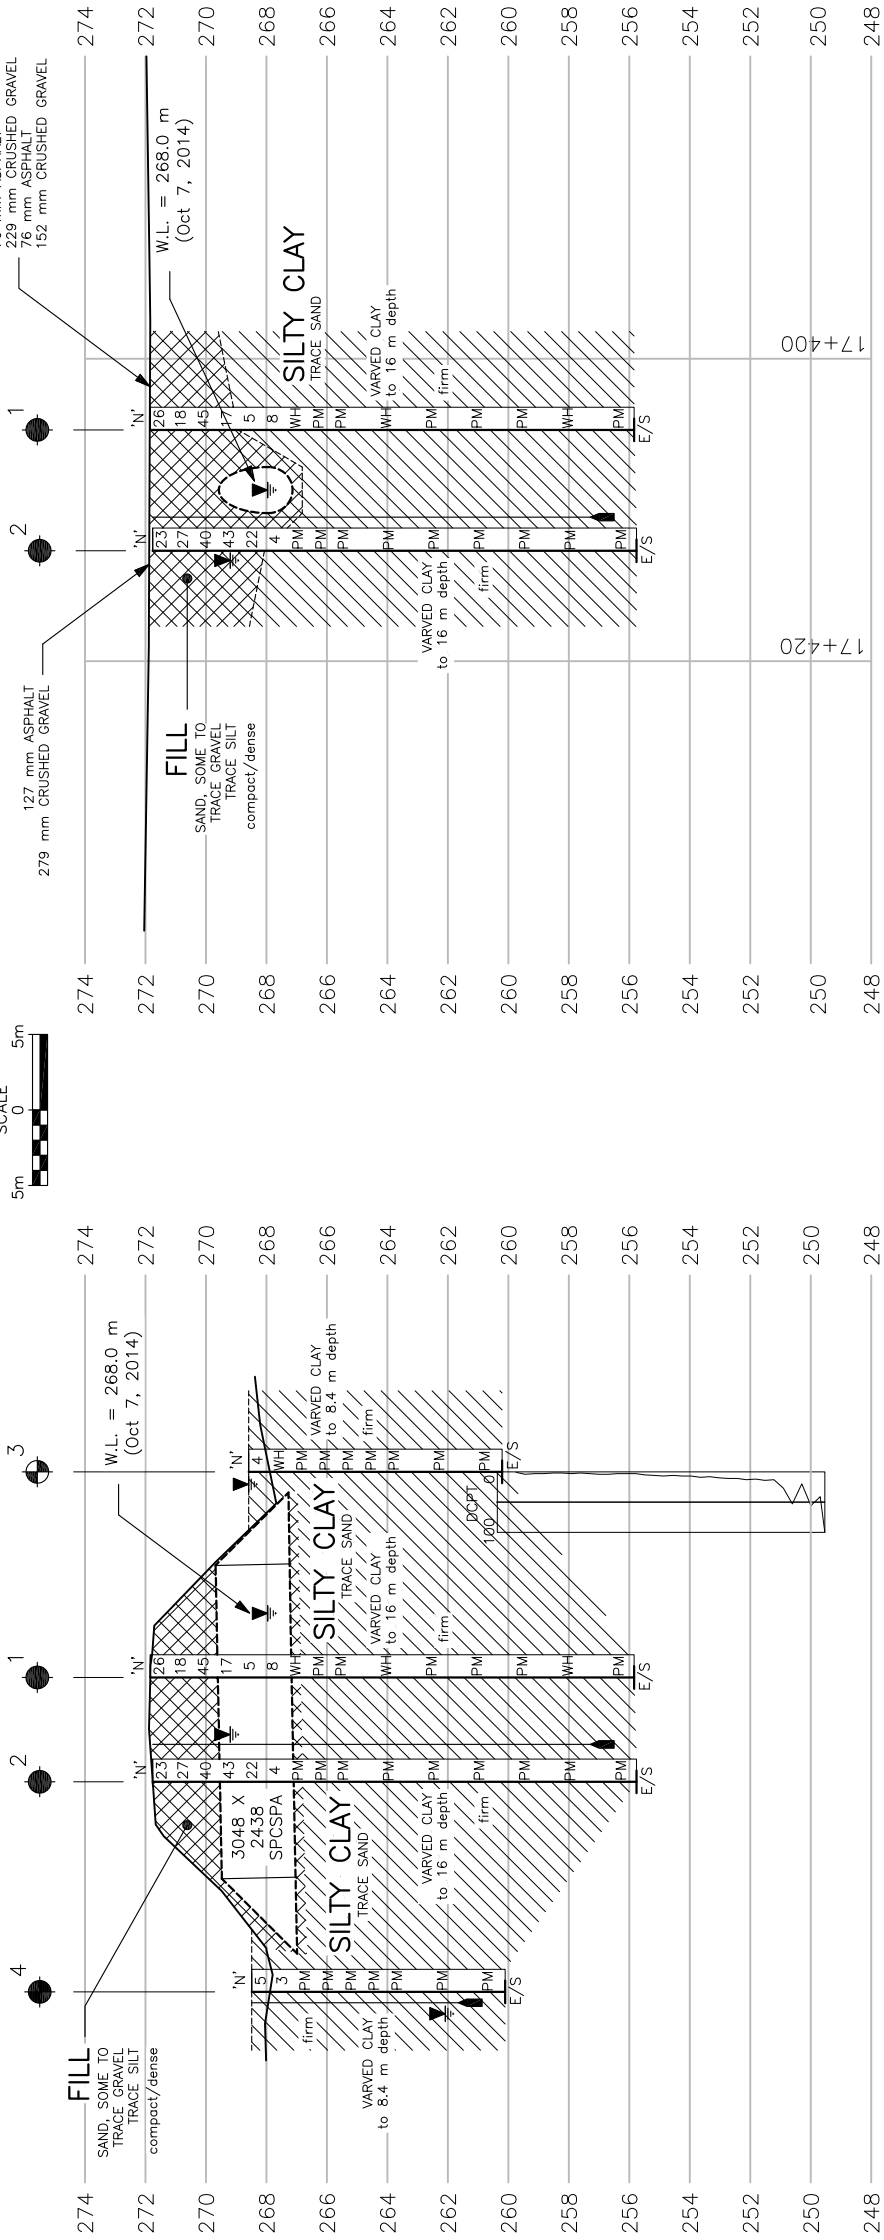
SECTION

A-A

Drawing No. 2: Borehole Location and Soil Strata
Figure Nos. L-1 and L-2: Grain Size Distribution Curves
Figure No. L-3: Atterberg Limits Chart
Figure No. L-4: In-situ Shear Strengths Chart
Table No. L-5: Laboratory Tests - Summary Sheet

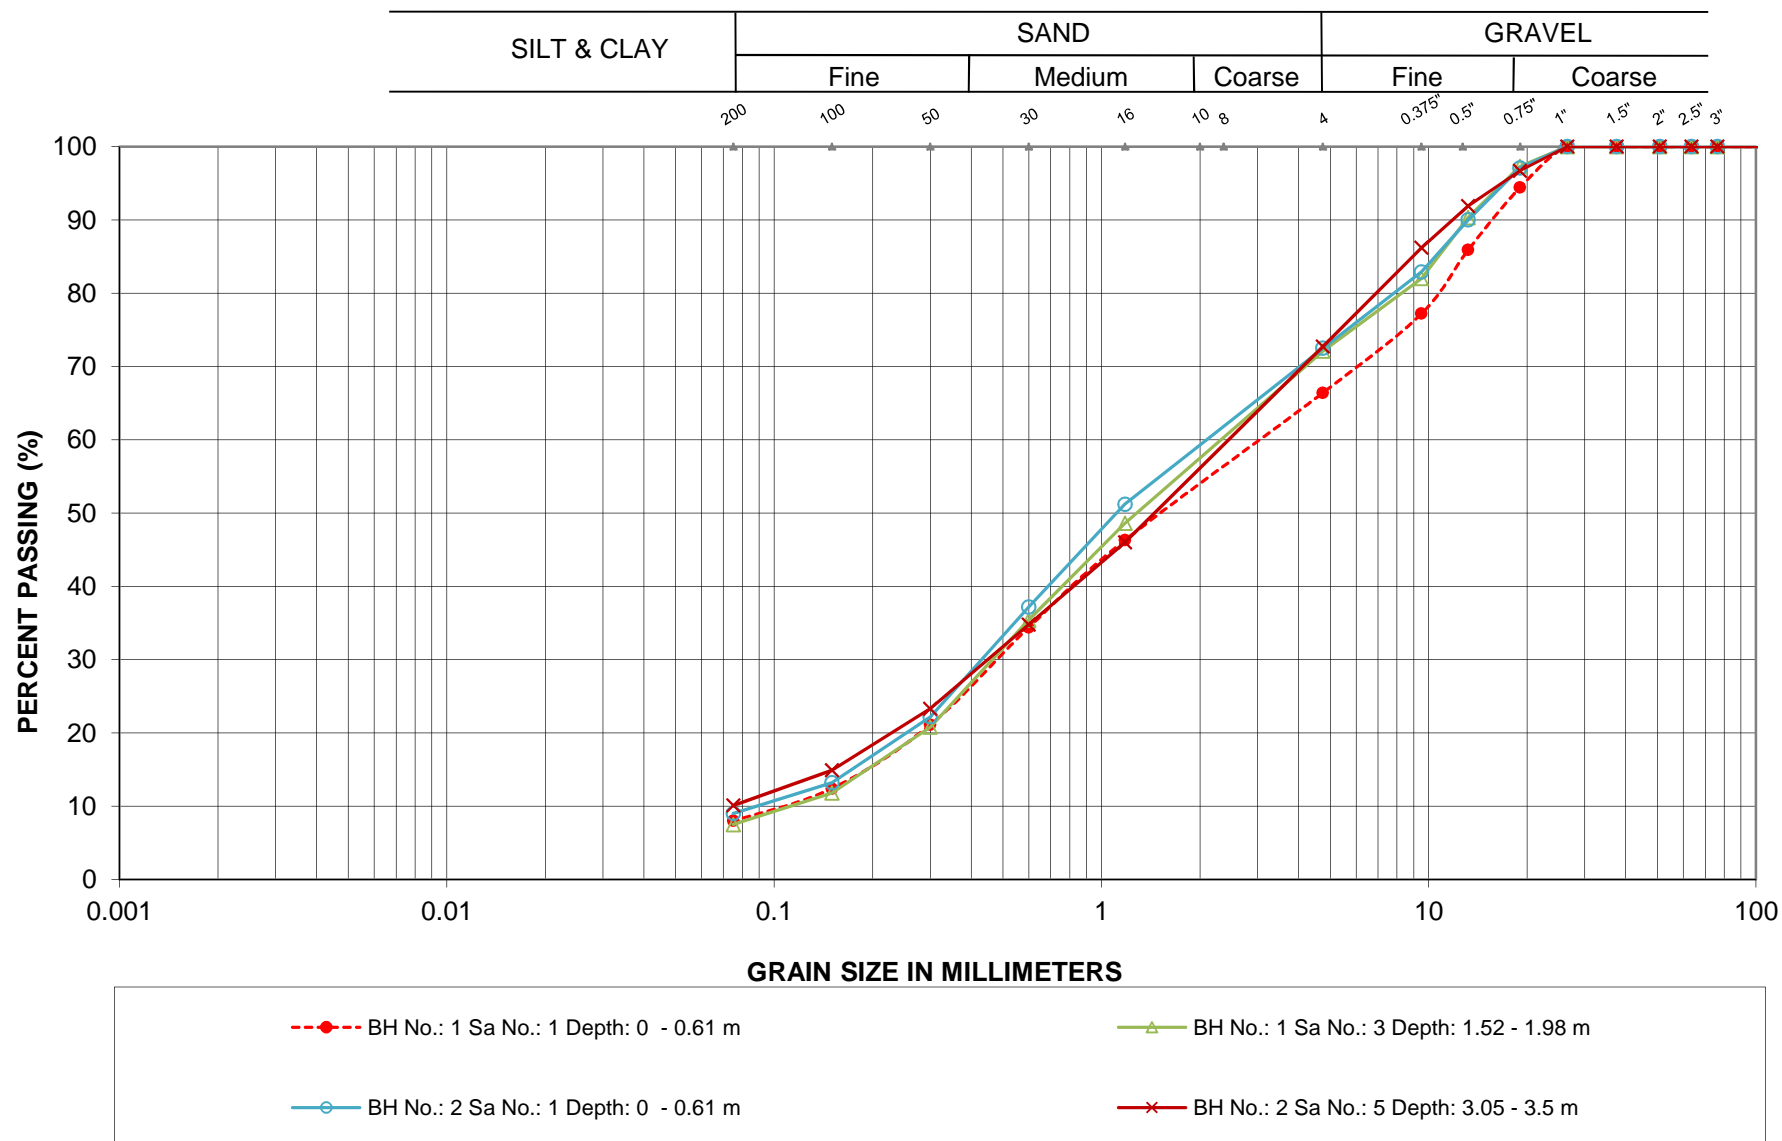
FIGURE L-1

GRAIN SIZE ANALYSIS

LOCATION: Hwy 112 Unnamed Creek Culvert
TWP Boston, Ontario

SAND FILL

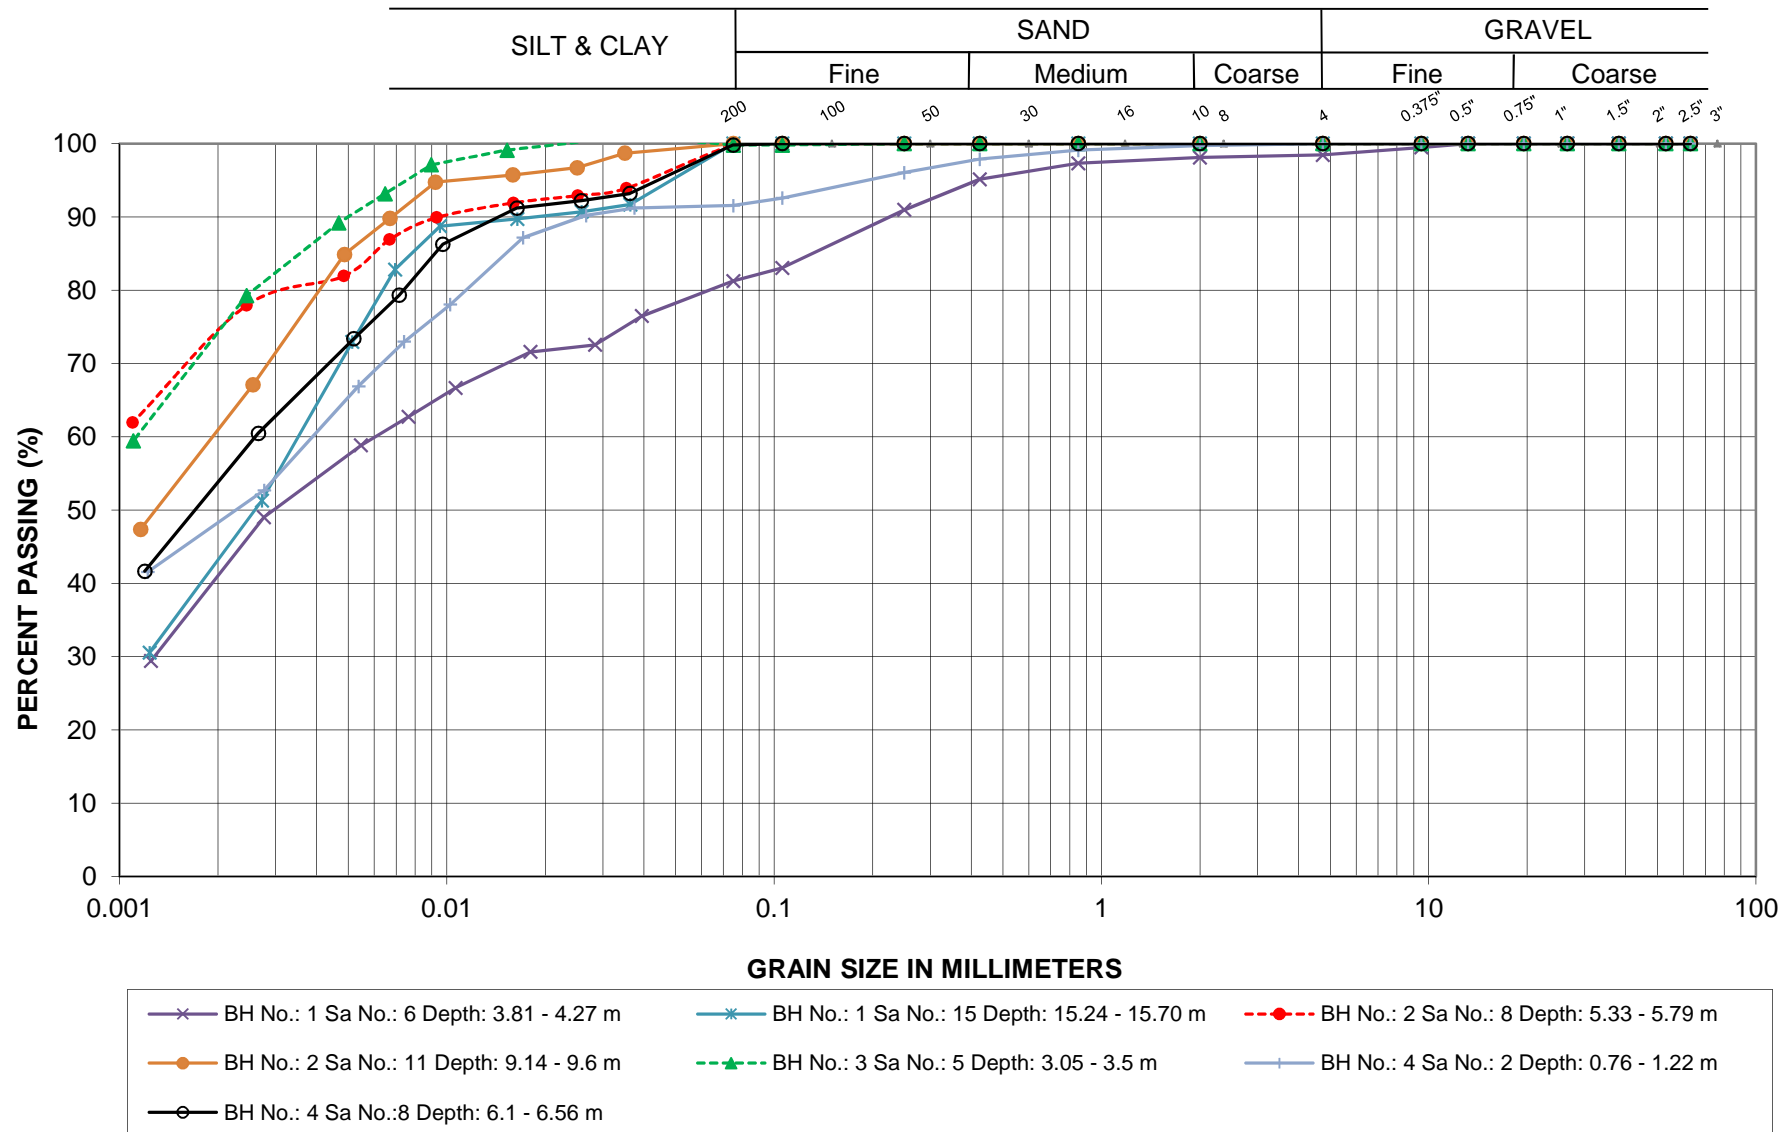
GRAIN SIZE ANALYSIS

LOCATION: Hwy 112 Unnamed Creek Culvert
TWP Boston, Ontario

SILTY CLAY to CLAY

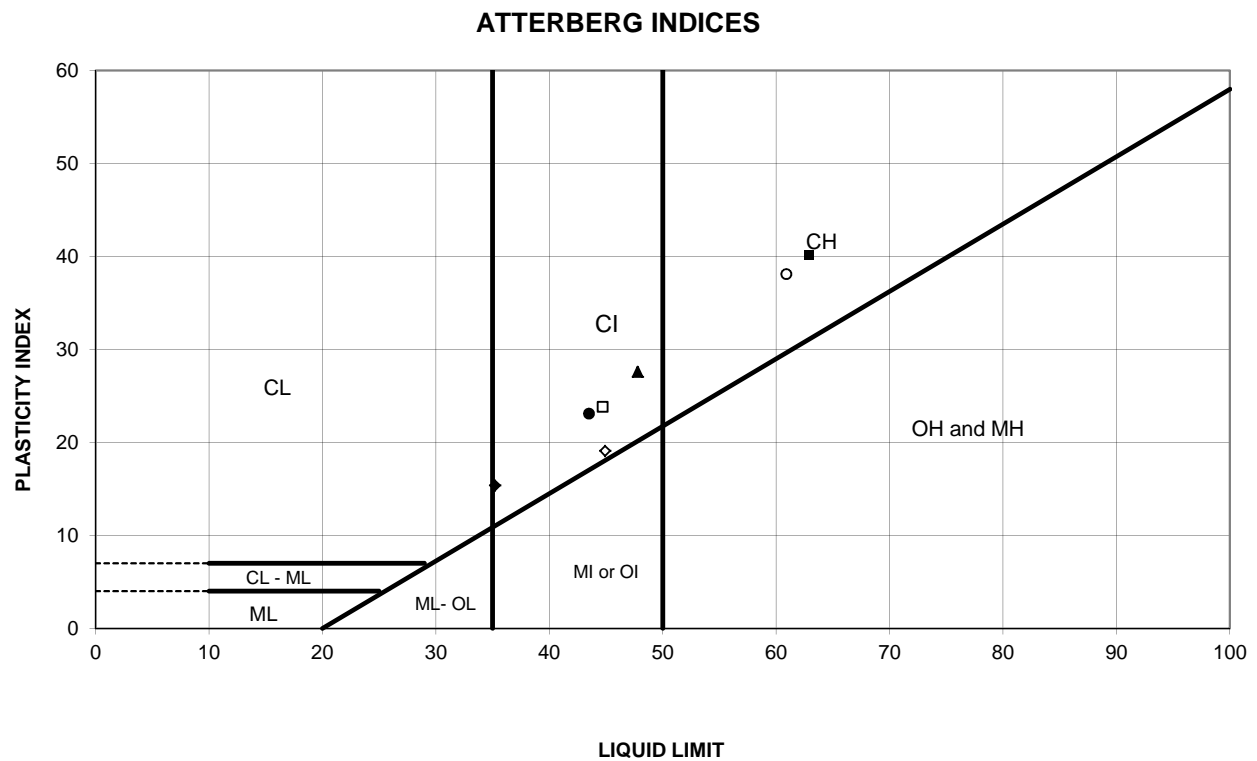
FIGURE L-3

ATTERBERG LIMITS CHART

SYMBOL	BH	Sa. No.	Depth(m)	Elev.(m)	Liquid Limit	Plastic Limit	Plasticity Index	NMC %
●	1	6	4.0	267.8	43.5	20.4	23.1	30.2
◆	1	15	15.5	256.3	35.2	19.8	15.4	42.9
■	2	8	5.6	266.2	62.9	22.8	40.1	57.0
▲	2	11	9.4	262.4	47.8	20.2	27.6	54.5
○	3	5	3.3	265.3	60.9	22.8	38.1	65.0
◇	4	2	1.0	267.5	44.9	25.8	19.1	46.5
□	4	8	6.3	262.2	44.7	20.9	23.8	53.1

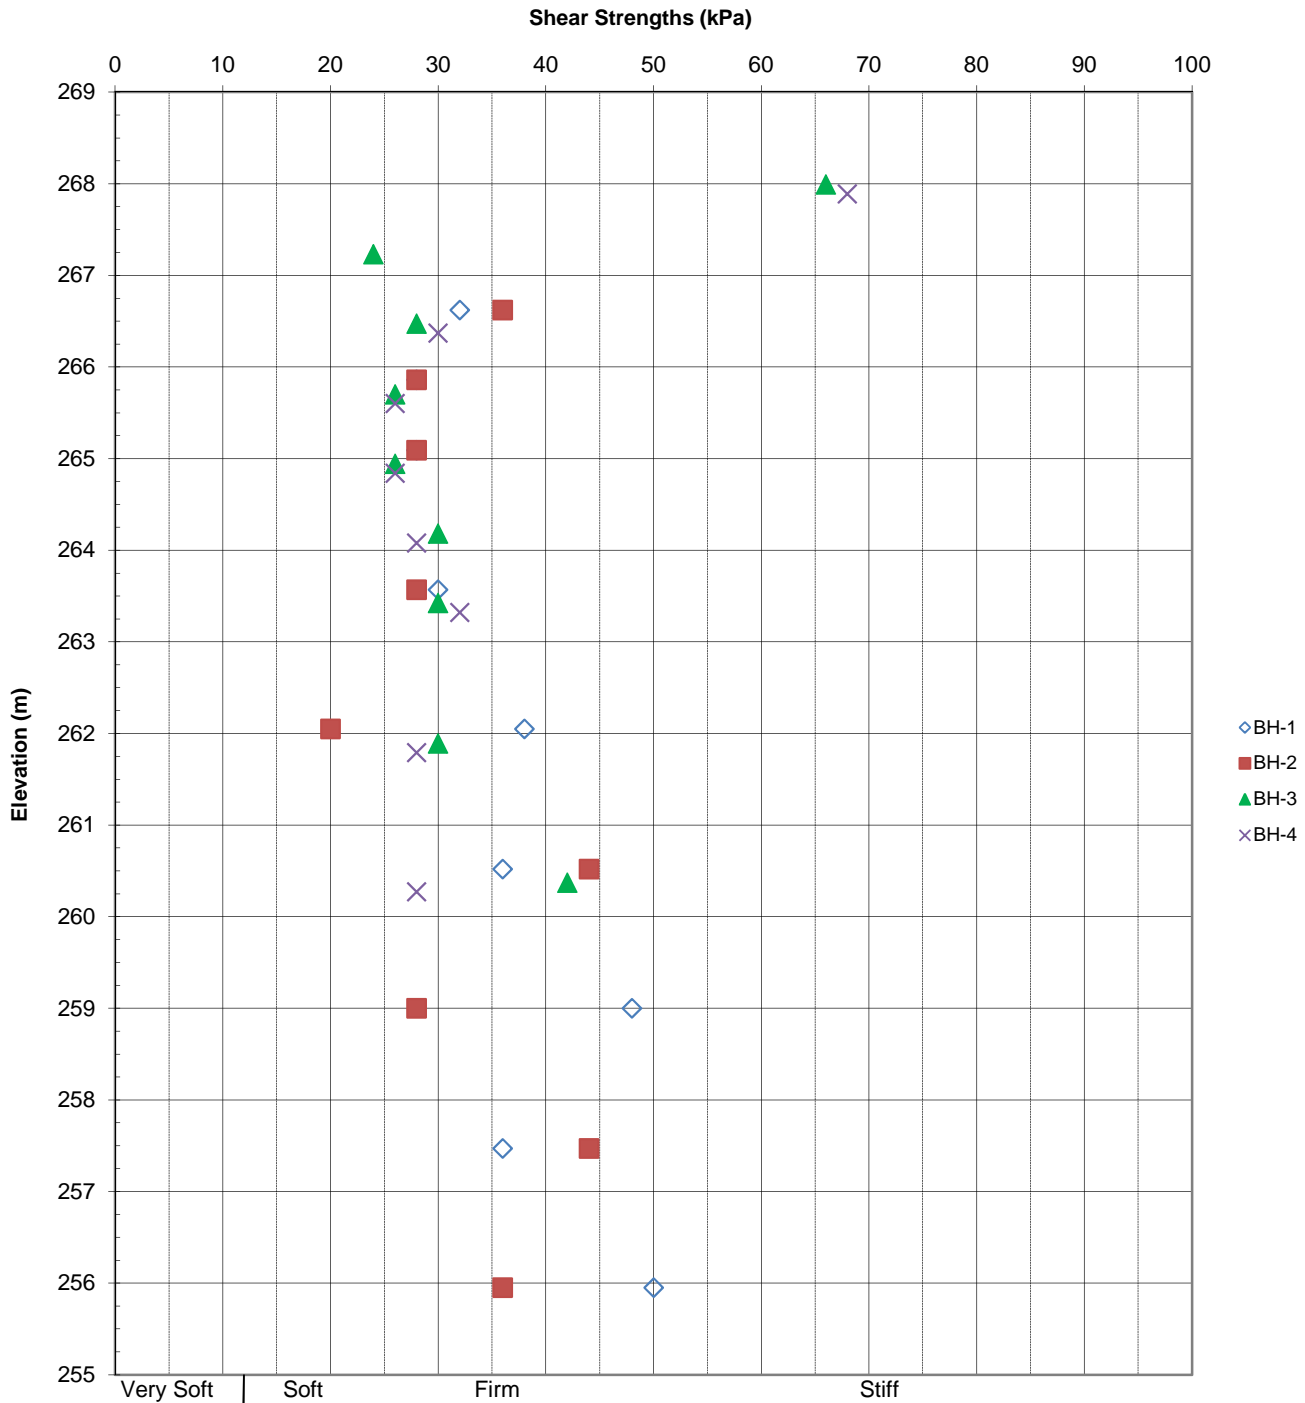
In-Situ Shear Strengths vs. Depth

Note: Shear strength greater than 100 kPa is shown as >100 kPa

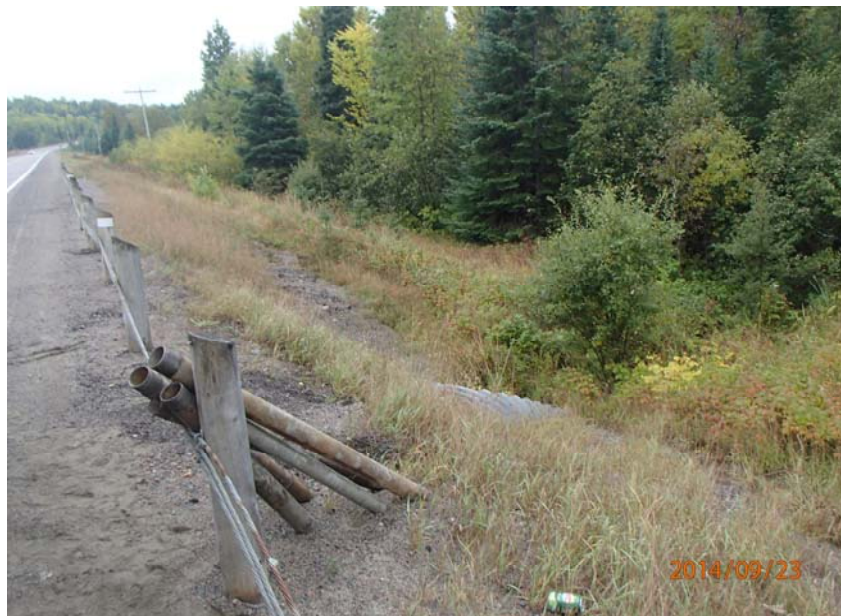
Photo: 1

Embankment at Culvert Location – Looking North

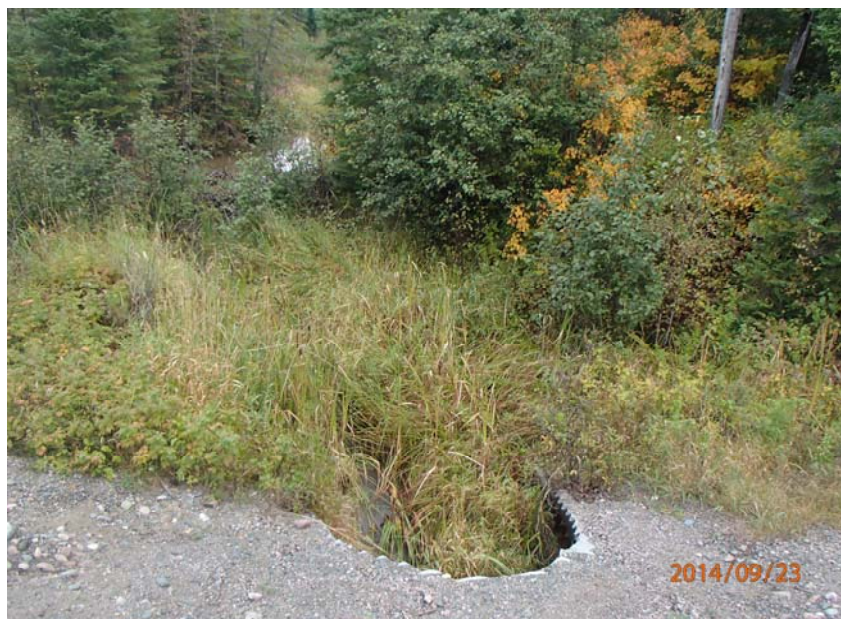
Photo: 2

Culvert Inlet – Looking East

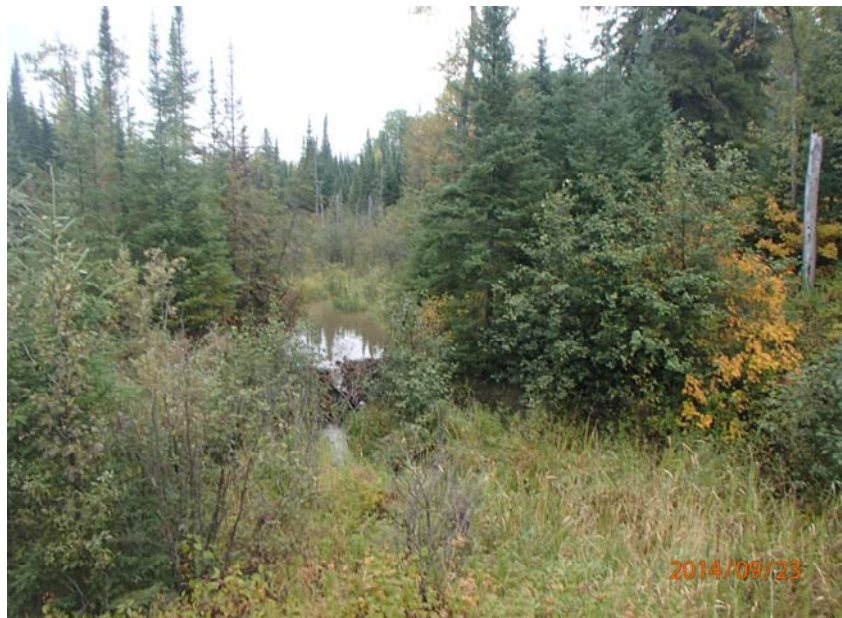
Photo: 3

Beaver Dam at Creek Upstream north of Culvert Inlet– Looking East

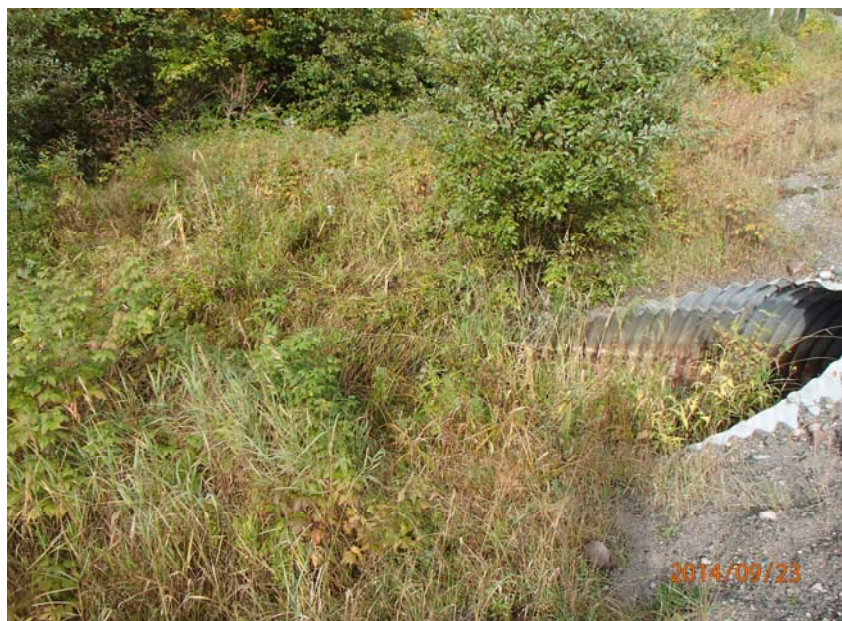
Photo: 4

Culvert Outlet – Looking West
