**Culvert Replacement
Highway 118
Station 23+554 - Twp. of Hindon
GWP 5140-13-00**

FINAL FOUNDATION INVESTIGATION REPORT

Date: October 25, 2016
Ref. N°: 15/03/15019-F6

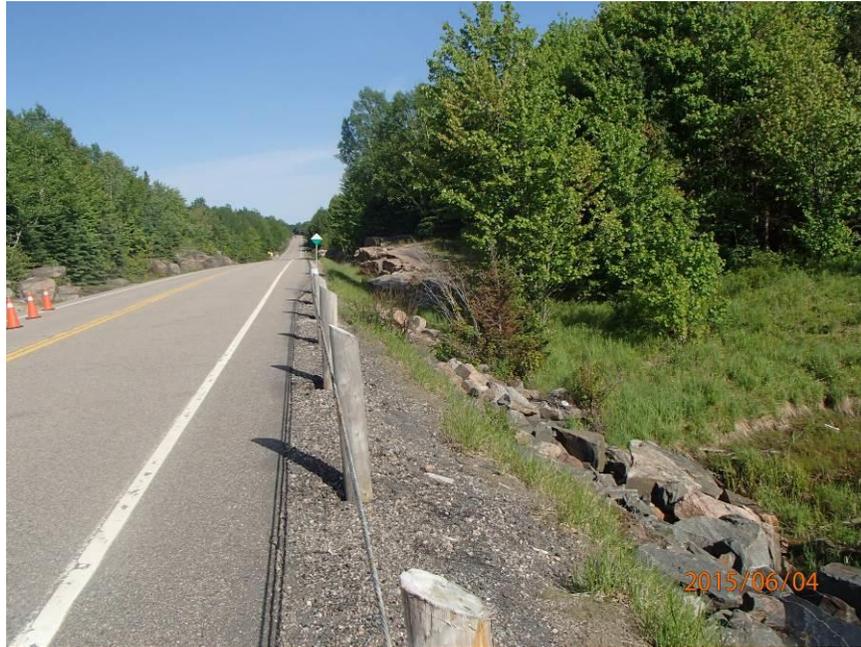
Photo: 1

Embankment at Culvert Location – Looking West

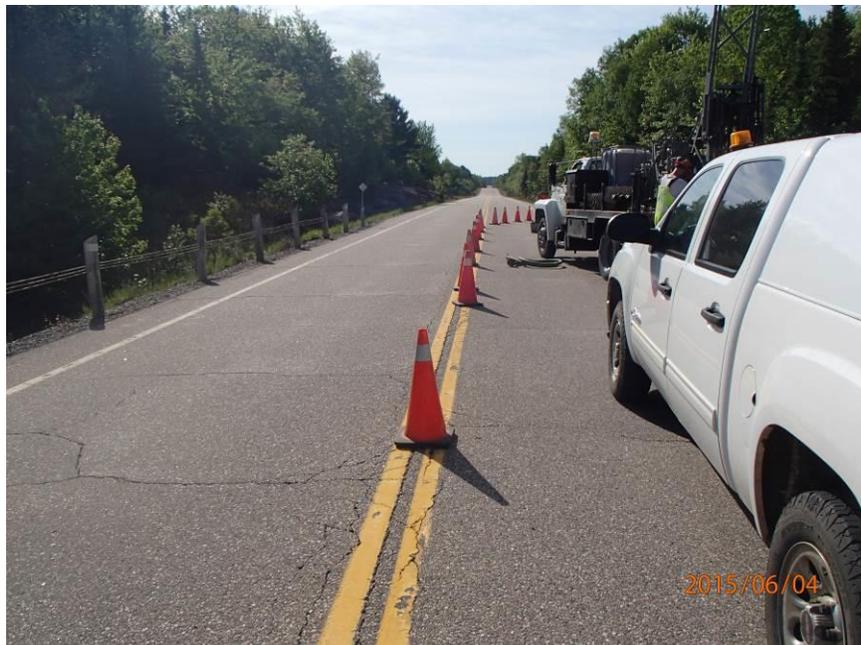
Photo: 2

Embankment at Culvert Location – Looking East

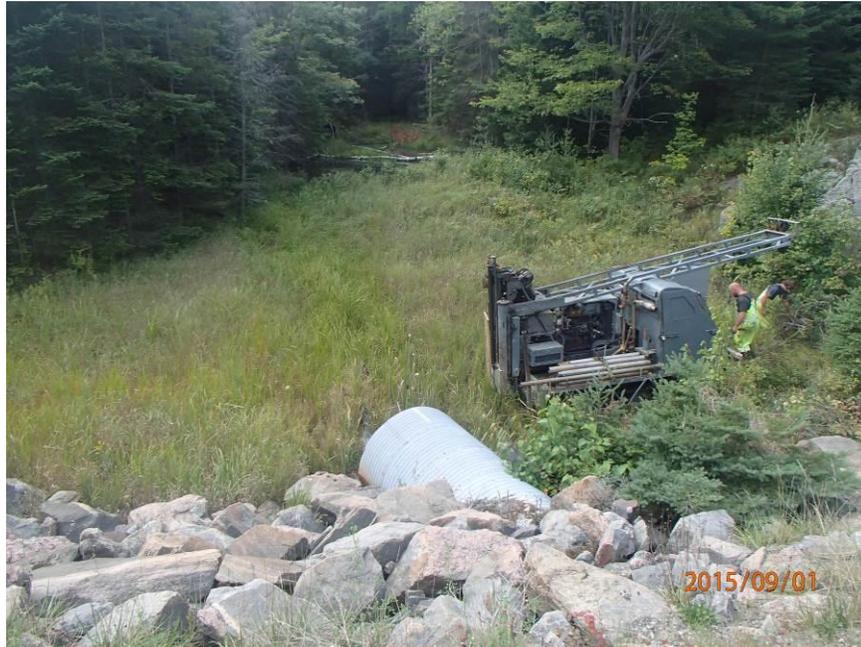
Photo: 3

Culvert Inlet – Looking South

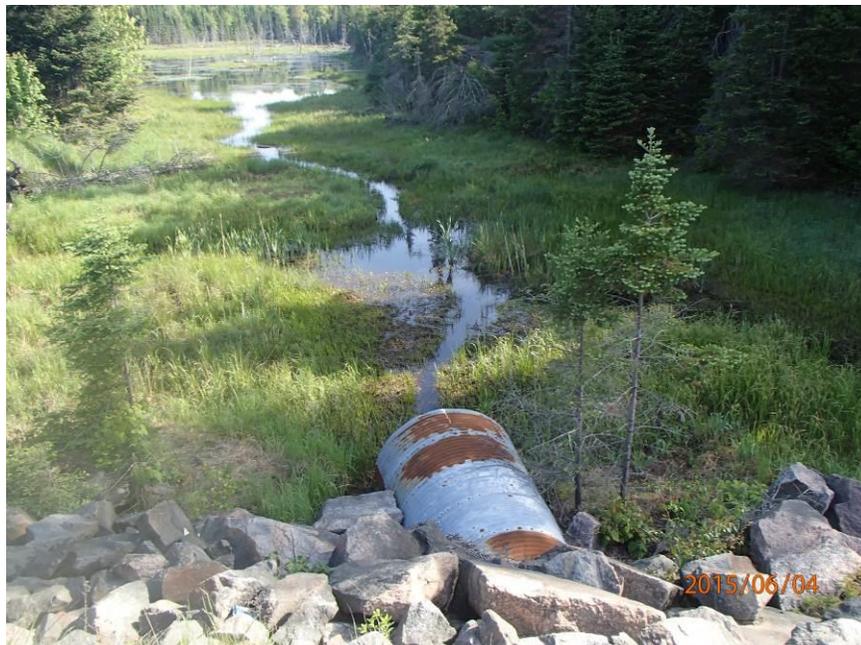
Photo: 4

Culvert Outlet – Looking North

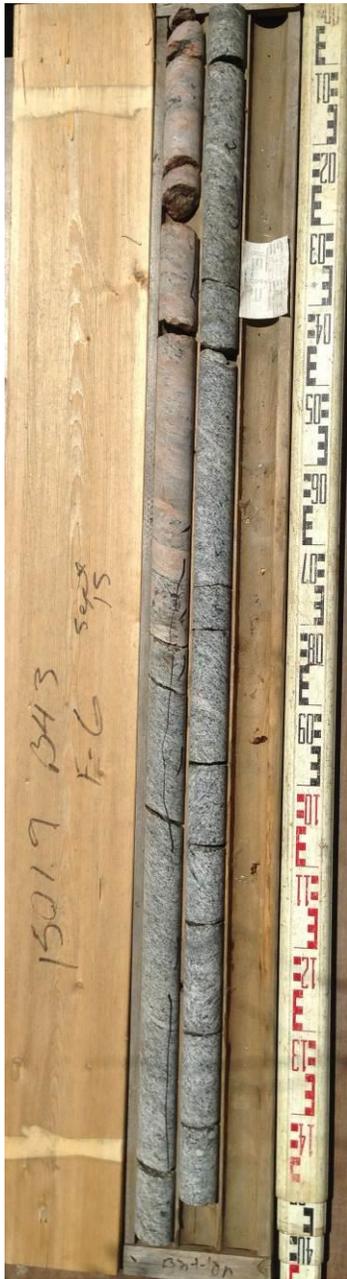
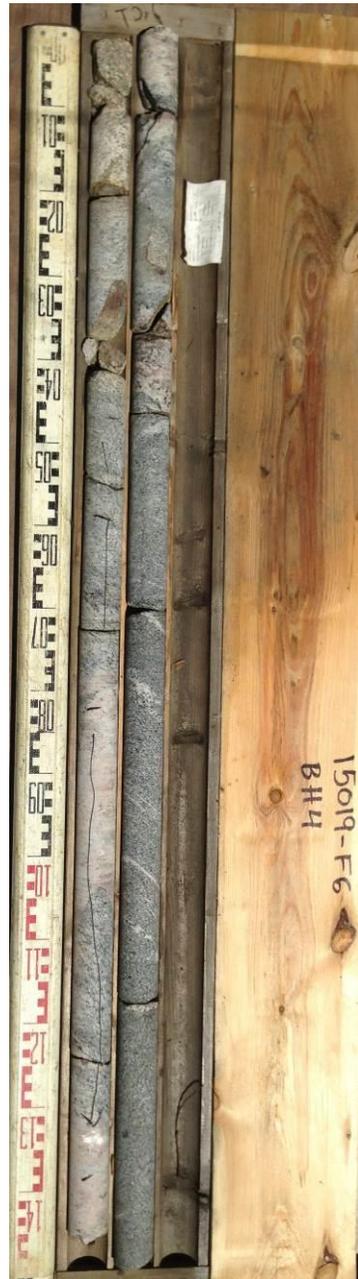
Photos: 5 and 6

Rock Cores – Borehole No. 3 and 4
