**Submitted To AECOM Canada Ltd.
189 Wyld Street Suite 103, North Bay, Ontario P1B 1Z2
On Behalf of the Ontario Ministry of Transportation**

**Culvert Replacement
Highway 118
Station 22+510 - Twp. of Dysart
GWP 5466-04-00**

FINAL FOUNDATION INVESTIGATION REPORT

Date: February 3, 2017
Ref. N^o: 15/04/15020-F16 – R2

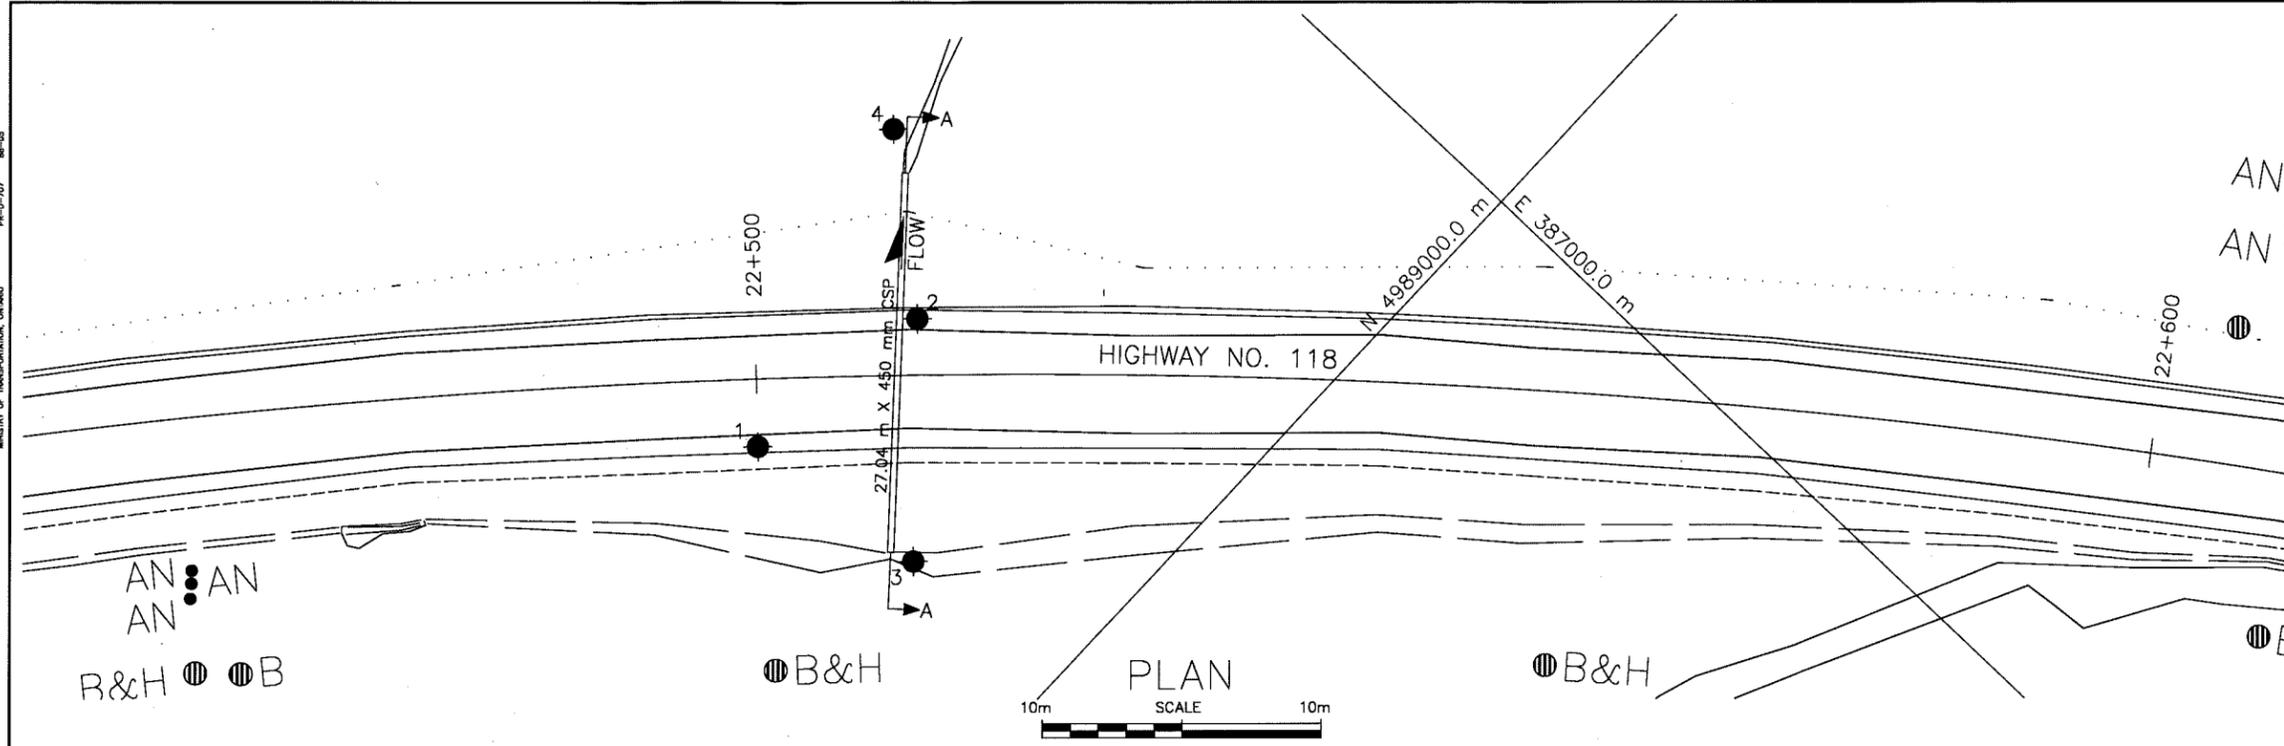
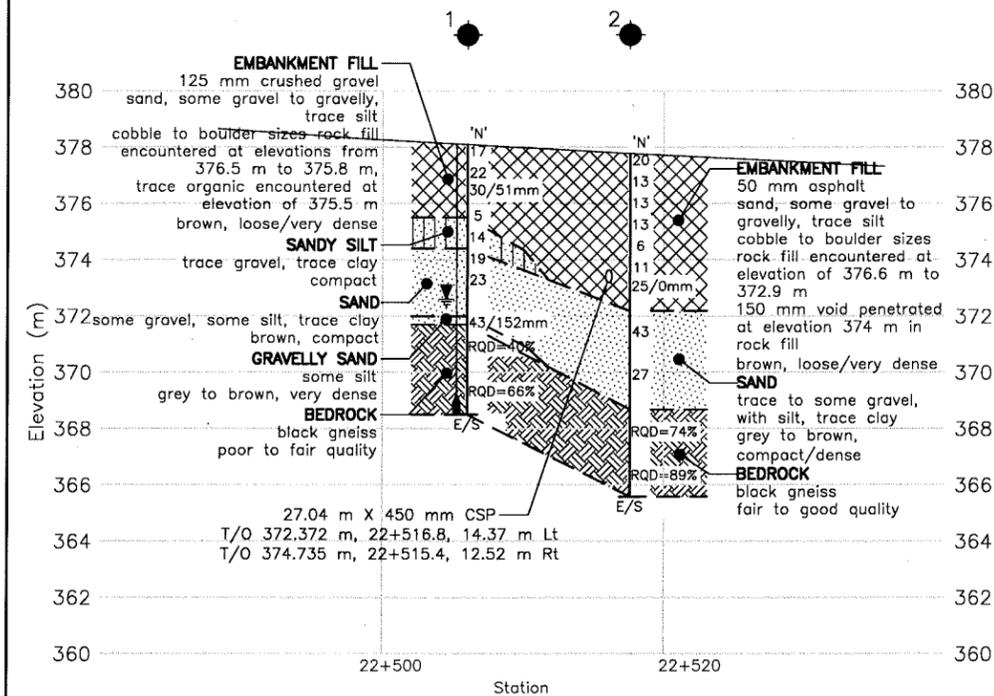
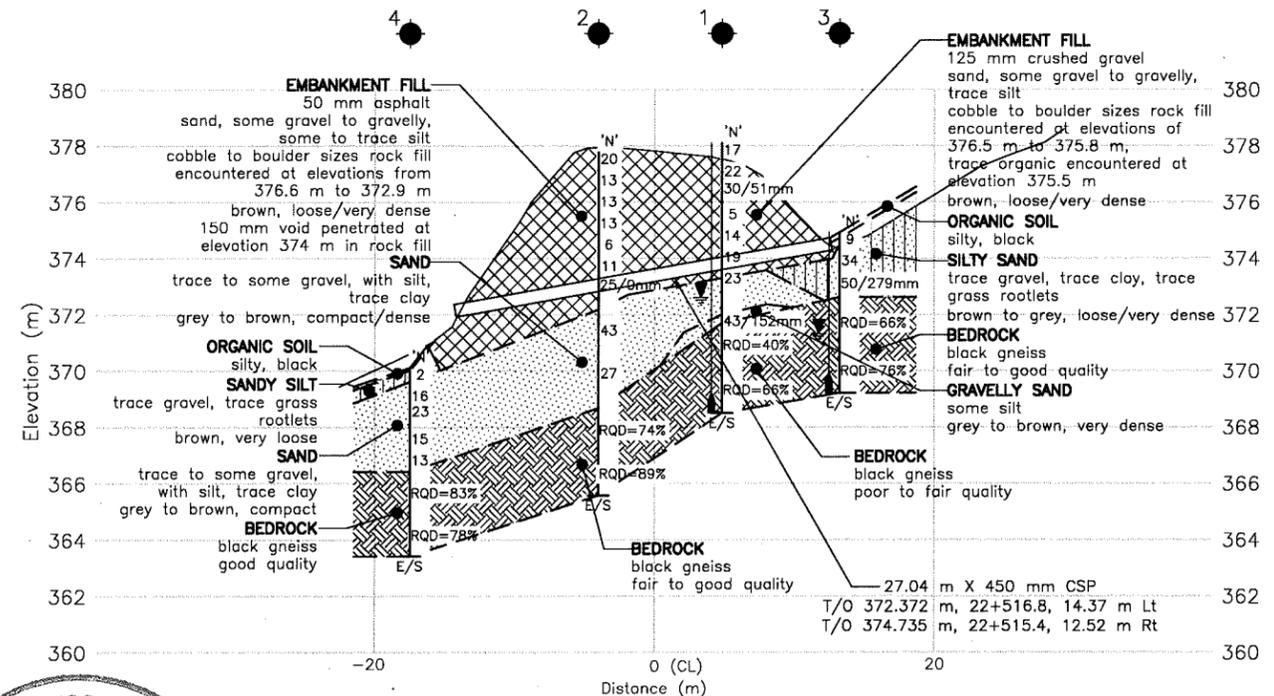
Drawing No. 2: Borehole Location and Soil Strata
Figure Nos. L-1 to L-5: Grain Size Distribution Curves
Table No. L-6: Lab Test Summary Sheet

Details of the subsurface conditions revealed by the investigation program are presented on the enclosed Records of Borehole Logs (Appendix 2) and on Drawing No. 2 (Appendix 3). Please note that stratigraphic delineation presented on the borehole logs and soil strata plot are the results of non-continuous sampling, response to drilling progress, the results of SPT, plus field observations. Typically such boundaries represent transitions from one zone to another and are not an exact demarcation of specific geological unit. Additional consideration should be given to the fact that subsurface conditions may vary markedly between adjacent boreholes and beyond any specific boring location, and are shown on the drawings for illustration purposes only.

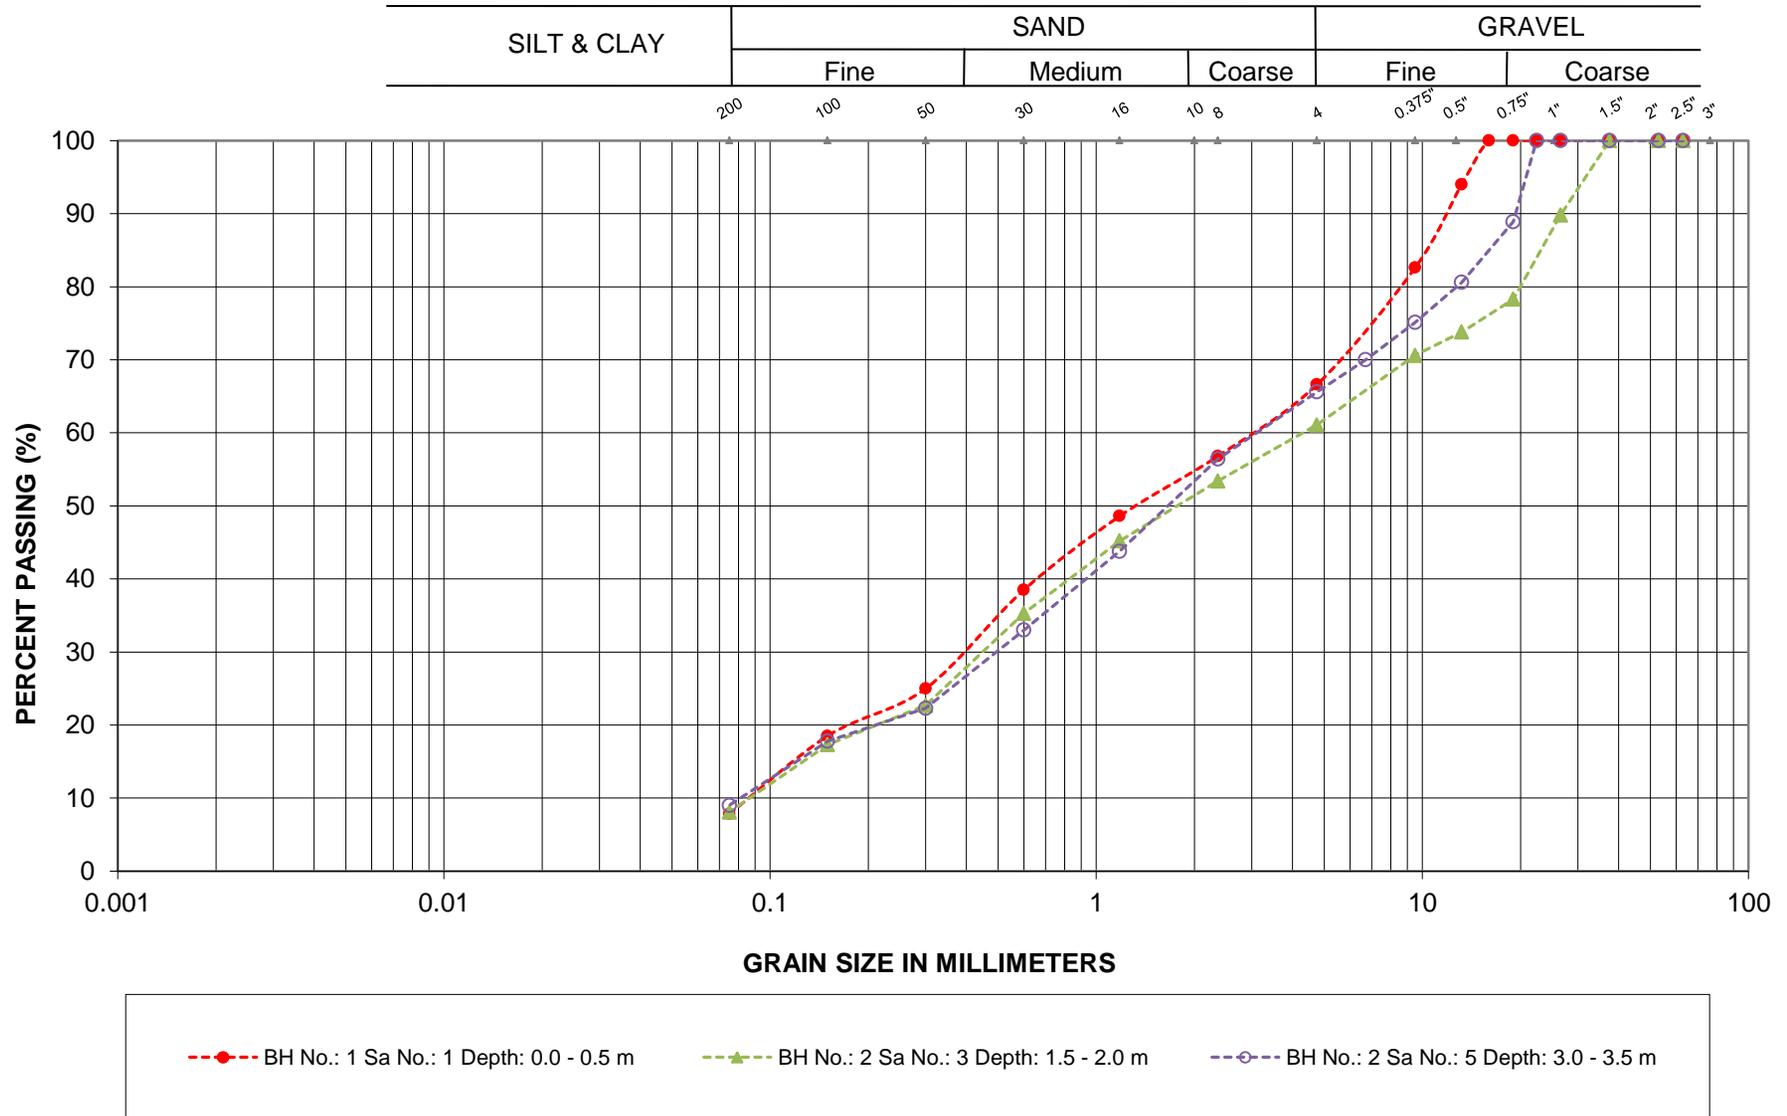
FIGURE L-1

EMBANKMENT FILL

LOCATION: Hwy 118, Station 22+510
 TWP of Dysart

Underlying the crushed gravel and asphalt at Borehole Nos. 1 and 2, respectively, a layer of fill consisting of brown sand some gravel to gravelly, trace silt, mixed with rock fill, was penetrated. Cobble and boulder size rock fill were encountered at depths between 1.2 to 4.9 m below ground surface (Elevations 376.6 to 372.9 m). The natural moisture content measured on retrieved samples of this deposit was generally in the order of 2 to 12%. Gradation (sieve) analyses were carried out on three (3) samples of this deposit, the results of which indicated 33 to 34% gravel size particles, 53 to 59% sand size particles, and 8 to 9% silt and clay size particles (Figure No. L-1, Appendix 3). Based on SPT 'N' values of 5 to 22 blows per 300 mm penetration, the compactness/relative density of the granular portion of the deposit was described as loose to compact. This deposit was encountered to depths of 2.6 and 5.6 m below grade at Borehole Nos. 1 and 2, respectively (Elevations 375.5 and 372.2 m, respectively).

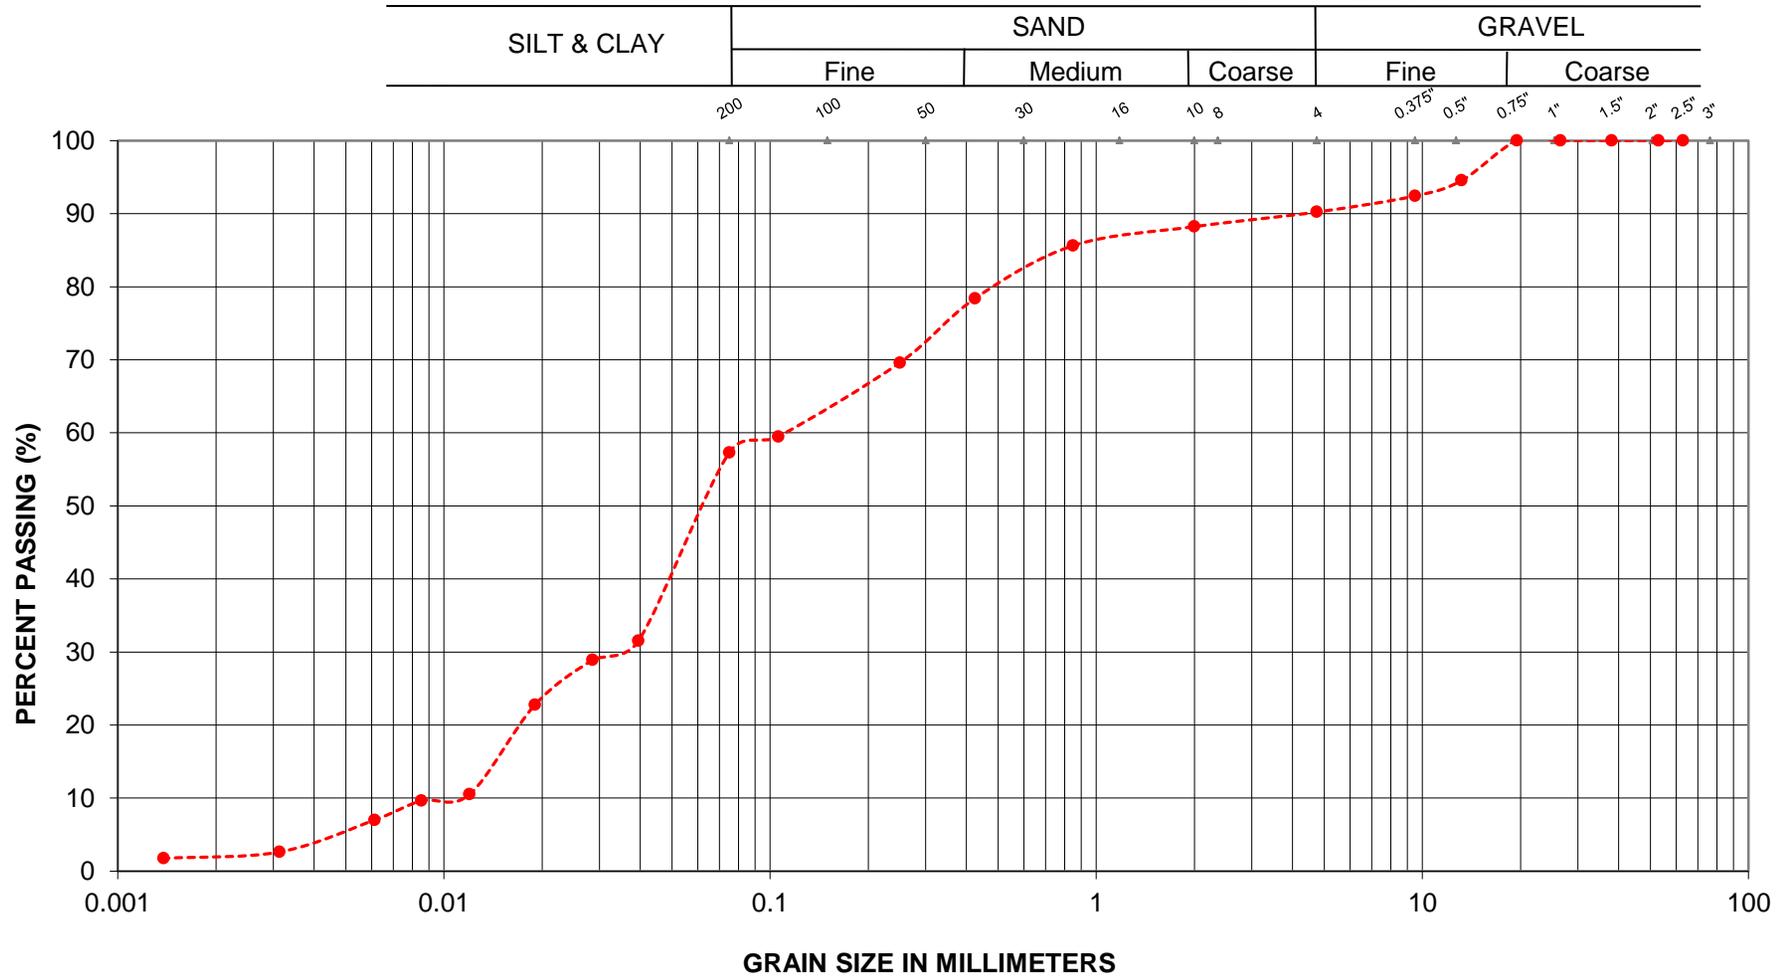
FIGURE L-2

---●--- BH No.: 1 Sa No.: 5 Depth: 3.0 - 3.5 m

SANDY SILT

Underlying the granular fill at Borehole No. 1, and underlying the organic soil at Borehole No. 4, a deposit of sandy silt, trace gravel, trace clay was penetrated. Trace grass and rootlets were encountered in this deposit. The natural moisture content measured on samples of this deposit was in the order of 34 to 39%. A gradation (hydrometer) analysis was carried out on one (1) sample of this deposit, and the results of testing indicated 10% gravel size particles, 33% sand size particles, 55% silt size particles, and 2% clay size particles (Figure No. L-2, Appendix 3). Based on a SPT 'N' value of 2 to 14 blows per 300 mm penetration, the compactness/relative density of this deposit was described as very loose to compact. This deposit was encountered to depths of 3.7 and 0.5 m below ground surface at Borehole Nos. 1 and 4, respectively (Elevations 374.4 and 369.6 m).

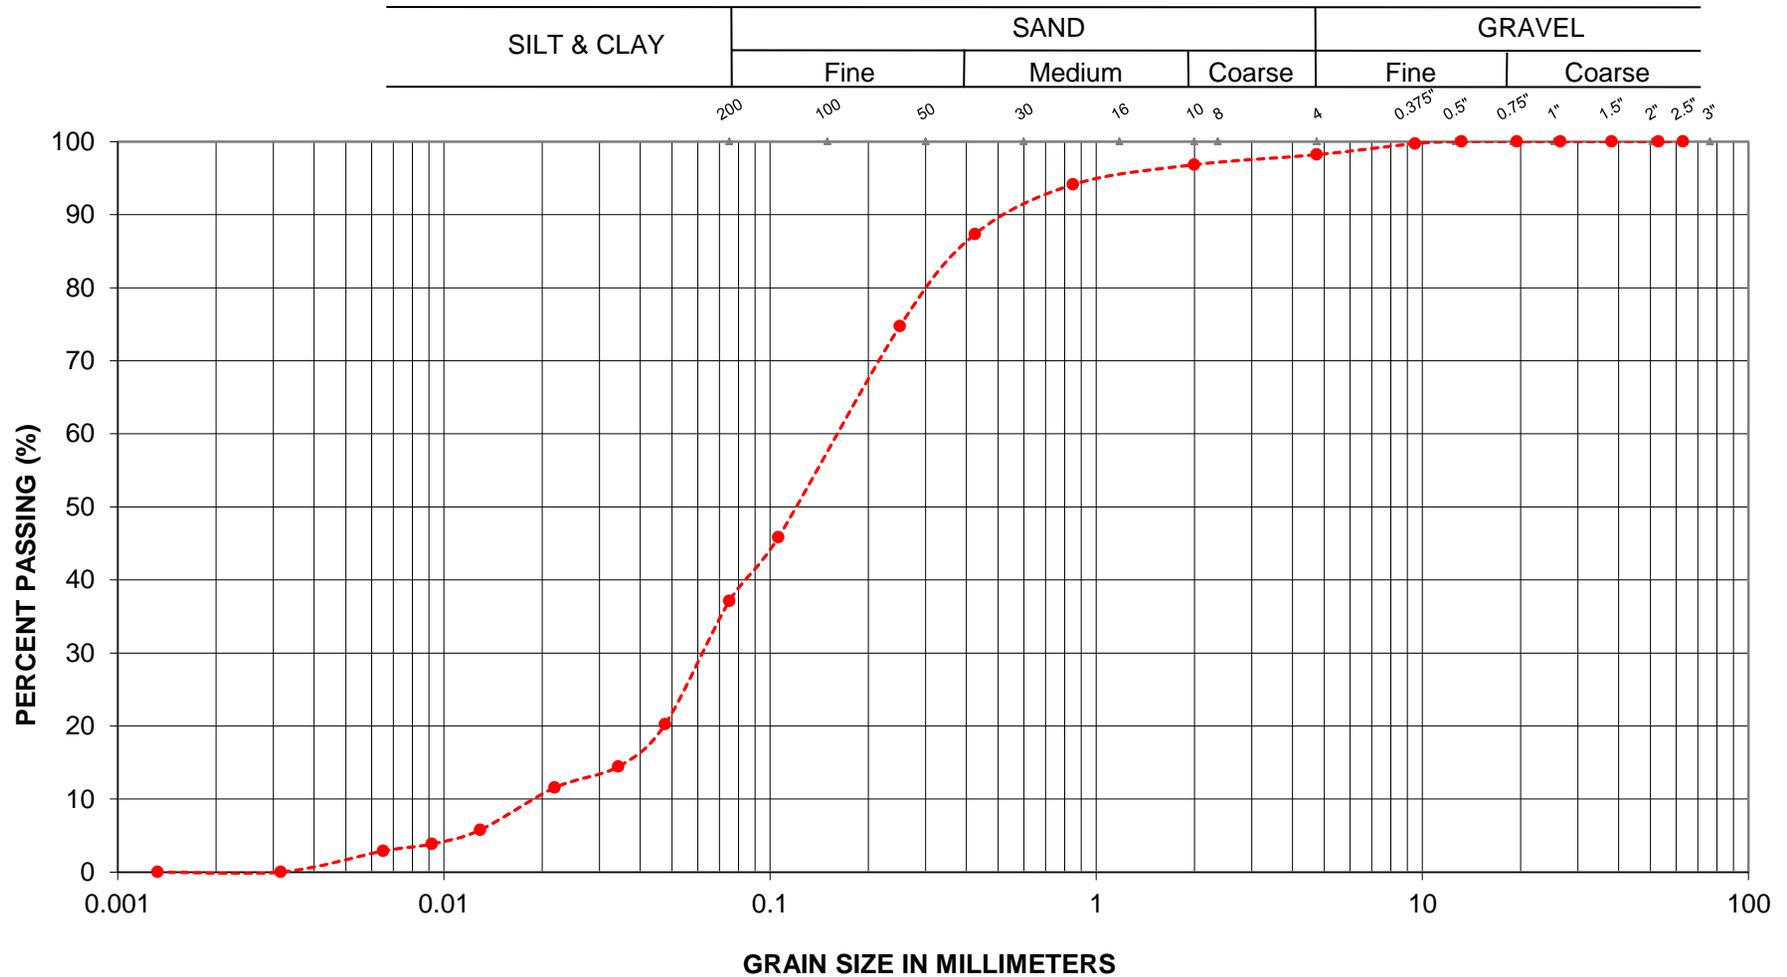
FIGURE L-3

---●--- BH No.: 3 Sa No.: 2 Depth: 0.8 - 1.2 m

SILTY SAND

Underlying the organic soils at Borehole No. 3, a deposit of silty sand, trace gravel was penetrated. Trace grass and rootlets were encountered in this deposit. The natural moisture content measured on samples of this deposit was in the order of 10 to 19%. A gradation (hydrometer) analysis was carried out on one (1) sample of this deposit, and the results of testing indicated 2% gravel size particles, 61% sand size particles, 37% silt size particles, and 0% clay size particles (Figure No. L-3, Appendix 3). Based on SPT 'N' values of 9 to 34 blows per 300 mm penetration, the compactness/relative density of this deposit was described as loose to dense. This deposit was encountered to a depth of 2.3 m below ground surface at Borehole No. 3 (Elevation 372.6 m).

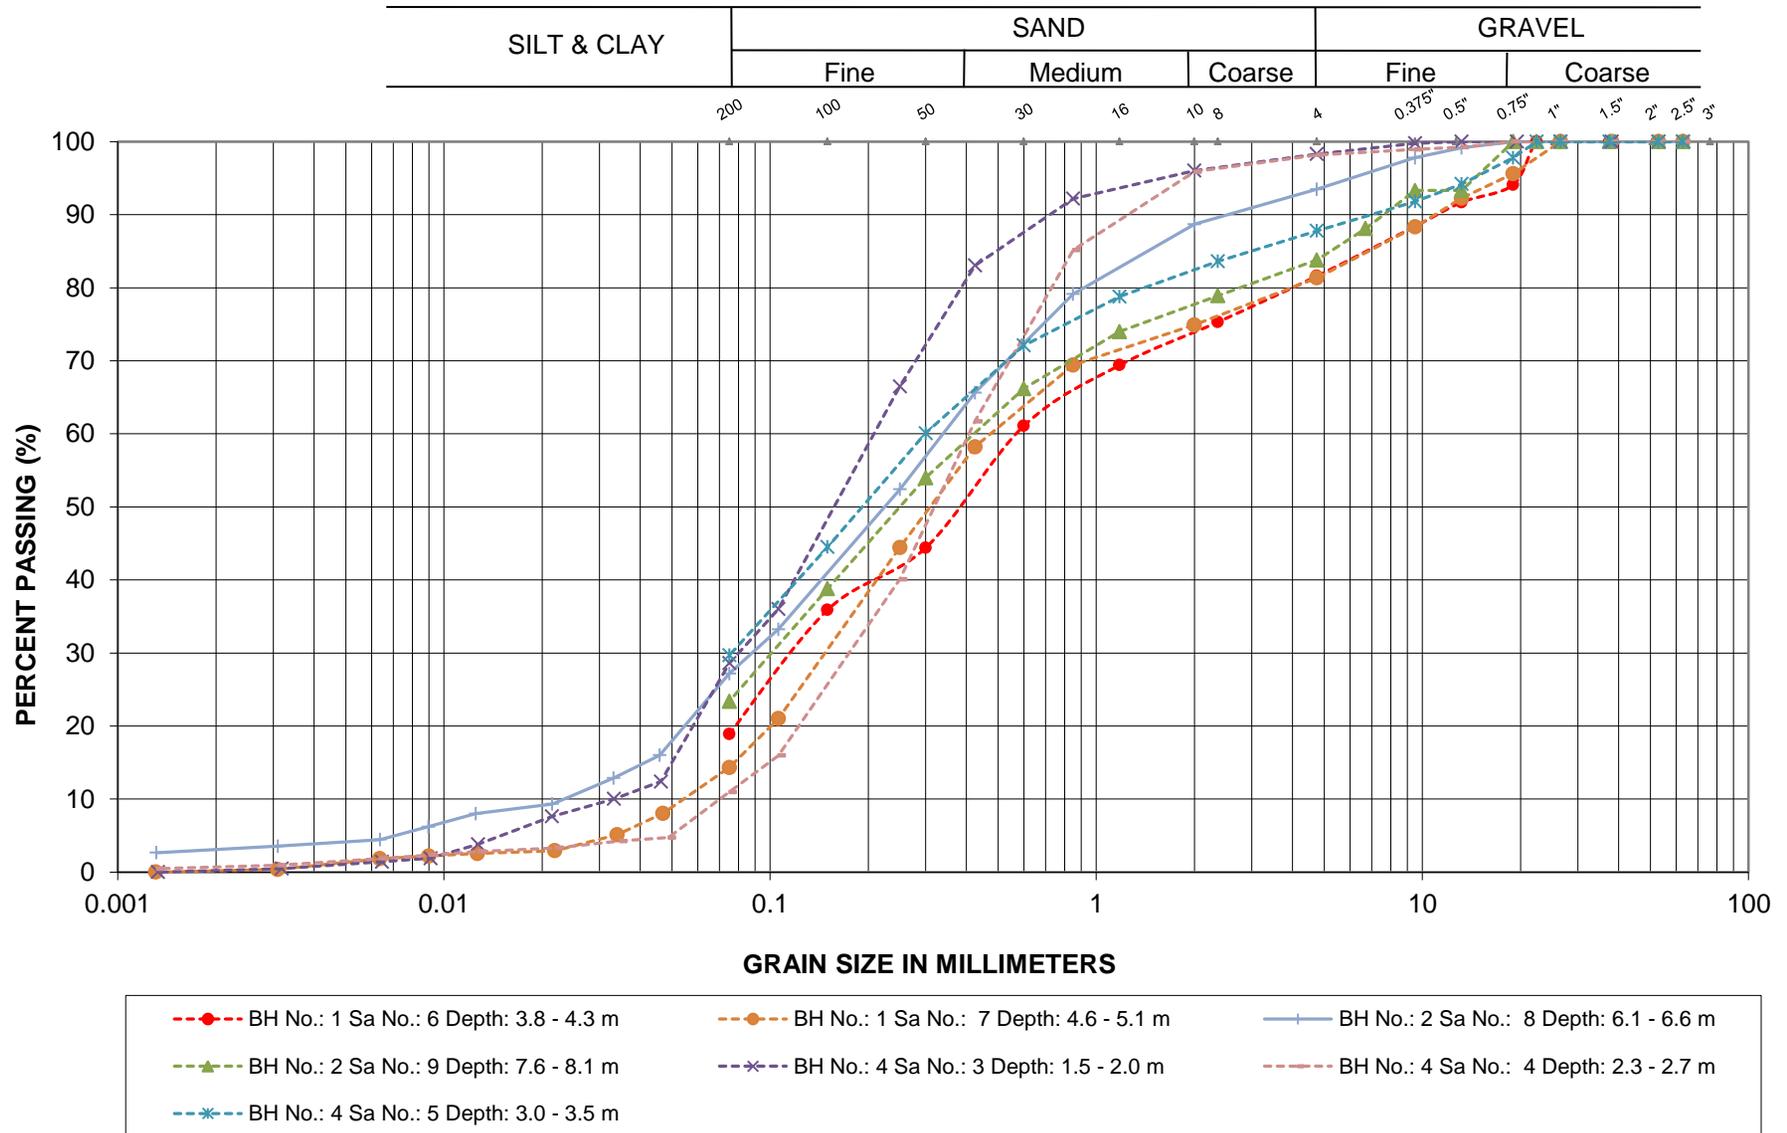
SAND

Underlying the sandy silt at Borehole Nos. 1 and 4, and underlying the fill at Borehole No. 2, a deposit of brown to grey sand trace to some gravel, some to with silt, trace clay was penetrated. The natural moisture content measured on samples of this deposit was in the order of 12 to 18%. Gradation (sieve) analyses were carried out on three (3) samples of this deposit, and the results of testing indicated 12 to 18% gravel size particles, 58 to 63% sand size particles, and 19 to 30% silt and clay size particles (Figure No. L-4, Appendix 3). Gradation (hydrometer) analyses were carried out on four (4) samples of this deposit, the results of which indicated 2 to 19% gravel size particles, 67 to 87% sand size particles, 10 to 24% silt size particles, and 0 to 3% clay size particles (Figure No. L-4, Appendix 3). Based on SPT 'N' values of 13 to 43 blows per 300 mm penetration, the compactness/relative density of this deposit was described as compact to dense, generally compact. This deposit was encountered to depths of 6.1, 9.1, and 3.7 m below grade at Borehole Nos. 1, 2, and 4, respectively (Elevations 372.0, 368.7, and 366.4 m, respectively).

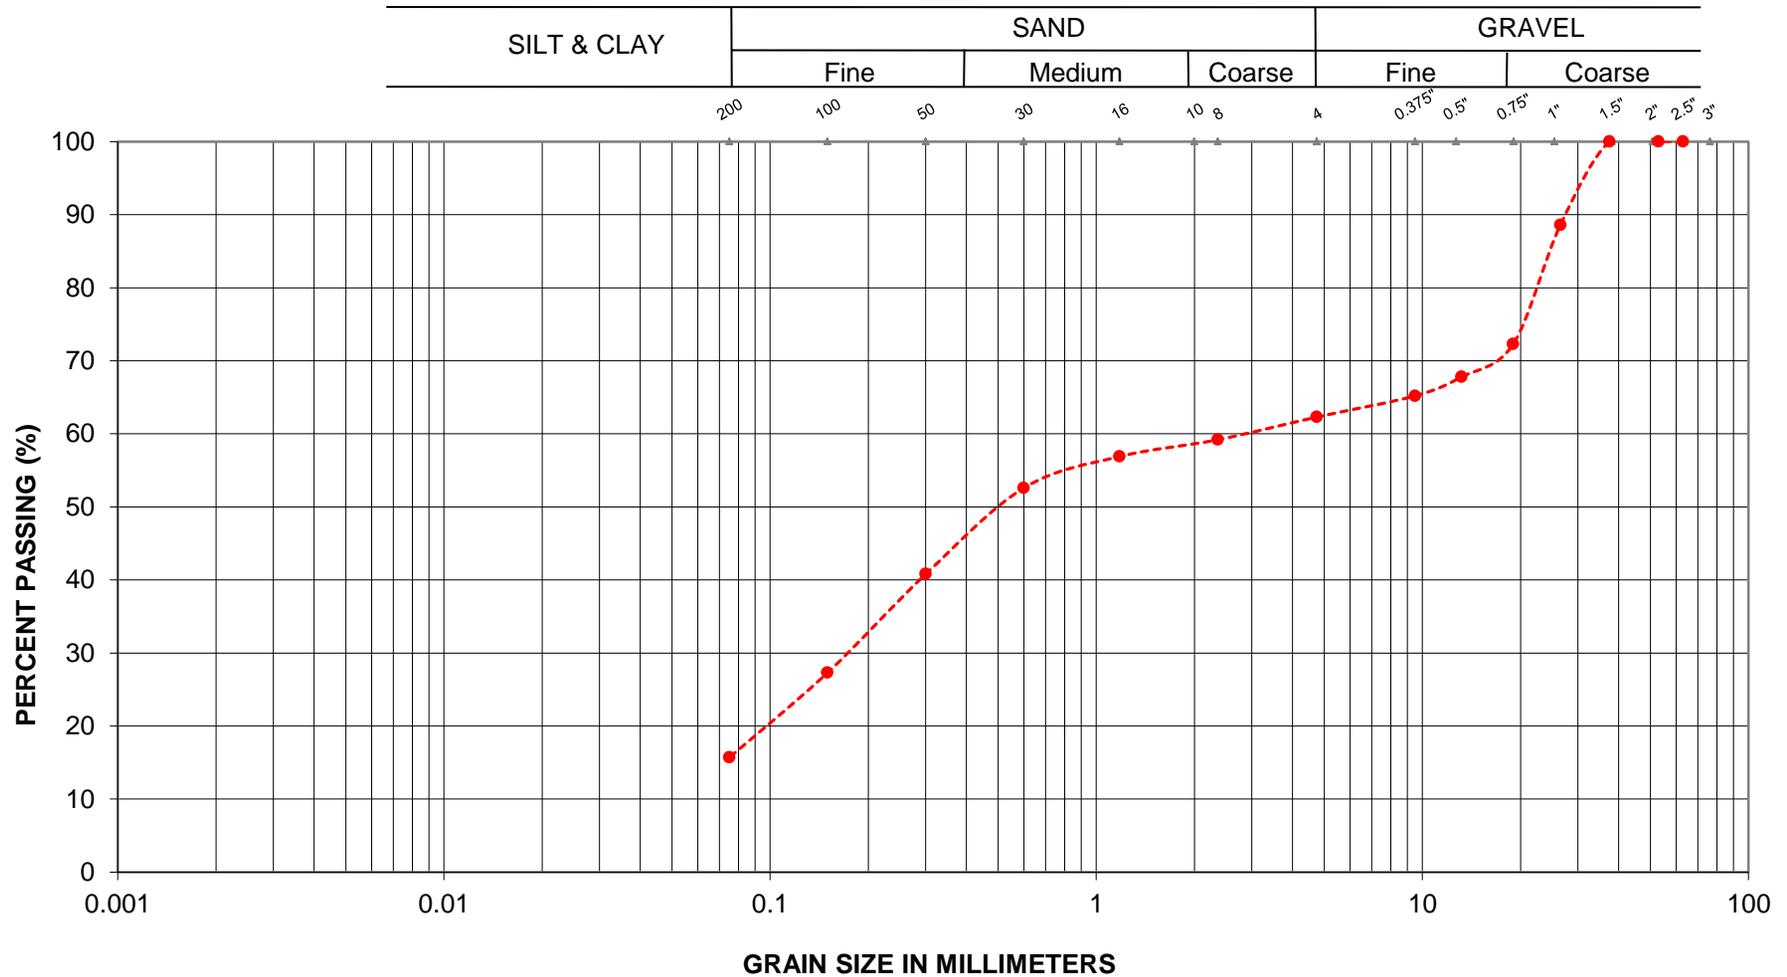
---●--- BH No.: 1 Sa No.: 8 Depth: 6.1 - 6.4 m

GRAVELLY SAND

Underlying the sand at Borehole No. 1, a deposit of grey to brown gravelly sand, some silt was penetrated. The natural moisture content measured on samples of this deposit was in the order of 9%. A gradation (sieve) analysis was carried out on one (1) sample of this deposit, and the results of testing indicated 38% gravel size particles, 46% sand size particles, and 16% silt and clay size particles (Figure No. L-5, Appendix 3). This deposit was encountered to a depth of 6.4 m below grade at Borehole No. 1 (Elevation 371.7 m).

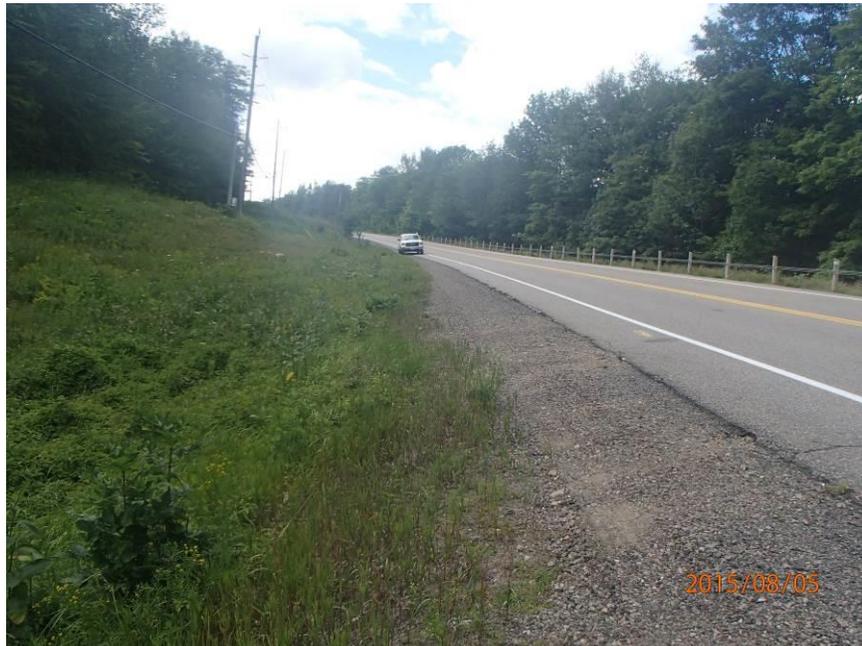
Photo: 1

Embankment at Culvert Location – Looking West, south side of embankment

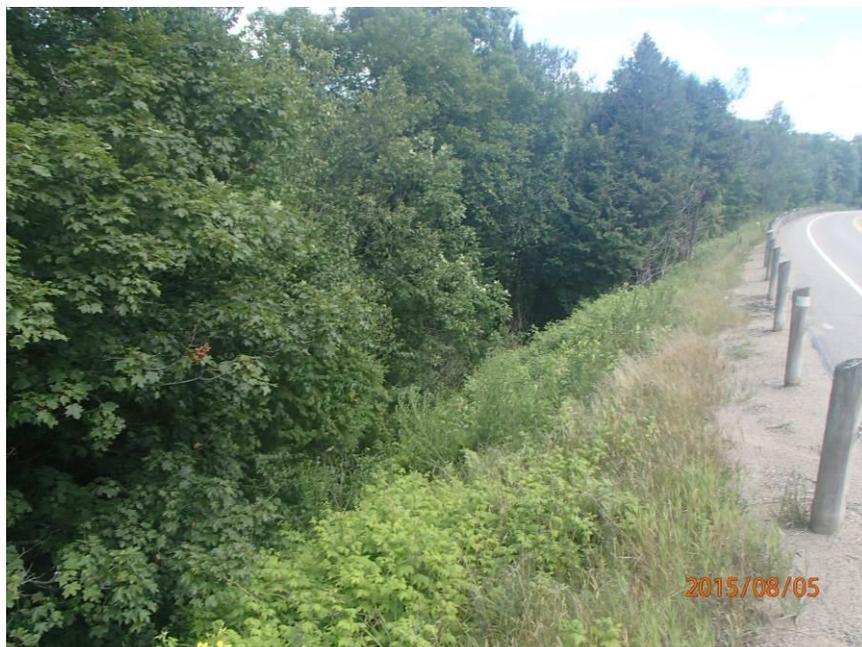
Photo: 2

Embankment at Culvert Location – Looking East, north side of embankment

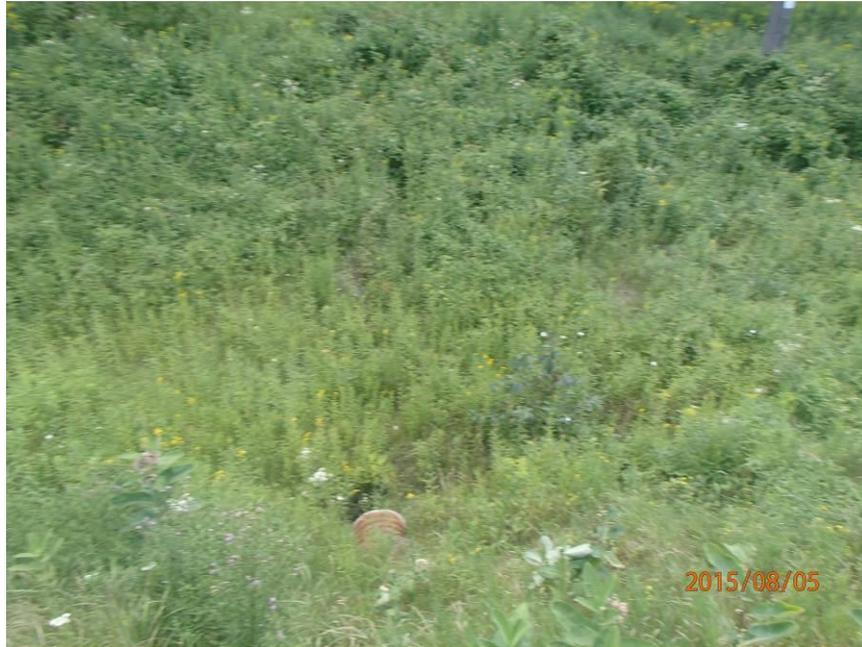
Photo: 3

Culvert Inlet – Looking South

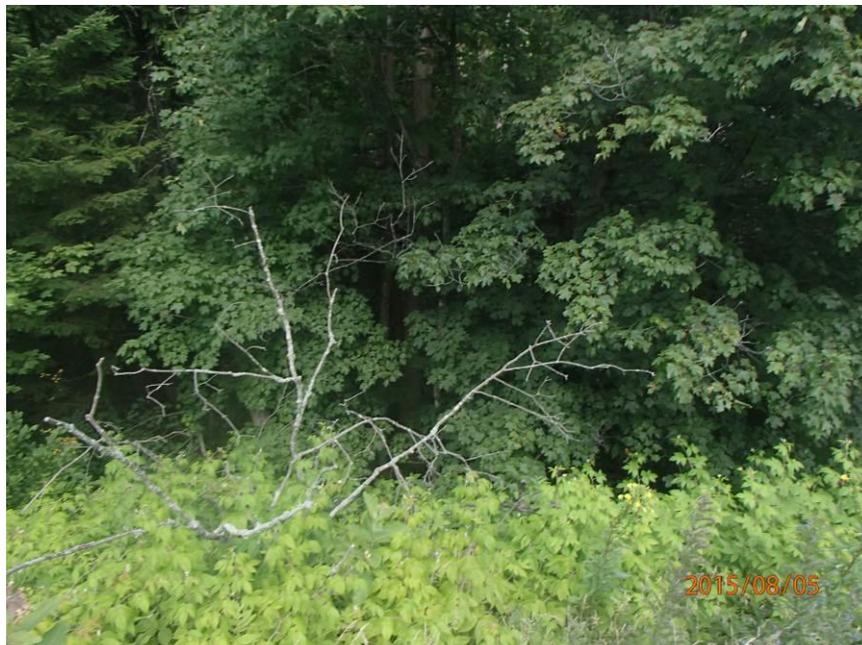
Photo: 4

View of Embankment at Culvert Outlet – Looking North

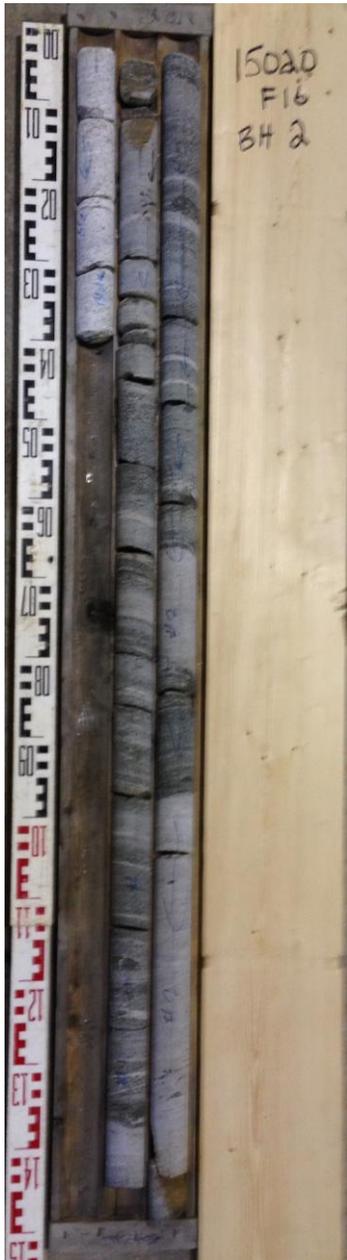
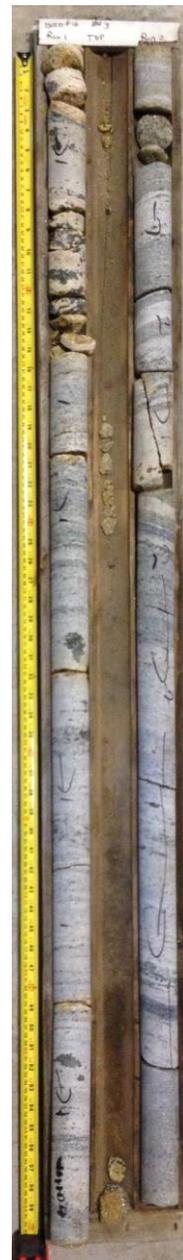
Photos: 5 and 6

Rock Cores – Borehole 2 (left) and Borehole 3 (right)
