Bridge Rehabilitation – Hawk Creek Bridge
Highway 547
Stations 13+727 to 13+758 – Township of Esquega
Site No. 38C-016
GWP 5377-11-00

FINAL FOUNDATION INVESTIGATION REPORT

Final Foundation Investigation Report

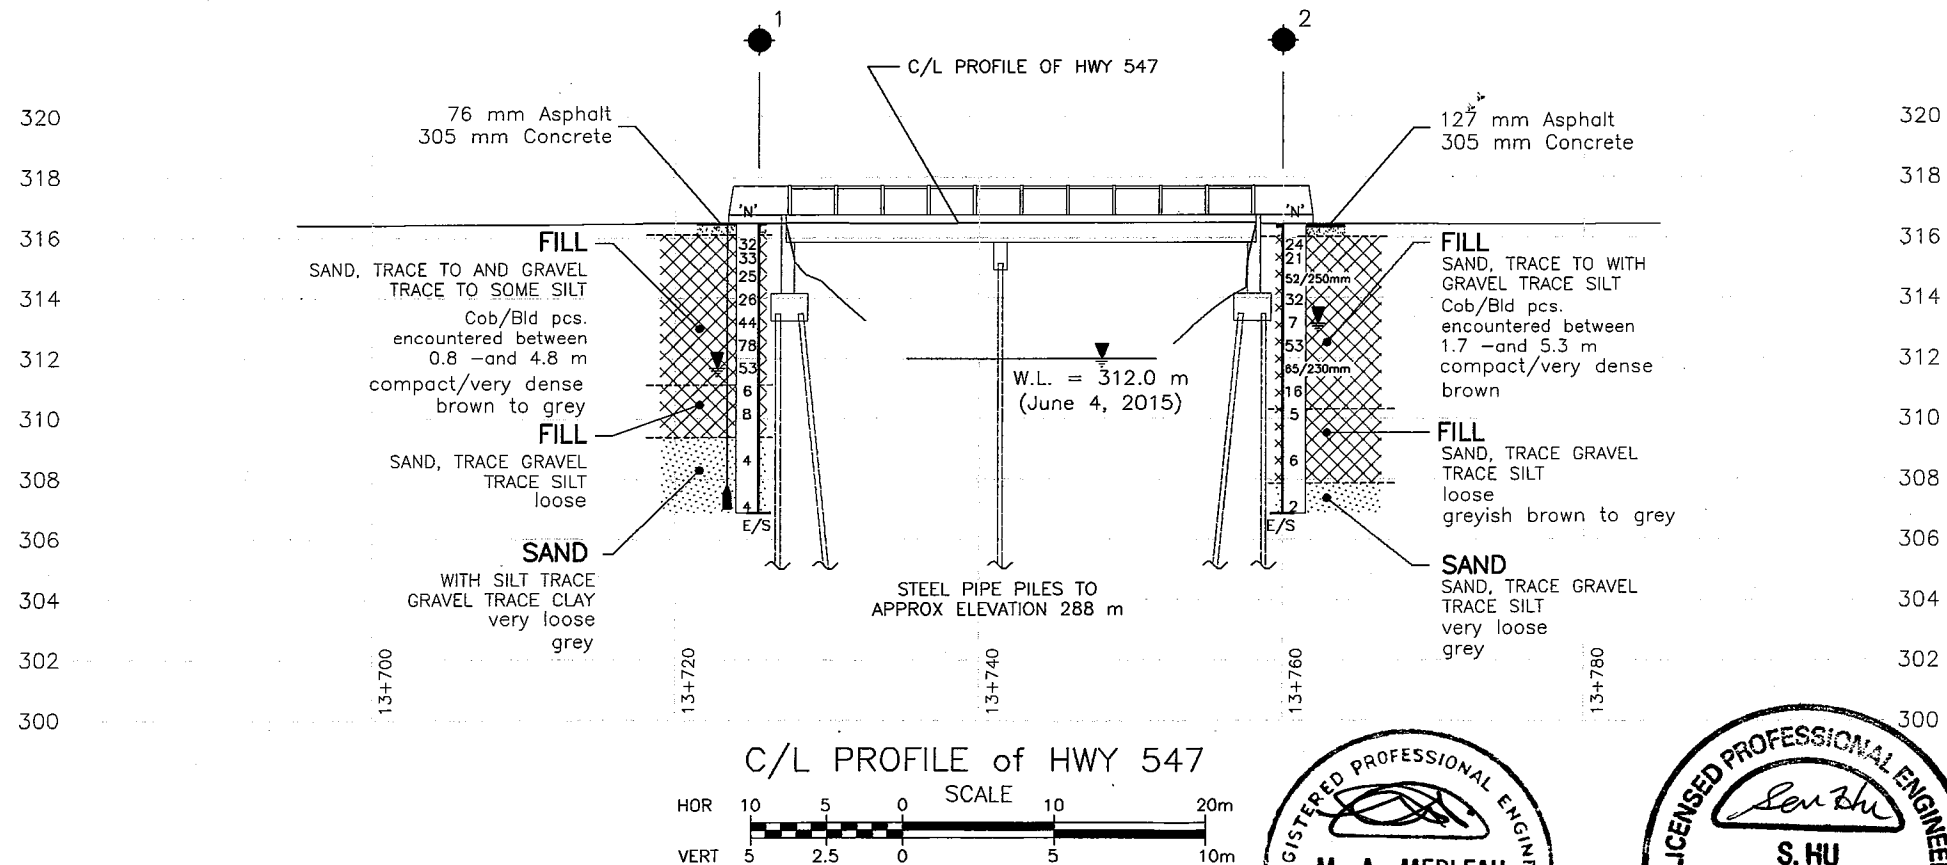
HAWK CREEK BRIDGE
SITE NO. 38C-016
BOREHOLE LOCATIONS
AND SOIL STRATIGRAPHY

This drawing is for subsurface information only. Surface details and features are for conceptual illustration. The proposed structure location is shown for illustration purposes only and may not be consistent with the final design configuration as shown elsewhere in the Contract Documents.

Details of the subsurface conditions revealed by the investigation program are presented on the enclosed Records of Borehole Logs (Appendix 2) and on Drawing No. 2 (Appendix 3). Please note that stratigraphic delineations presented on the borehole logs and soil strata plot are the results of non-continuous sampling, response to drilling progress, the results of SPT, plus field observations. Typically such boundaries represent transitions from one zone to another and are not an exact demarcation of specific geological unit. Additional consideration should be given to the fact that subsurface conditions may vary markedly between adjacent boreholes and beyond any specific boring location, and are shown on the drawings for illustration purposes only.

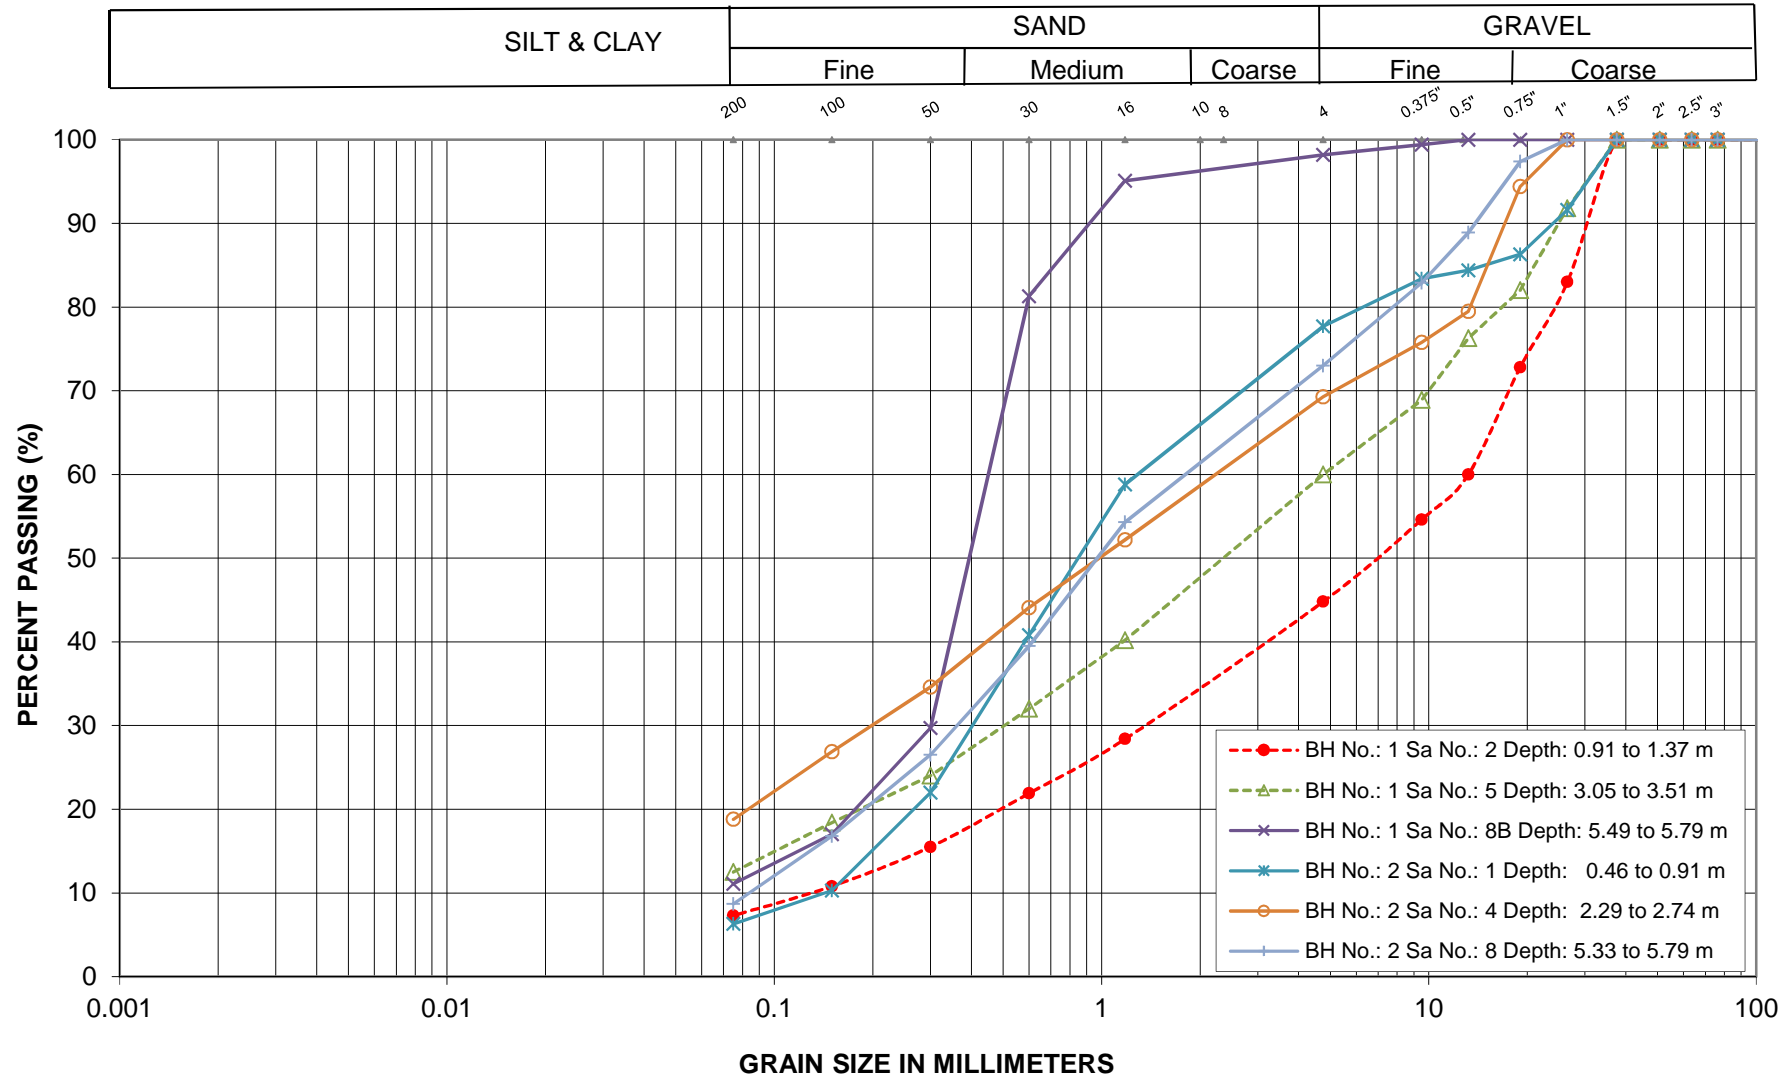
FIGURE L-1
GWP 5377-11-00

GRAIN SIZE ANALYSIS

LOCATION: Hwy 547, Hawk Creek Bridge

Sand Fill

plus overall drill supervision. All samples received a visual confirmatory inspection in our laboratory. Laboratory testing of select samples included routine testing for natural moisture content determination and particle size analysis. The results of the laboratory testing are presented on the individual Record of Borehole Sheets (Appendix 2), with a summary of results presented on the laboratory sheets in Appendix 3 (Figures Nos. L-1 to L-2 and Table No. L-3).

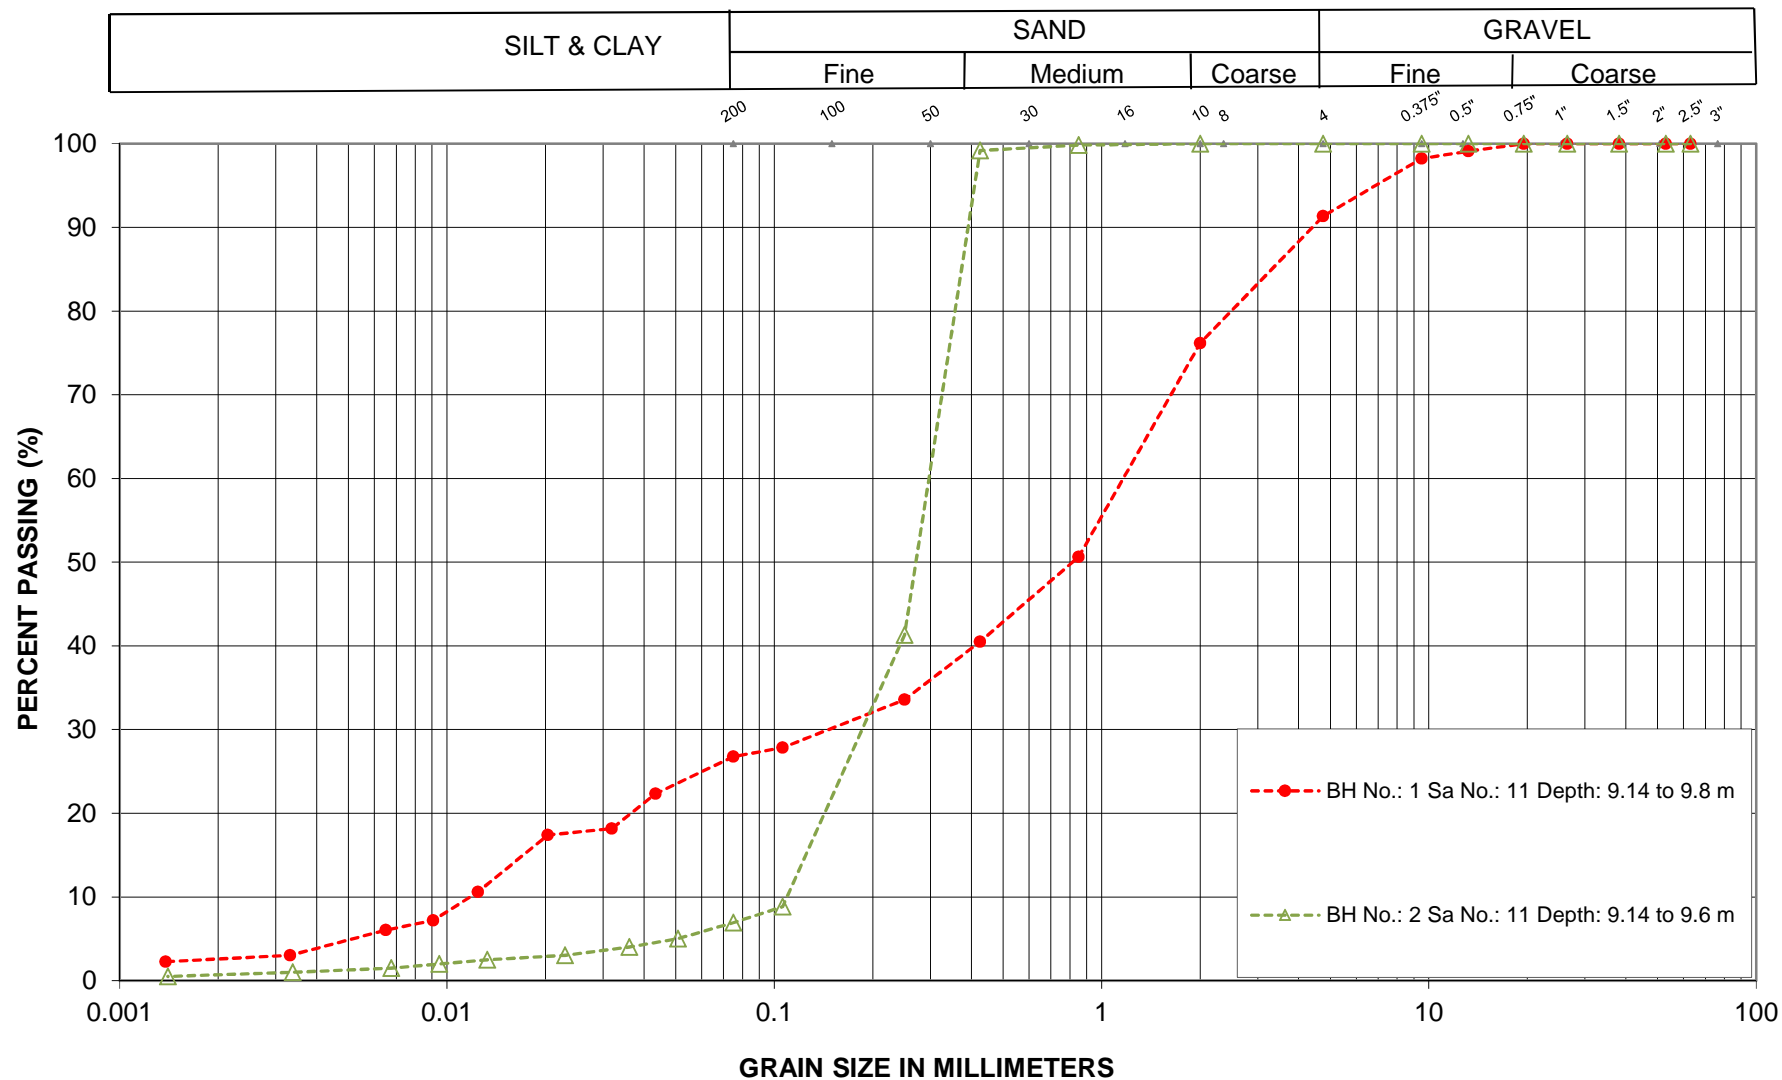
GRAIN SIZE ANALYSIS

LOCATION: Hwy 547, Hawk Creek Bridge

SAND to SAND with SILT

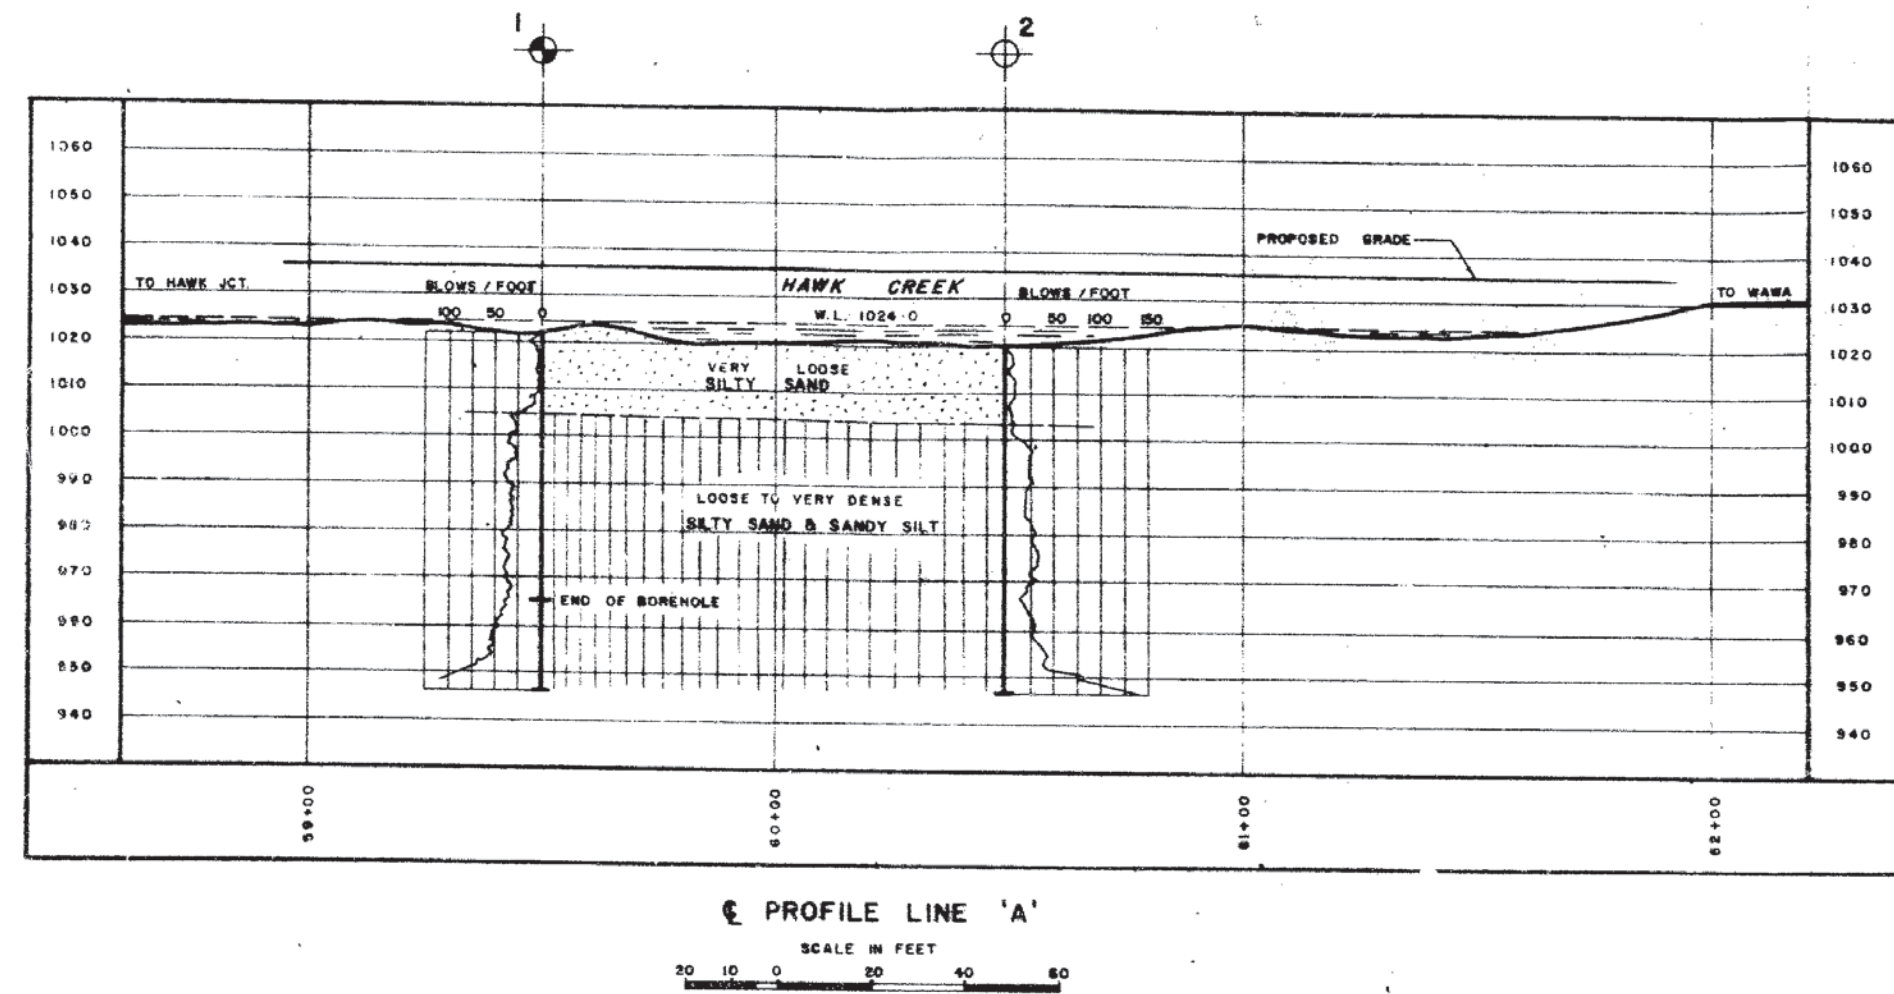
LEGEND			
	BORE & PENETRATION HOLE		
	PENETRATION HOLE (CORE)		
	BORE HOLE		
	WATER LEVELS - Established at Time of Field Investigation, DEC. 8, 1961		
NO.	ELEVATION	STATION	OFFSET
1	1022.0	59+50	E
2	1020.0	60+50	E

The boundaries between soil strata have been established only at bore hole locations. Between bore holes the boundaries are assumed from geological evidence and may be subject to considerable error.

DEPARTMENT OF HIGHWAYS - ONTARIO			
MATERIALS & RESEARCH DIVISION - FOUNDATION SECTION			
HAWK CREEK AND PROPOSED HIGHWAY NO. 101 LINE 'A'			
ORIGINATED W. KULBATICZ	DISTRICT NO. 18	DATE FEB. 8, 1962	
DRAWN F. CLARK	W.P. NO. 144-81	JOB NO. 61-F-120	
CHECKED <i>[Signature]</i>	CONTRACT NO.	REVISION: 00	
APPROVED <i>[Signature]</i>		61-F-120A

A previous foundation investigation, W.P. 144-61, was carried out at this location in 1961 by the Ontario Ministry of Transportation. Results of the previous investigation shown on a Drawing No. 61-F-120A indicated the subsurface soils on the river banks consisted of very loose silty sand overlying the loose to very dense silty sand to sandy silt. Refusal of Dynamic Cone Penetration Testing (DCPT) was countered at approximate elevation 290 m (see Enclosure No.

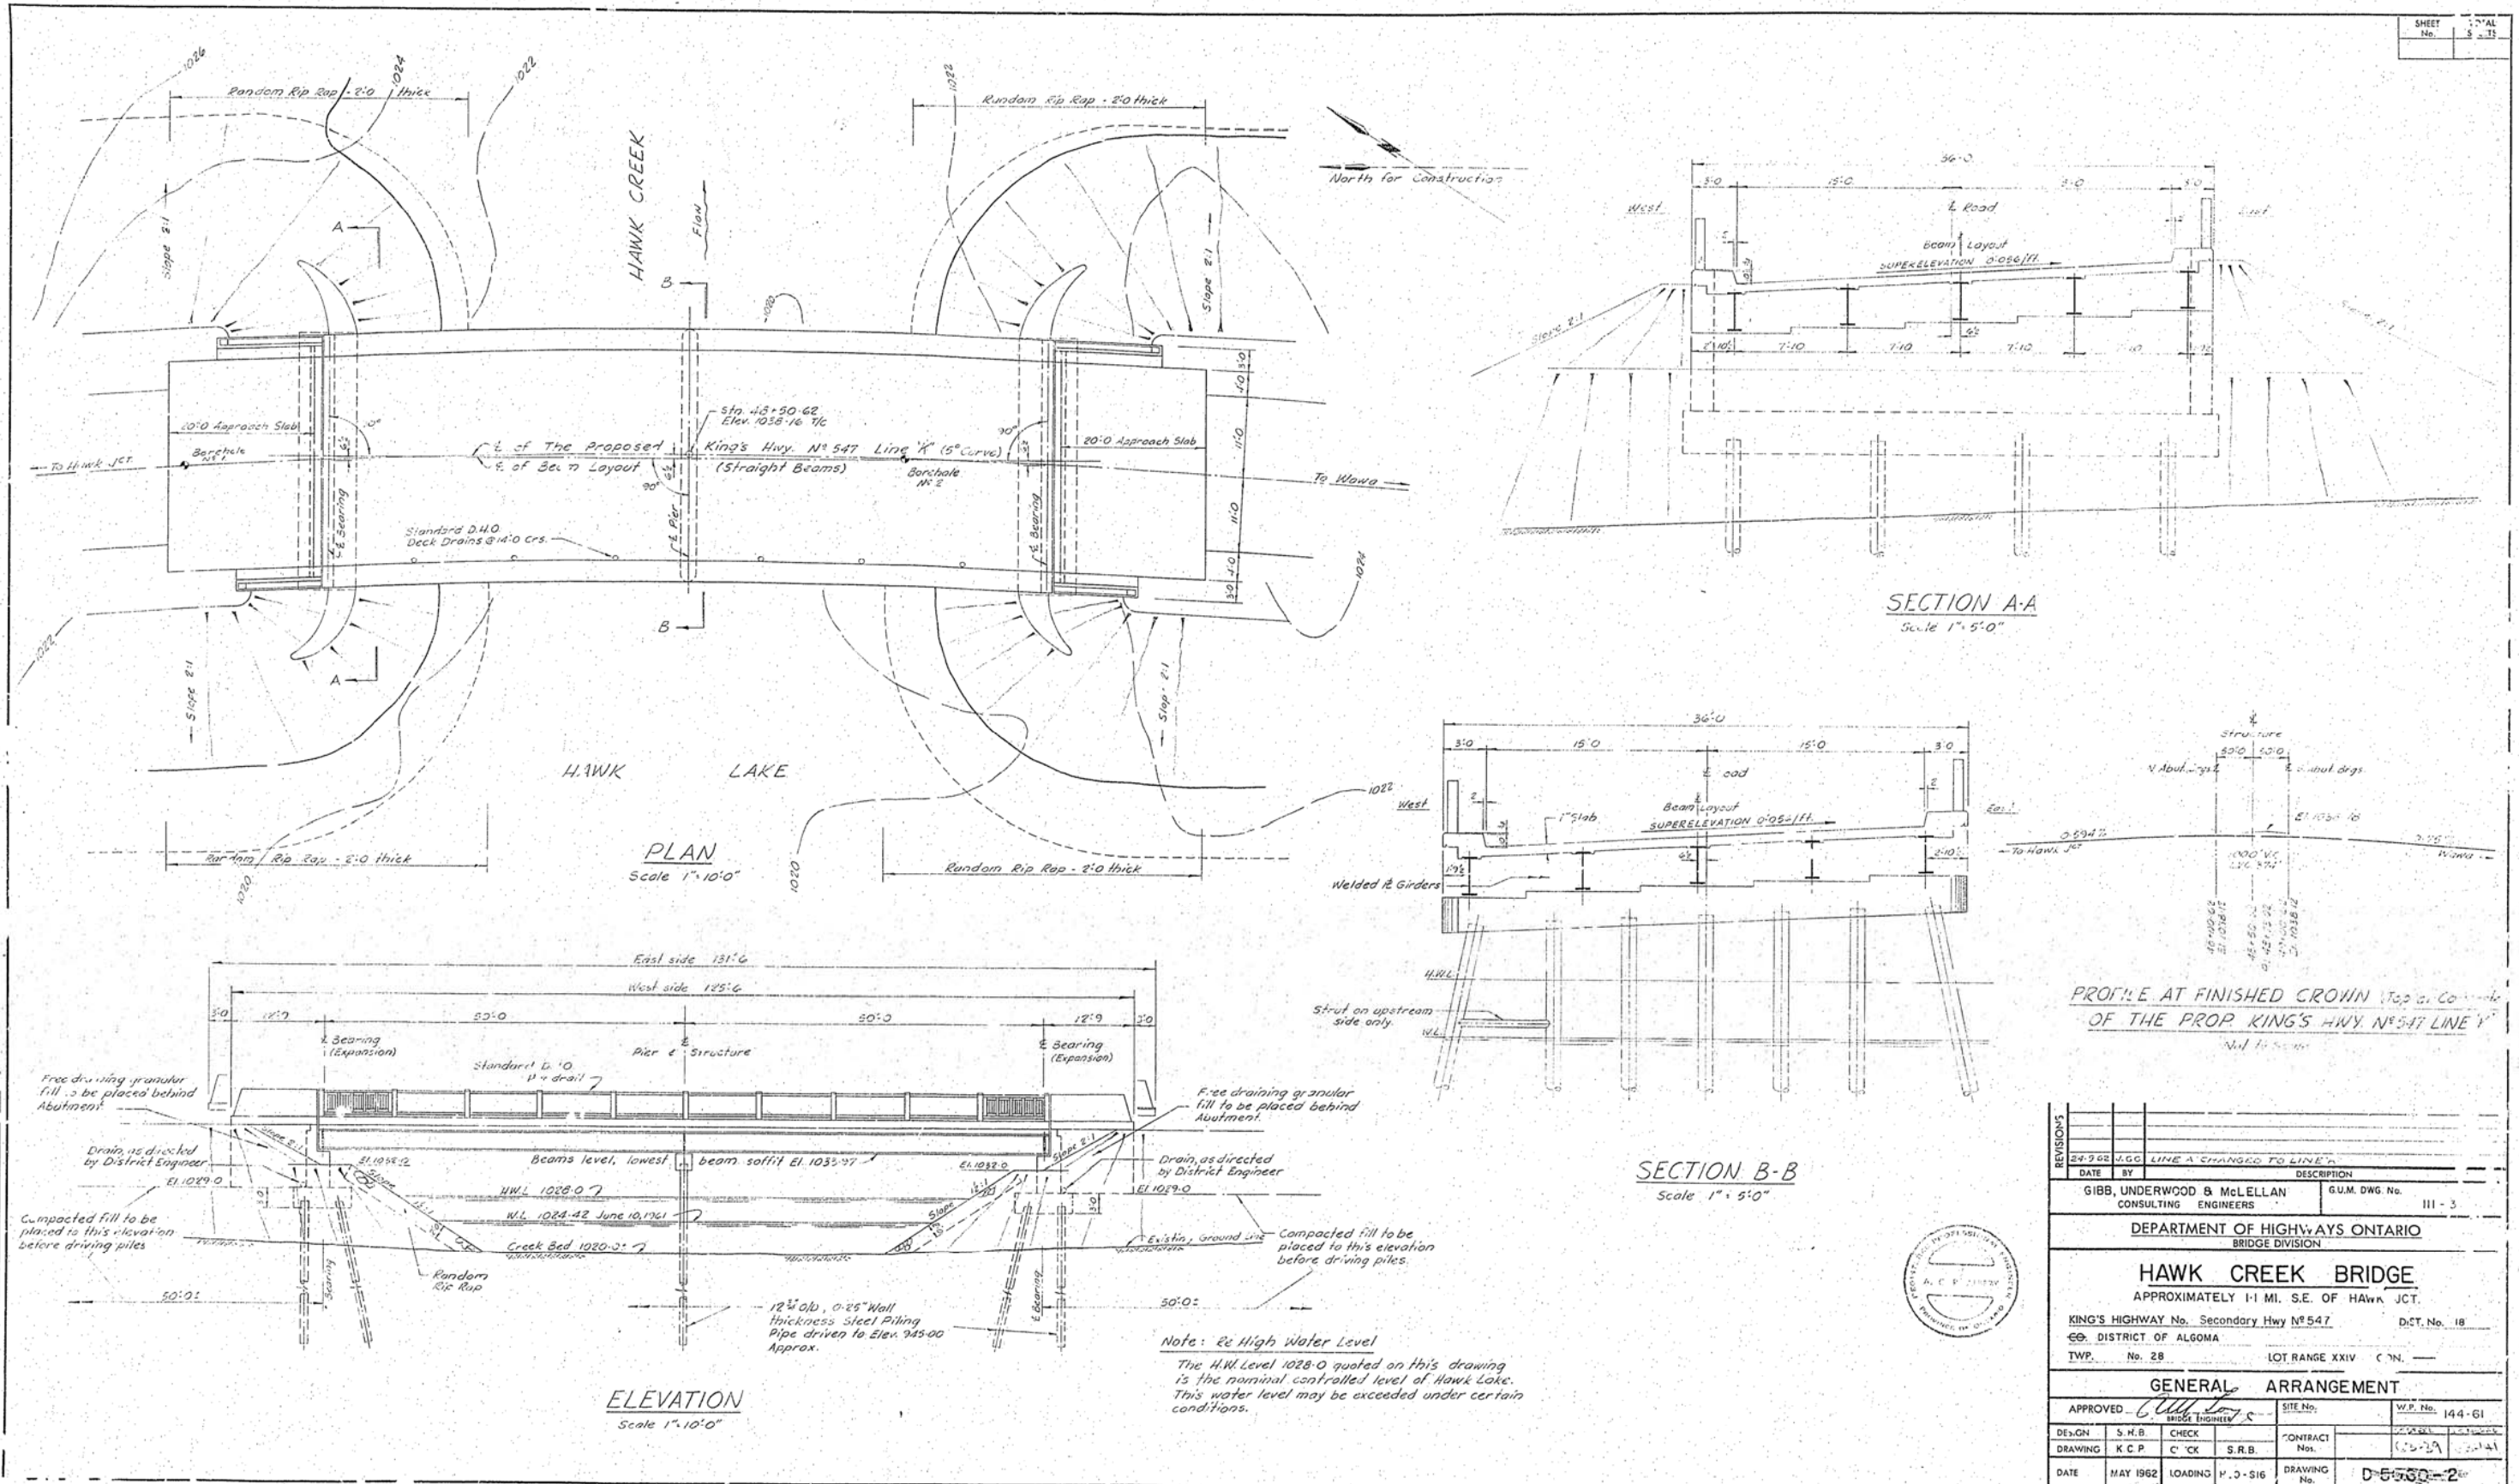
PROFILE AT FINISHED CROWN (Top of Center) OF THE PROPOSED KING'S HWY. NO. 547 LINE 1

REVISIONS		DATE		BY		DESCRIPTION			
1		24-9-62		J.G.C.		LINE A CHANGED TO LINE 1			
GIBB, UNDERWOOD & McLELLAN				CONSULTING ENGINEERS		G.U.M. DWG. No.		III - 3	
DEPARTMENT OF HIGHWAYS ONTARIO									
BRIDGE DIVISION									
HAWK CREEK BRIDGE									
APPROXIMATELY 1.1 MI. S.E. OF HAWK JCT.									
KING'S HIGHWAY No. Secondary Hwy No. 547						DIST. No. 18			
DISTRICT OF ALGOMA									
TWP. No. 28		LOT RANGE XXIV		C.N.					
GENERAL				ARRANGEMENT					
APPROVED <i>C.C.K.</i>				SITE No.		W.P. No.		144-61	
DESIGN S.H.B.		CHECK C.C.K.		CONTRACT No.		D-550-2		10-29	
DRAWING K.C.P.		LOADING J.C.S.				DRAWING No.		D-550-2	
DATE MAY 1962		LOADING J.C.S.		DRAWING No.		D-550-2

5, Appendix 5). Based on a Drawing No. TWP 682-16-2-A of Contract No. 63-39, the existing bridge was founded on deep foundations (324 mm diameter steel pipe piles driven to refusal at approximate elevation 288 m) at both of the north and the south abutments and the central pier (Enclosure No. 6, Appendix 5).
