Bridge Rehabilitation – Solomon Creek Bridge
Highway 11
Stations 21+735.7 to 21+757.7 – Township of Idington
Site No. 39W-063
GWP 163-98-00

FINAL FOUNDATION INVESTIGATION REPORT

Date: January 21, 2016
Ref. N°: 15/05/15059-F3

Final Foundation Investigation Report

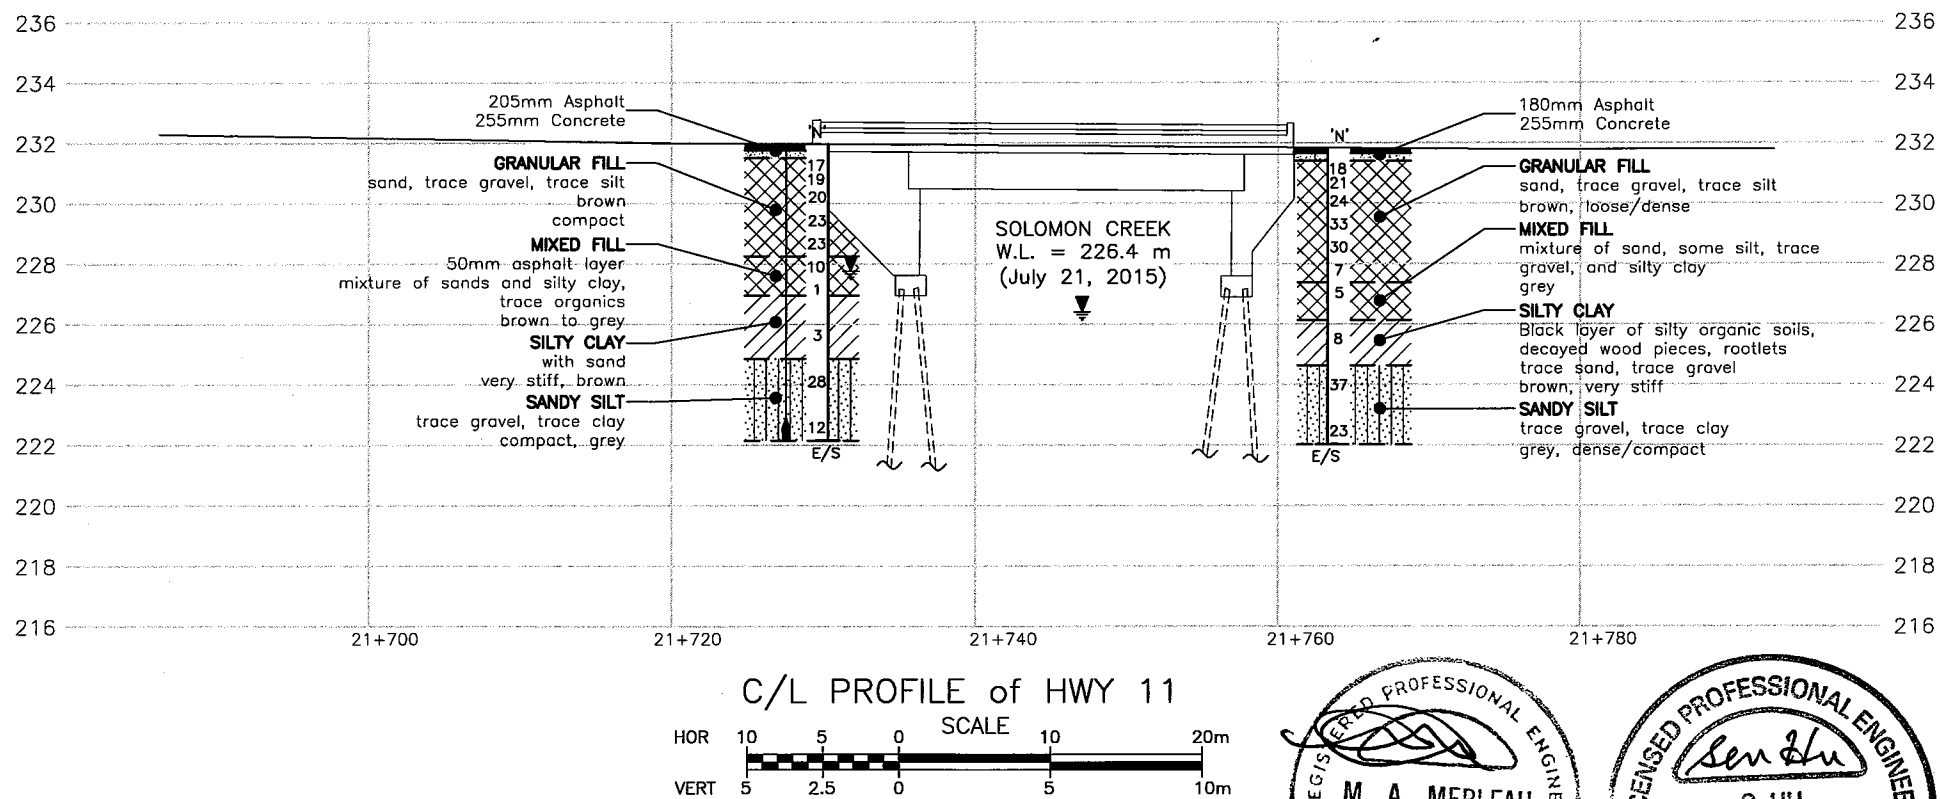
SHEET
2

This drawing is for subsurface information only. Surface details and features are for conceptual illustration. The proposed structure location is shown for illustration purposes only and may not be consistent with the final design configuration as shown elsewhere in the Contract Documents.

Details of the subsurface conditions revealed by the investigation program are presented on the enclosed Records of Borehole Logs (Appendix 2) and on Drawing No. 2 (Appendix 3). Please note that stratigraphic delineations presented on the borehole logs and soil strata plot are the results of non-continuous sampling, response to drilling progress, the results of SPT, plus field observations. Typically such boundaries represent transitions from one zone to another and are not an exact demarcation of specific geological unit. Additional consideration should be given to the fact that subsurface conditions may vary markedly between adjacent boreholes and beyond any specific boring location, and are shown on the drawings for illustration purposes only.

Drawing No. 2:	Borehole Location and Soil Strata
Figure Nos. L-1 to L-4:	Grain Size Distribution Curves
Figure No. L-5:	Atterberg Limits Summary
Table No. L-6:	Laboratory Test Summary Sheet

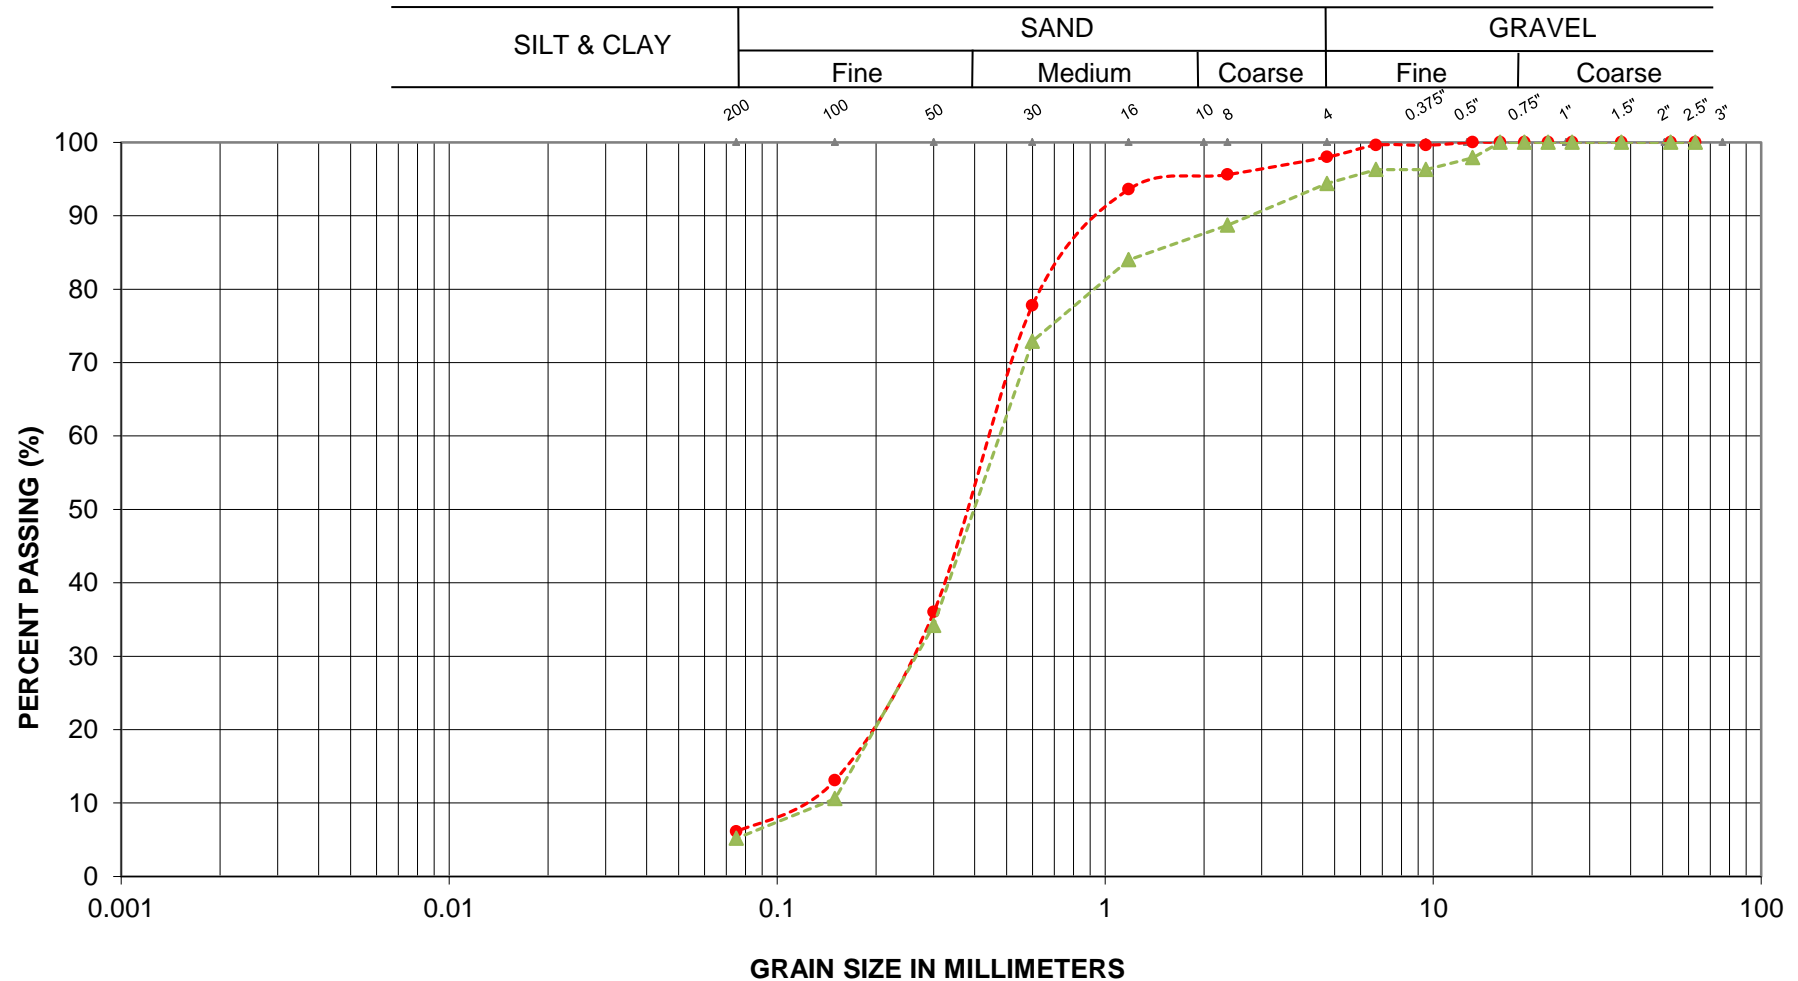
FIGURE L-1

GRAIN SIZE ANALYSIS

GRANULAR FILL

LOCATION: Hwy 11, Solomon Creek Culvert
TWP of Idington

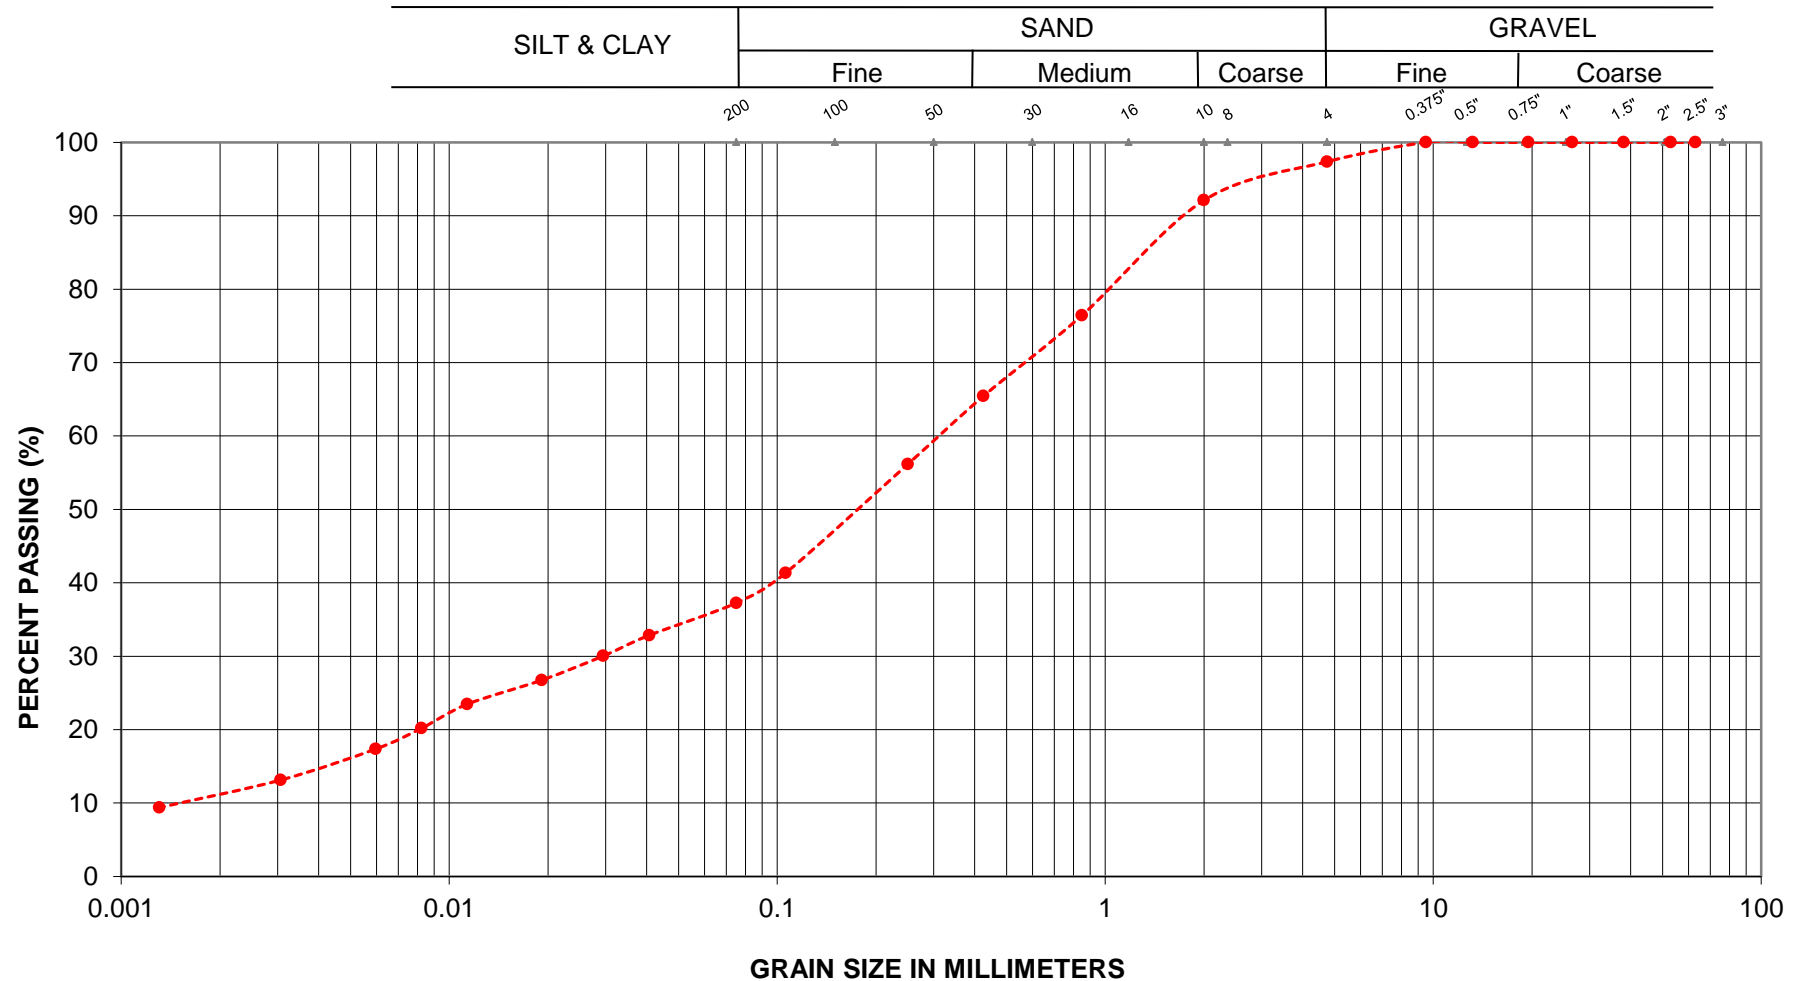
FIGURE L-2

GRAIN SIZE ANALYSIS

---●--- BH No.: 1 Sa No.: 6 Depth: 3.8 - 4.3 m

MIXED FILL

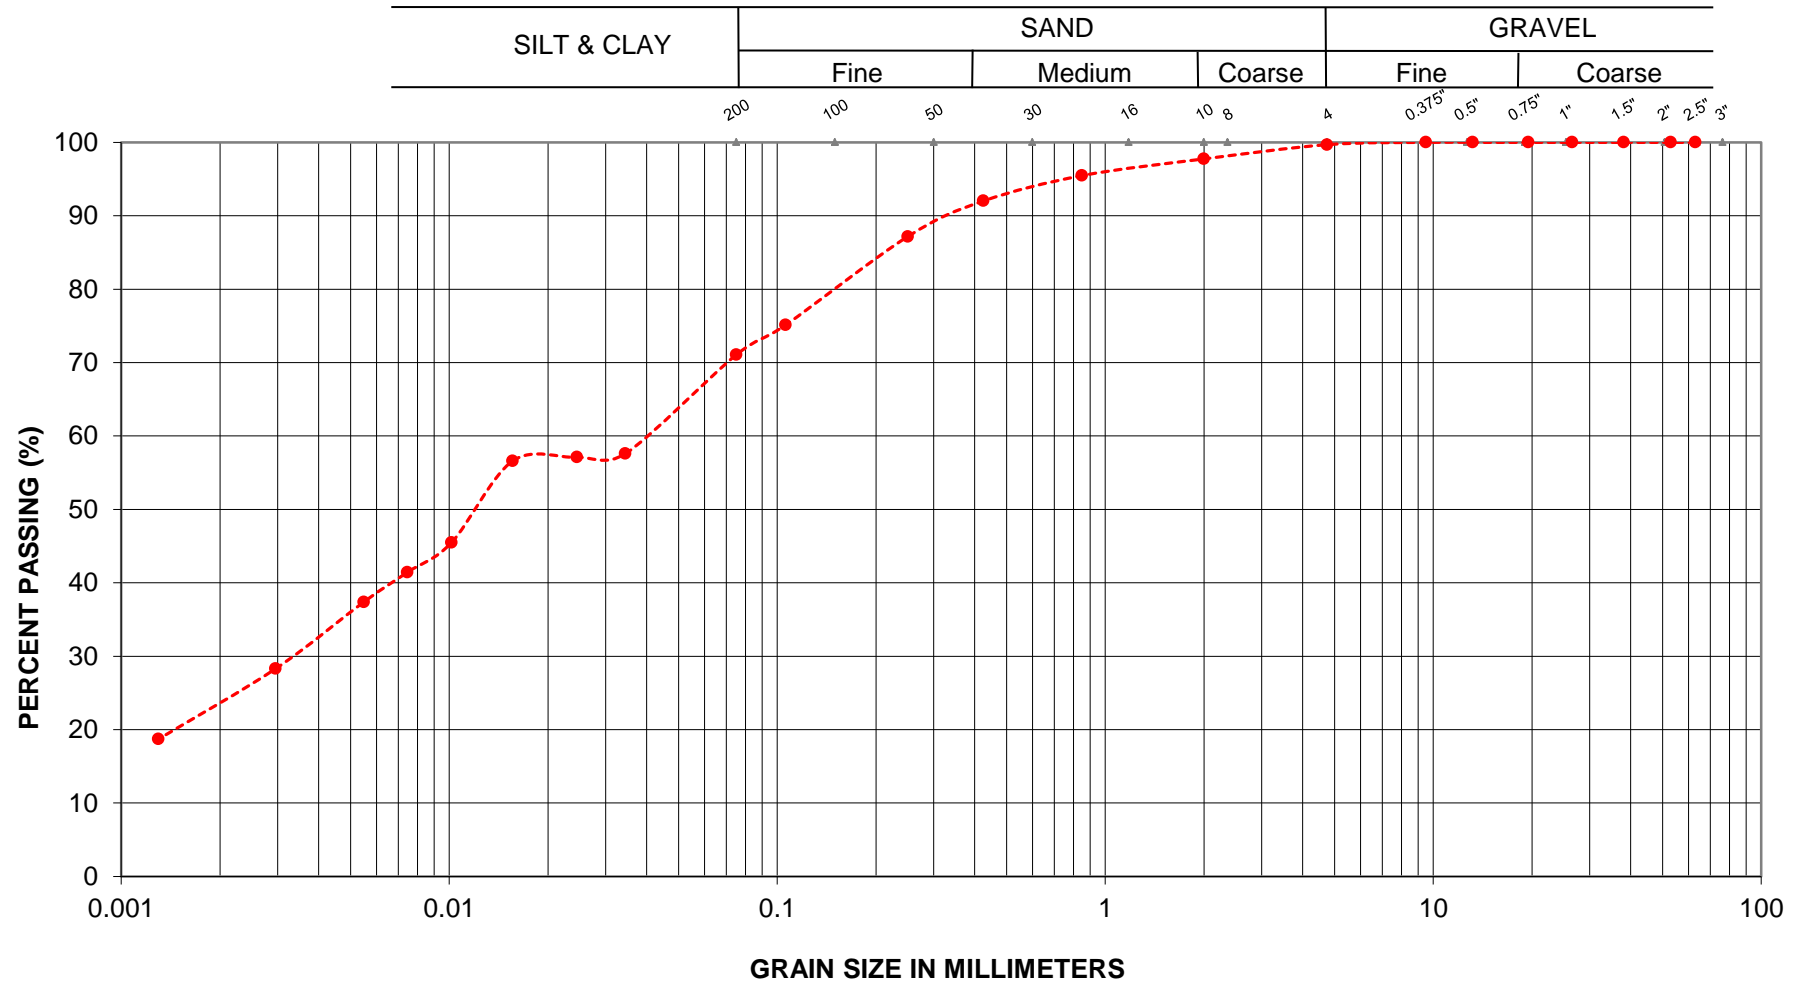
FIGURE L-3

GRAIN SIZE ANALYSIS

SILTY CLAY

LOCATION: Hwy 11, Solomon Creek Culvert
TWP of Idington

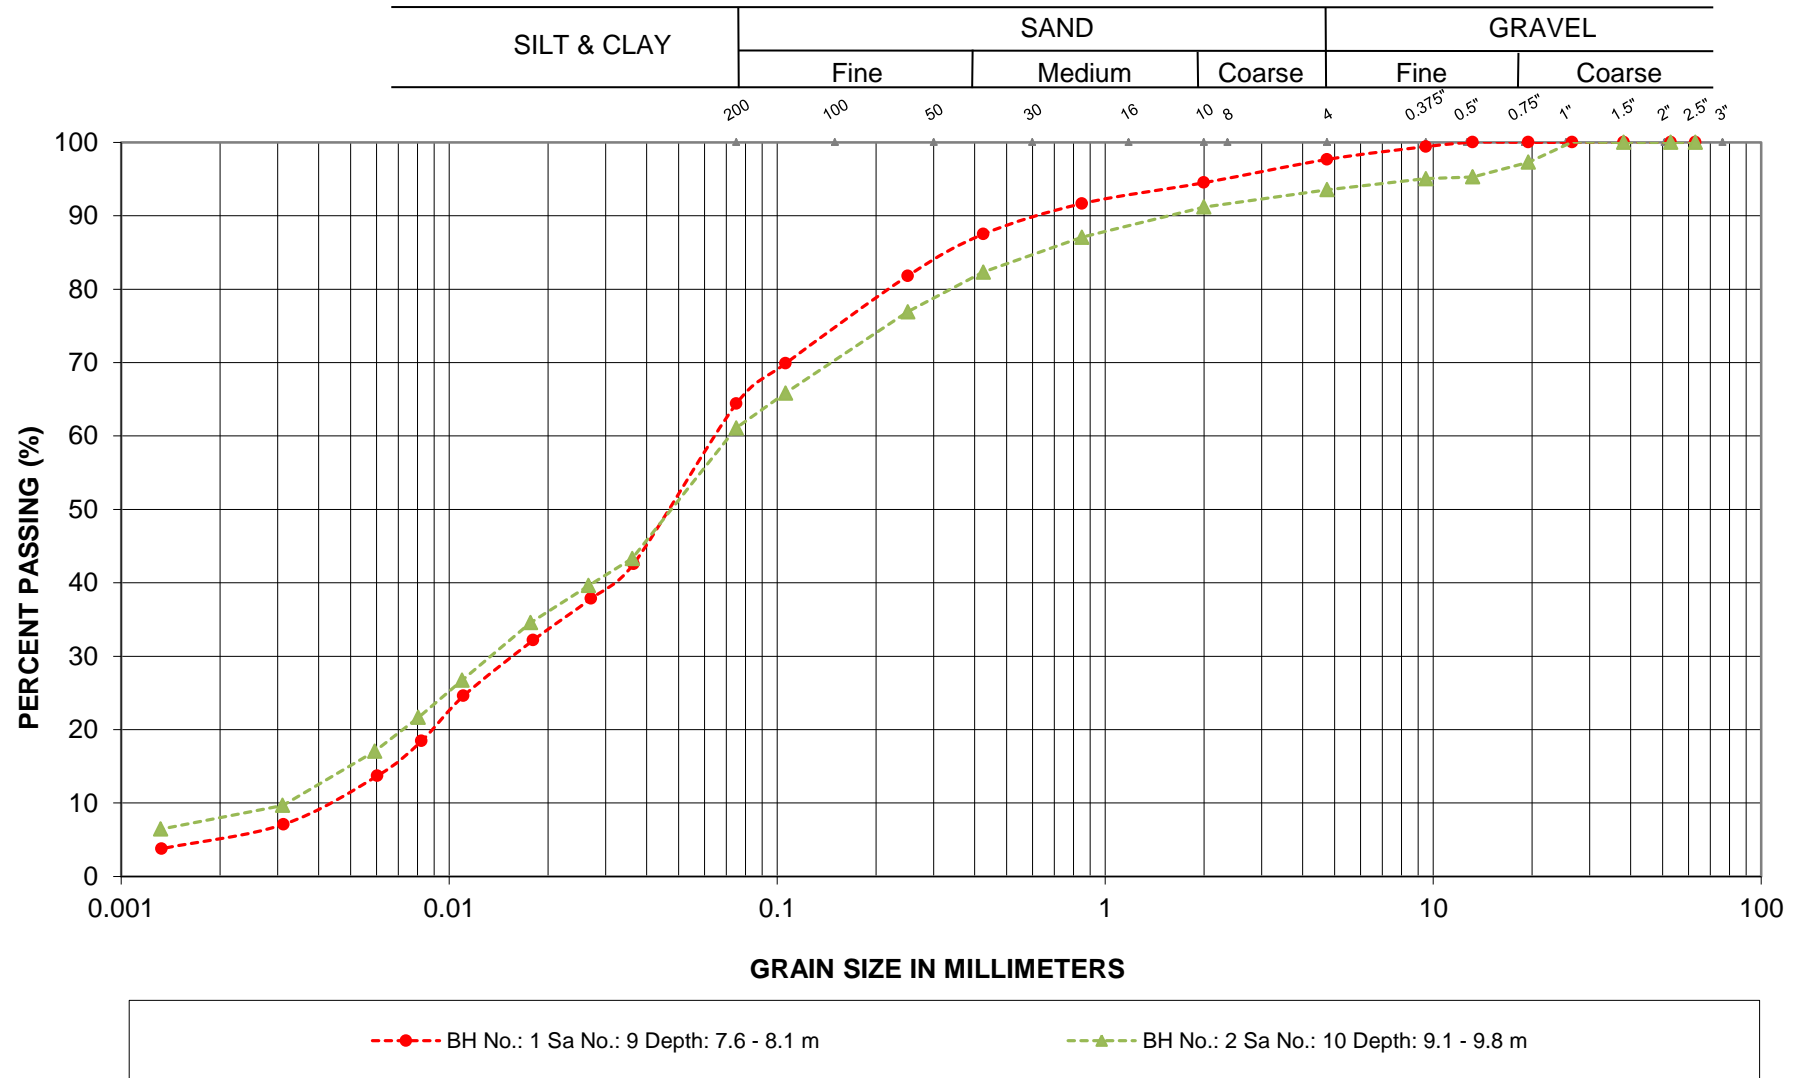
FIGURE L-4

GRAIN SIZE ANALYSIS

SANDY SILT

LOCATION: Hwy 11, Solomon Creek Culvert
TWP of Idington

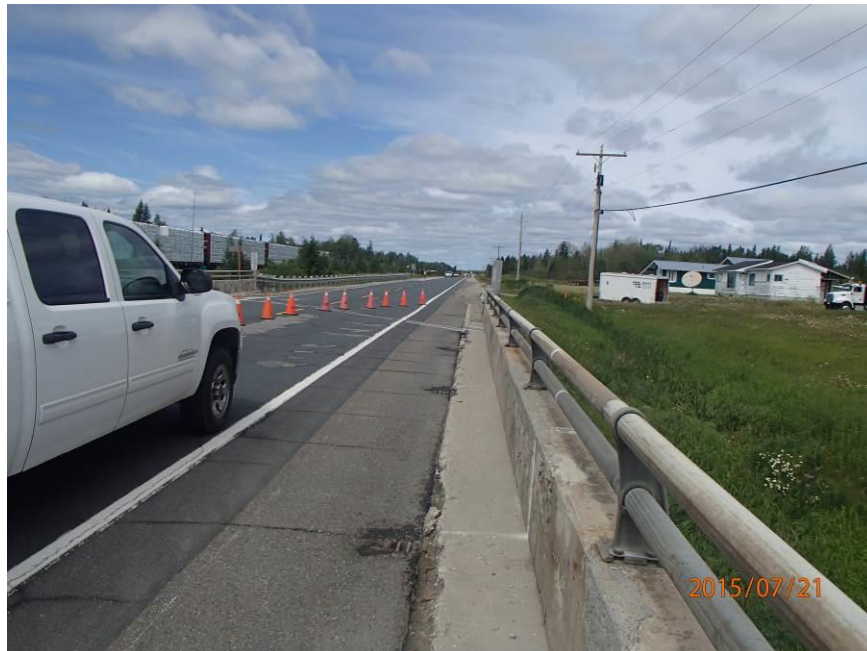
Photo: 1

Existing Bridge – Looking West (down chainage)

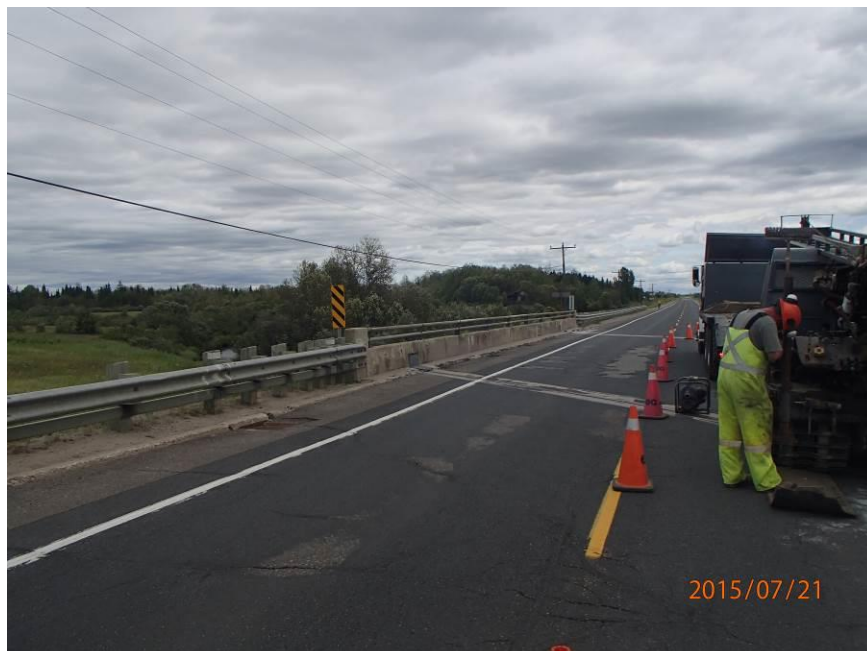
Photo: 2

Existing Bridge – Looking East (up chainage)

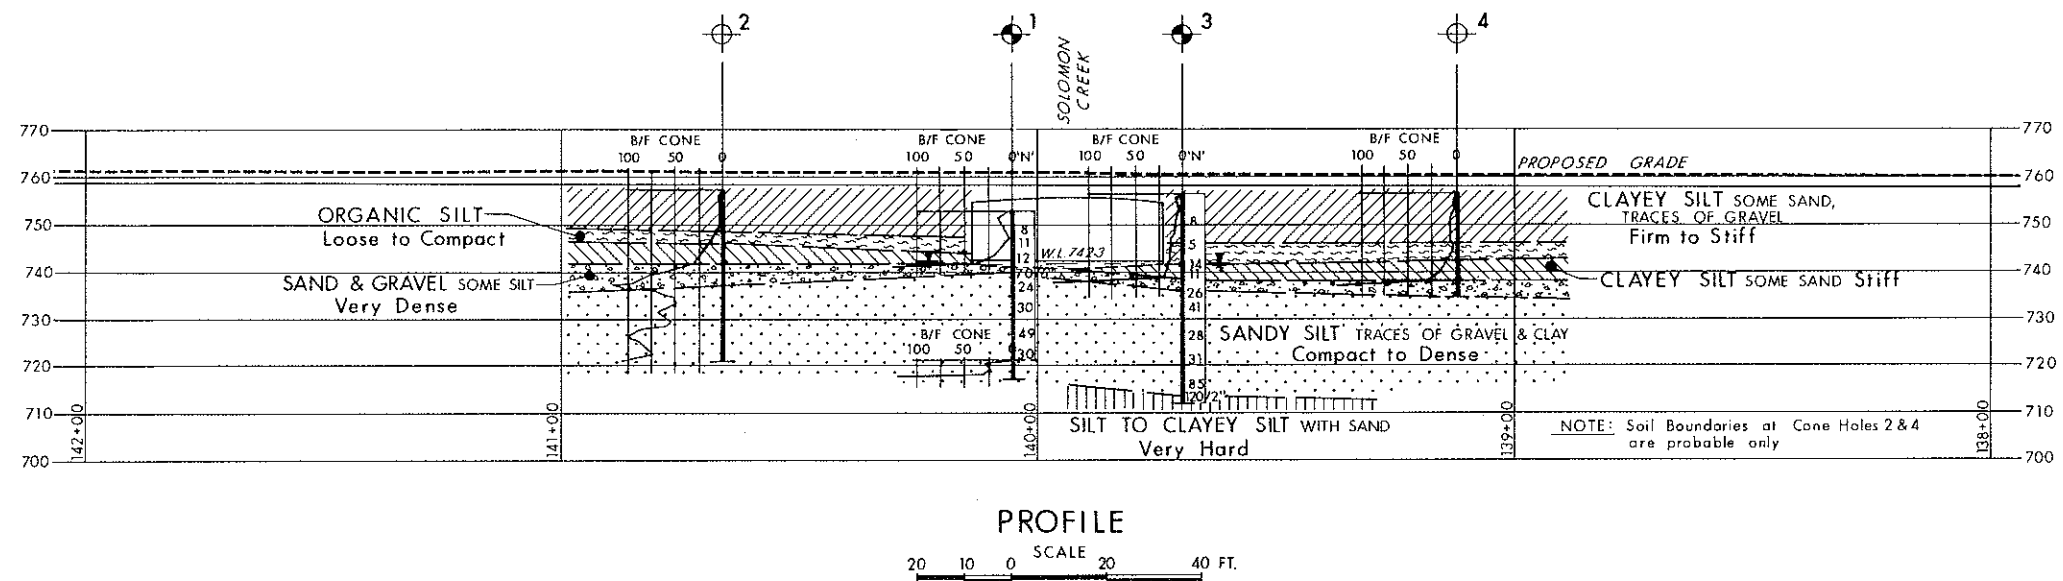
BORE HOLE LOCATIONS & SOIL STRATA

LEGEND			
	Bore Hole		
	Cone Penetration Hole		
	Bore & Cone Penetration Hole		
	Water Levels established at time of field investigation. JULY 1970.		
	Water Levels not established in Bore Holes 2 & 4.		
NO.	ELEVATION	STATION	OFFSET
1	753.0	140+05	28' RT.
2	757.3	140+66	22' LT.
3	756.6	139+70	22' LT.
4	757.0	139+12	21' RT.

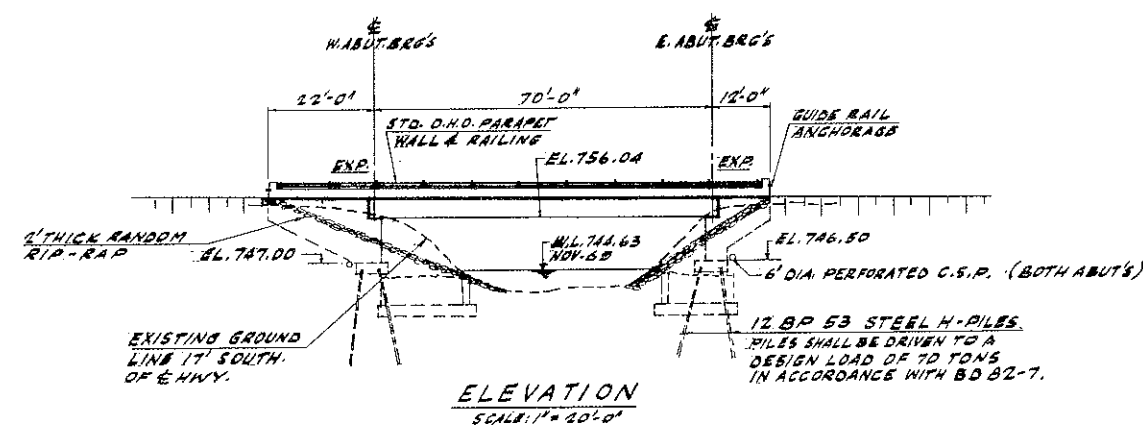
NOTE:
ORGANIC MATERIAL TO BE REMOVED FROM
UNDER ABUTMENT FOOTINGS AND REPLACED
BY SUITABLE GRANULAR BACKFILL.
FOR DETAILS SEE GRADING DRAWINGS.
