**Culvert Replacement – Holledge Creek Culvert  
Highway 11  
Station 15+735 – Township of Owens  
Site No. 39W-107  
GWP 163-98-00**

## **FINAL FOUNDATION INVESTIGATION REPORT**

Date: February 23, 2016  
Ref. N<sup>o</sup>: 15/05/15059-F1

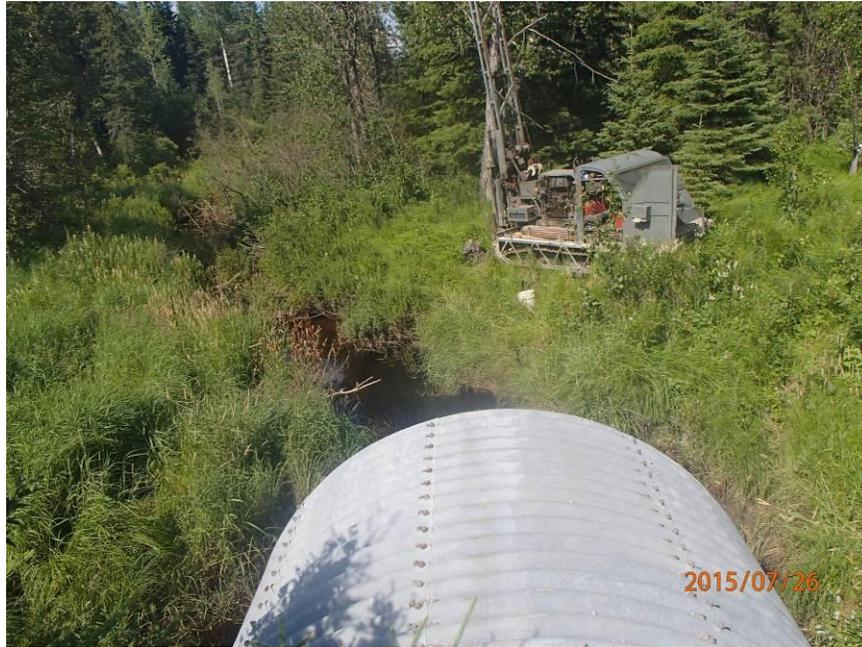
Photo: 3

Culvert Outlet – Looking North

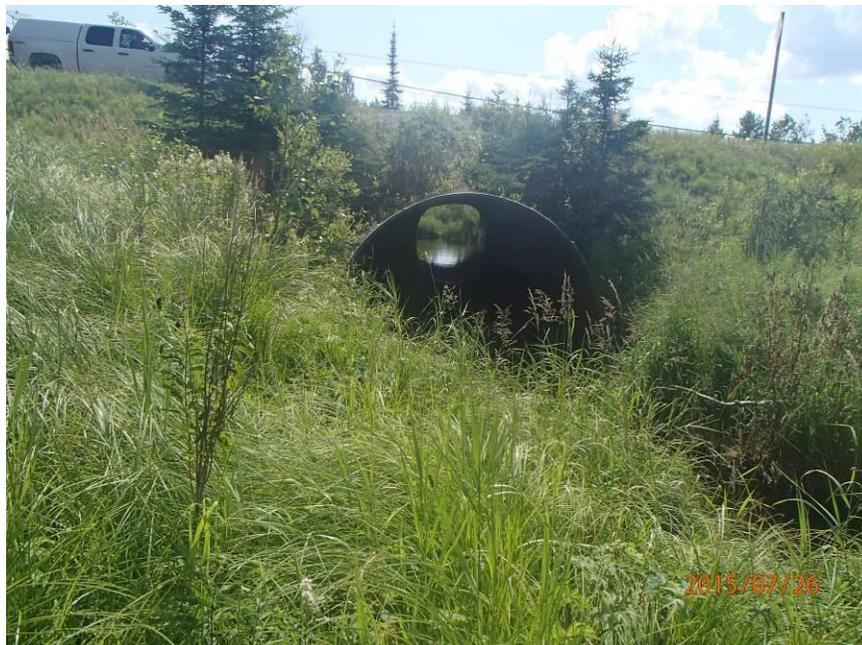
Photo: 4

View Through Culvert – Looking South
