**Culvert Replacement  
Highway 11  
Station 11+545 – Township of Eilber  
Site No. 39W-054  
GWP 5145-05-00**

## **FINAL FOUNDATION INVESTIGATION REPORT**

Date: February 23, 2016  
Ref. N<sup>o</sup>: 15/05/15059-F5

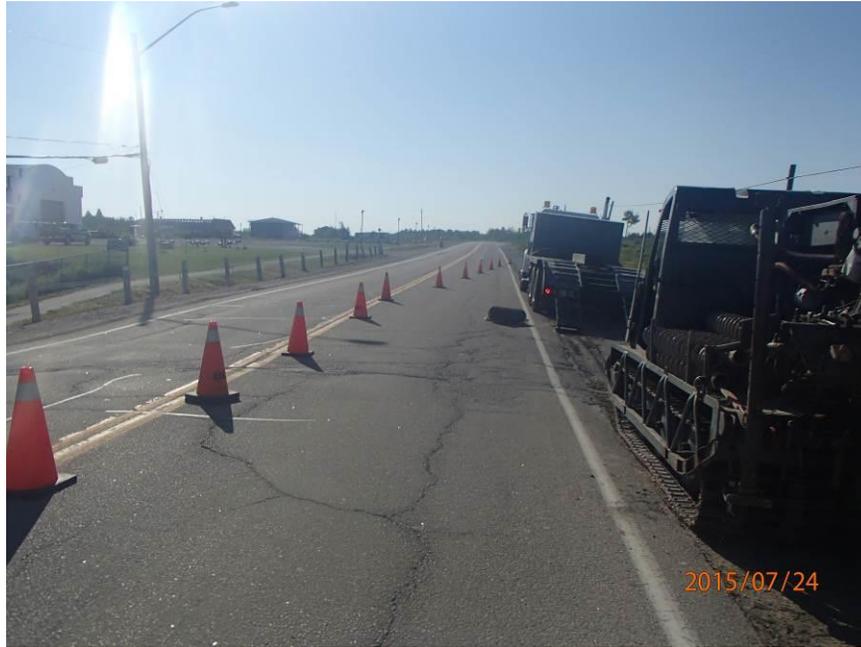
Photo: 1

Existing Embankment – Looking East

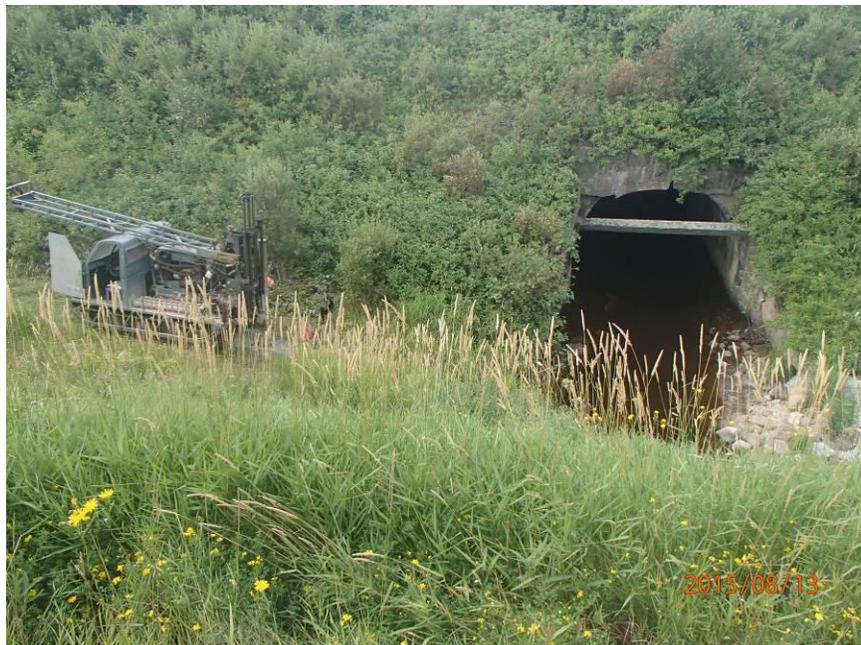
Photo: 2

South Slope – Looking South, Note ONR Culvert

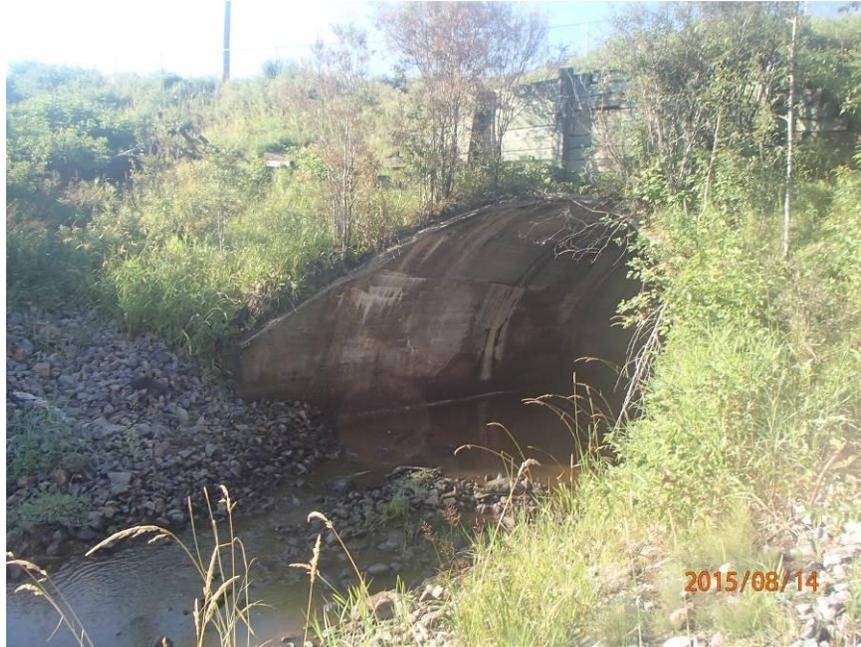
Photo: 3

Culvert Outlet – Looking South-East

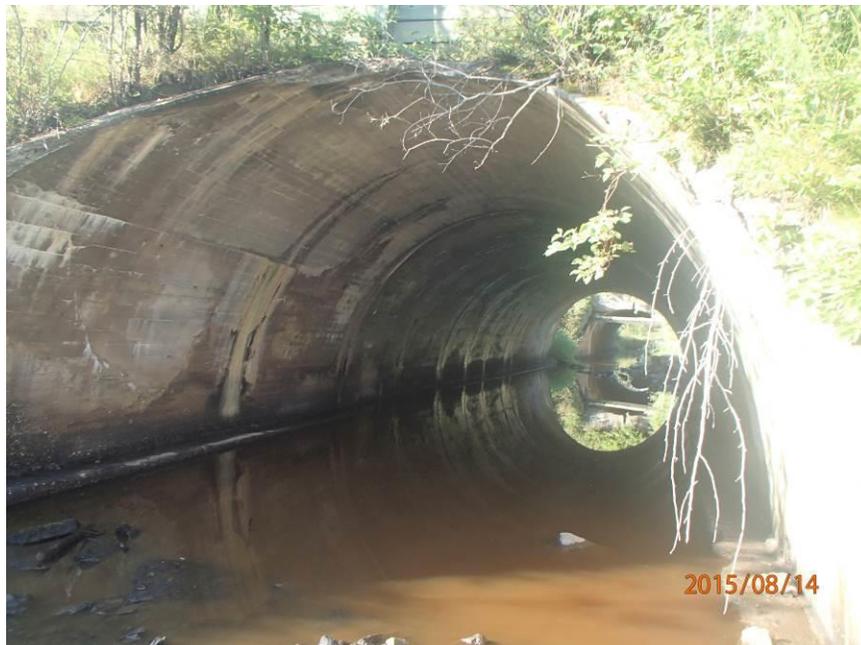
Photo: 4

View Through Culvert – Looking south
