## **FINAL FOUNDATION INVESTIGATION REPORT**

**Culvert 38 Rehabilitation, Highway 69 – 2.0 km South of Highway 7182**

**Rehabilitation of Highway 69 and Shawanaga River Bridge**

**G.W.P. 5246-18-00**

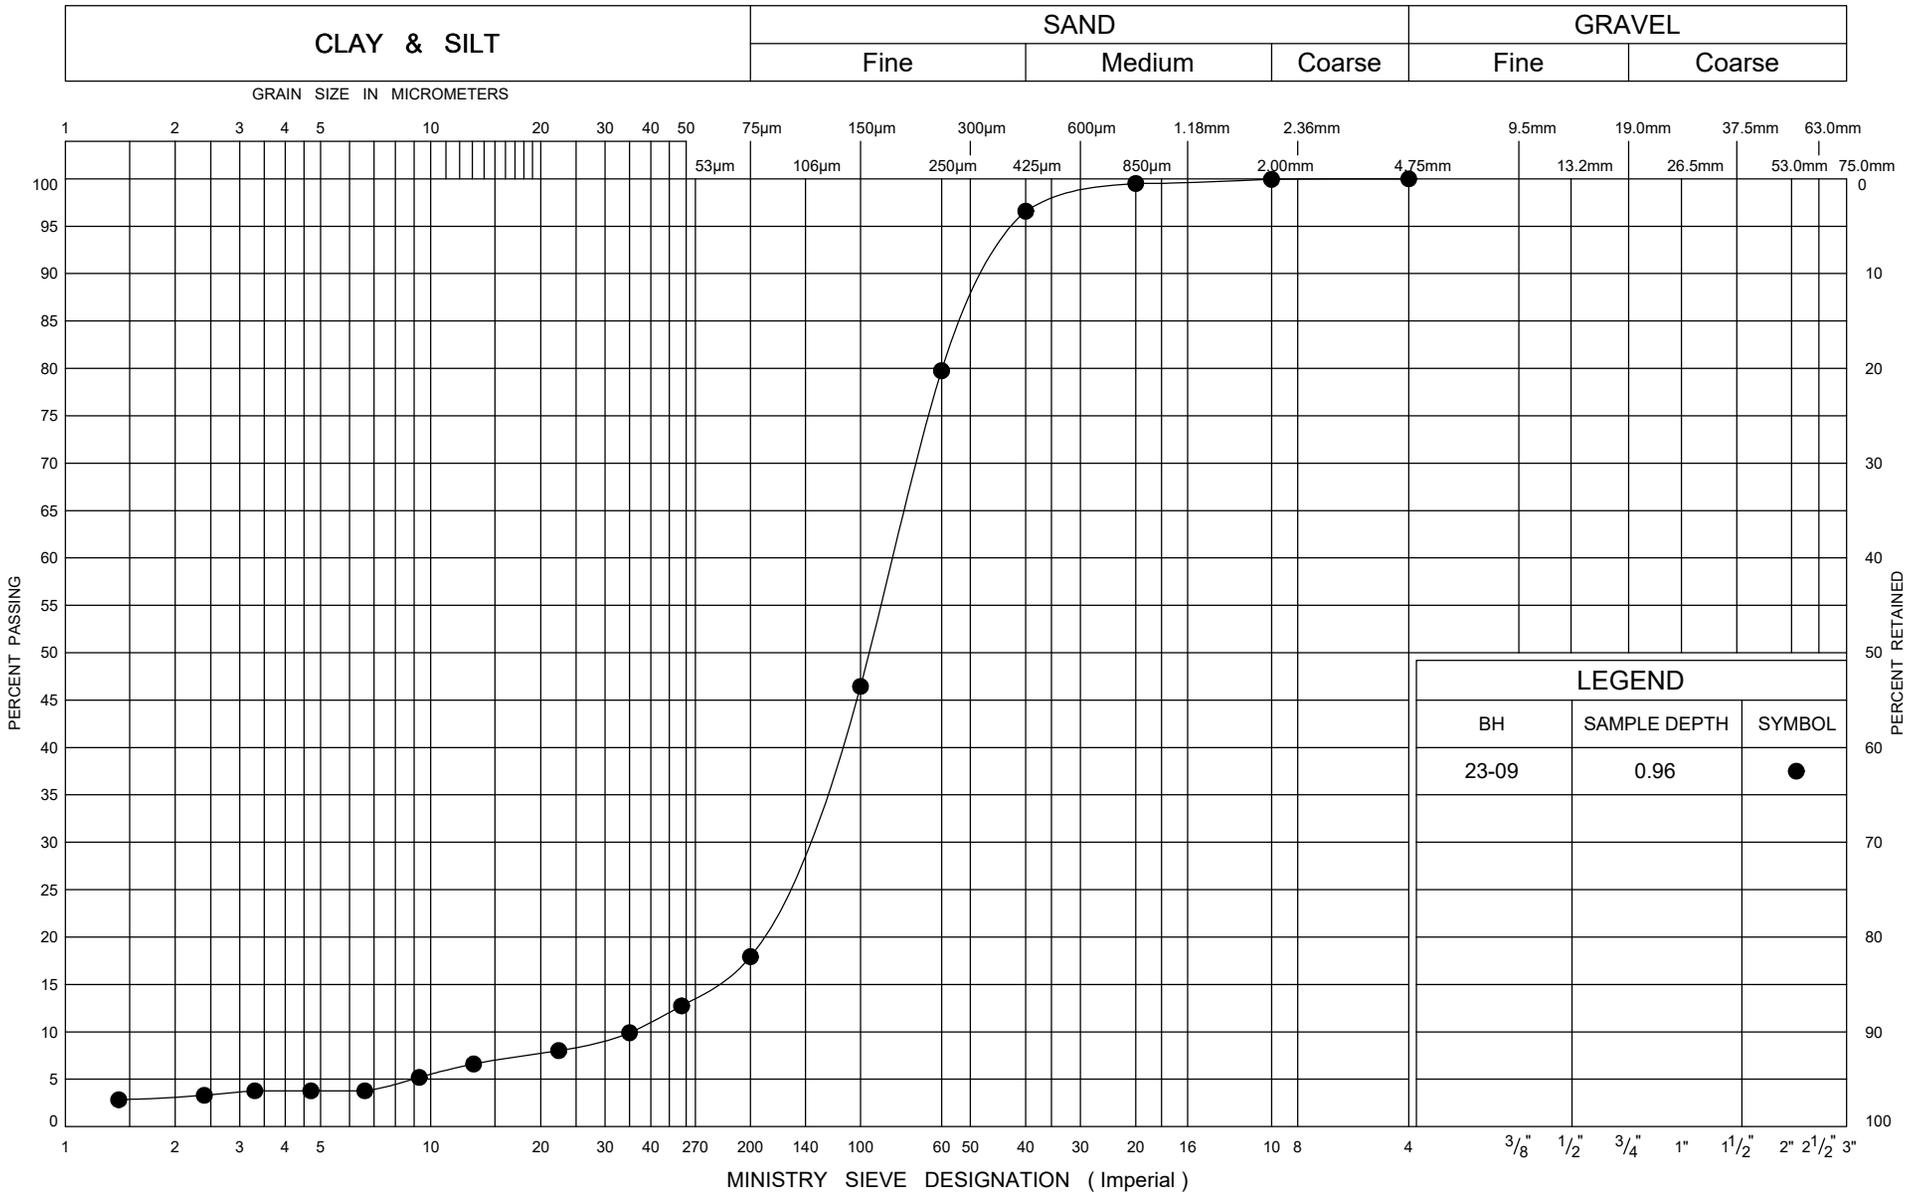
FIG No C1  
GWP# 5246-18-00  
HWY 69 & Shawanaga River Bridge

**GRAIN SIZE DISTRIBUTION**  
SAND to Silty SAND

Moisture contents measured in this material ranged from 17% to 48%. The higher value of 48% was measured in a sample from the top of the sand layer in Borehole 23-09 which contained organic material. The results of grain size distribution analyses carried out on a sample of this material are provided on Figure C1 in Appendix C. The results are also summarized in Table 5-1 and on the Record of Borehole sheets in Appendix B.

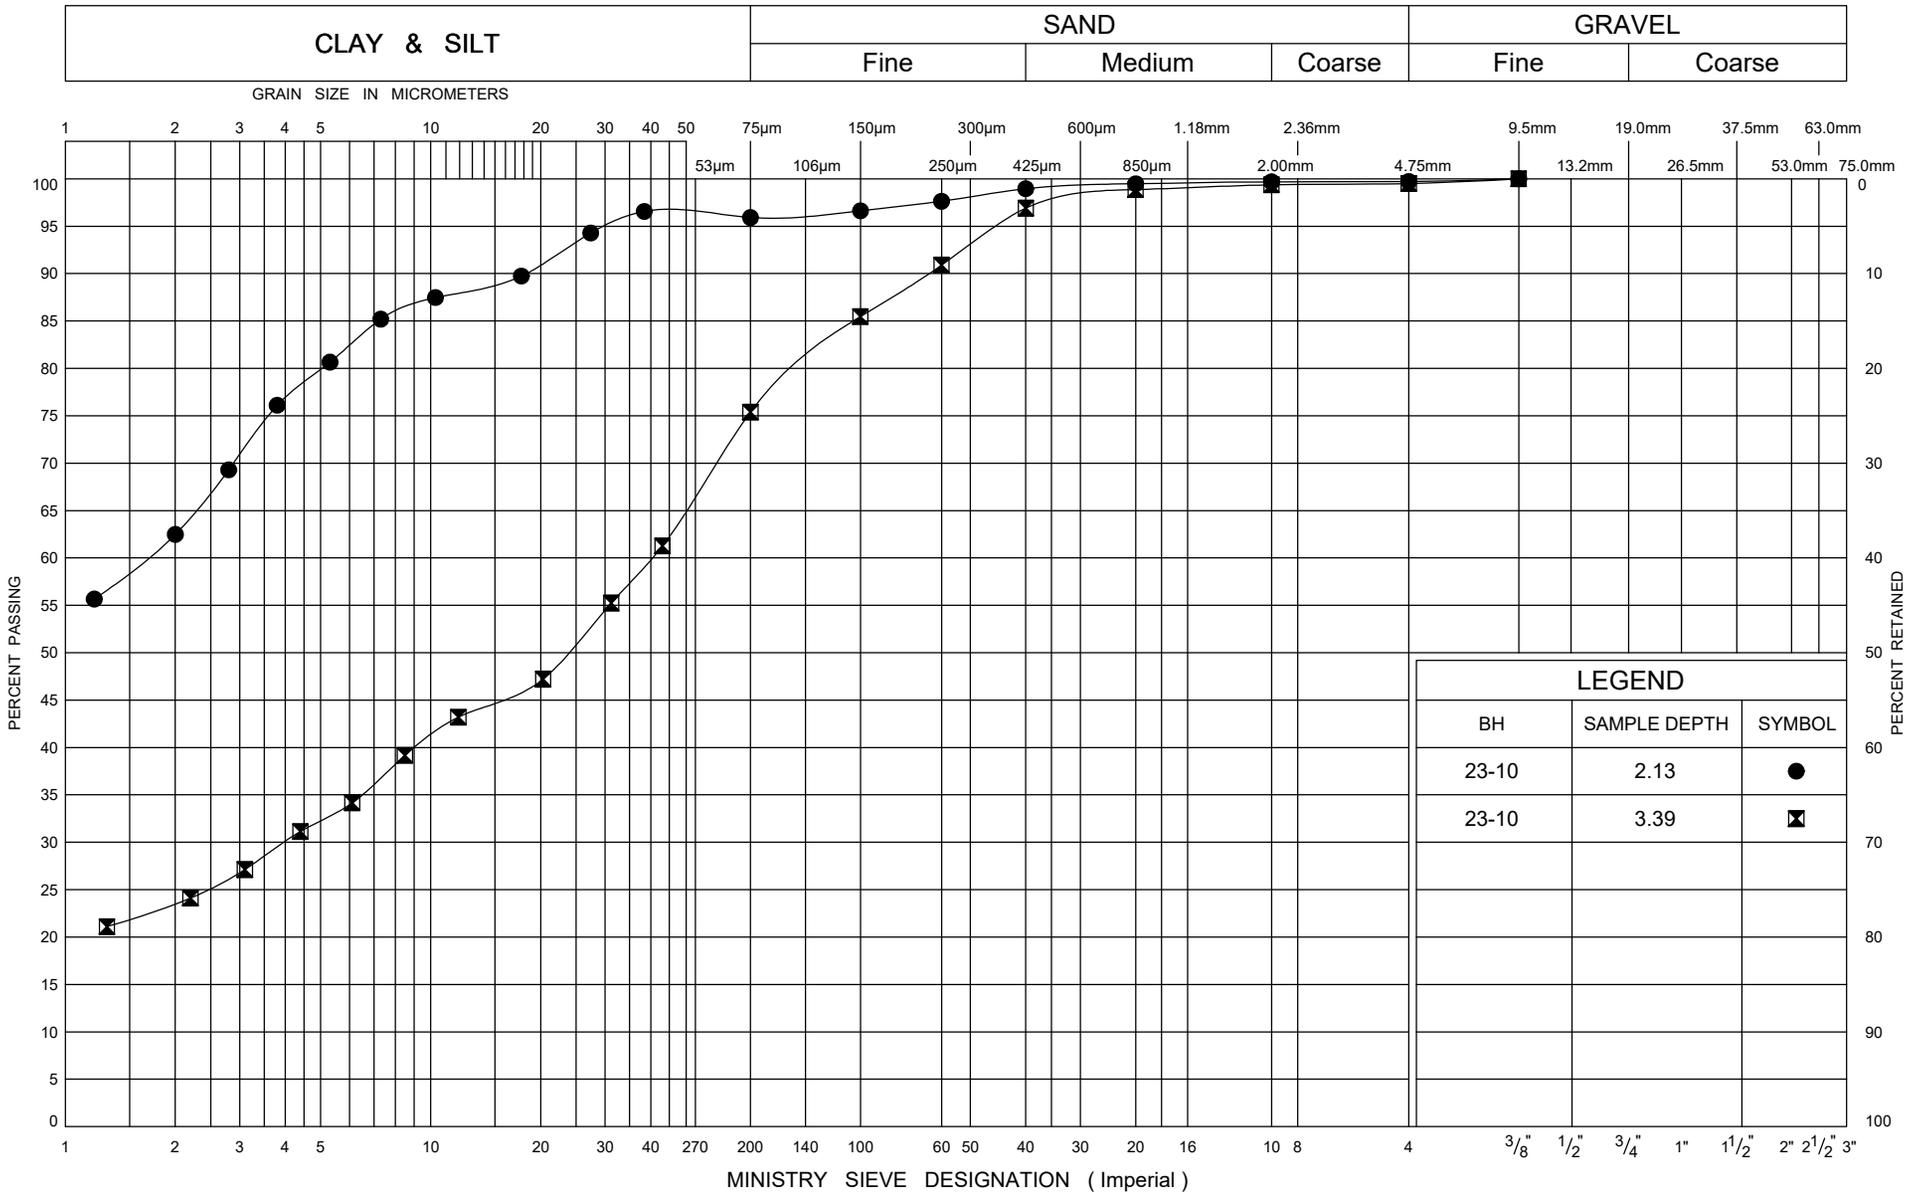
FIG No C2  
 GWP# 5246-18-00  
 HWY 69 & Shawanaga River Bridge

LEGEND		
BH	SAMPLE DEPTH	SYMBOL
23-10	2.13	●
23-10	3.39	■

### Silty CLAY

Moisture contents ranging from 22% to 68% were recorded in the silty clay. The results of gradation analyses completed on selected samples of the silty clay are illustrated on Figure C2 of Appendix C. The results of the tests are also summarized in the table below and on the Record of Borehole sheet in Appendix B.

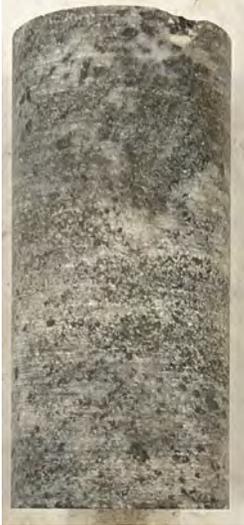
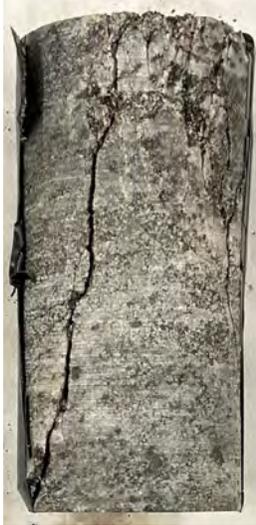
Specimen parameters		Diameter (mm) <sup>a</sup>	60.80	Length (mm) <sup>a</sup>	129.90	Bulk density $\rho$ (g/cm <sup>3</sup> )	2.769	UCS (MPa)	90.5	Lithology	Granite gneiss	Failure description <sup>b</sup>	1, 2	<p>Prior to testing</p>

Specimen parameters																	
Diameter (mm) <sup>a</sup>	60.80																
Length (mm) <sup>a</sup>	129.90																
Bulk density $\rho$ (g/cm <sup>3</sup> )	2.769																
UCS (MPa)	90.5																
Lithology	Granite gneiss																
Failure description <sup>b</sup>	1, 2																
<p><sup>a</sup> Additional specimen measurement/details provided in accompanying summary spreadsheet.  <sup>b</sup> Failure description: <sup>1</sup> Inclined shear failure; <sup>2</sup> Partial hourglass failure;</p>																	
<p>Remarks: Loading Rate: 0.05mm/min.</p>																	
<b>Performed by</b>	SD	<b>Date</b>	2023-11-08

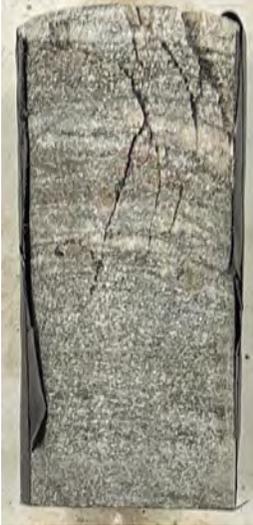
<b>Client</b>	Thurber Engineering Ltd.	<b>Project</b>	30351
<b>Sample</b>	BH23-07	<b>Depth</b>	13'5" - 14'4"
<u>Specimen parameters</u>		Prior to testing	After testing
Diameter (mm) <sup>a</sup>	46.74

Length (mm) <sup>a</sup>	103.86		
Bulk density $\rho$ (g/cm <sup>3</sup> )	2.746		
UCS (MPa)	90.2		
Lithology	Granite gneiss		
Failure description <sup>b</sup>	3		
<sup>a</sup> Additional specimen measurement/details provided in accompanying summary spreadsheet. <sup>b</sup> Failure description: <sup>3</sup> Inclined shear fracture and axial splitting failure;			
Remarks: Loading Rate: 0.05mm/min.			
<b>Performed by</b>	SD	<b>Date</b>	2023-11-08

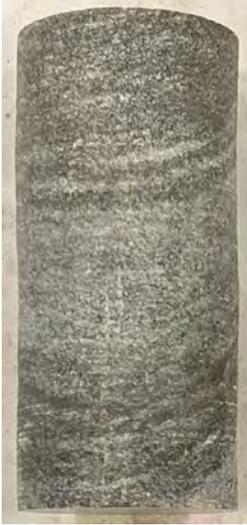
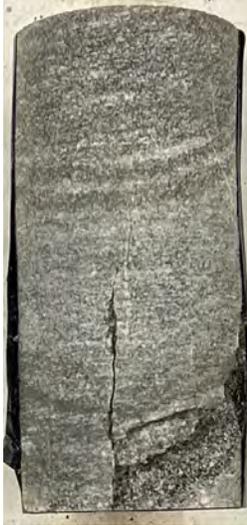
<b>Client</b>	Thurber Engineering Ltd.	<b>Project</b>	30351
<b>Sample</b>	BH23-09	<b>Depth</b>	7'10" - 8'5"
<u>Specimen parameters</u>		Prior to testing	After testing
Diameter (mm) <sup>a</sup>	48.54

Length (mm) <sup>a</sup>	103.59		
Bulk density $\rho$ (g/cm <sup>3</sup> )	2.753		
UCS (MPa)	113.8		
Lithology	Granite gneiss		
Failure description <sup>b</sup>	3, 5		
<sup>a</sup> Additional specimen measurement/details provided in accompanying summary spreadsheet. <sup>b</sup> Failure description: <sup>3</sup> Inclined shear fracture and axial splitting failure; <sup>5</sup> Failure partly along pre-existing structure;			
Remarks: Loading Rate: 0.05mm/min.			
<b>Performed by</b>	SD	<b>Date</b>	2023-11-08

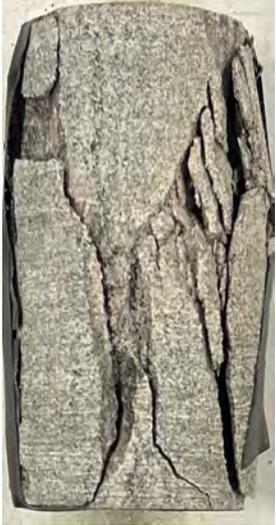
<b>Client</b>	Thurber Engineering Ltd.	<b>Project</b>	30351
<b>Sample</b>	BH23-13	<b>Depth</b>	6'6" - 7'2"
<u>Specimen parameters</u>		Prior to testing	After testing
Diameter (mm) <sup>a</sup>	48.89

Length (mm) <sup>a</sup>	103.89		
Bulk density $\rho$ (g/cm <sup>3</sup> )	2.674		
UCS (MPa)	129.4		
Lithology	Granite gneiss		
Failure description <sup>b</sup>	6		
<sup>a</sup> Additional specimen measurement/details provided in accompanying summary spreadsheet. <sup>b</sup> Failure description: <sup>6</sup> Hourglass failure;			
Remarks: Loading Rate: 0.05mm/min.			
<b>Performed by</b>	SD	<b>Date</b>	2023-11-08

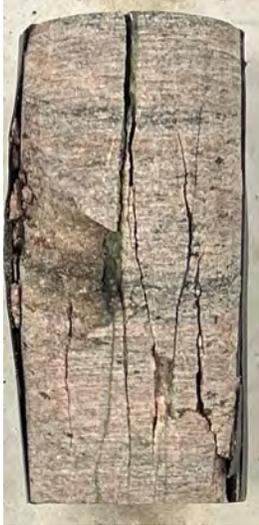
<b>Client</b>	Thurber Engineering Ltd.	<b>Project</b>	30351
<b>Sample</b>	BH23-15	<b>Depth</b>	17'2" - 17'10"
<u>Specimen parameters</u>		Prior to testing	After testing
Diameter (mm) <sup>a</sup>	49.61

Length (mm) <sup>a</sup>	103.77		
Bulk density $\rho$ (g/cm <sup>3</sup> )	2.416		
UCS (MPa)	98.6		
Lithology	Granite gneiss		
Failure description <sup>b</sup>	3, 5		
<sup>a</sup> Additional specimen measurement/details provided in accompanying summary spreadsheet. <sup>b</sup> Failure description: <sup>3</sup> Inclined shear fracture and axial splitting failure; <sup>5</sup> Failure partly along pre-existing structure;			
Remarks: Loading Rate: 0.05mm/min.			
<b>Performed by</b>	SD	<b>Date</b>	2023-11-08

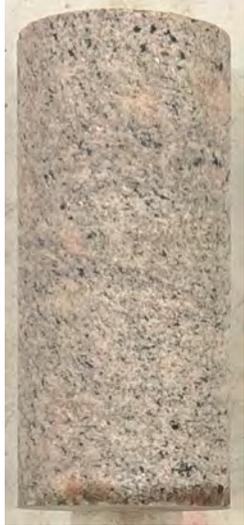
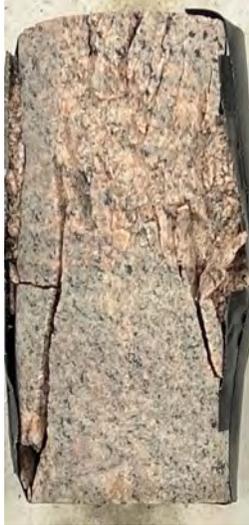
<b>Client</b>	Thurber Engineering Ltd.	<b>Project</b>	30351
<b>Sample</b>	BH23-16	<b>Depth</b>	7'3" - 7'11"
<u>Specimen parameters</u>		Prior to testing	After testing
Diameter (mm) <sup>a</sup>	47.11

Length (mm) <sup>a</sup>	103.57		
Bulk density $\rho$ (g/cm <sup>3</sup> )	2.648		
UCS (MPa)	147.0		
Lithology	Granite gneiss		
Failure description <sup>b</sup>	3, 2		
<sup>a</sup> Additional specimen measurement/details provided in accompanying summary spreadsheet. <sup>b</sup> Failure description: <sup>3</sup> Inclined shear fracture and axial splitting failure; <sup>2</sup> Partial hourglass failure;			
Remarks: Loading Rate: 0.05mm/min.			
<b>Performed by</b>	SD	<b>Date</b>	2023-11-08

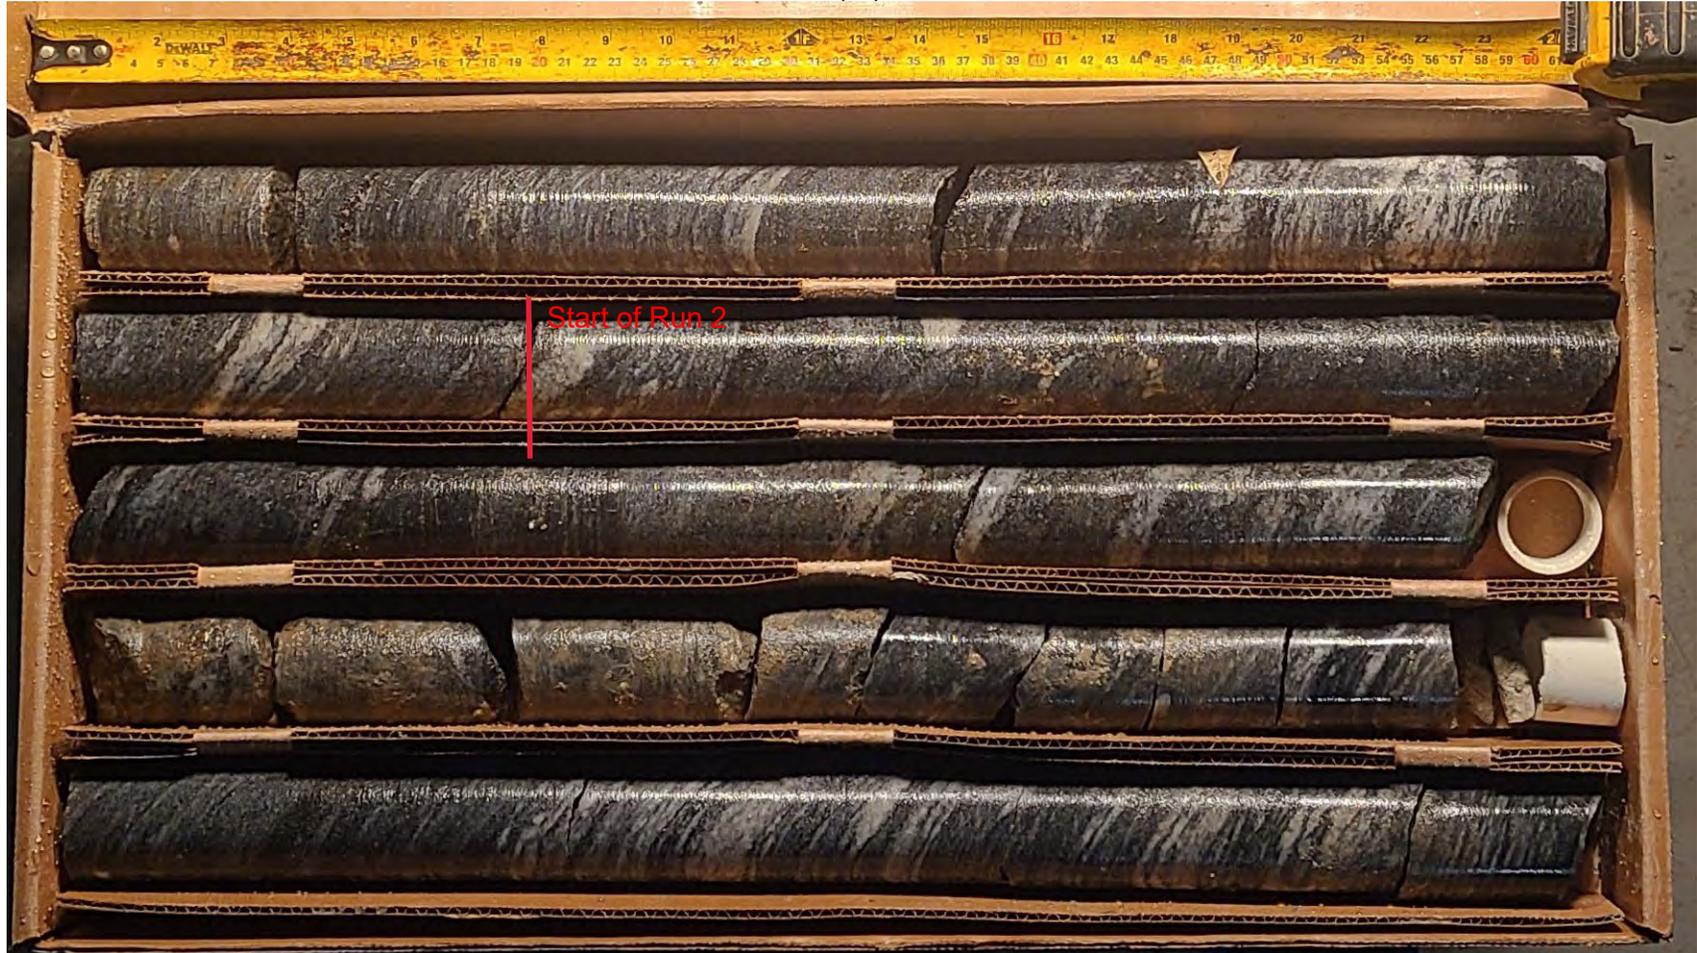
**HIGHWAY 69 AND REHABILITATION OF SHAWANAGA RIVER BRIDGE**  
Photographs of Rock Core

**Borehole 23-09 – Runs 1, 2, 3 and 4 – 2.01 – 5.05 m**

Top of Run 1

Run 1 Continues

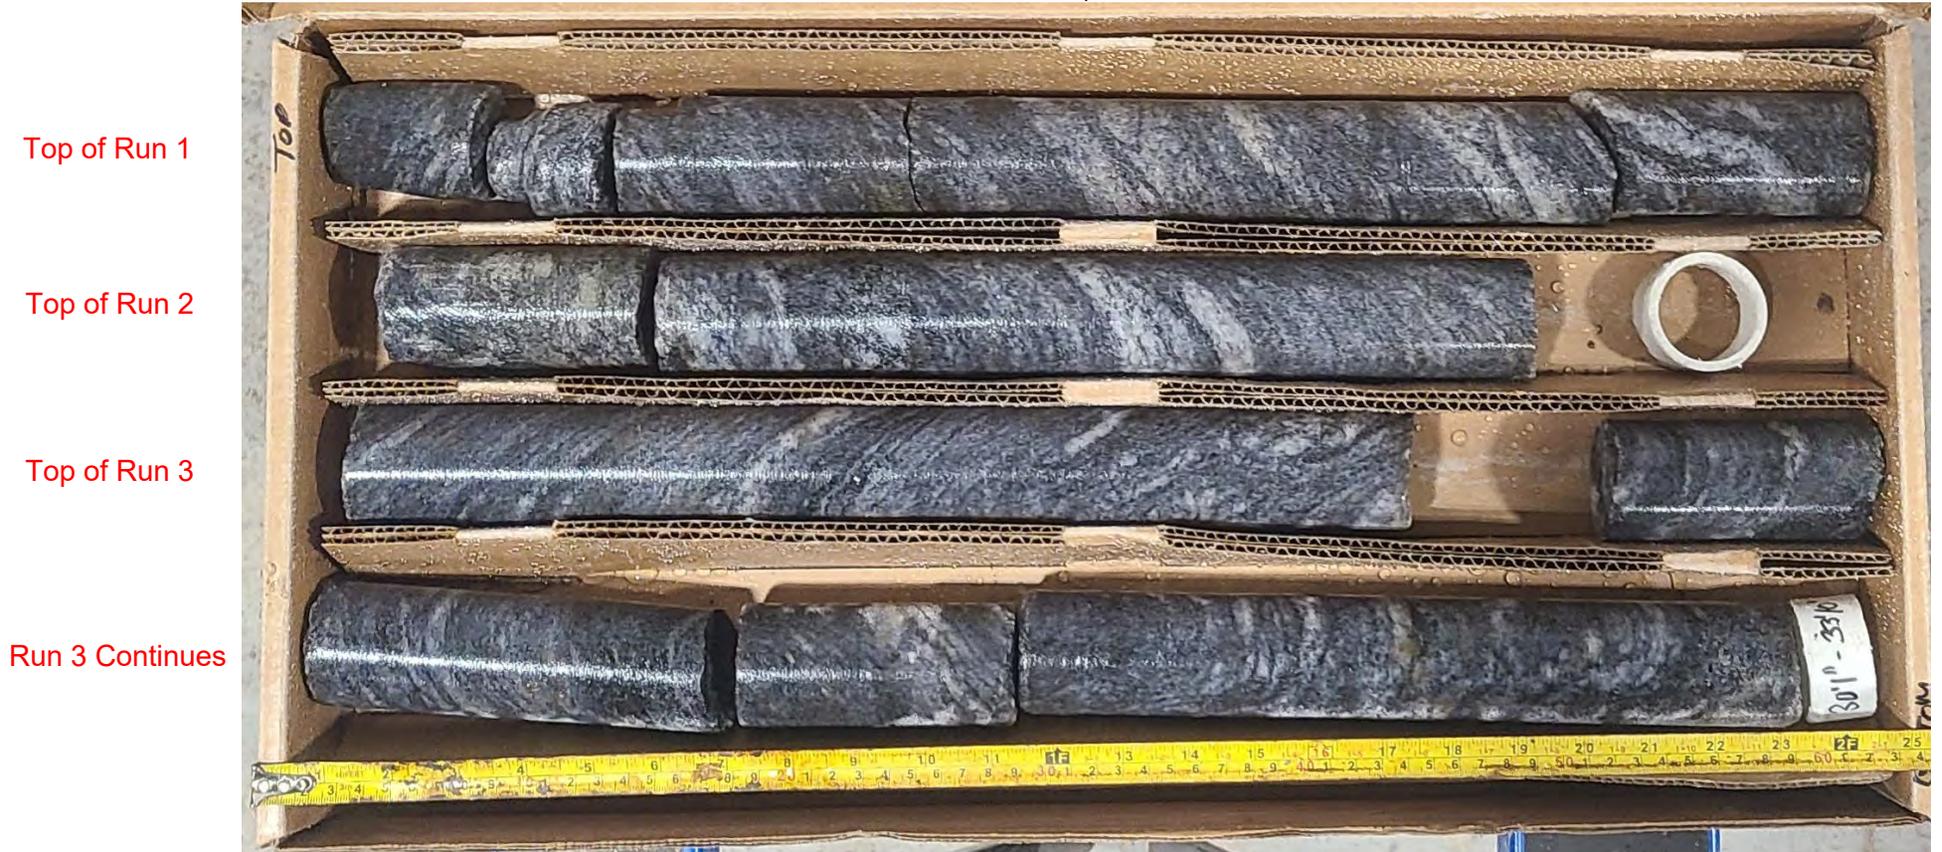
**HIGHWAY 69 AND REHABILITATION OF SHAWANAGA RIVER BRIDGE**  
Photographs of Rock Core

**Borehole 23-10 – Runs 1, 2 and 3 – 8.13 – 10.31 m**

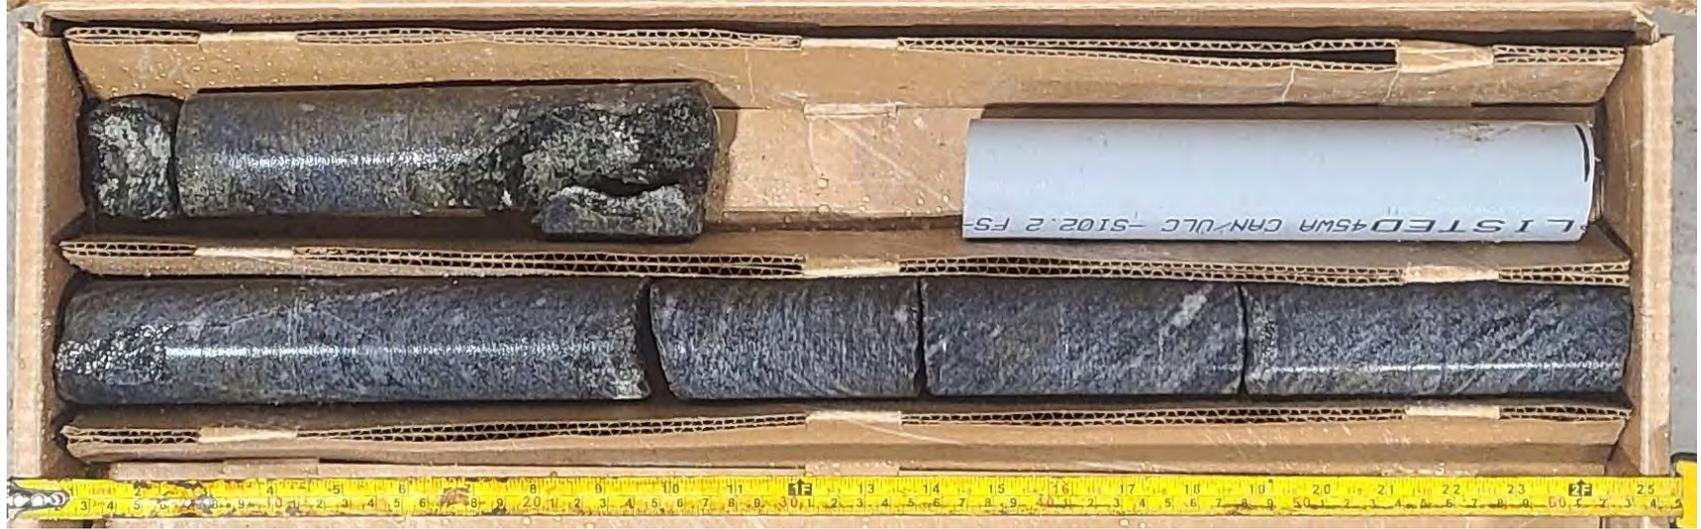
**HIGHWAY 69 AND REHABILITATION OF SHAWANAGA RIVER BRIDGE**  
Photographs of Rock Core

**Borehole 23-10 – Run 4 – 10.31 – 11.15 m**

Top of Run 4

Run 4 Continues

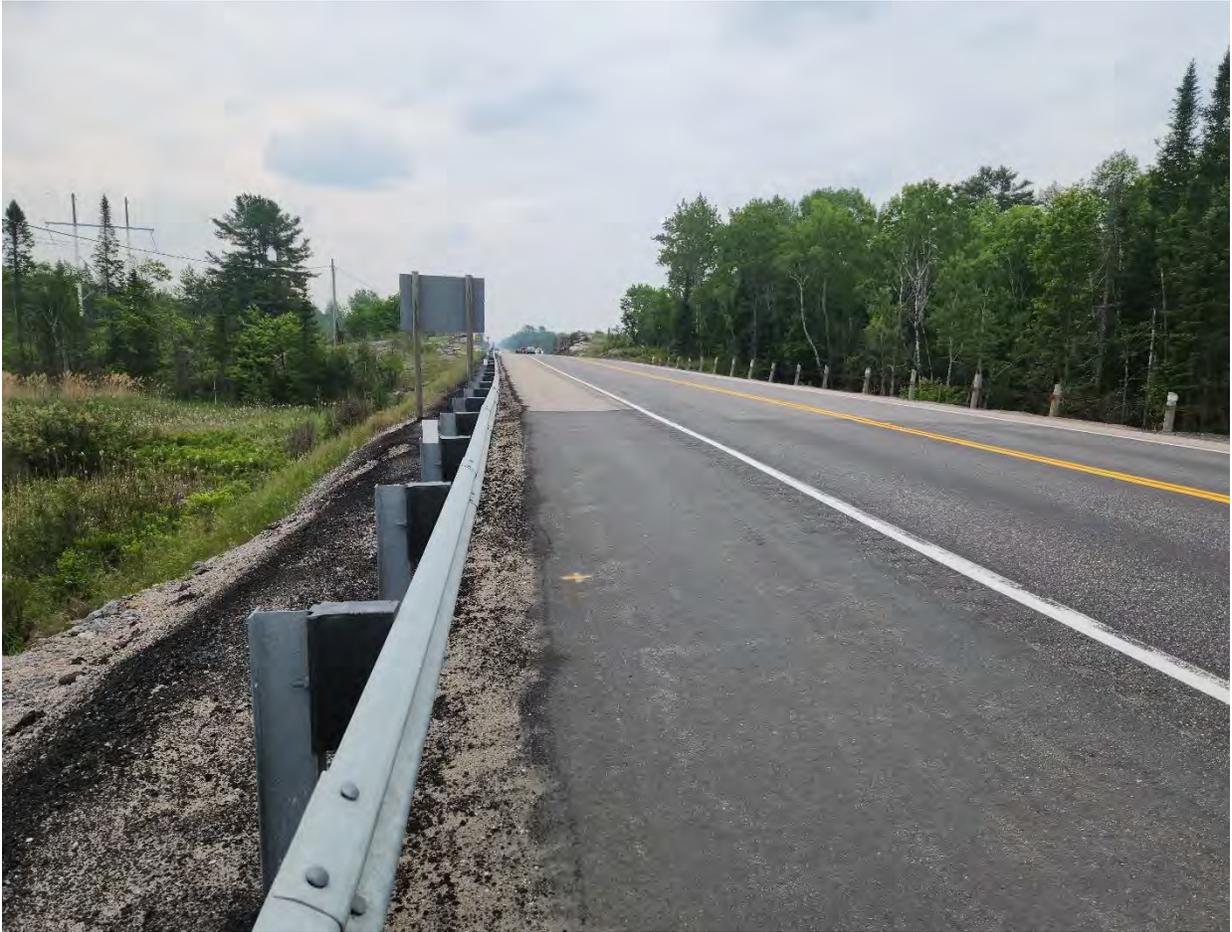
**Photograph 1: East Shoulder of Highway Over Culvert 38 Looking South**

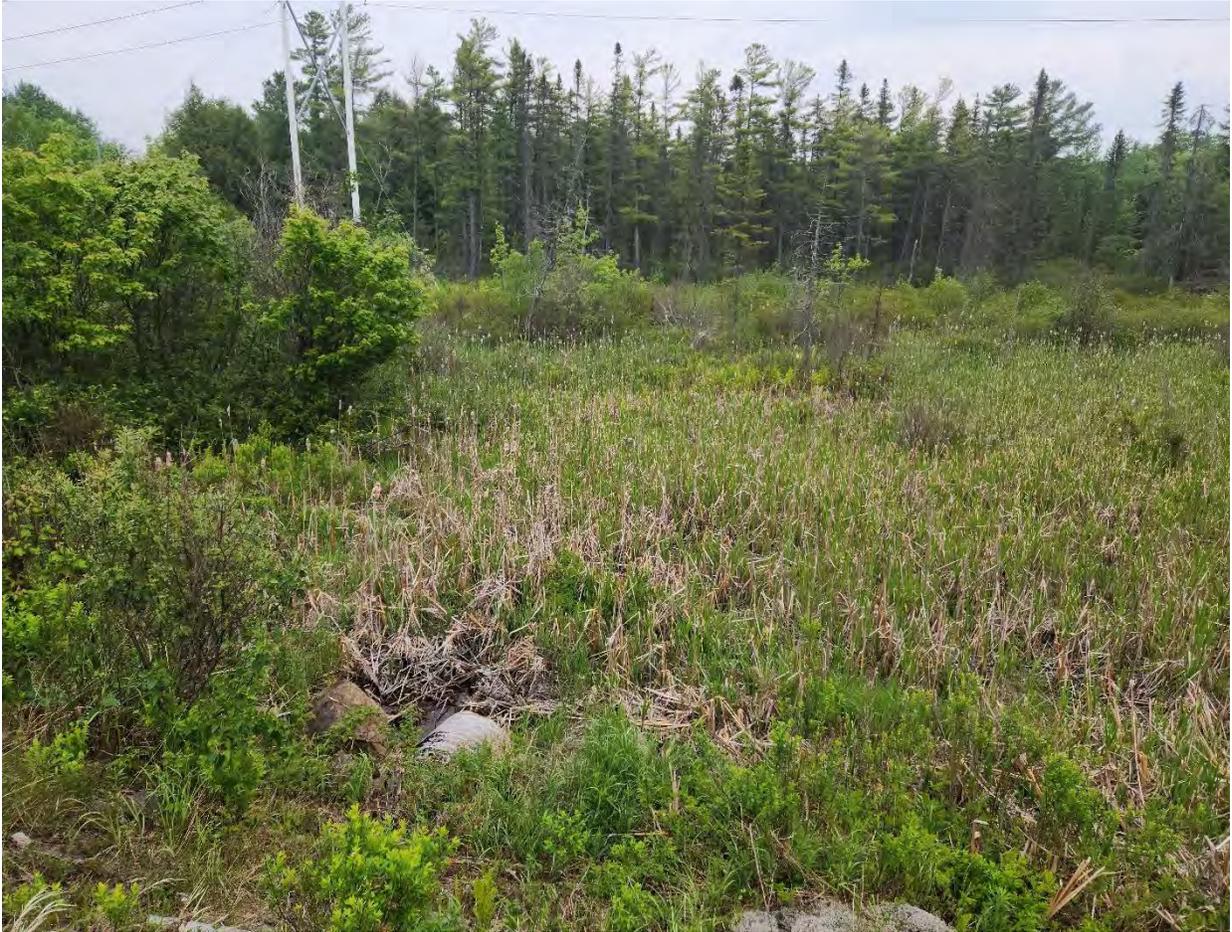
**Photograph 2: Culvert Outlet, Looking East**

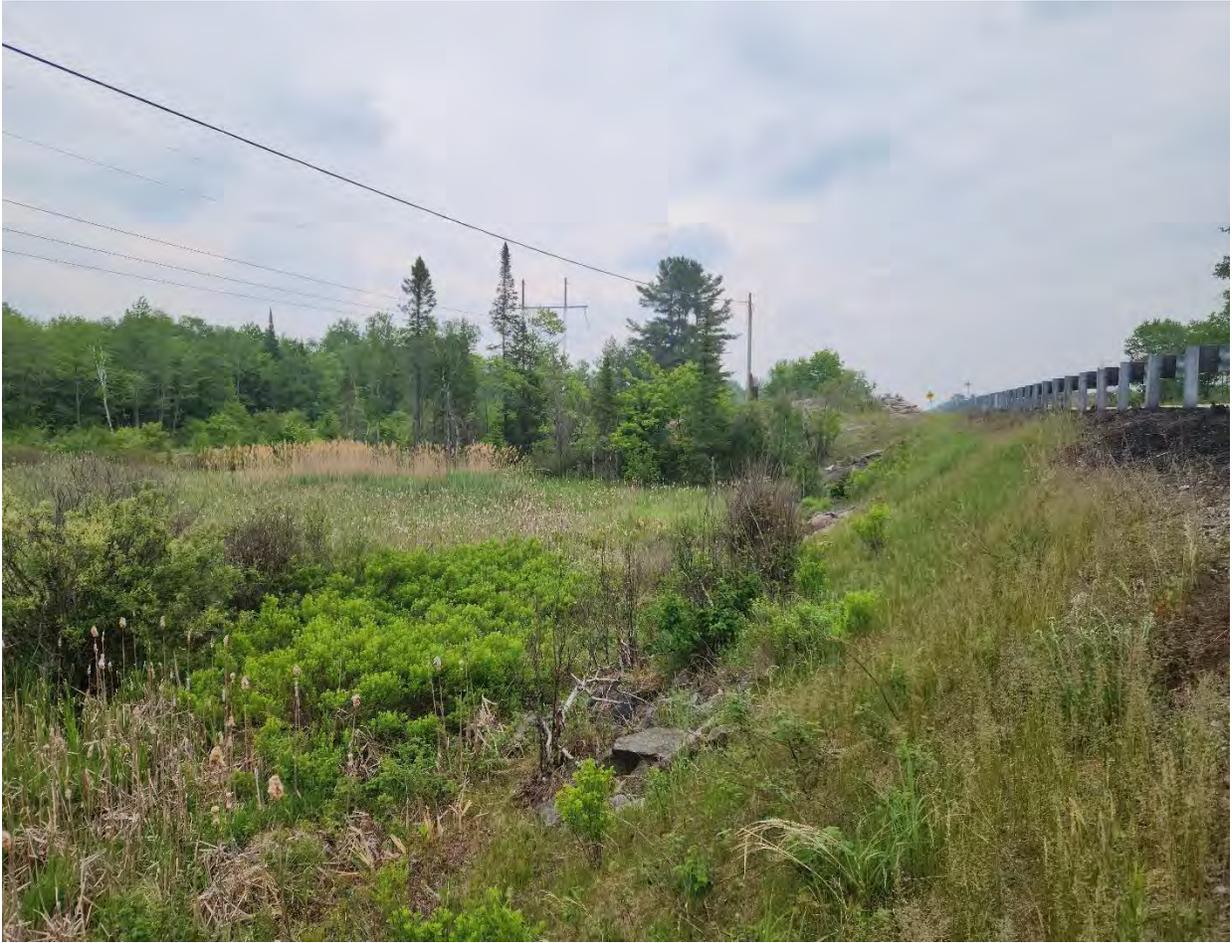
**Photograph 3: Culvert Outlet, East Embankment Slope Looking South**

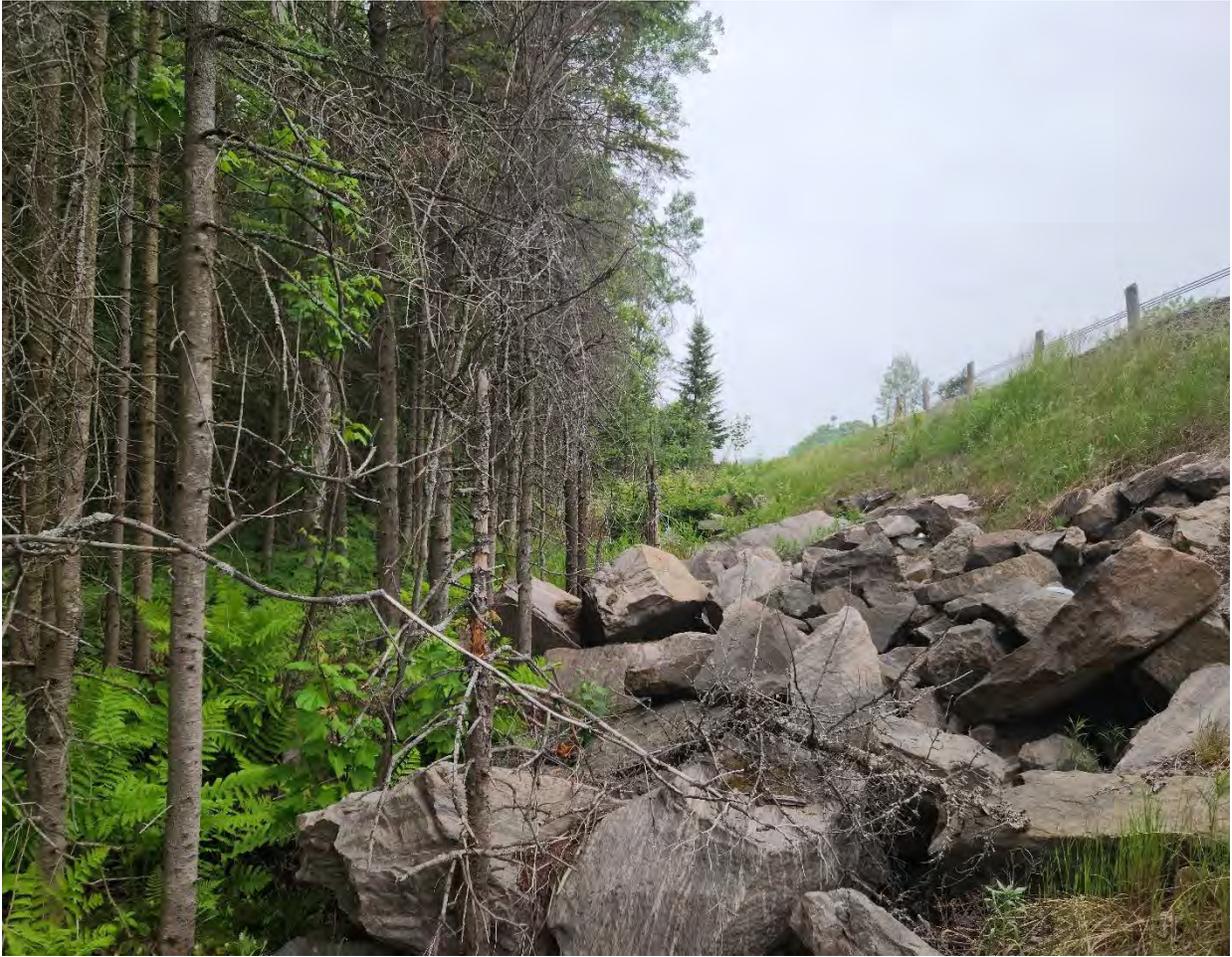
**Photograph 4: Culvert Inlet, West Embankment Looking North**

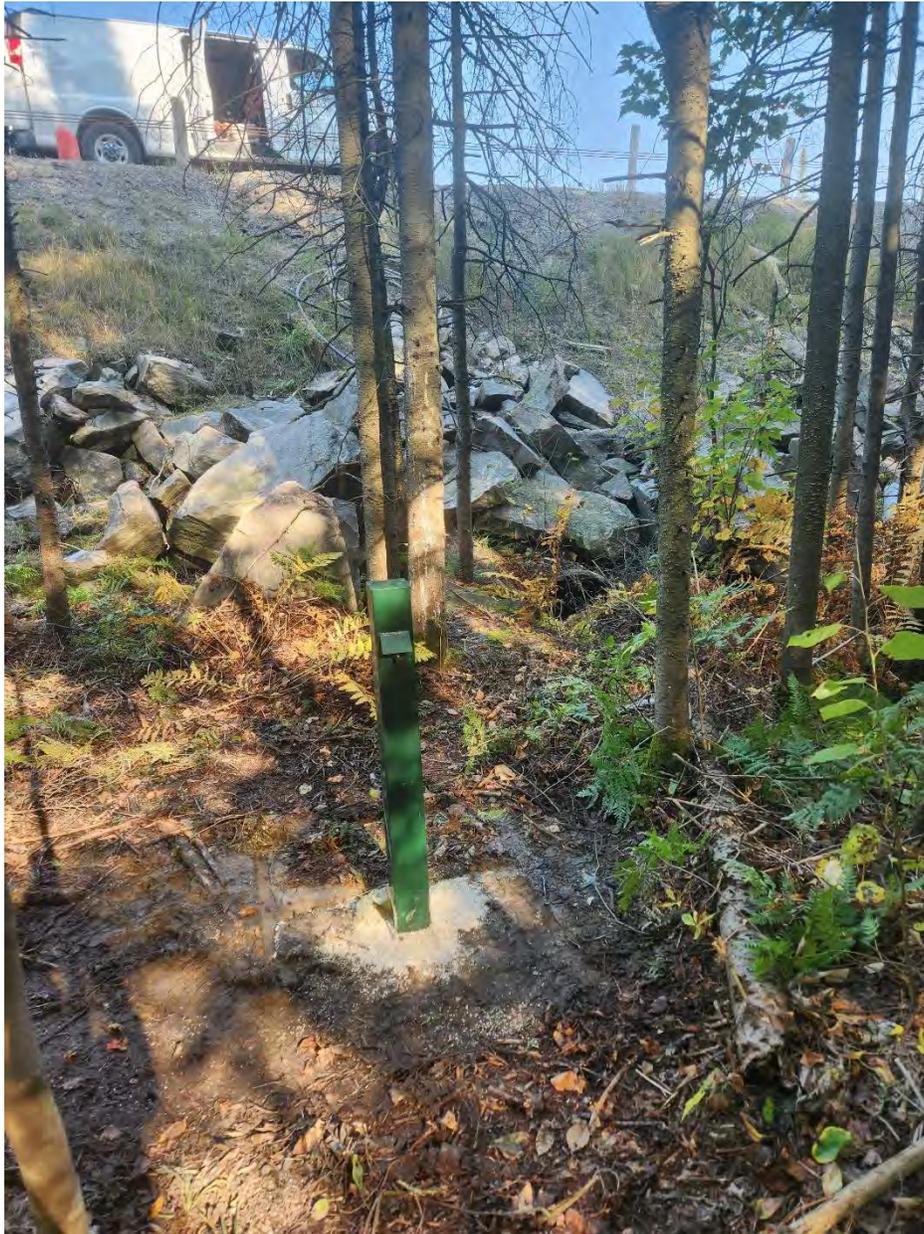
**Photograph 5: Borehole 23-09 After Completion**

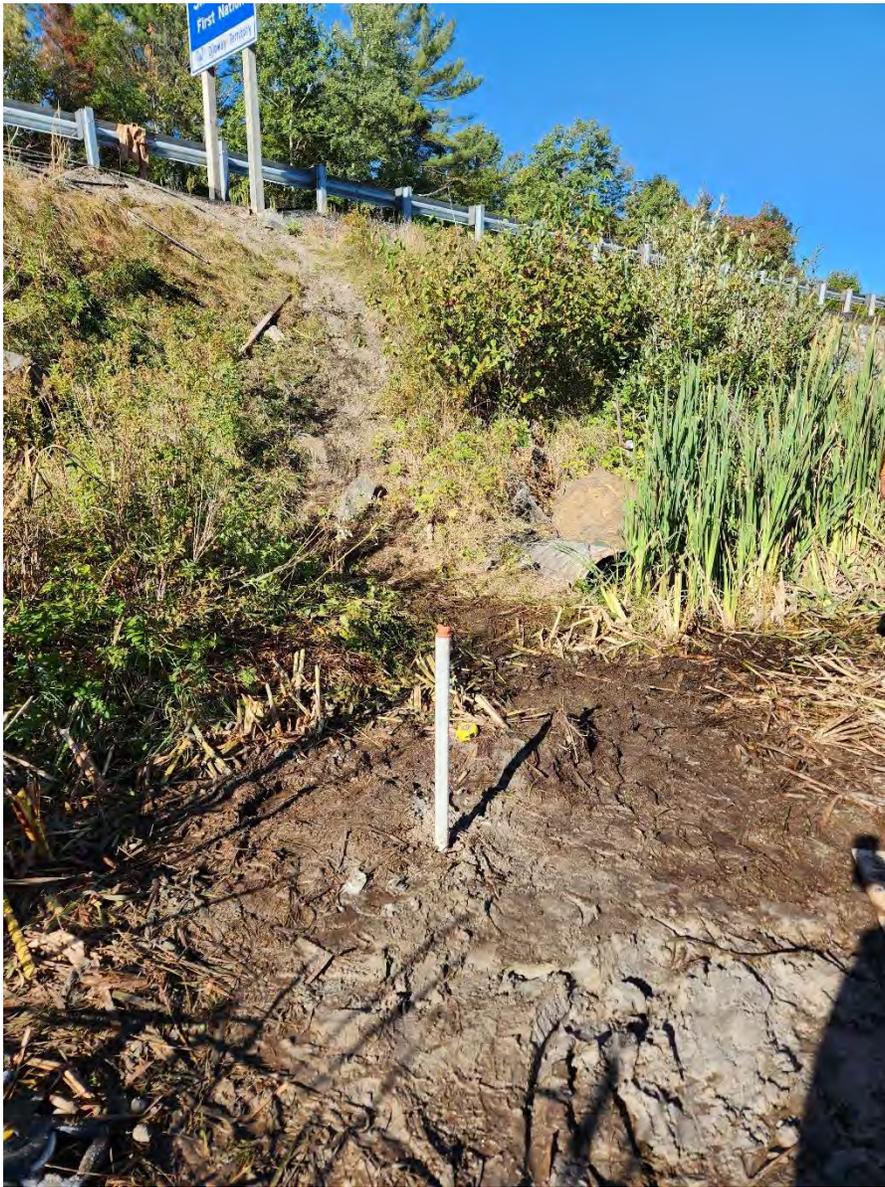
**Photograph 6: Borehole 23-10 After Completion**
