THURBER ENGINEERING LTD.

FOUNDATION INVESTIGATION AND DESIGN REPORT

Culvert 24, Highway 69 – 5.8 km South of Highway 7182

Rehabilitation of Highway 69 and Shawanaga River Bridge

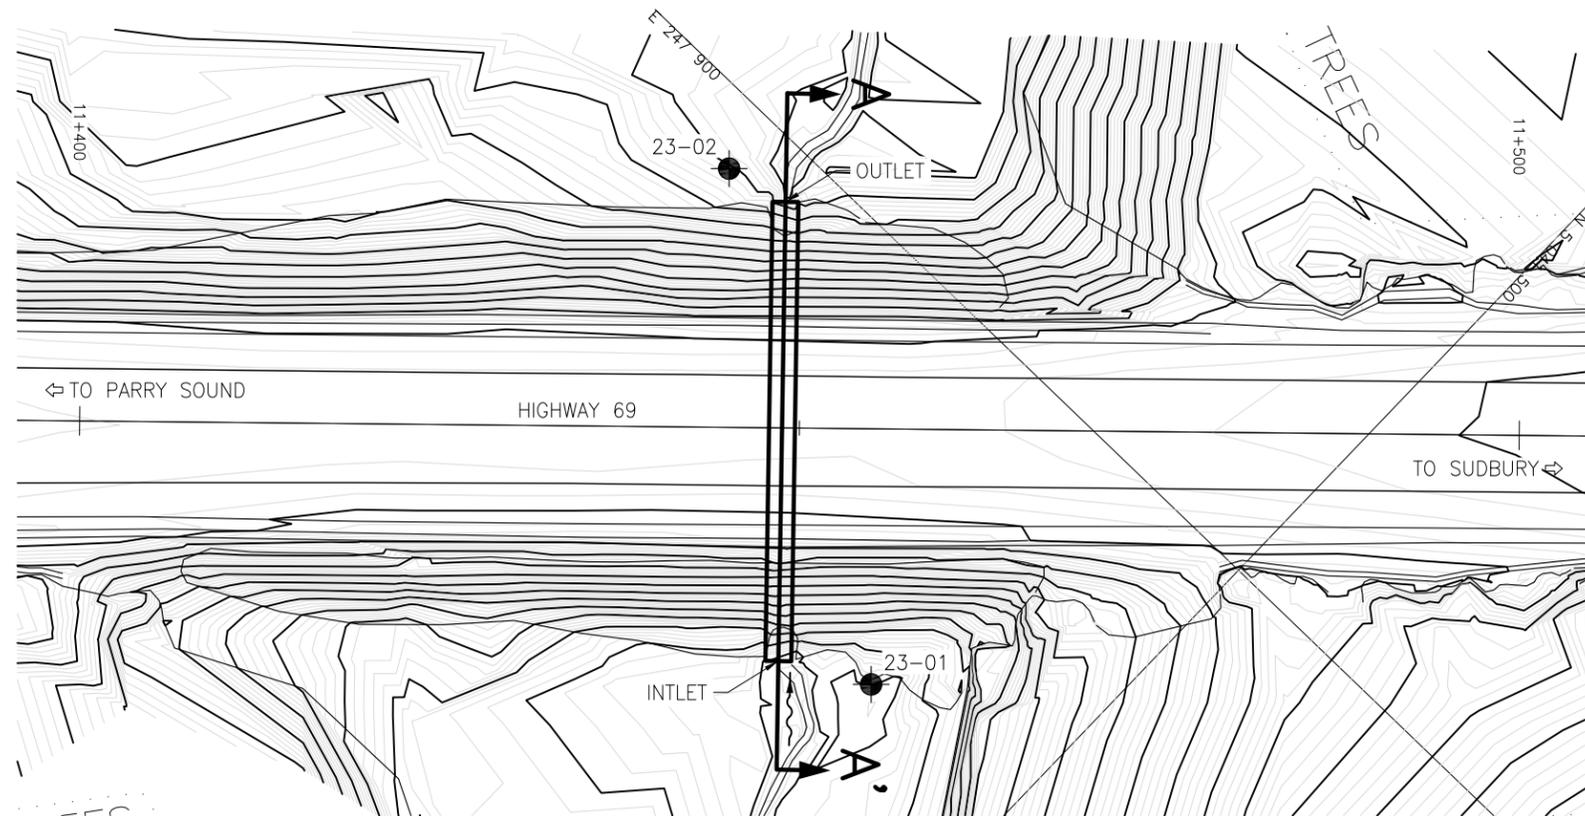
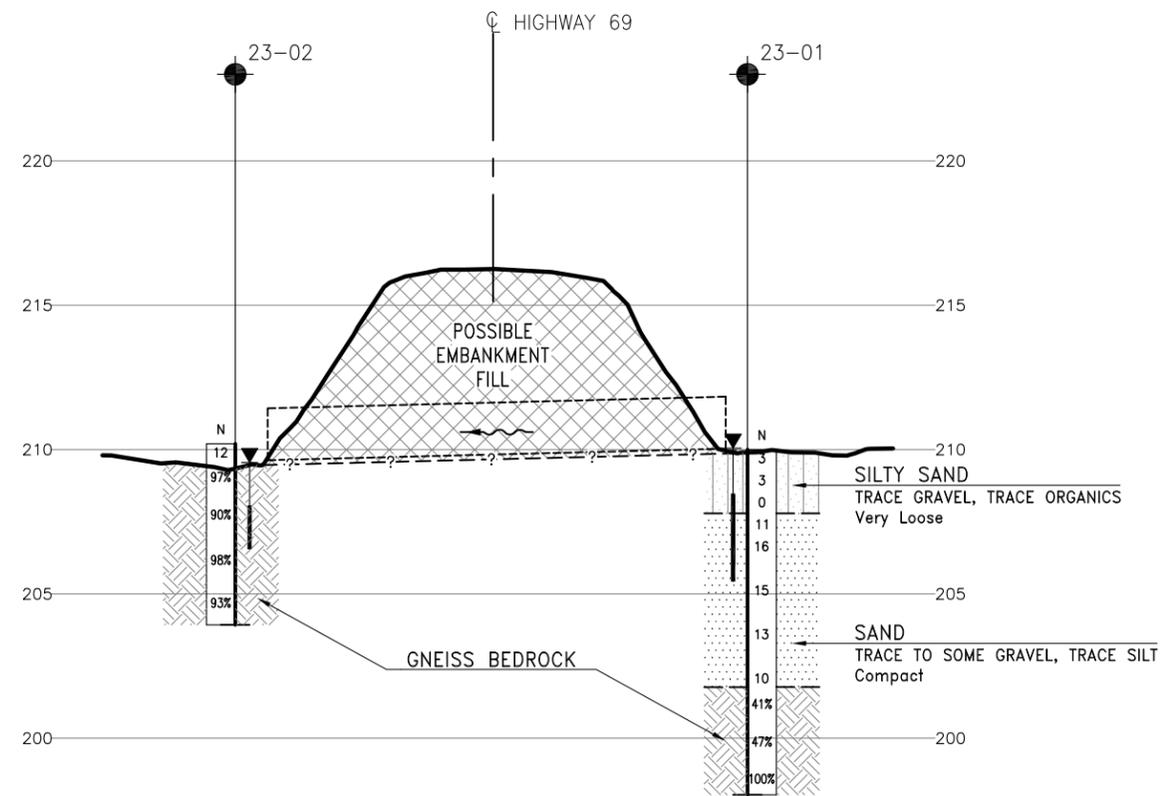
| HIGHWAY 69 SHAWANAGA RIVER BRIDGE CULVERT 24 BOREHOLE LOCATIONS AND SOIL STRATA | |

PLAN
SCALE 1:500

SECTION ALONG A-A'
H 1:500
V 1:250

Details of the encountered soil stratigraphy are presented on the Record of Borehole sheets included in Appendix B and on the Borehole Locations and Soil Strata drawing in Appendix A. A general description of the stratigraphy, based on the conditions encountered in the boreholes, is given in the following paragraphs. However, the factual data presented in the Record of Borehole sheets governs any interpretation of the site conditions. It must be recognized that soil conditions may vary between and beyond the borehole locations.

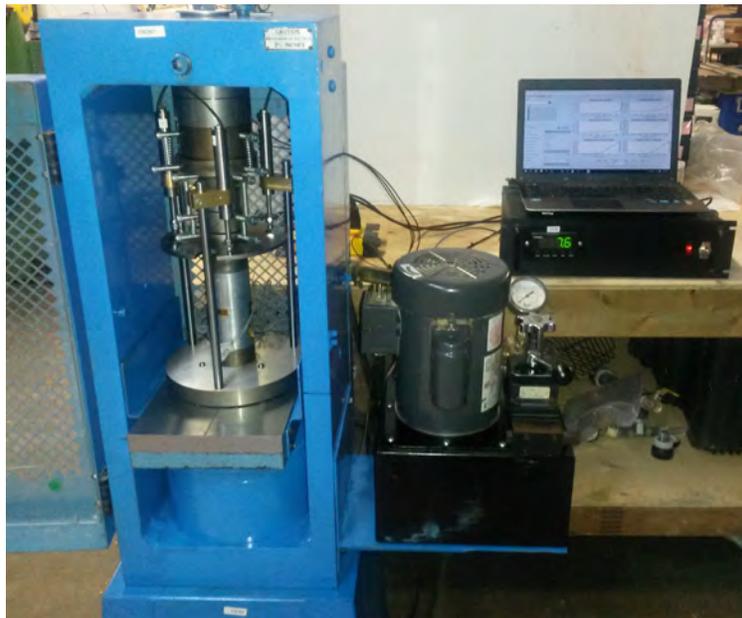
Figure 1: Forney loading frame setup for UCS testing.

This section summarizes the results of uniaxial compressive strength (UCS) testing. The testing was performed in Geomechanica's rock testing laboratory using a 150 ton (1.3 MN) Forney loading frame equipped with pressure-compensated control valve to maintain an axial displacement rate of approximately 0.05 mm/min (Figure 1). The preparation and testing procedure for each specimen included the following:

Using a precision V-block mounted on the magnetic chuck of the surface grinder, test specimens met the end flatness, end parallelism, and perpendicularity criteria set out in ASTM D4543-19. The side straightness criteria, as checked with a feeler gauge, and the minimum length:diameter criteria were met for all specimens unless noted otherwise in Table 1. Testing of the specimens followed ASTM D7012-14 Method C.

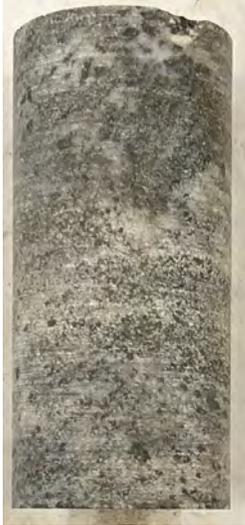
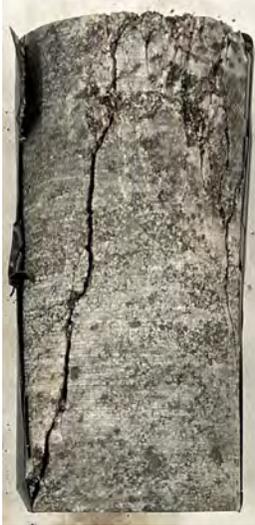
| Sample | BH23-01 | Depth | 32' 10" - 33' 10" |

| Diameter (mm) ^a | 60.80 | | |
| Length (mm) ^a | 129.90 | | |
| Bulk density ρ (g/cm ³) | 2.769 | | |

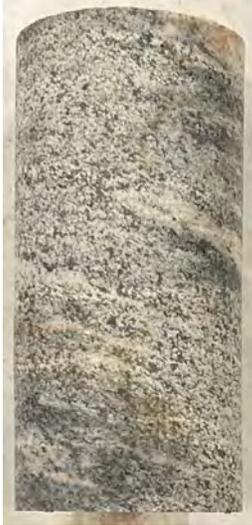
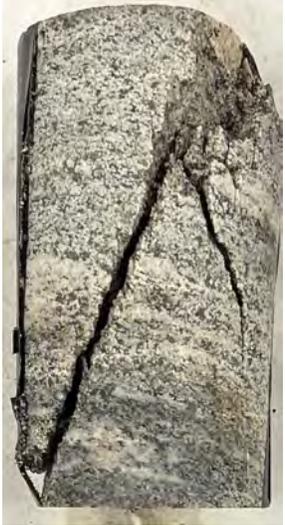
| Sample | BH23-02 | Depth | 2'3" - 3'2" |

| Diameter (mm) ^a | 62.92 | | |
| Length (mm) ^a | 129.18 | | |
| Bulk density ρ (g/cm ³) | 2.770 | | |

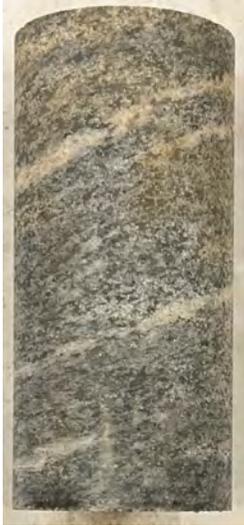
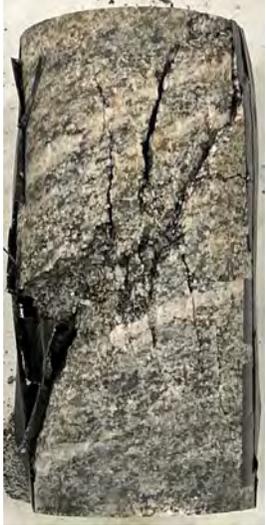
| Sample | BH23-03 | Depth | 3'10" - 4'8" |

| Diameter (mm) ^a | 60.75 | | |
| Length (mm) ^a | 129.54 | | |
| Bulk density ρ (g/cm ³) | 2.792 | | |

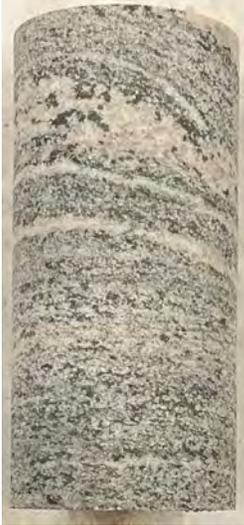
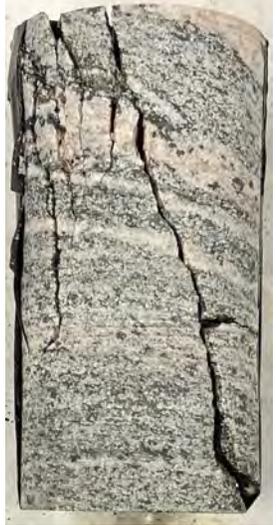
| Sample | BH23-04 | Depth | 8'0" - 8'10" |

| Diameter (mm) ^a | 61.85 | | |
| Length (mm) ^a | 129.19 | | |
| Bulk density ρ (g/cm ³) | 2.753 | | |

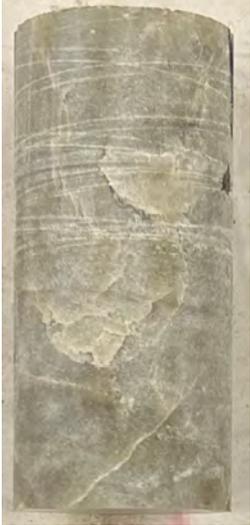
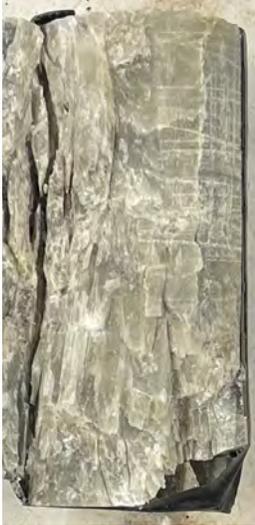
| Sample | BH23-05 | Depth | 21'0" - 22'11" |

| Diameter (mm) ^a | 47.52 | | |
| Length (mm) ^a | 102.95 | | |
| Bulk density ρ (g/cm ³) | 2.646 | | |

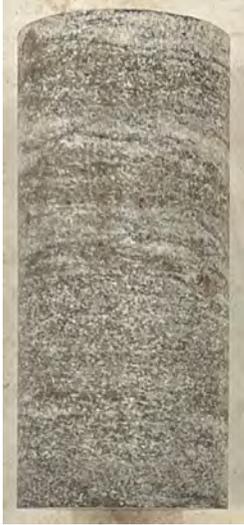
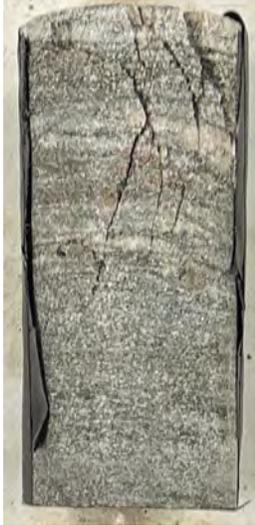
| Sample | BH23-07 | Depth | 13'5" - 14'4" |

| Diameter (mm) ^a | 46.74 | | |
| Length (mm) ^a | 103.86 | | |
| Bulk density ρ (g/cm ³) | 2.746 | | |

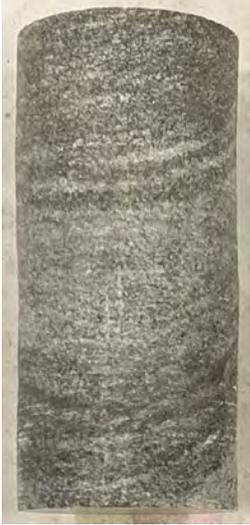
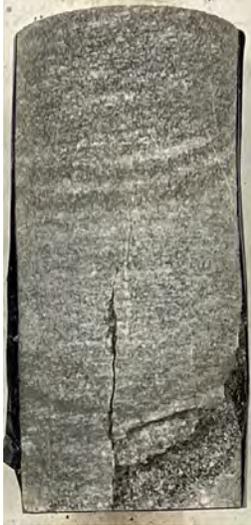
| | Specimen parameters | | Diameter (mm) ^a | 48.54 | Length (mm) ^a | 103.59 | Bulk density ρ (g/cm ³) | 2.753 | UCS (MPa) | 113.8 | Lithology | Granite gneiss | Failure description ^b | 3, 5 | <p>Prior to testing</p>

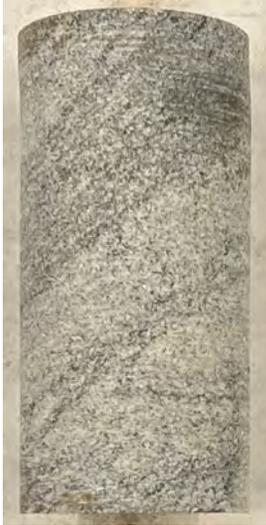
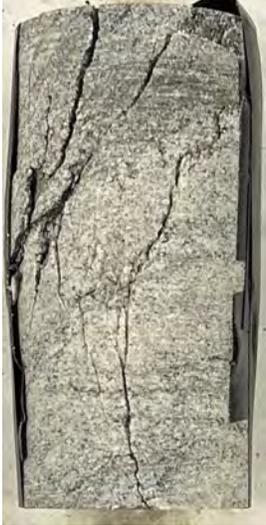
| Sample | BH23-10 | Depth | 27'6" - 28'5" |

| Diameter (mm) ^a | 50.08 | | |
| Length (mm) ^a | 103.01 | | |
| Bulk density ρ (g/cm ³) | 2.661 | | |

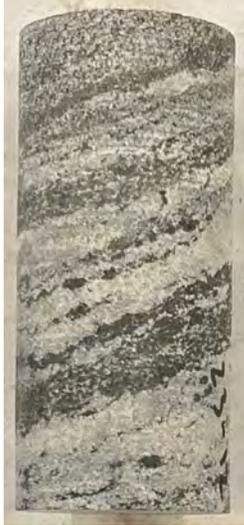
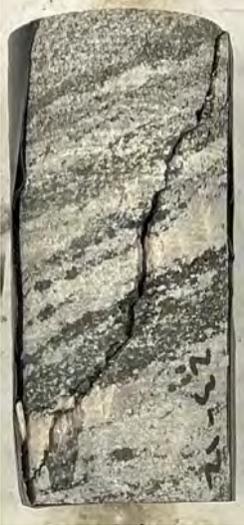
| Sample | BH23-12 | Depth | 21'5" - 22'4" |

| Diameter (mm) ^a | 46.99 | | |
| Length (mm) ^a | 103.61 | | |
| Bulk density ρ (g/cm ³) | 2.775 | | |

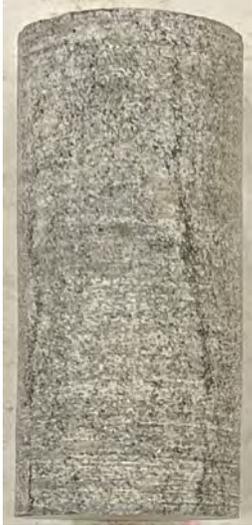
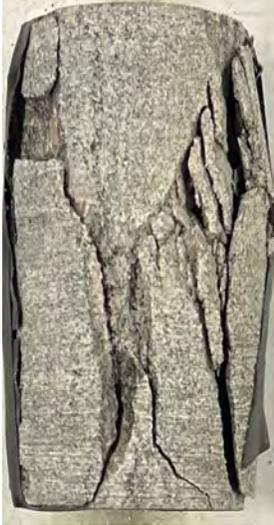
| Sample | BH23-13 | Depth | 6'6" - 7'2" |

| Diameter (mm) ^a | 48.89 | | |
| Length (mm) ^a | 103.89 | | |
| Bulk density ρ (g/cm ³) | 2.674 | | |

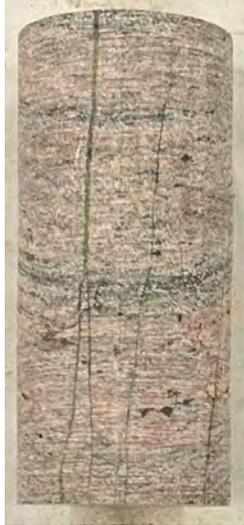
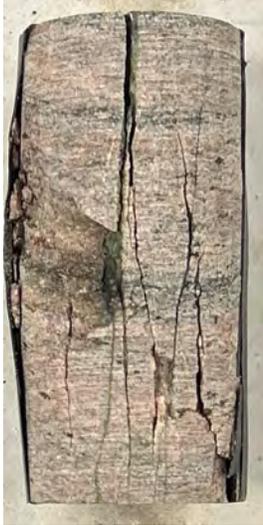
| Sample | BH23-15 | Depth | 17'2" - 17'10" |

| Diameter (mm) ^a | 49.61 | | |
| Length (mm) ^a | 103.77 | | |
| Bulk density ρ (g/cm ³) | 2.416 | | |

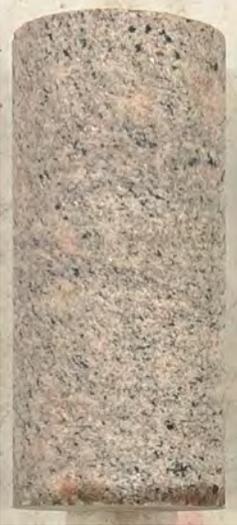
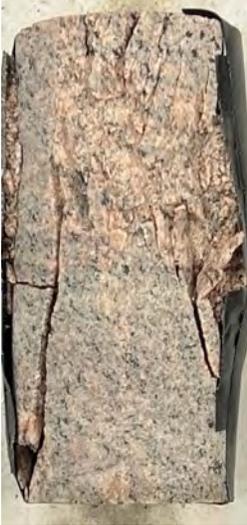
| Sample | BH23-16 | Depth | 7'3" - 7'11" |

| Diameter (mm) ^a | 47.11 | | |
| Length (mm) ^a | 103.57 | | |
| Bulk density ρ (g/cm ³) | 2.648 | | |

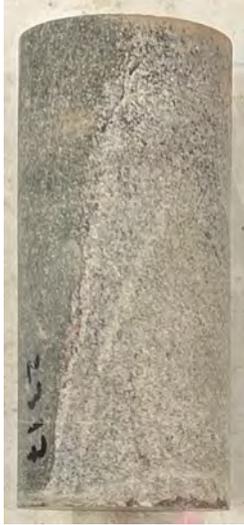
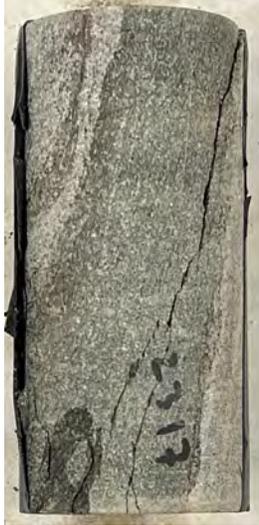
| Sample | BH23-17 | Depth | 12'6" - 13'5" |

| Diameter (mm) ^a | 46.83 | | |
| Length (mm) ^a | 102.54 | | |
| Bulk density ρ (g/cm ³) | 2.751 | | |

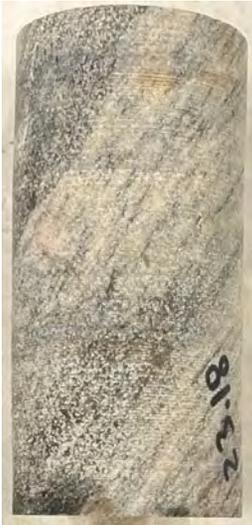
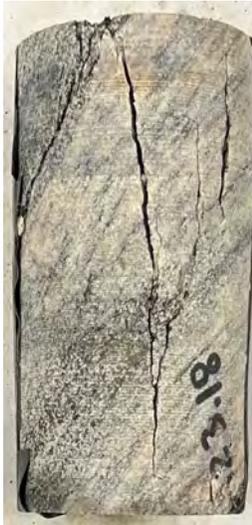
| Sample | BH23-18 | Depth | 28'7" - 29'7" |

| Diameter (mm) ^a | 62.81 | | |
| Length (mm) ^a | 129.38 | | |
| Bulk density ρ (g/cm ³) | 2.707 | | |

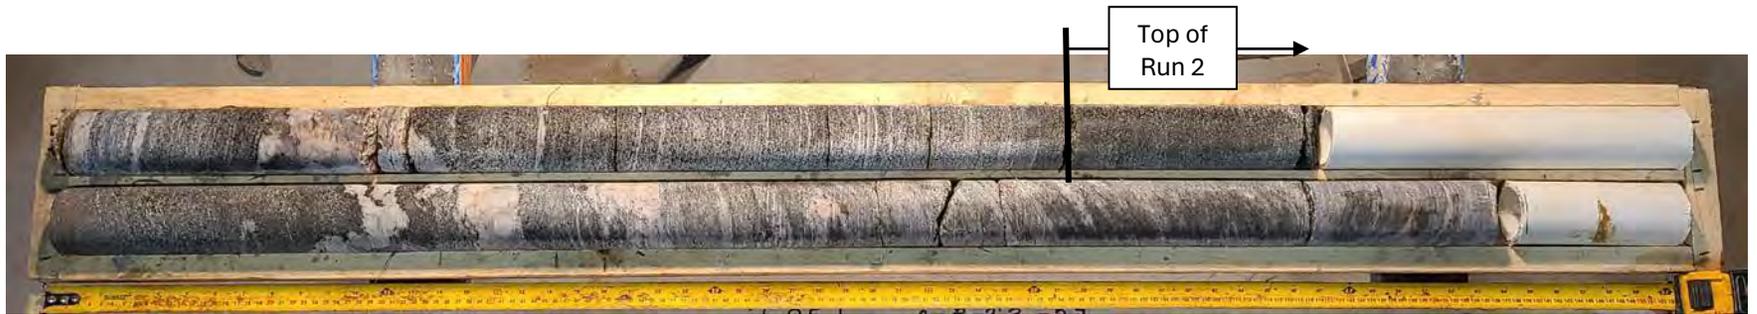
Borehole 23-02 – Runs 1 and 2 – 0.69 to 3.28 m

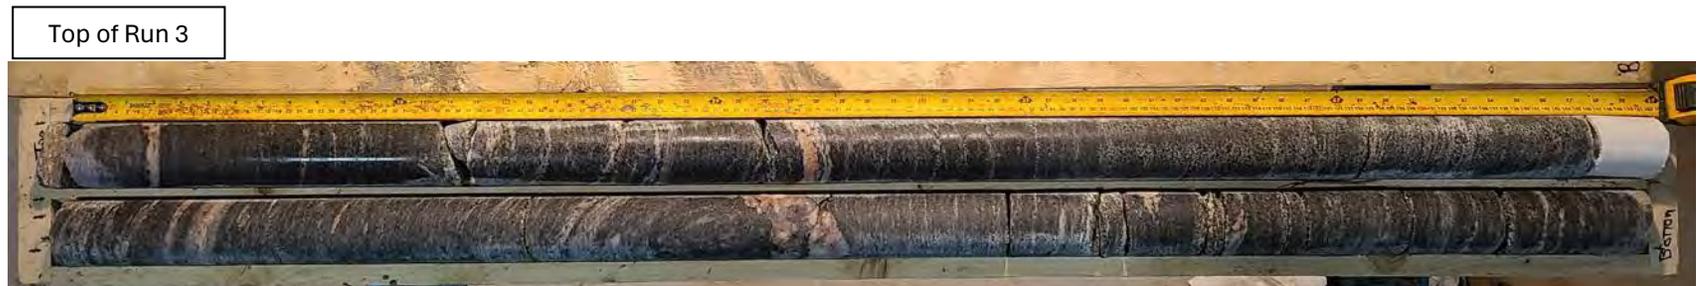
Borehole 23-02 – Runs 3 and 4 – 3.28 to 6.27 m

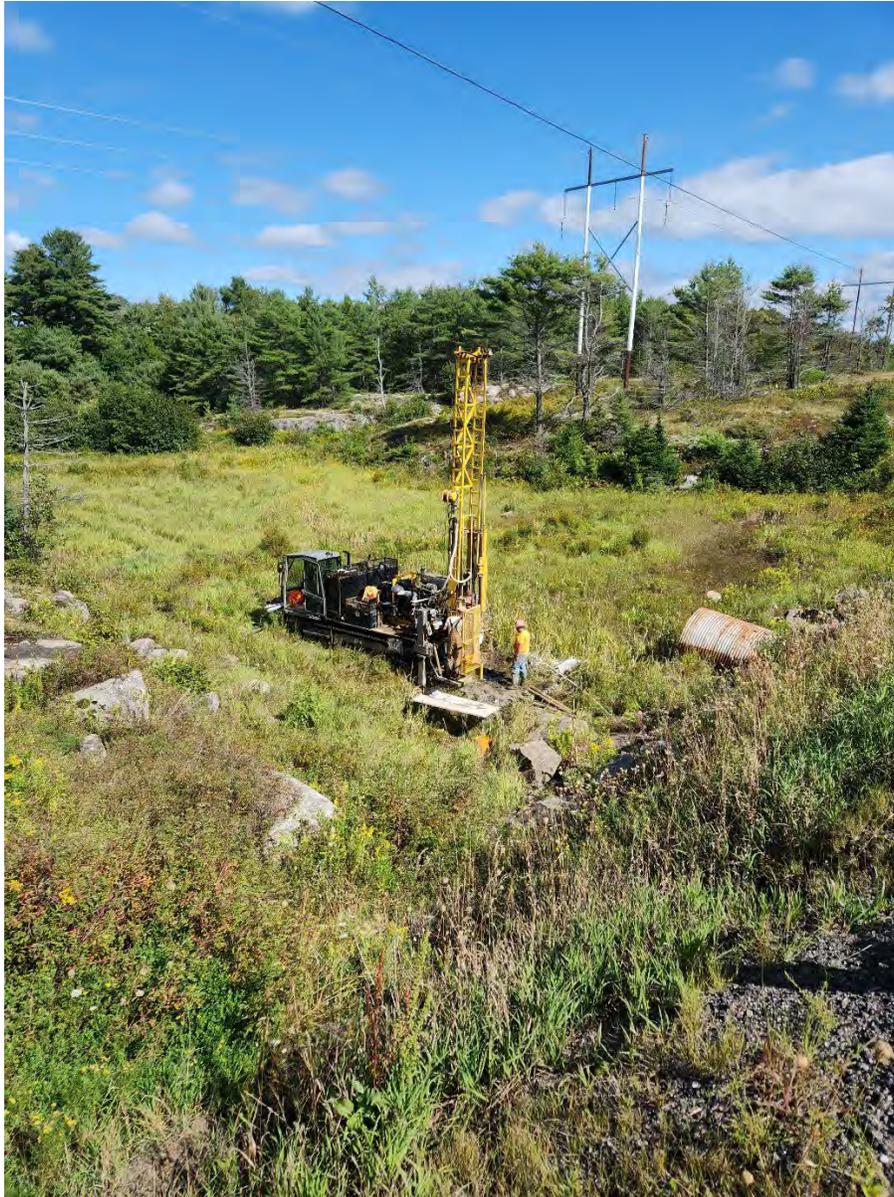
Photograph 1: Drilling Borehole 23-01 Looking Southeast

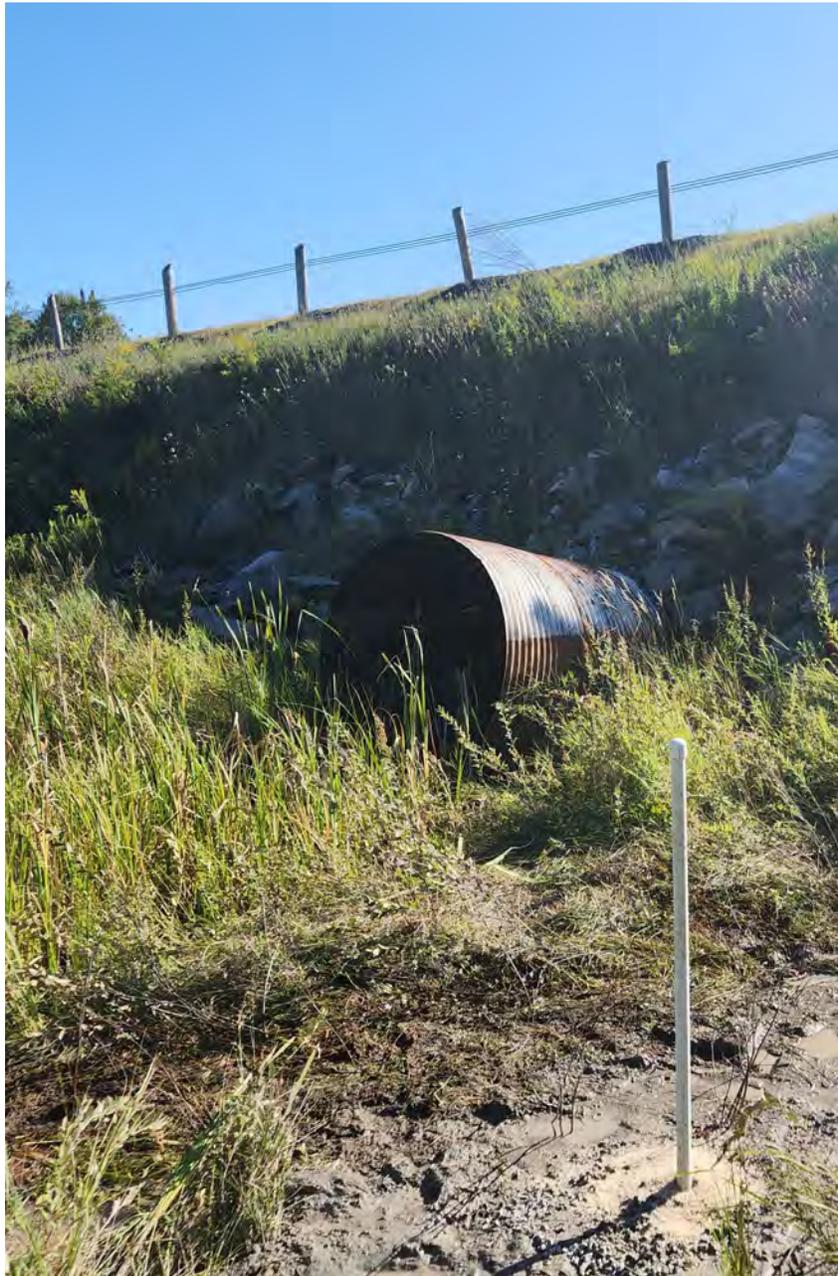
Photograph 2: Borehole 23-01 after piezometer installation, looking southwest towards Culvert Inlet

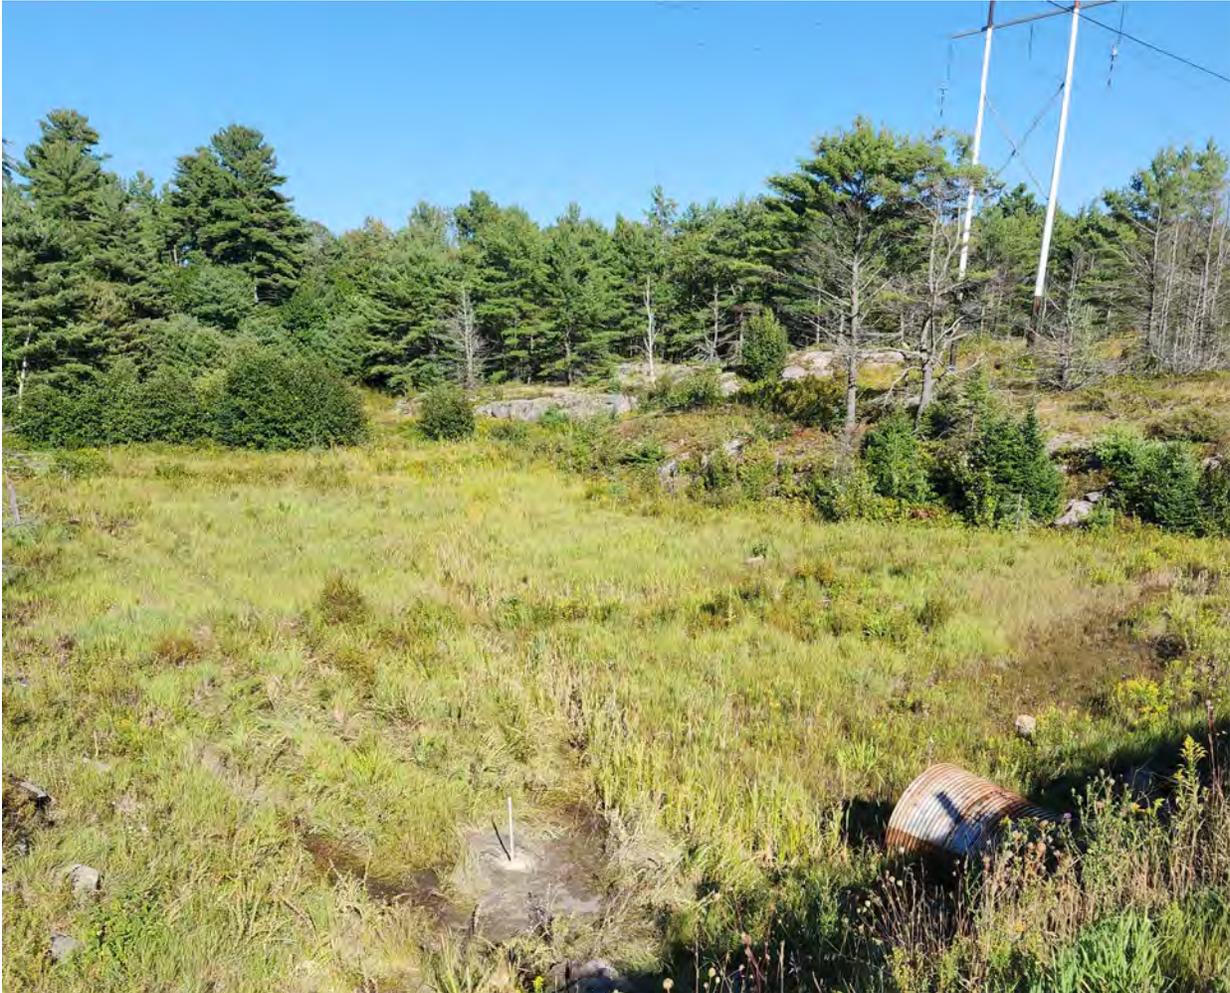
Photograph 3: Culvert Inlet with Piezometer at Borehole 23-01

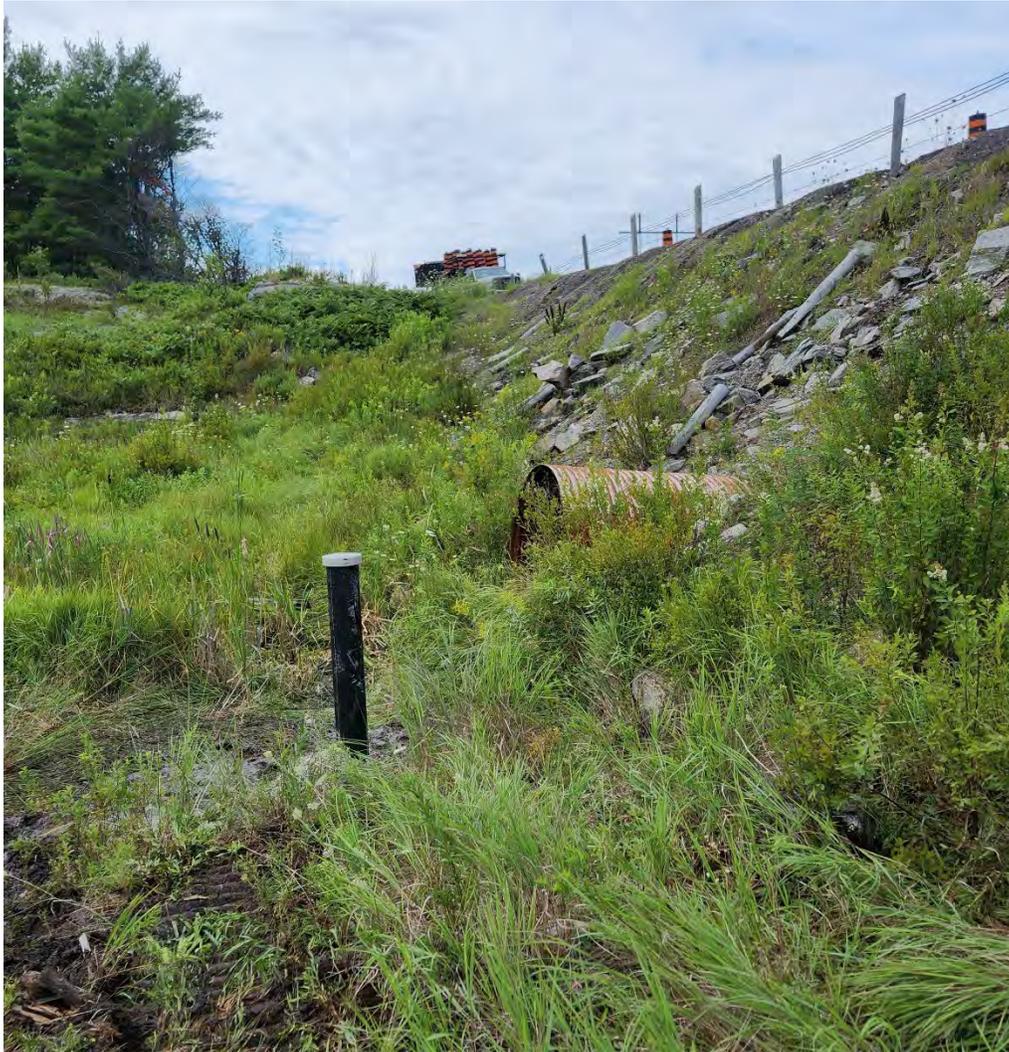
Photograph 5: Borehole 23-02 after well installation, looking north towards Culvert outlet
