e. m. peto associates ltd.

Re: Robbins Bridge
Welland River - Ontario

We submit six copies of our report on the stability problems arising on the north approach of this bridge in August 1965, and authorized by purchase order No. 603.

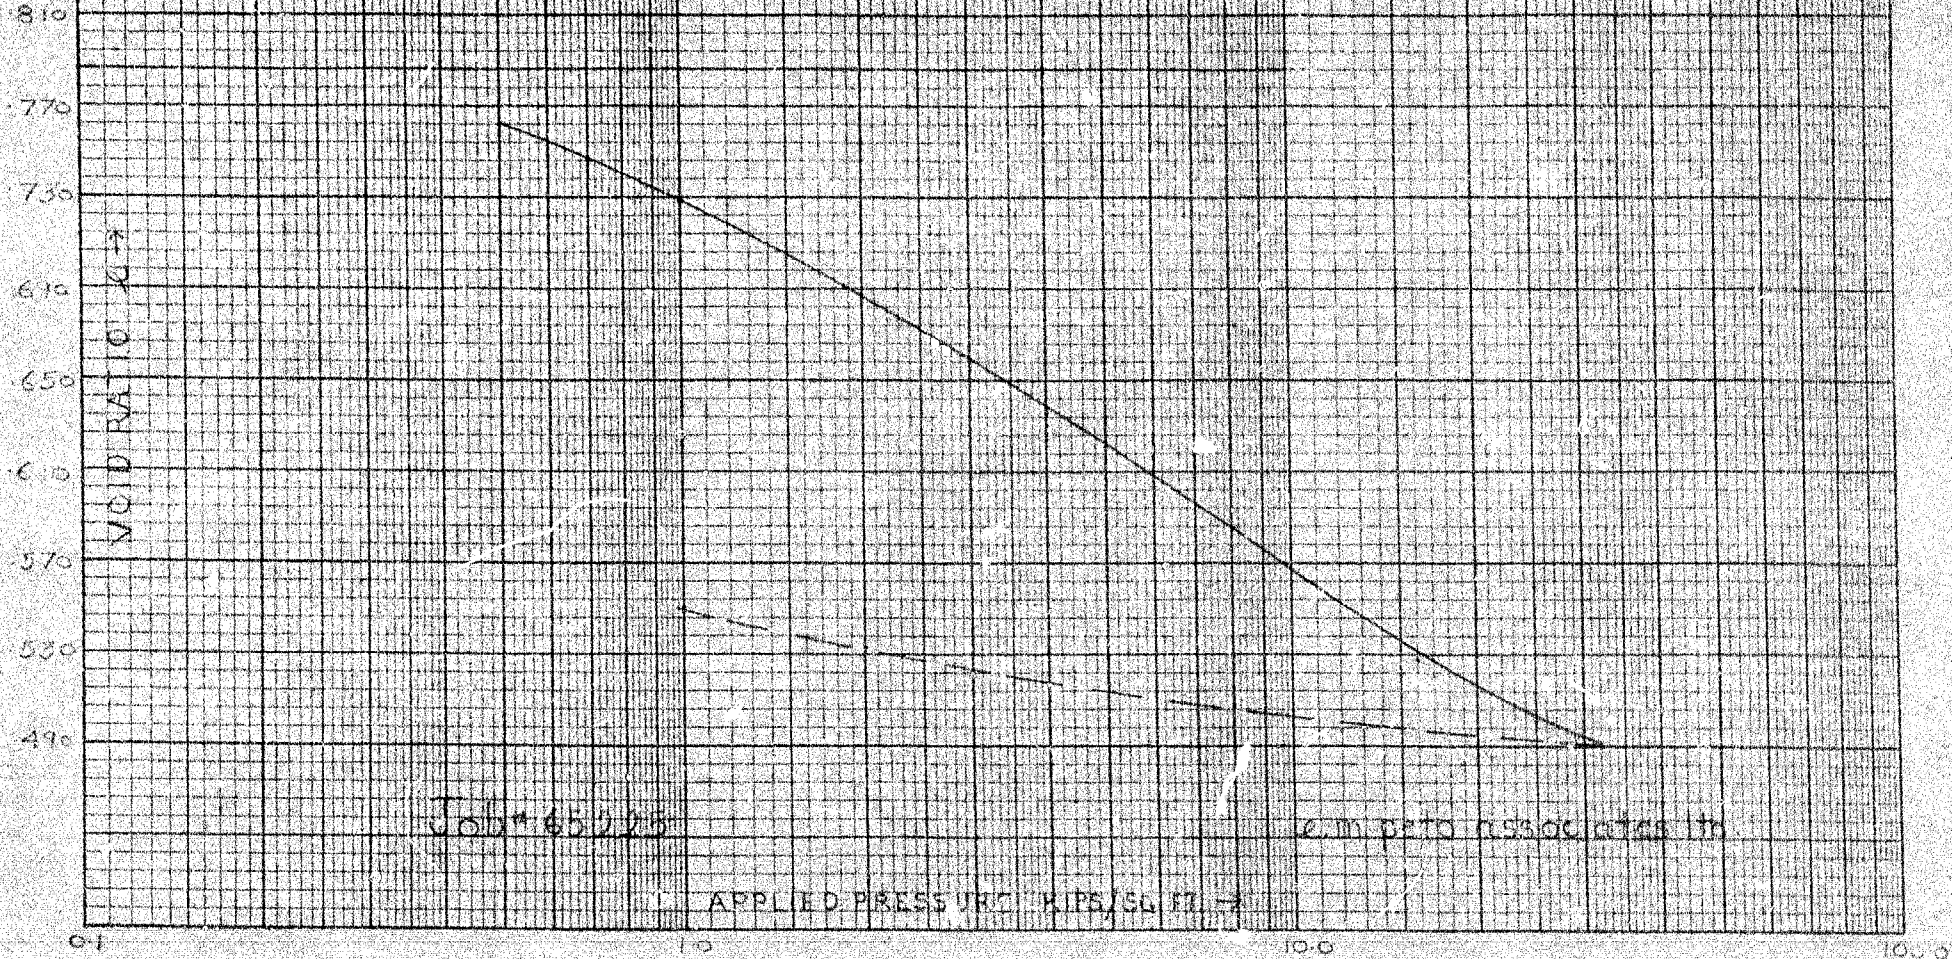
CONSOLIDATION TEST RESULTS

BOREHOLE #1 SAMPLE #26
 DEPTH 30' 8" - 31'
 8 - 120 3/8" C.U.T.
 LI 27.5%
 REDDISH GREY SILTY CLAY

Based on consolidation test results, included with this report, the final settlement of the embankment would theoretically reach 13 to 24 inches. This is in addition to shear deformation settlement, which mostly takes place during the construction stage. The large settlements are caused not only by the highly compressible layer of organic clay, but also by the considerable compressibility of the 62 ft. thick stratum of red-brown clay.
