MONTROSE

BRIDGE

WELAND

RIVER

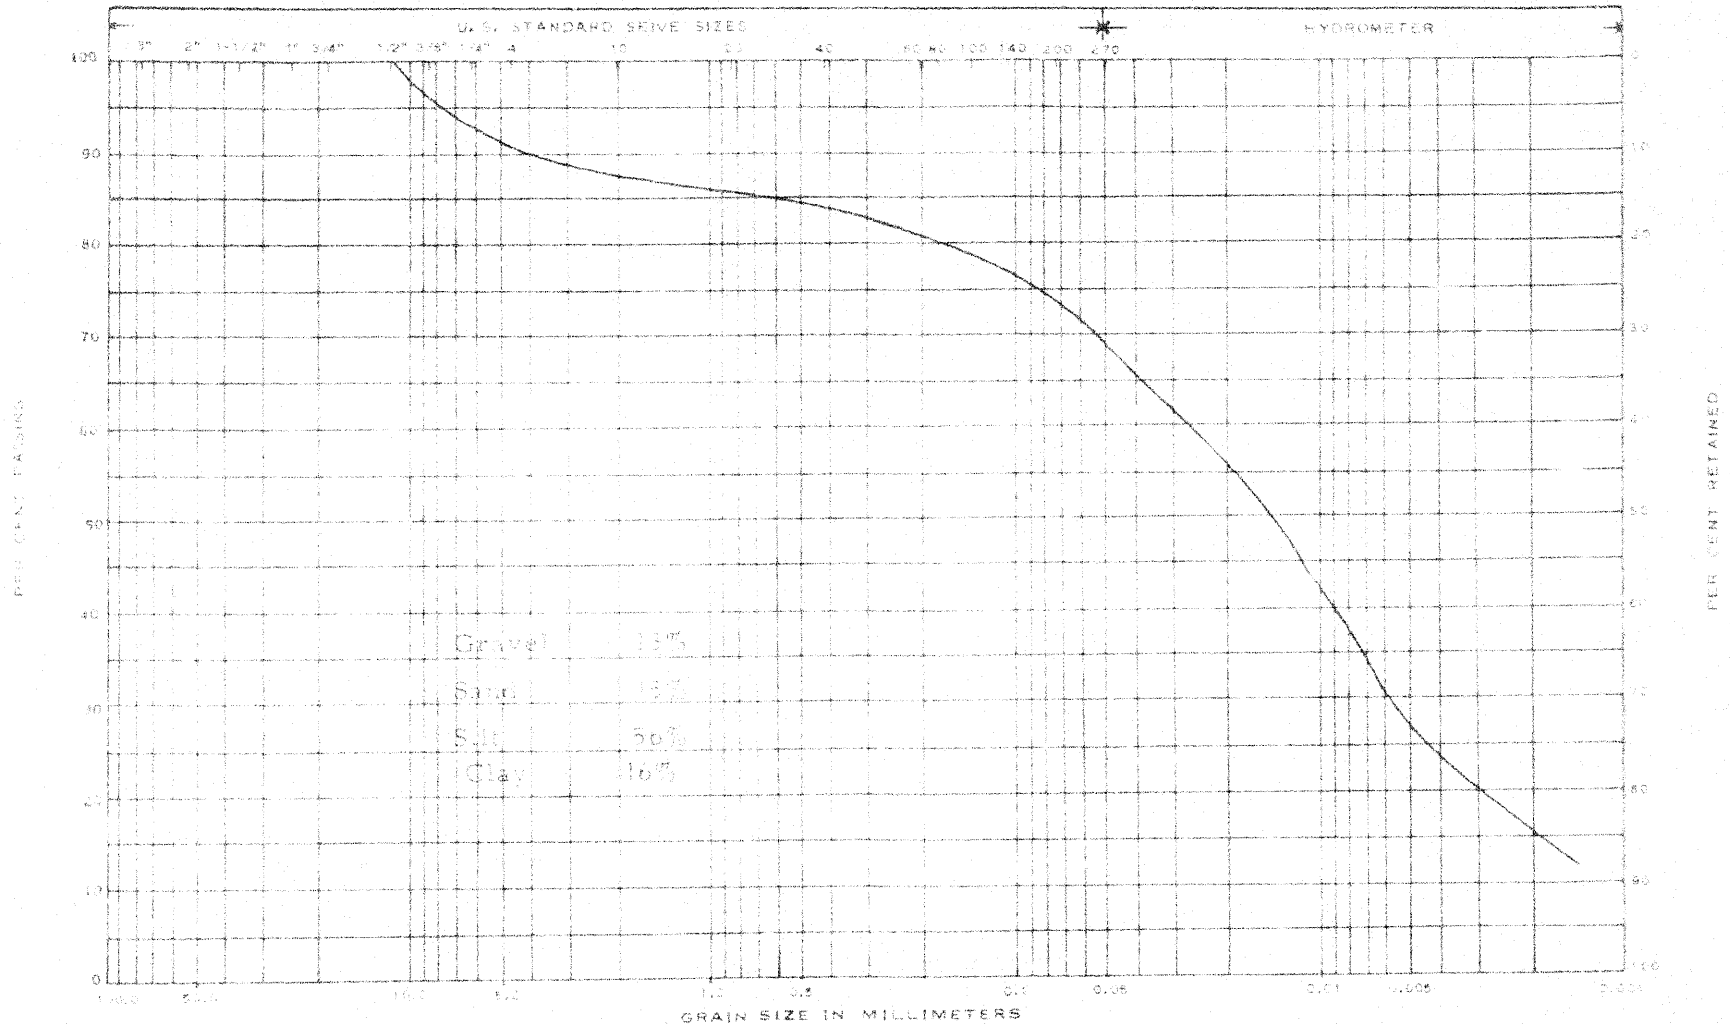
JOB NAME Montrose Bridge MASS. INST. OF TECH. CLASSIFICATION 6439 HOLE NO. 4 SAMPLE NO. 17  
 DEPTH 35'-36'6" ELEVATION \_\_\_\_\_ REMARKS Sandy silt
