BRIDGE OVER
BRONTE CREEK
E. FLAMBOROUGH
TWP.

STRUCTURE SITE No. 37-9

Re: Foundation Investigation, for
Proposed Bridge over Bronte Creek,
Near Flamboro Station.

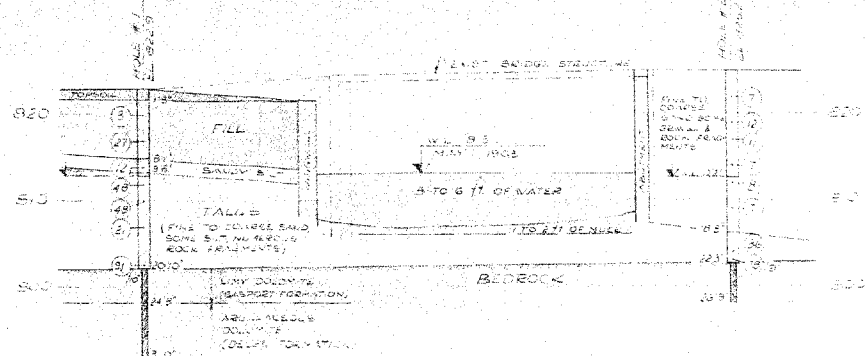
Borehole logs are prepared giving details of the soil description and condition as recorded in the field. These logs form the basis of the soil profile, which indicates the general stratigraphy assumed to exist between the boreholes as represented by the borehole logs.

- BOREHOLE
- ⬇ PEEL-OLE
- 20' BLOW, FOOT, EAT
- WATER LEVEL
