LOCATION OAKVILLE CREEK BRIDGE

SLOPE EROSION - WEST END

RE: Erosion, West End, Oakville Creek Bridge
W.P. 205-~~63~~-01, Site 10

FOUNDATION INVESTIGATION FOR A
BRIDGE OVER THE OAKVILLE CREEK,
HIGHWAY No. 5, DISTRICT 4,
ONTARIO.

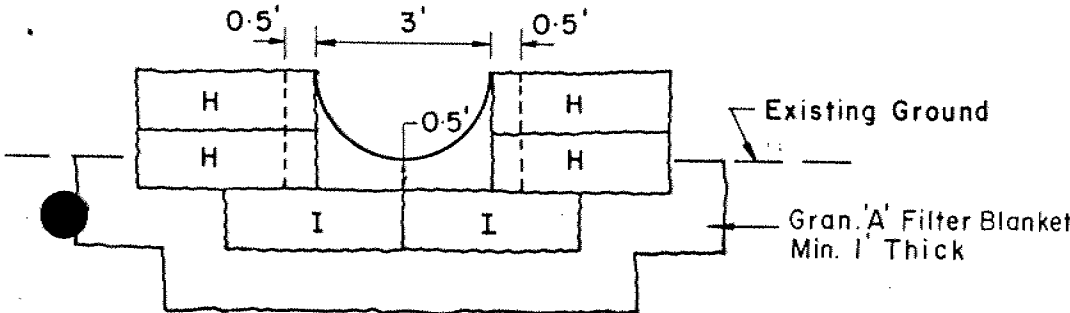
DETAIL OF GUTTER ENLARGEMENT OUTLET TO
EXPANSION JOINT STATION 281+07

RECONSTRUCTED CONDITION

Scale: 3/4" = 1'-0"

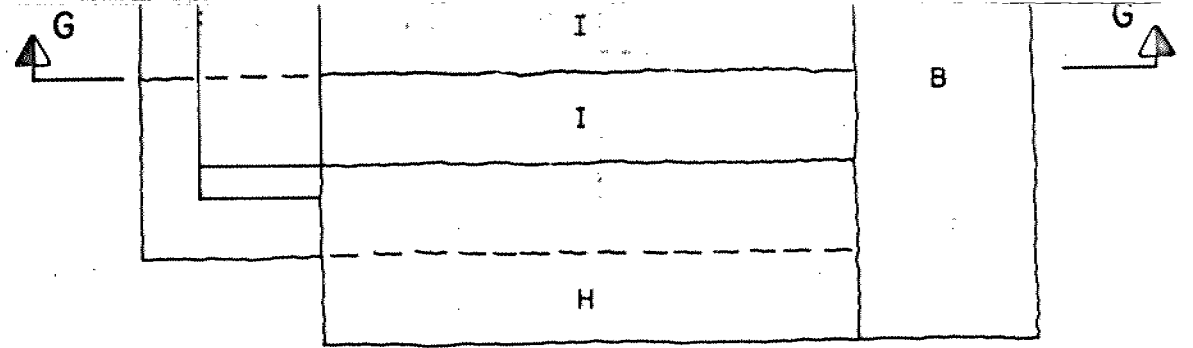
STANDARD GABION DIMENSIONS

- 12' x 3' x 1'
- 9' x 3' x 1'
- 9' x 3' x 3'
