LOCATION Q.E.W. O'PASS AT
MISSISSAUGA ROAD

REPORT S-500-516/55/T-103-1

We are pleased to submit the attached report covering the soils investigation at the proposed overpass of the Queen Elizabeth Way at the Mississauga Road.

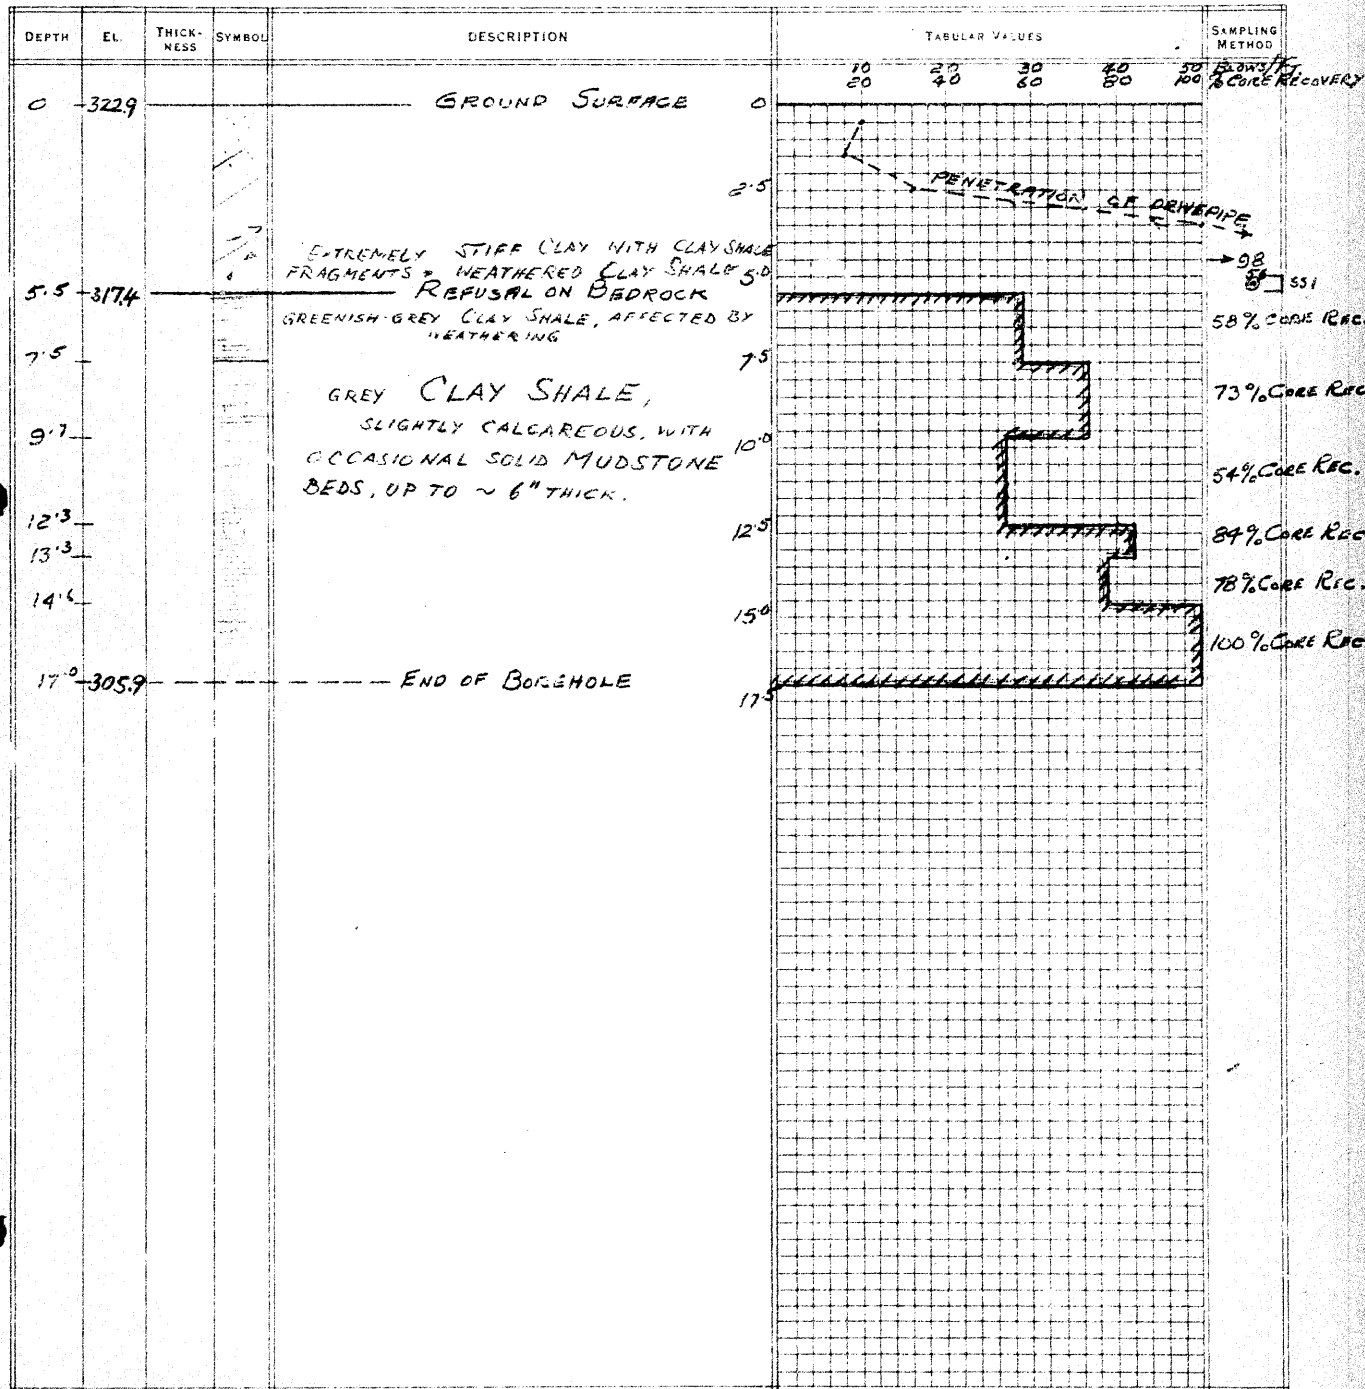
Hole Ended 19/5/55Engineering Data Sheet for Borehole: 4

Job Name: Queen Elizabeth Way Overpass at Mississauga Road

Hole Located: AS SHOWN ON ATTACHED SKETCH PLANHole Elevation: 322.9 Datum: M.S.L.Day 6/6/55 Month Year
