LOCATION CNR OVERHEAD

Re: Brampton Intermodal Terminal  
Hwy #7 Overhead, Mile 2.69

Detailed logs of the boreholes are presented on Figures 2 to 7 inclusive herein. The properties of the subsoil strata relevant to foundation design and construction are discussed in the following.

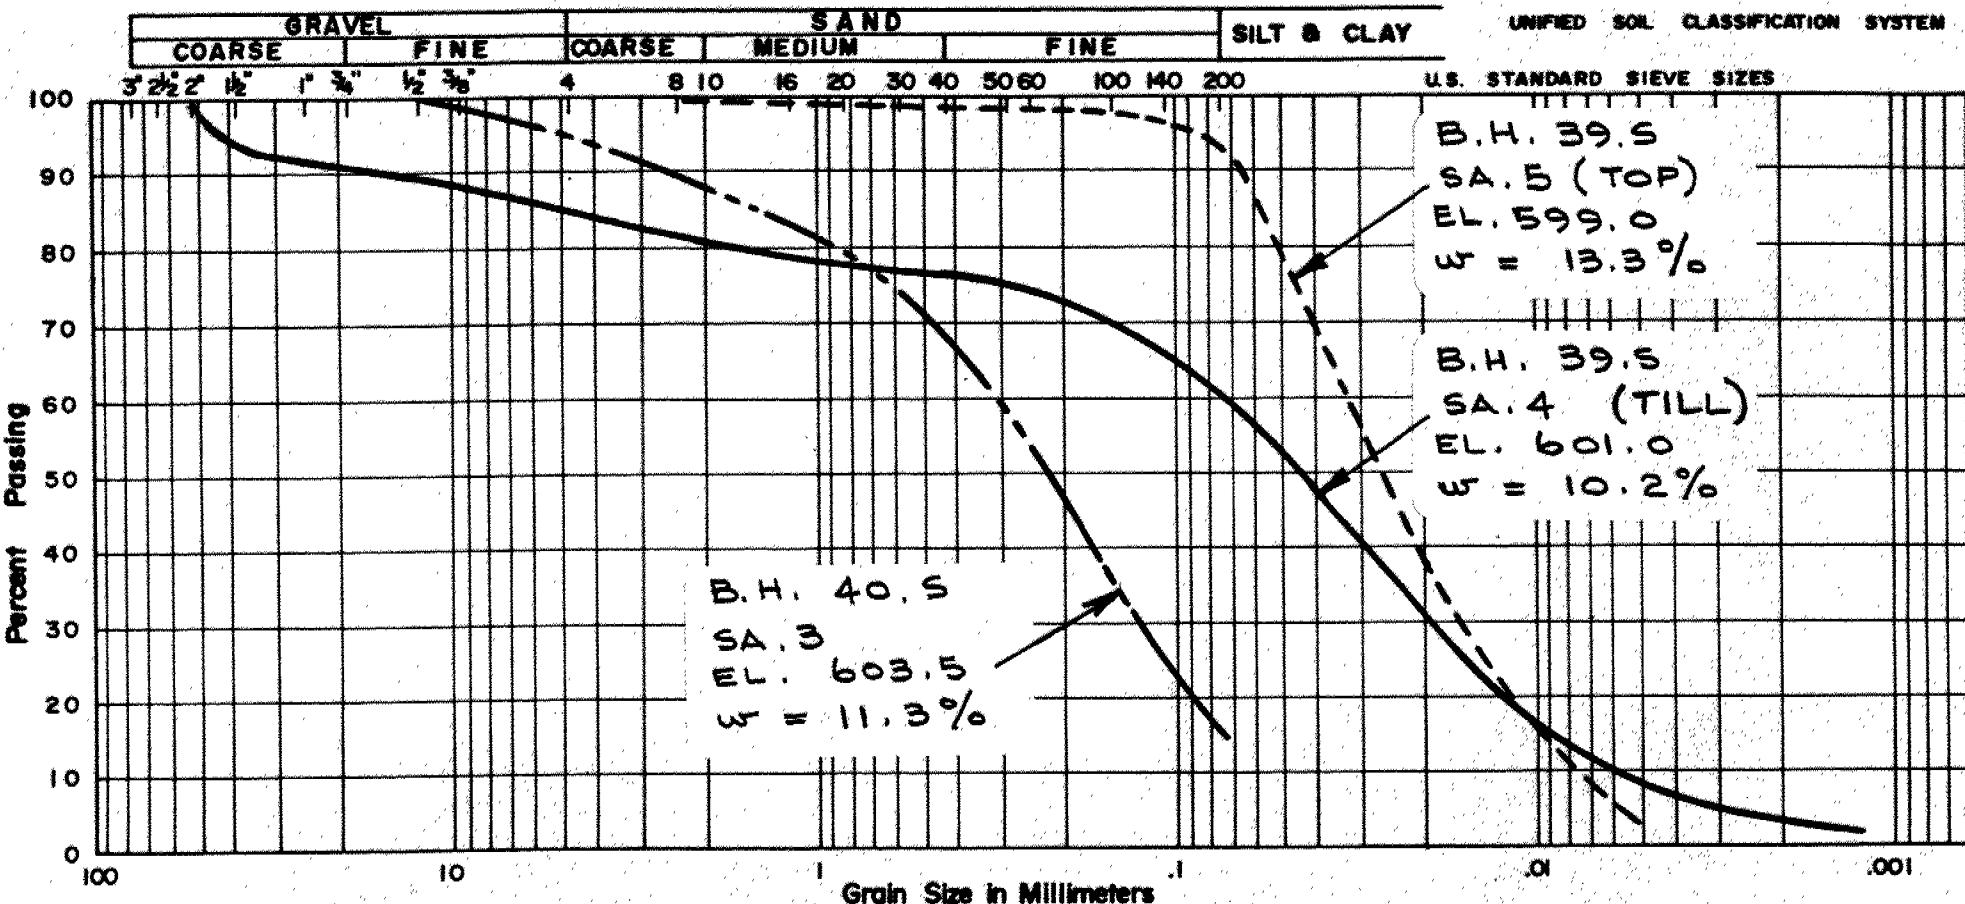
## GRAIN SIZE DISTRIBUTION

PROJECT: HWY. 7 OVERHEAD  
 LOCATION: BRAMPTON  
 BOREHOLE NO.:  
 SAMPLE NO.:  
 DEPTH:  
 ELEVATION:

TYPICAL GRADING CURVES  
 & NATURAL WATER CONTENTS  
 OF UPPER TILL AND THE  
 INTERBEDDED SEAMS OF  
 WATER-BEARING SANDS AND  
 SILTS BETWEEN APPROXIMATE  
 ELEVATIONS 597 AND 605
