GEOCRES No. 30M16-7

LOCATION GANARASKA RIVER

### Re: Soil Conditions - Ganaraska River Bridge

**e.m. peto & associates ltd.**  
SOIL SITE INVESTIGATION  
AT  
**HWY. 401-GANARASKA RIVER BRIDGE**  
FOR  
**DEPT. OF HIGHWAYS OF ONTARIO.**  
OUR JOB No. **5765** DATE **JULY 10, 1957**  
CLIENTS PLAN No. **E-2866-1 & E-2869-1PER** M.M.

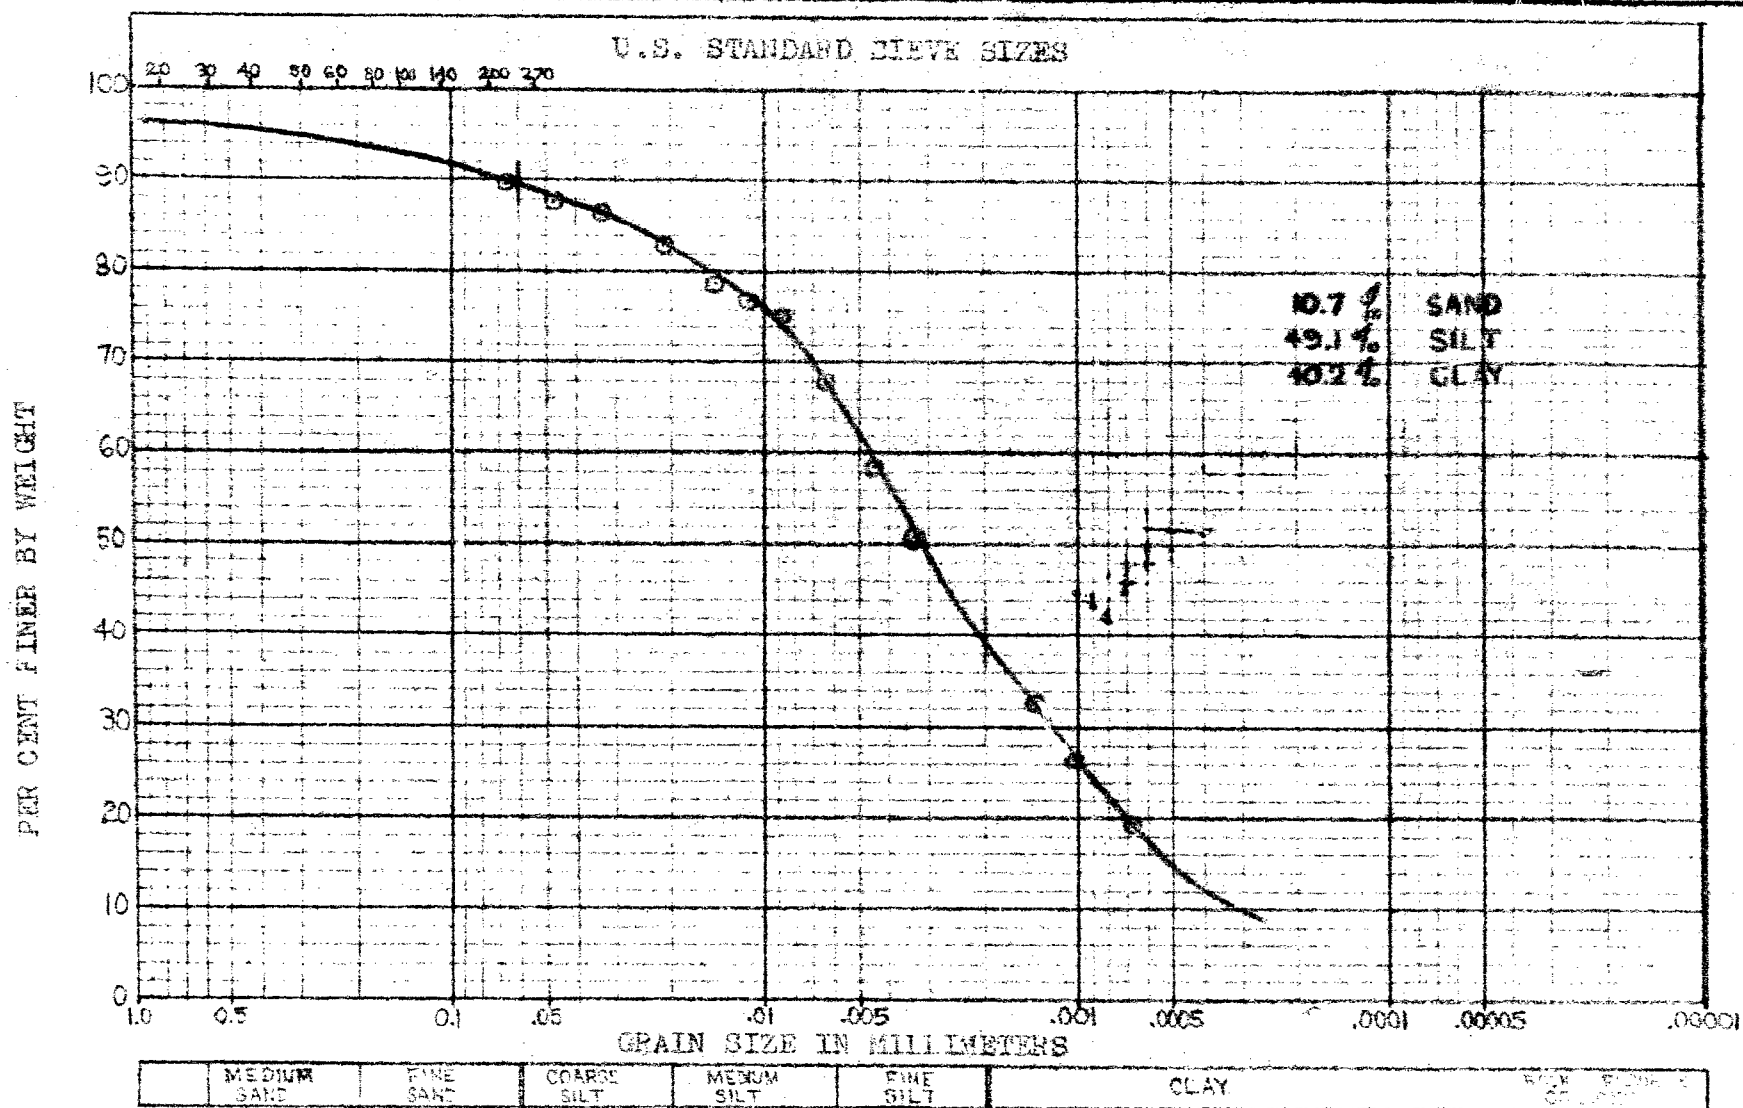
HYDROMETER GRAIN SIZE DISTRIBUTION DIAGRAM

## M.I.T. CLASSIFICATION

Job Name: **APPROACHES - CANARASAP BRIDGE** Job No. **5765 A** Borehole No. **A.M. 14A** Sample No. **---**

Depth **5' - (5')** Elevation **-----** Remarks **MAX. PARTICLE SIZE  $\approx 2\phi$  96.6% FINER THAN #10 SIEVE**

A cohesive soil type with high natural moisture content was encountered on the East approach only, and some laboratory tests were carried out in order to classify it. The hydrometer grain size distribution diagram is included in this report. According to textural classification, this soil is a very clayey silt, but actually its engineering properties are those of a clay. This material is an A-7.5 soil under the U.S. Public Roads classification system, which means that it may be highly elastic as well as subject to considerable volume change. Fortunately the occurrence of this material on the site is limited only to portions of the East bank well back from the river.

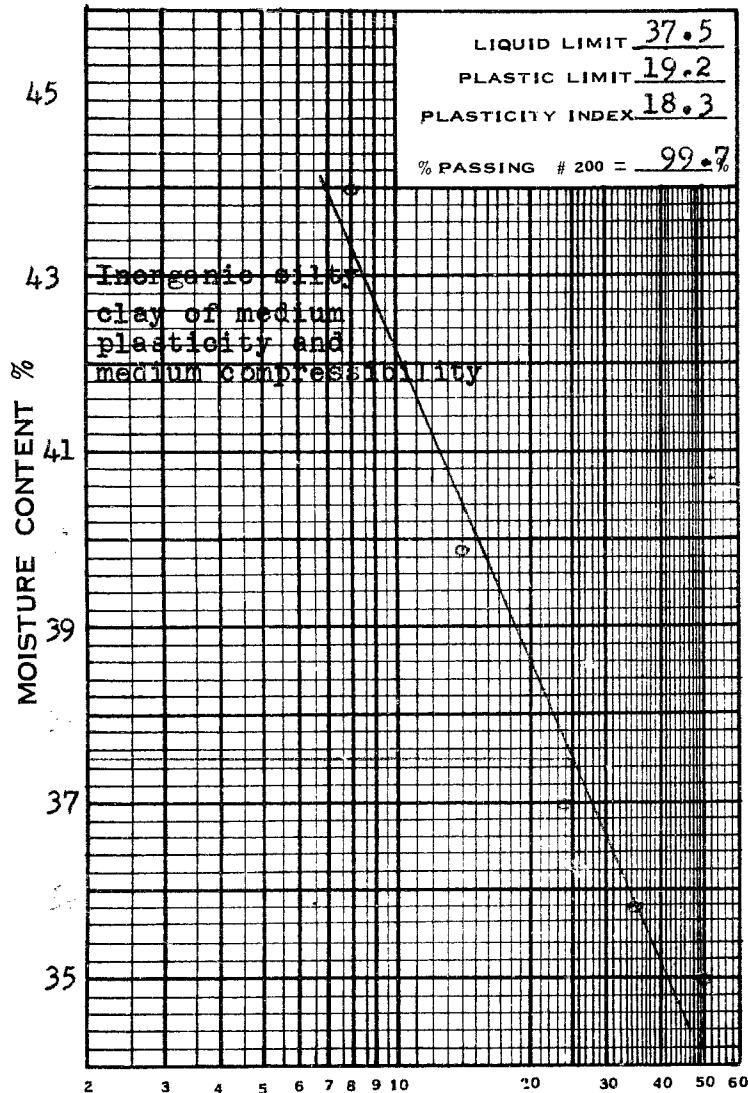
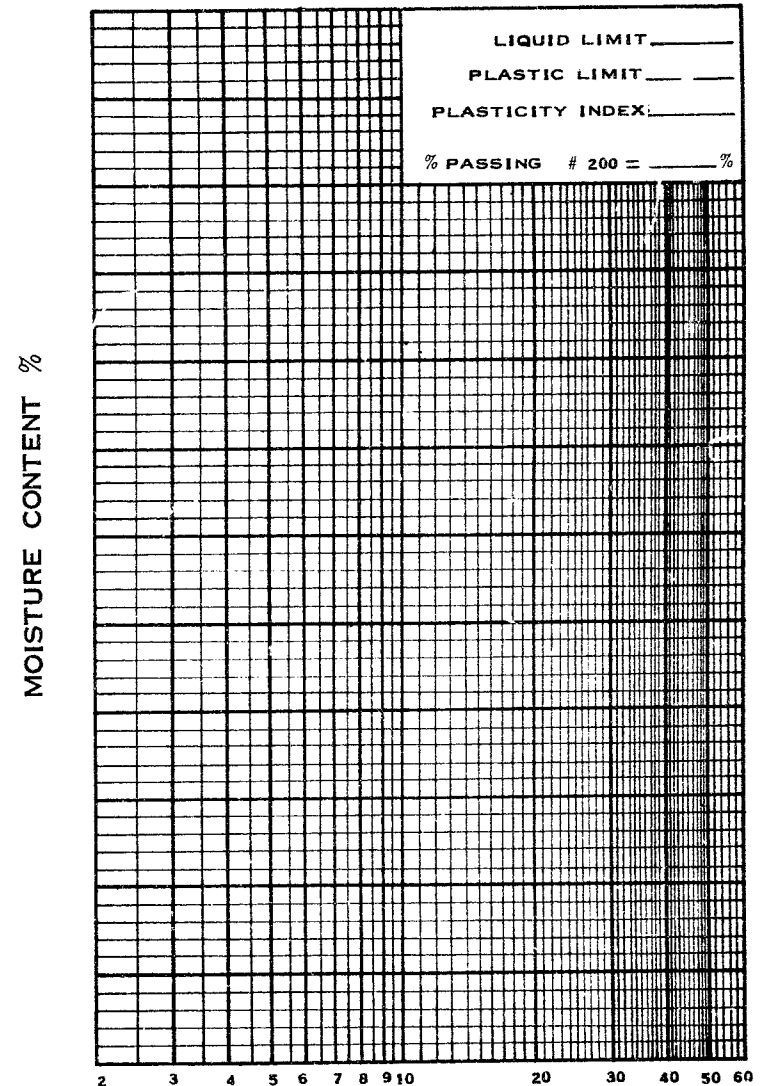
FLOW LINE CHARTS

JOB No. 57144 PROJECT M. M. Dillon and Co. Ltd.  
SAMPLE FROM B.H. 3 sample 2 SAMPLE FROM \_\_\_\_\_  
DEPTH 5' - 6' DEPTH \_\_\_\_\_

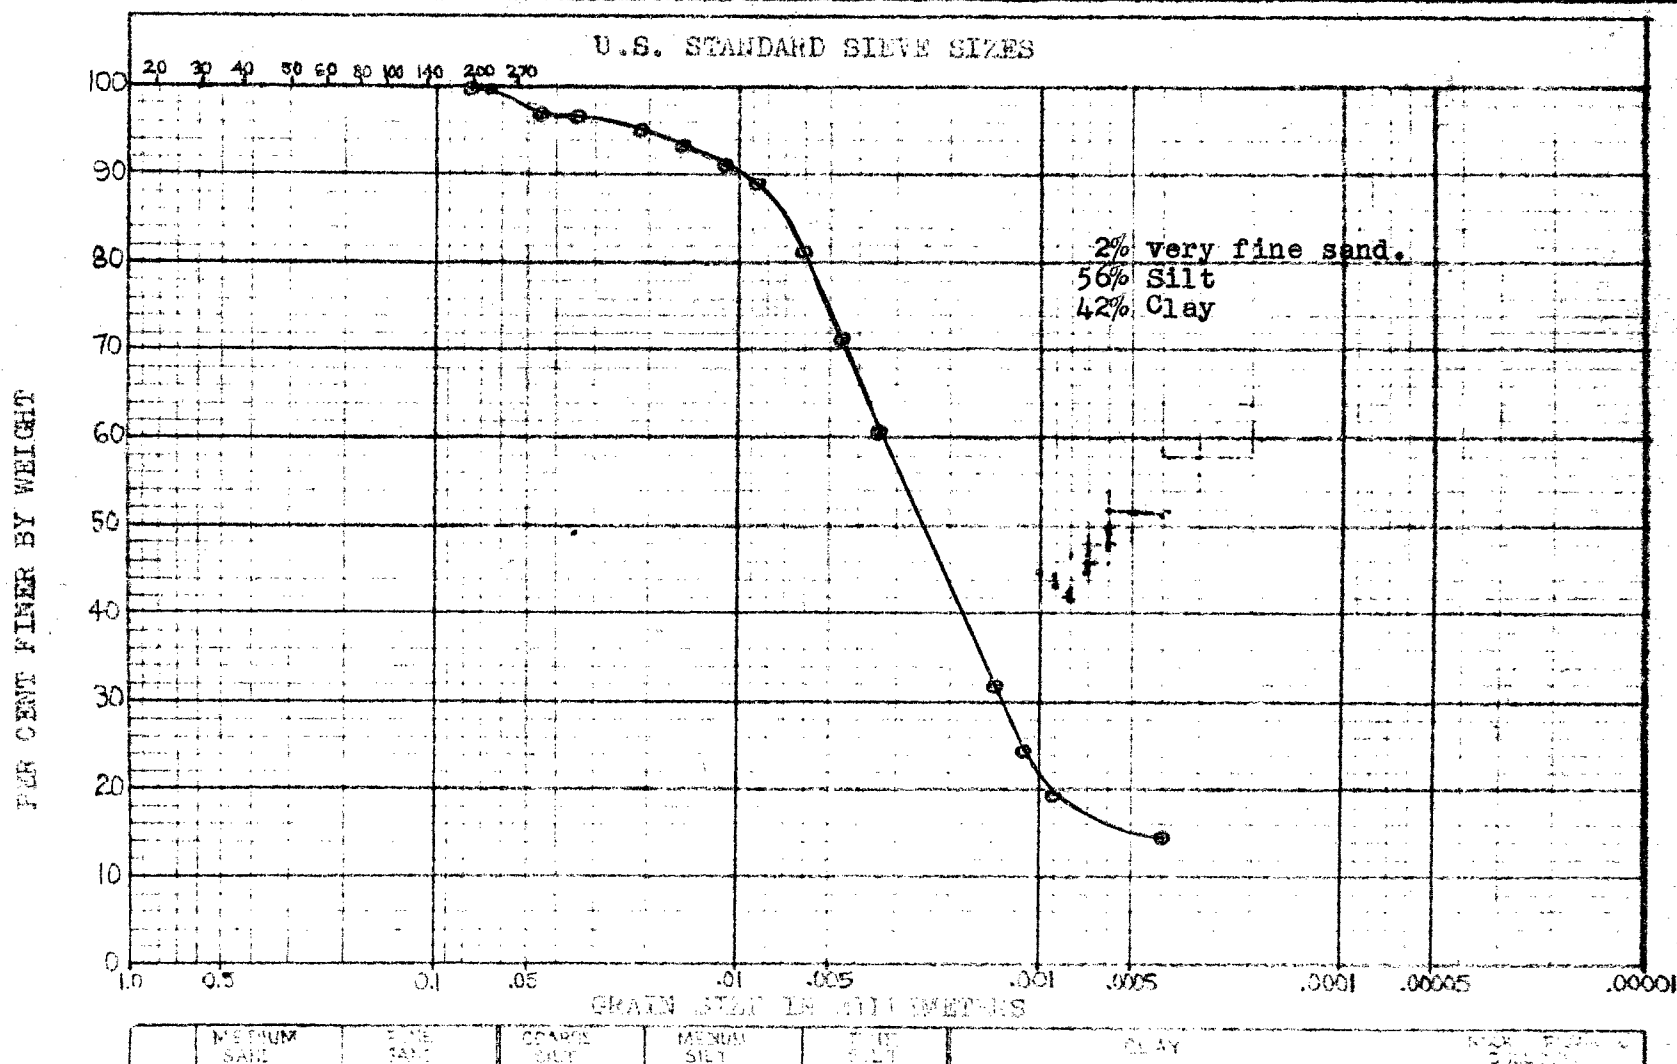
E. M. PETO ASSOCIATES LTD.  
HYDROMETER GRAIN SIZE DISTRIBUTION DIAGRAM

M.I.T. CLASSIFICATION

Job Name Hope Twp. Bridge No. 15 Job No. 57144 Borehole No. 3 Sample No. 3  
 Depth 7' - 8' Elevation 314 Remarks Specific Gravity of this sample = 2.71
