Memorandum Number: 1 Agreement Number: 4242-9082-267
Agreement Date: 1983-02-11
Agreement Description: Geotechnical Investigation to determine
causes of and remedies for water seepage
at Thorold Tunnel, Hwy. 58
District 4, Hamilton

Re: Consultant Assignment for Foundation Investigation,
Thorold Tunnel - Water Seepage Problem
Hwy. 58, District 4, Hamilton

ACRES	MINISTRY OF TRANSPORTATION AND COMMUNICATIONS	
	THOROLD TUNNEL STUDIES	
EXISTING CONDITIONS AT TUNNEL STATION 61+03 ± (FT) LOOKING EAST		
DATE SEPT, 1982 DEPARTMENT PROJECT	SCALE AS SHOWN	
	DRAWING NO.	REV.
ACRES	PLATE 1	OF

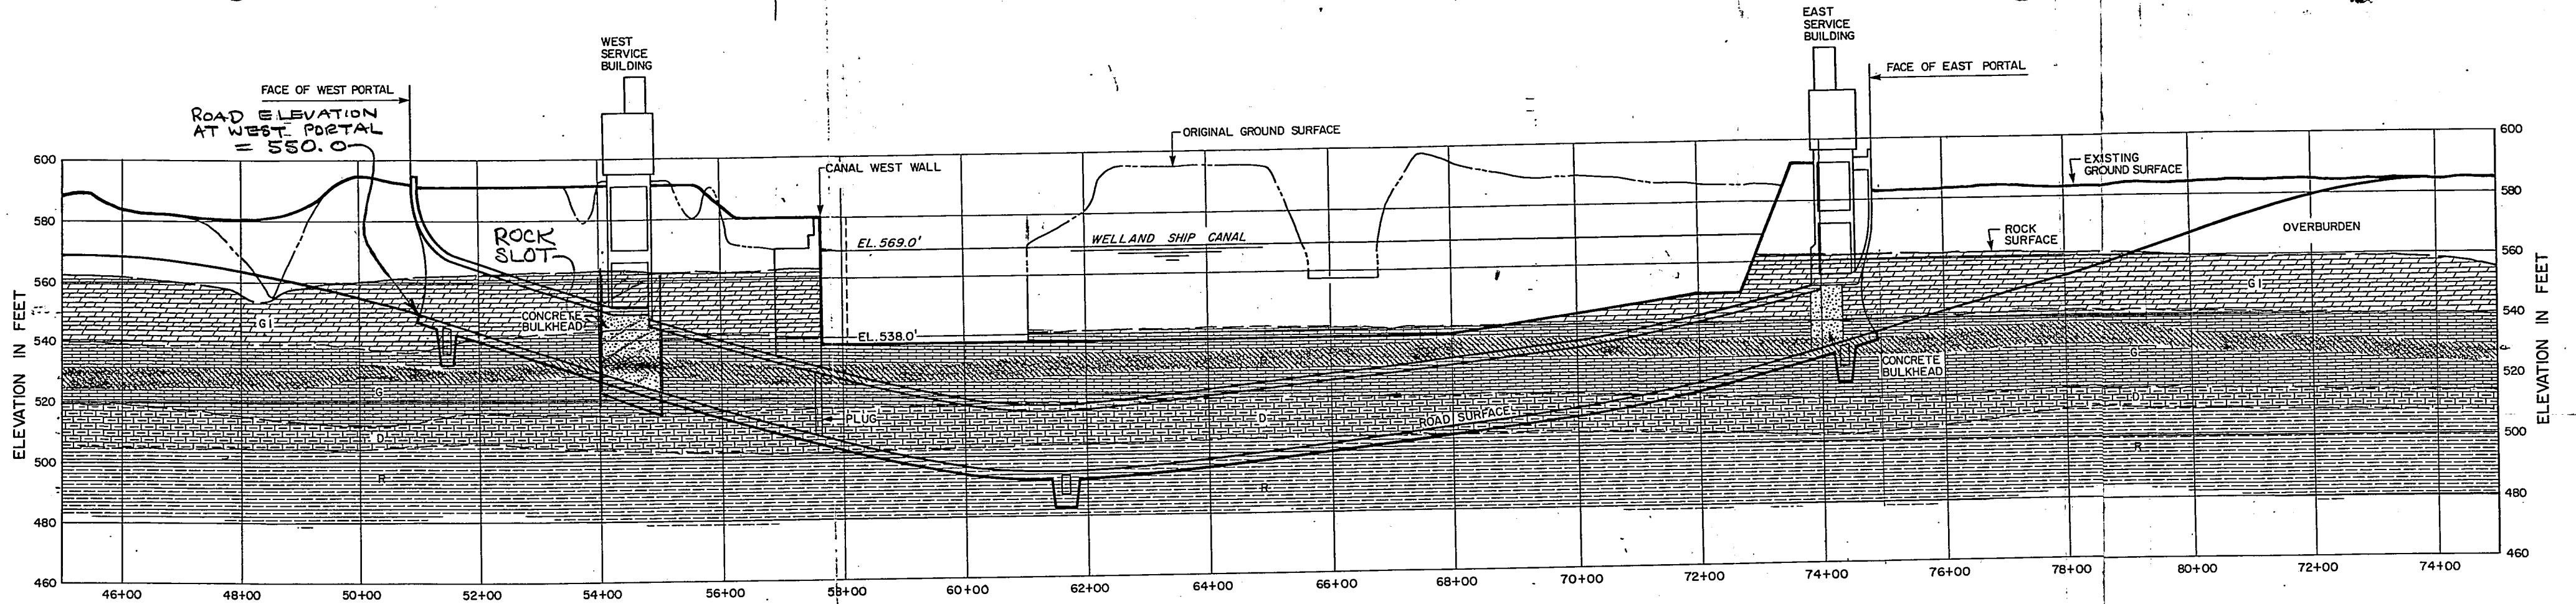
GEOLOGICAL PROFILE ALONG TUNNEL CENTRE LINE

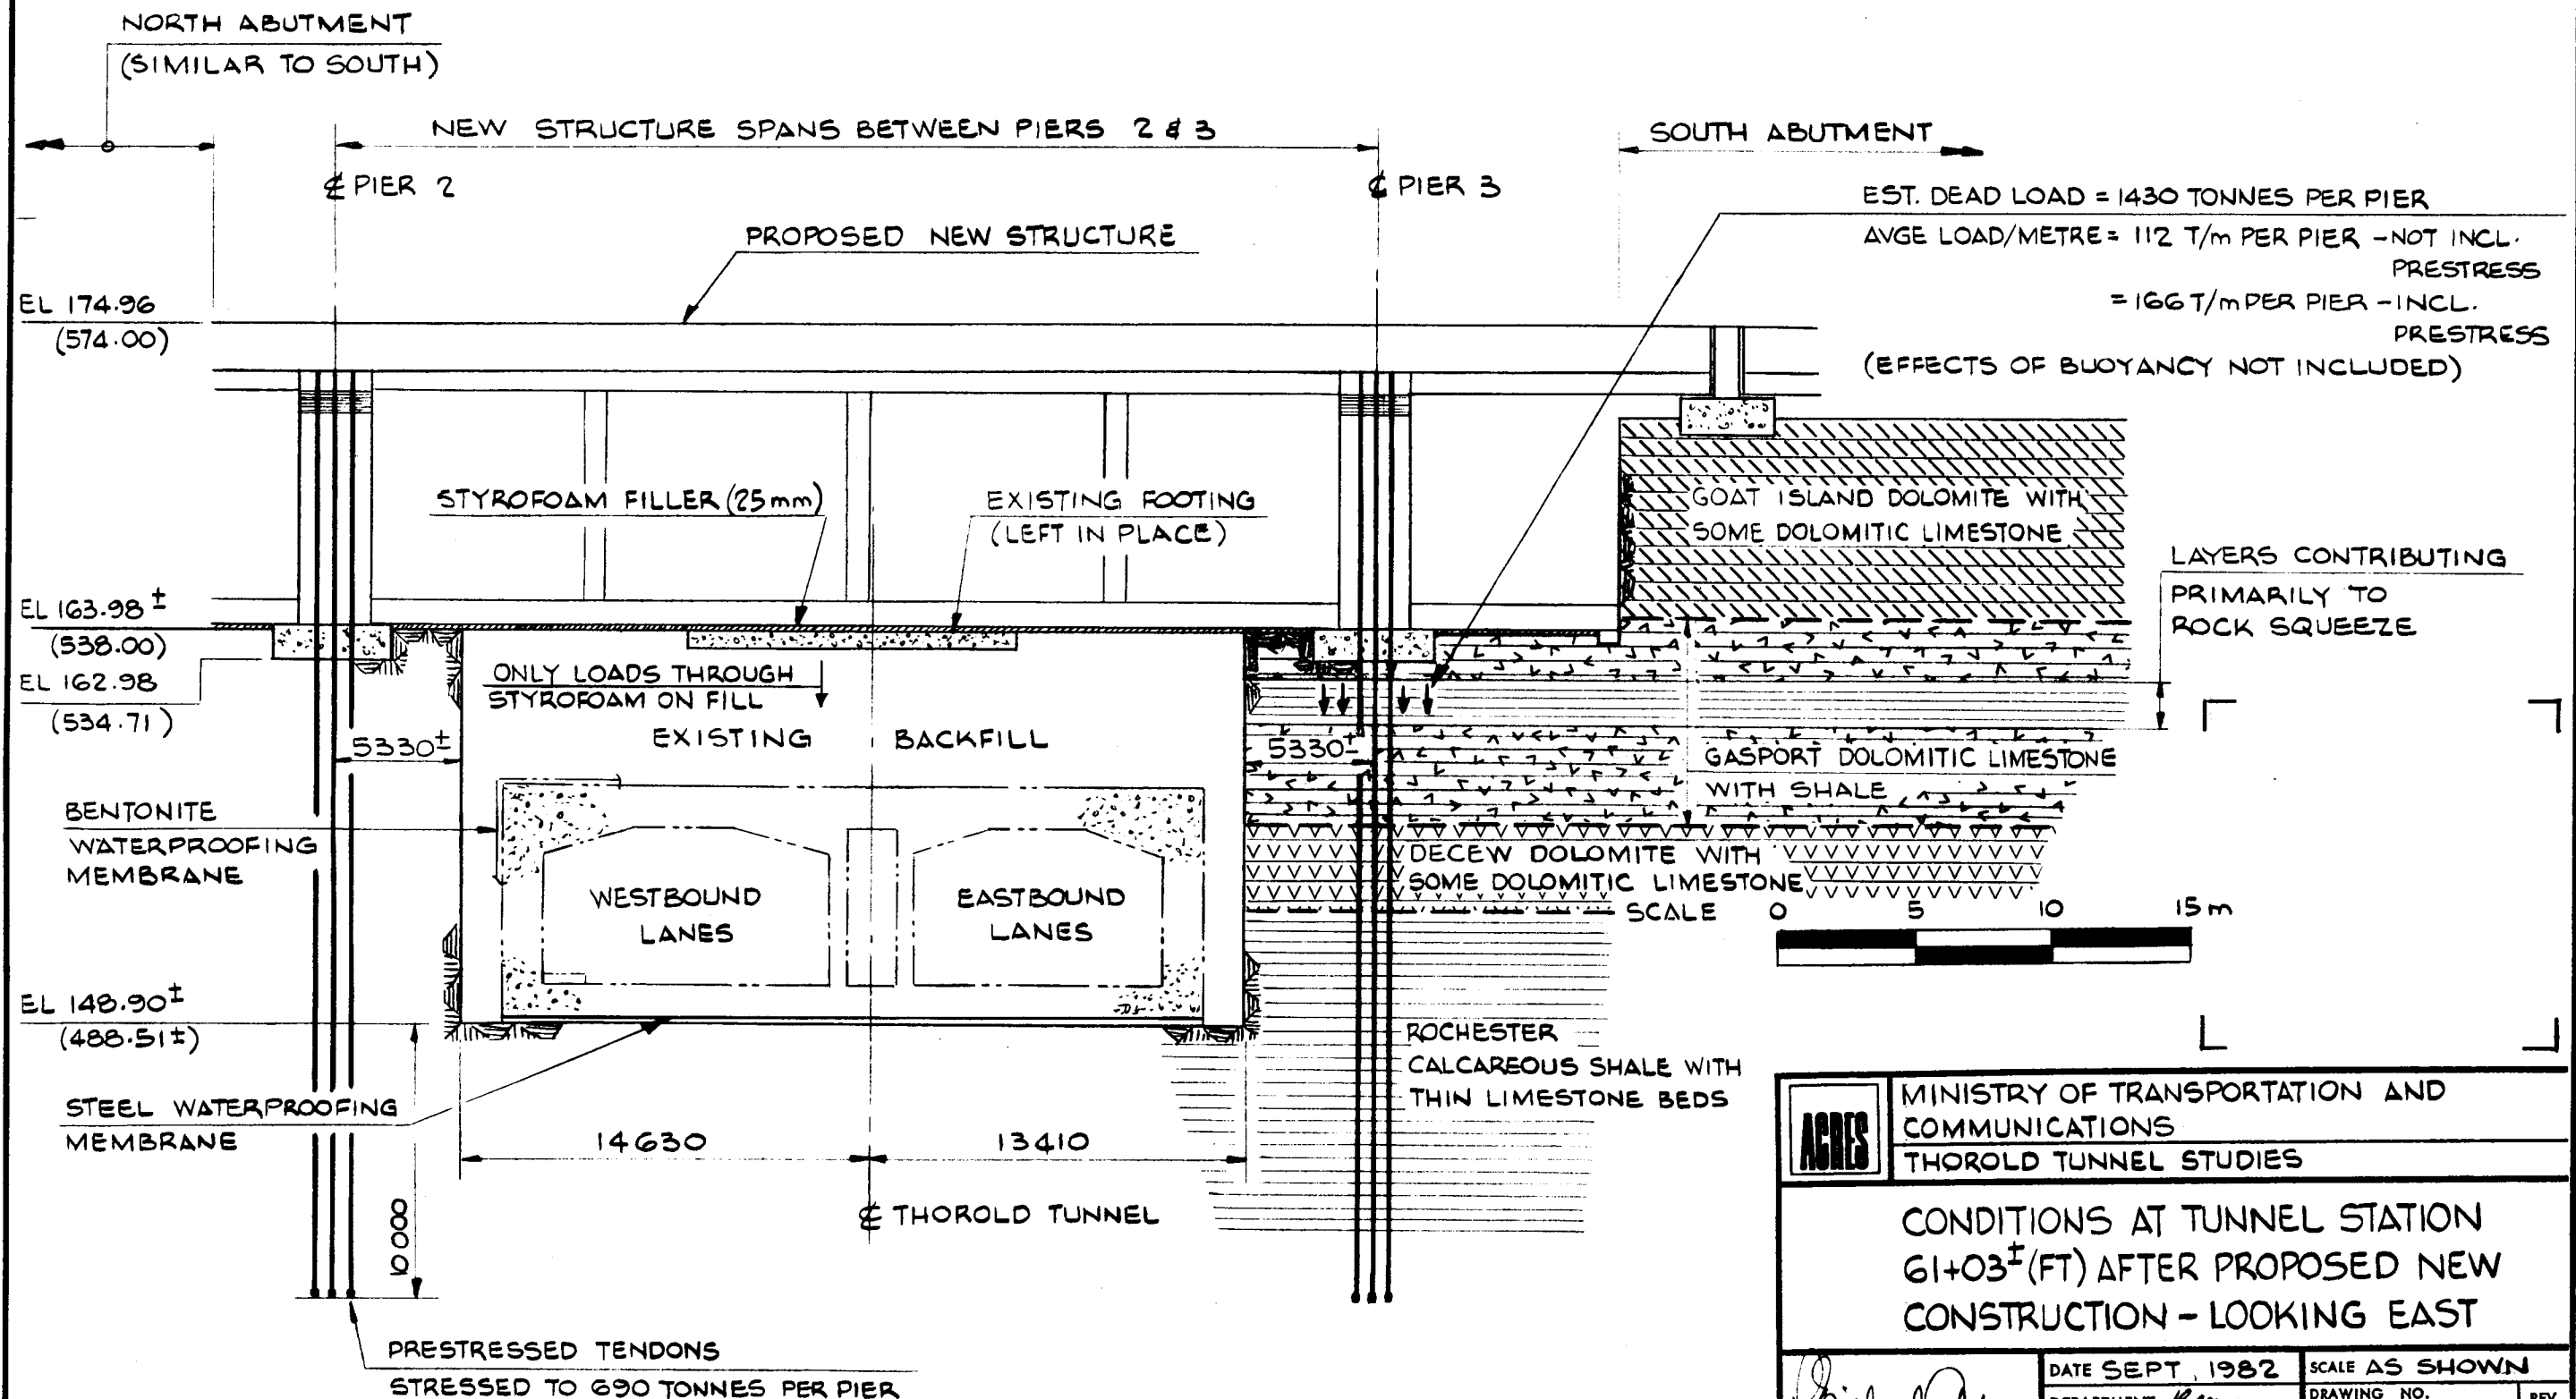
ACRES	MINISTRY OF TRANSPORTATION AND COMMUNICATIONS	
	THOROLD TUNNEL STUDIES	
CONDITIONS AT TUNNEL STATION 61+03± (FT) AFTER PROPOSED NEW CONSTRUCTION - LOOKING EAST		
 ACRES	DATE SEPT. 1982	SCALE AS SHOWN
	DEPARTMENT <i>km</i>	DRAWING NO. PLATE 2
PROJECT <i>903</i>	SHEET OF	REV.

<u>Number</u>	<u>Title</u>
1	Existing Conditions at Tunnel Station 61+03±(Ft) - Looking East
2	Conditions at Tunnel Station 61+03±(Ft) After Proposed New Construction - Looking East

Calculations of gravity loads from the existing Bailey Bridge and proposed new approach wall indicate that although the total load per pier for the new structure will be higher than that from the existing Bailey Bridge, the average gravity load per unit width of pier is about the same for each case, as shown on Plates 1 and 2. The vertical prestressing of the anchor rods adds a load of 691 t per pier for the new structure. This will make the average stress under the new pier approximately 1.5 times higher than the existing. The effect of this additional vertical loading on rock squeeze and bench stability is thought to be minor.

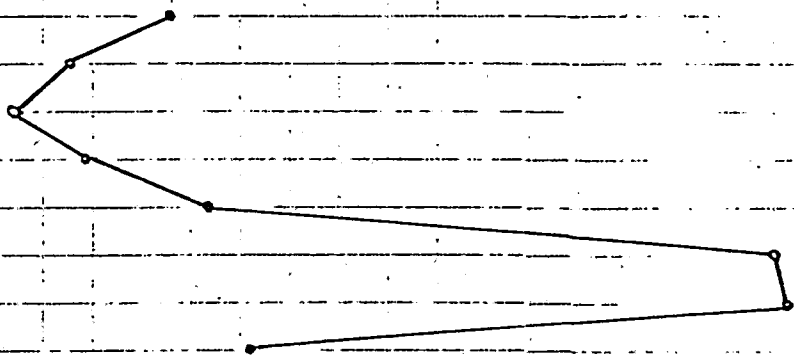
THOROLD TUNNEL
PUMP HOUR READINGS

1K5
600
90
80
70
60
50
40
30
20
10
500
90
80
70
60
50
40
30
20
10
400
90
80
70
60
50
40
30
20
10
300
90
80
70
60
50
40
30
20
10
200
90
80
70
60
50
40
30
20
10
100
90
80
70
60
50
40
30
20
10
0

1980-MAR
APR
MAY
JUNE
JULY
AUG
SEPT
OCT
NOV
DEC
JAN
FEB
MAR

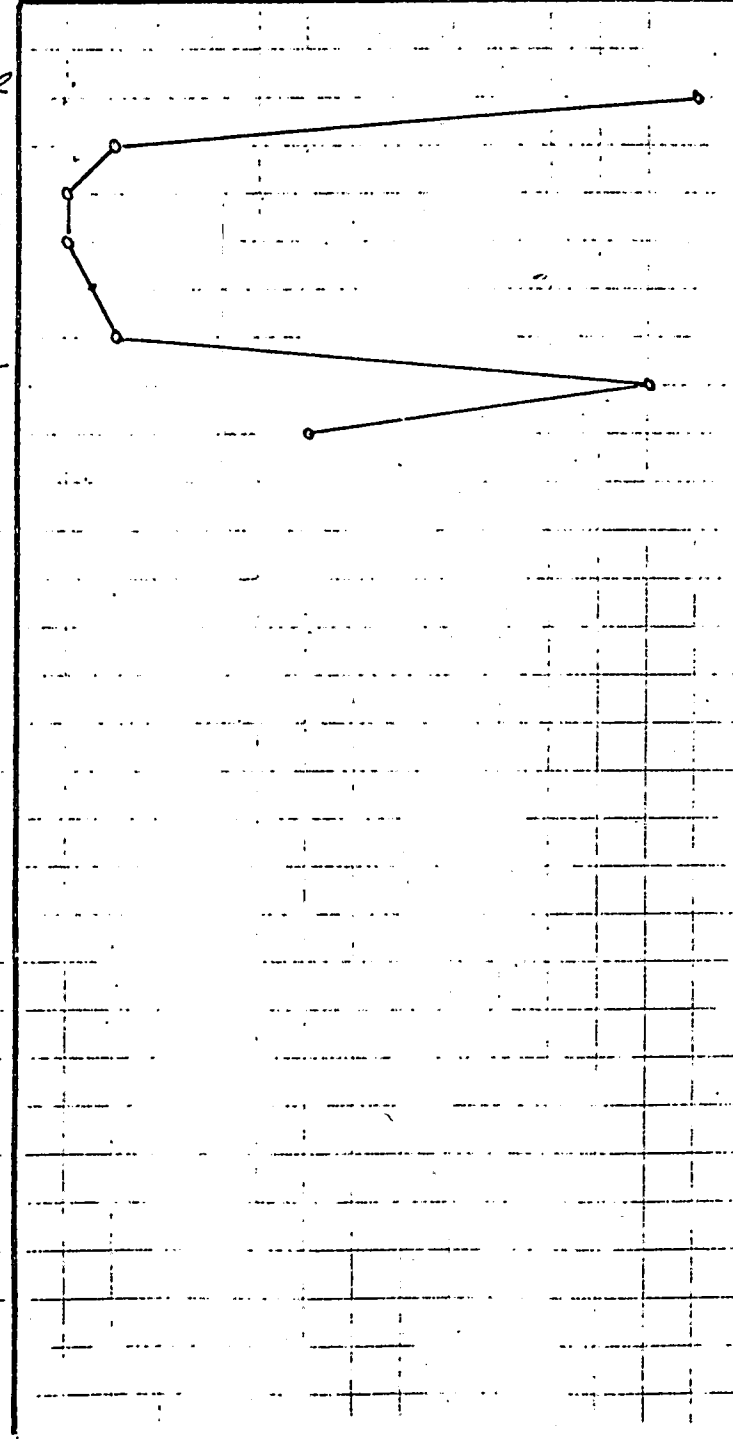
TH COLD TUNNEL
PUMP HOUR READINGS-

WEST PUMP #9

0 1 2 3 4 5 6 7 8 9 10 11 12 13 14 15 16 17 18 19 20
PUMPS

1980-MAR
APR
MAY
JUNE
JULY
AUG
SEPT
OCT
NOV
DEC
JAN
FEB
MAR.

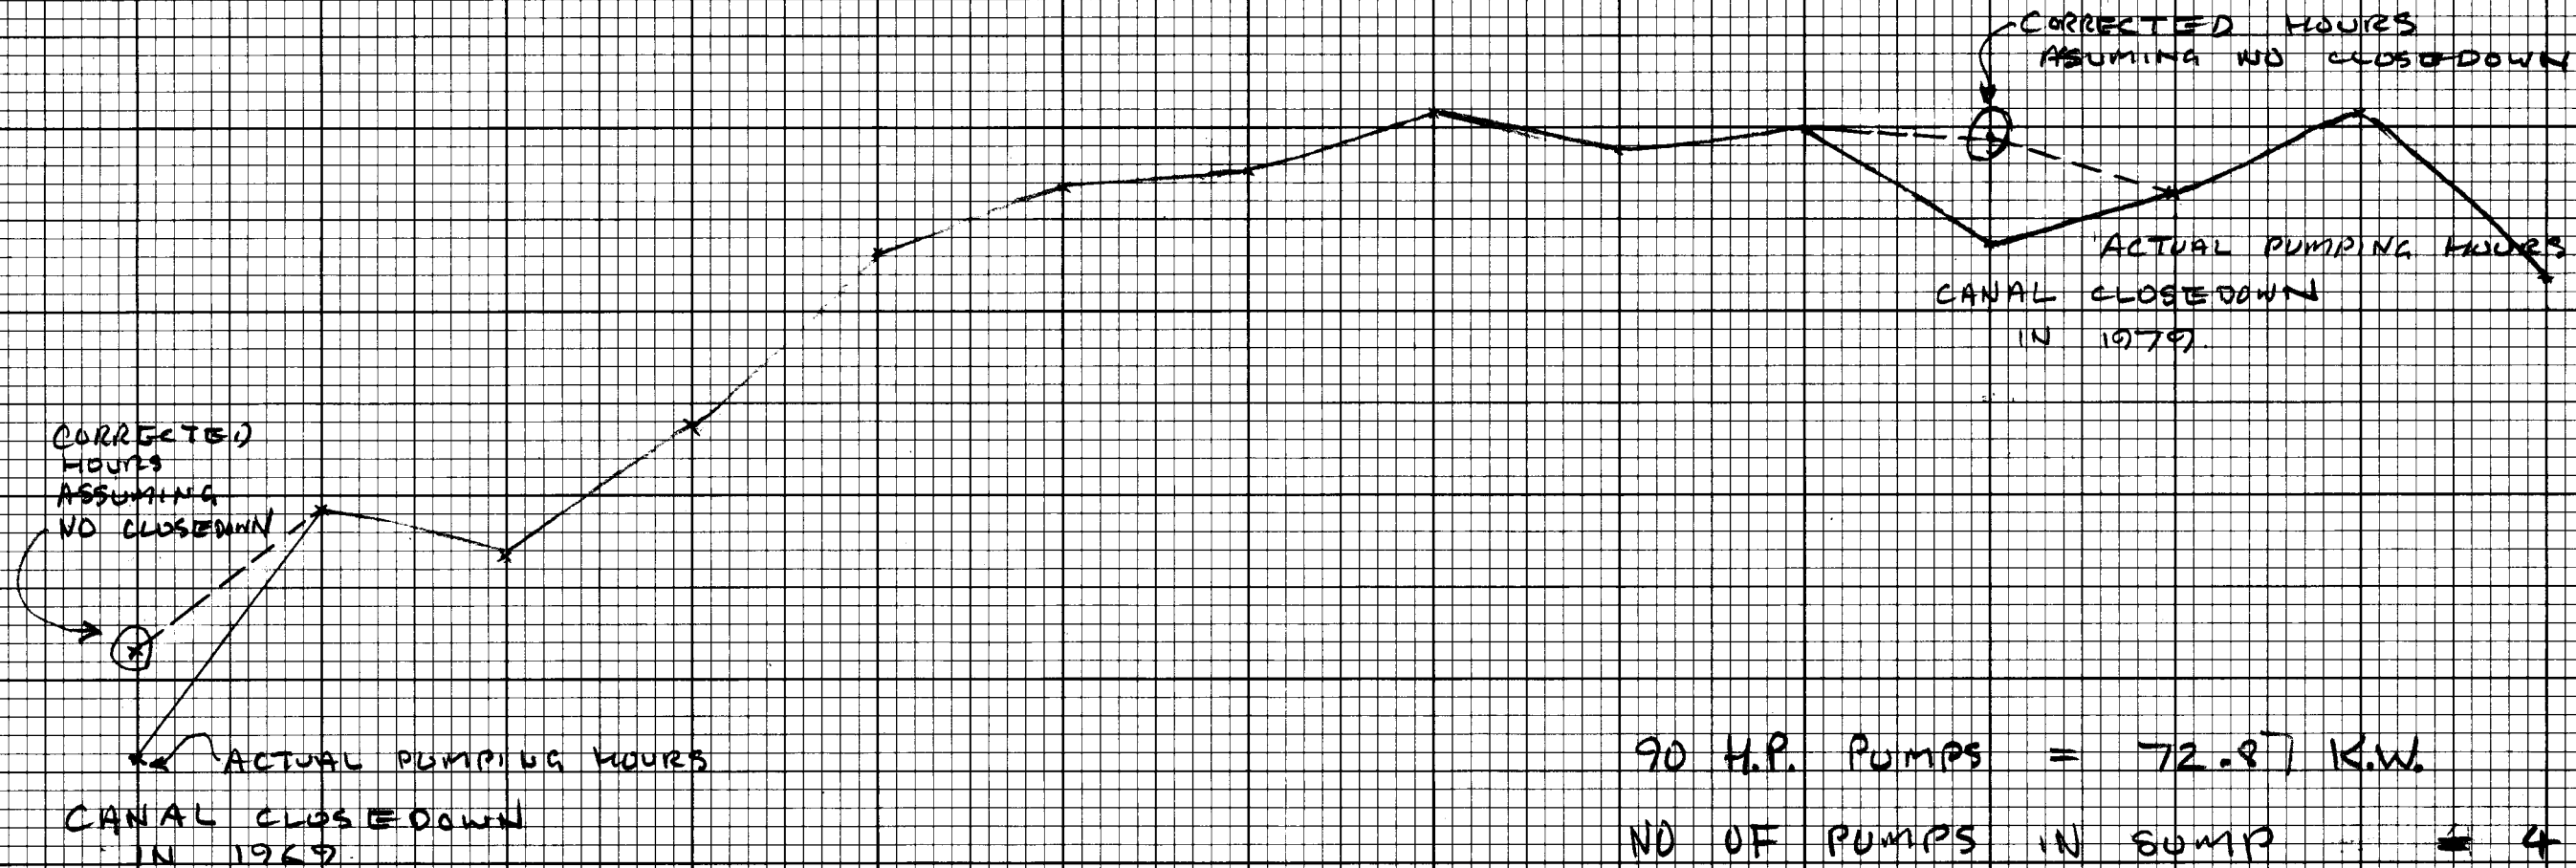
18000
16000
14000
12000
10000
8000
6000
4000
2000

AVERAGE DAILY PUMPING HOURS → 38.9 37.8 38.4 35.1 36.3 38.9
