#59-F-204C
W.P. # 216-58
HWY # 401 & #16
REALIGNMENT

e.m. peto & associates ltd.
SOIL SITE INVESTIGATION
AT
CROSSING HWY 401-HWY 16
EDWARDSBURG TOWNSHIP BRIDGE NO. 4
FOR
DEPARTMENT OF HIGHWAYS OF ONTARIO
OUR JOB No. 5819 DATE: MAR. 13-59
CLIENTS PLAN No. E 3556-1 PER. G. T.

Re: Soil Site Investigation
Highway #401 - Highway #16 Realignment
Edwardsburg Twp. W.P. 216-58.

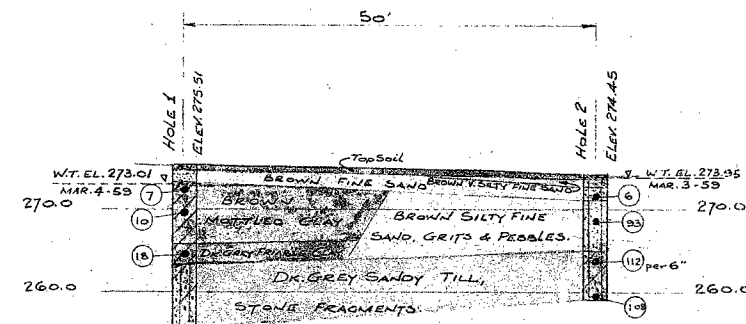
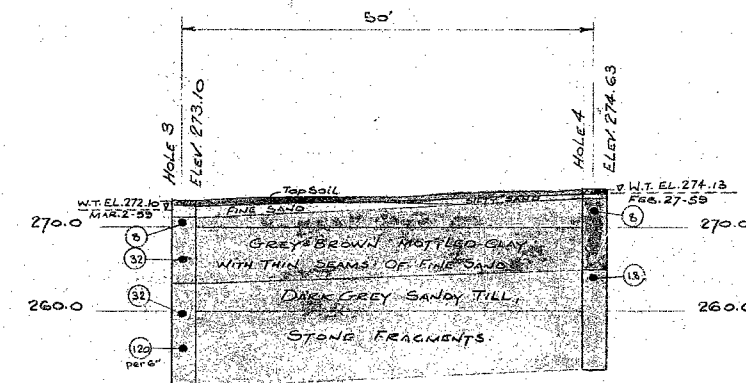
PROFILES.
SCALES: HOR 1" = 10'
VERT.

NOTE:- PLEASE SEE BOREHOLE LOGS FOR COMPLETE SOIL DETAILS.

NOTE:-
THE BOUNDARIES BETWEEN SOIL STRATA HAVE BEEN ESTABLISHED ONLY AT BOREHOLE LOCATIONS. A LINEAR VARIATION IN SOIL STRATIGRAPHY HAS BEEN ASSUMED BETWEEN BOREHOLES, AND THIS MAY ACTUALLY DIFFER FROM THAT SHOWN.

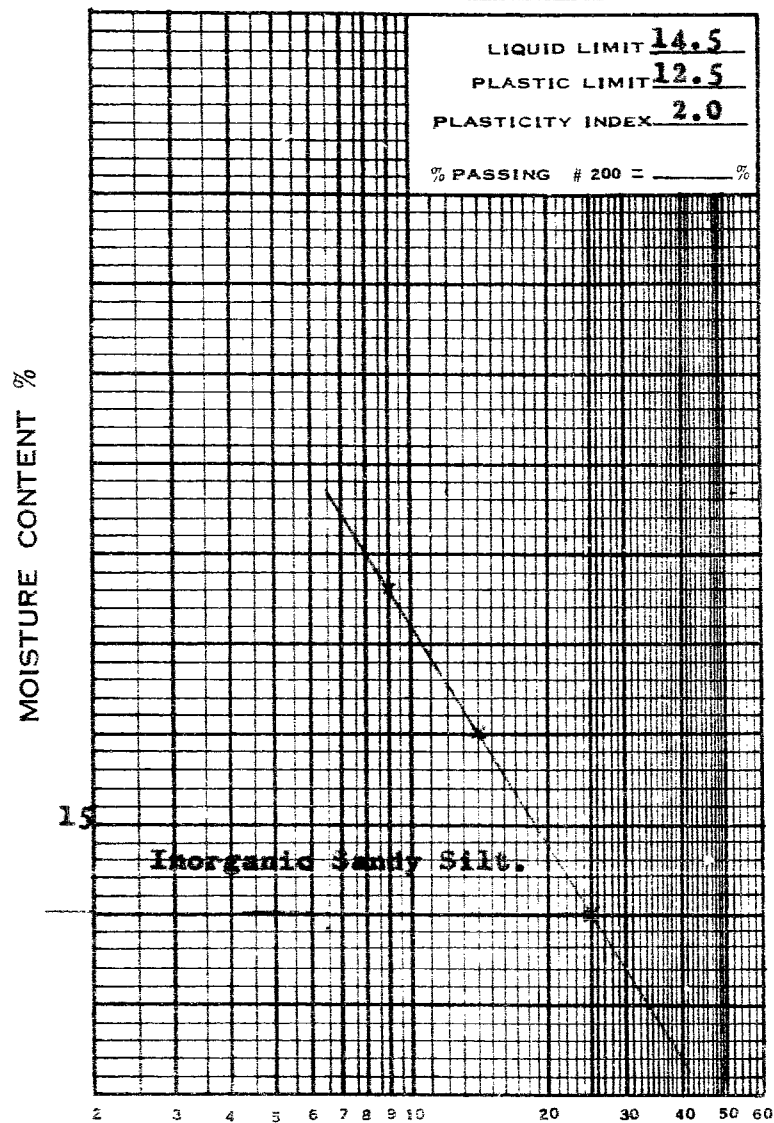
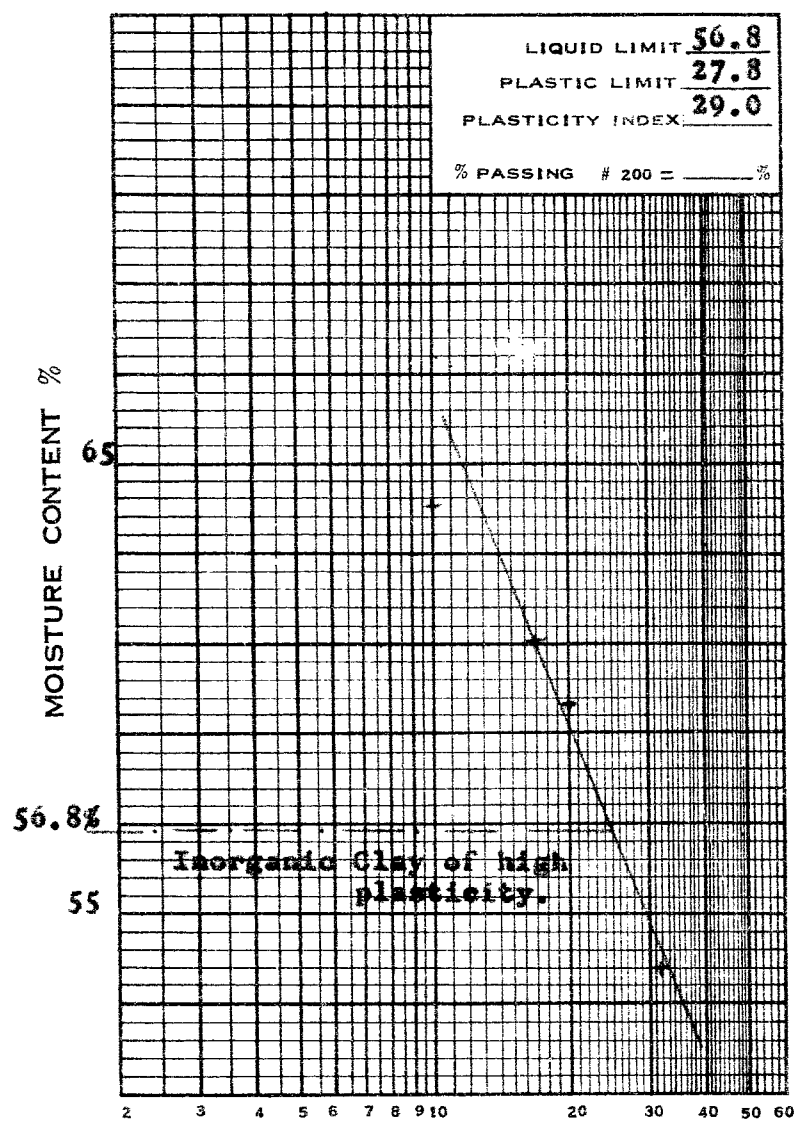
FLOW LINE CHARTS

JOB NO. 5919 PROJECT D.H.O. Bridge # 4 Hwy. 401 - Hwy. 16 Re-alignment, Johnstown.
SAMPLE FROM B.H. # 2. Sample # 3. SAMPLE FROM B.H. # 3. Sample # 2.
DEPTH 10' - 11' DEPTH 6' - 6'4"

NO. OF BLOWS (LOG SCALE)

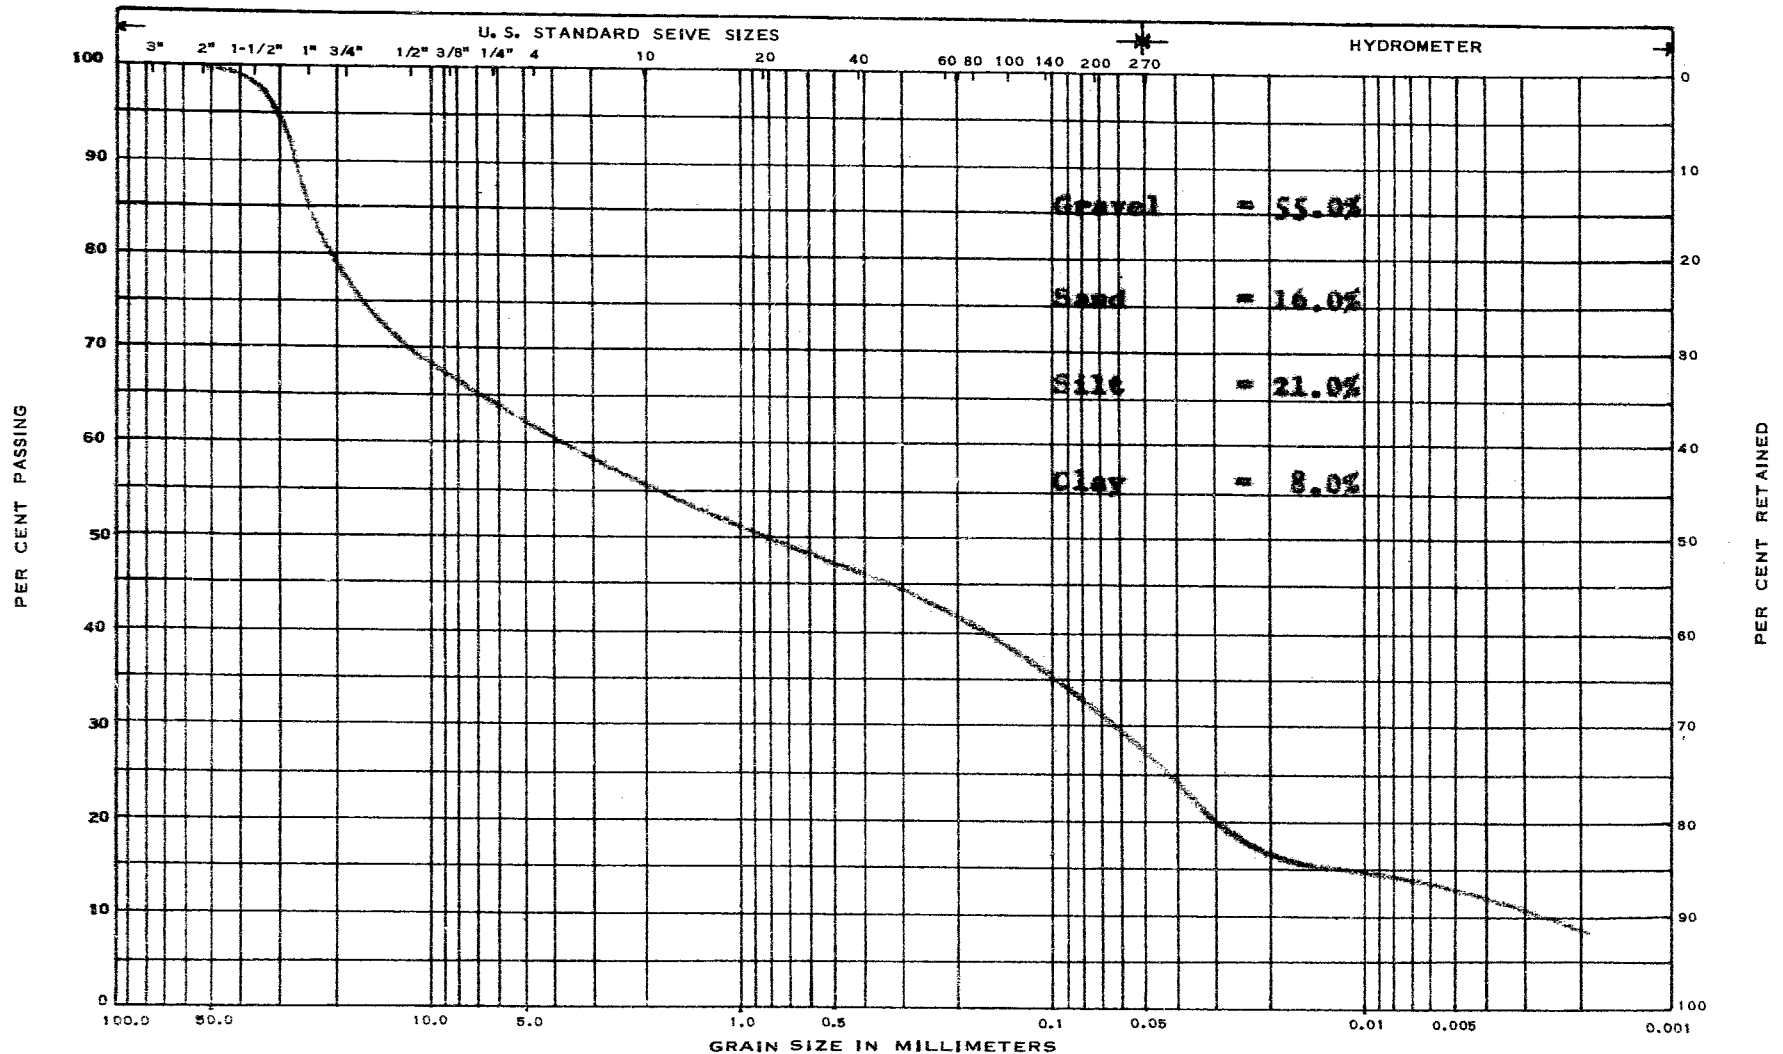
STONES	GRAVEL	COARSE SAND	MED. SAND	FINE SAND	COARSE SILT	MED. SILT	FINE SILT	CLAY
--------	--------	-------------	-----------	-----------	-------------	-----------	-----------	------

MASS. INST. OF TECH. CLASSIFICATION

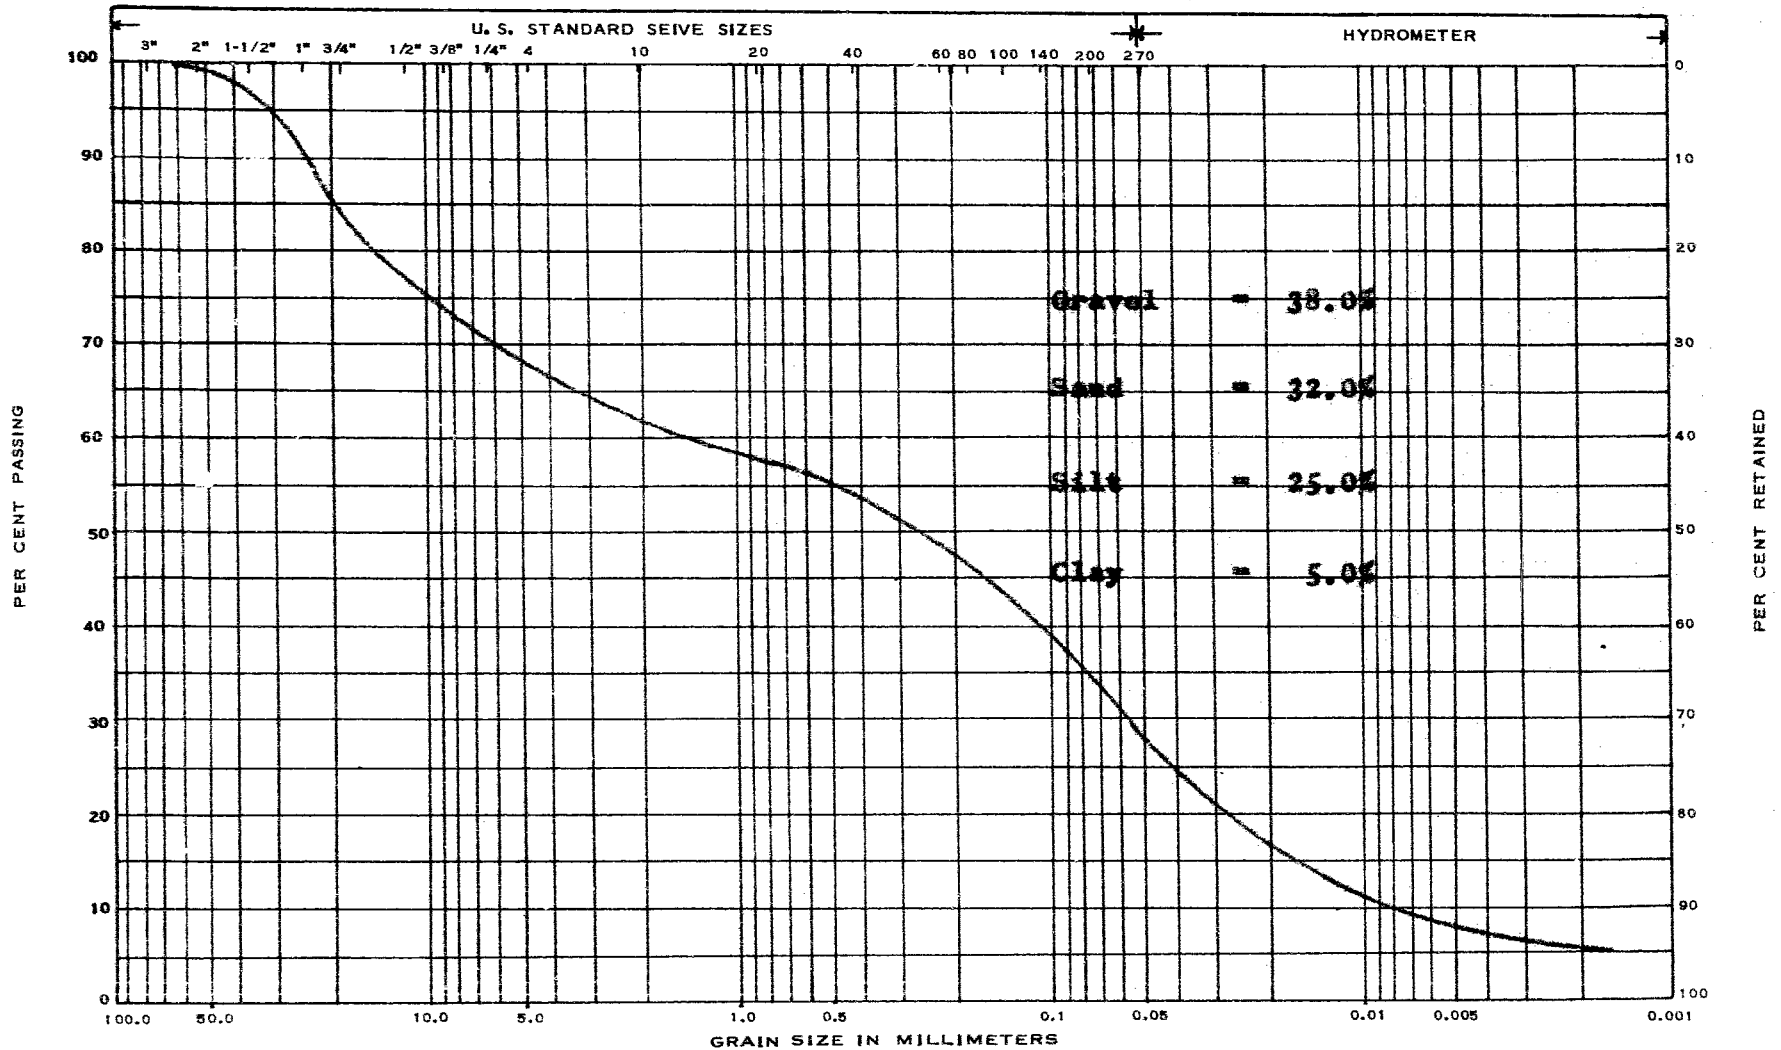
STONES	GRAVEL	COARSE SAND	MED. SAND	FINE SAND	COARSE SILT	MED. SILT	FINE SILT	CLAY
--------	--------	-------------	-----------	-----------	-------------	-----------	-----------	------

MASS. INST. OF TECH. CLASSIFICATION
