**Geotechnical Investigation
Proposed Adolphustown Ferry Dock Improvement
Project No. 686941
Bay of Quinte, Ontario**

**Public Works Canada
4900 Yonge Street
Willowdale, Ontario
M2N 6A6**

Trow Consulting Engineers Ltd.

**H03435-G
September 22, 1994**

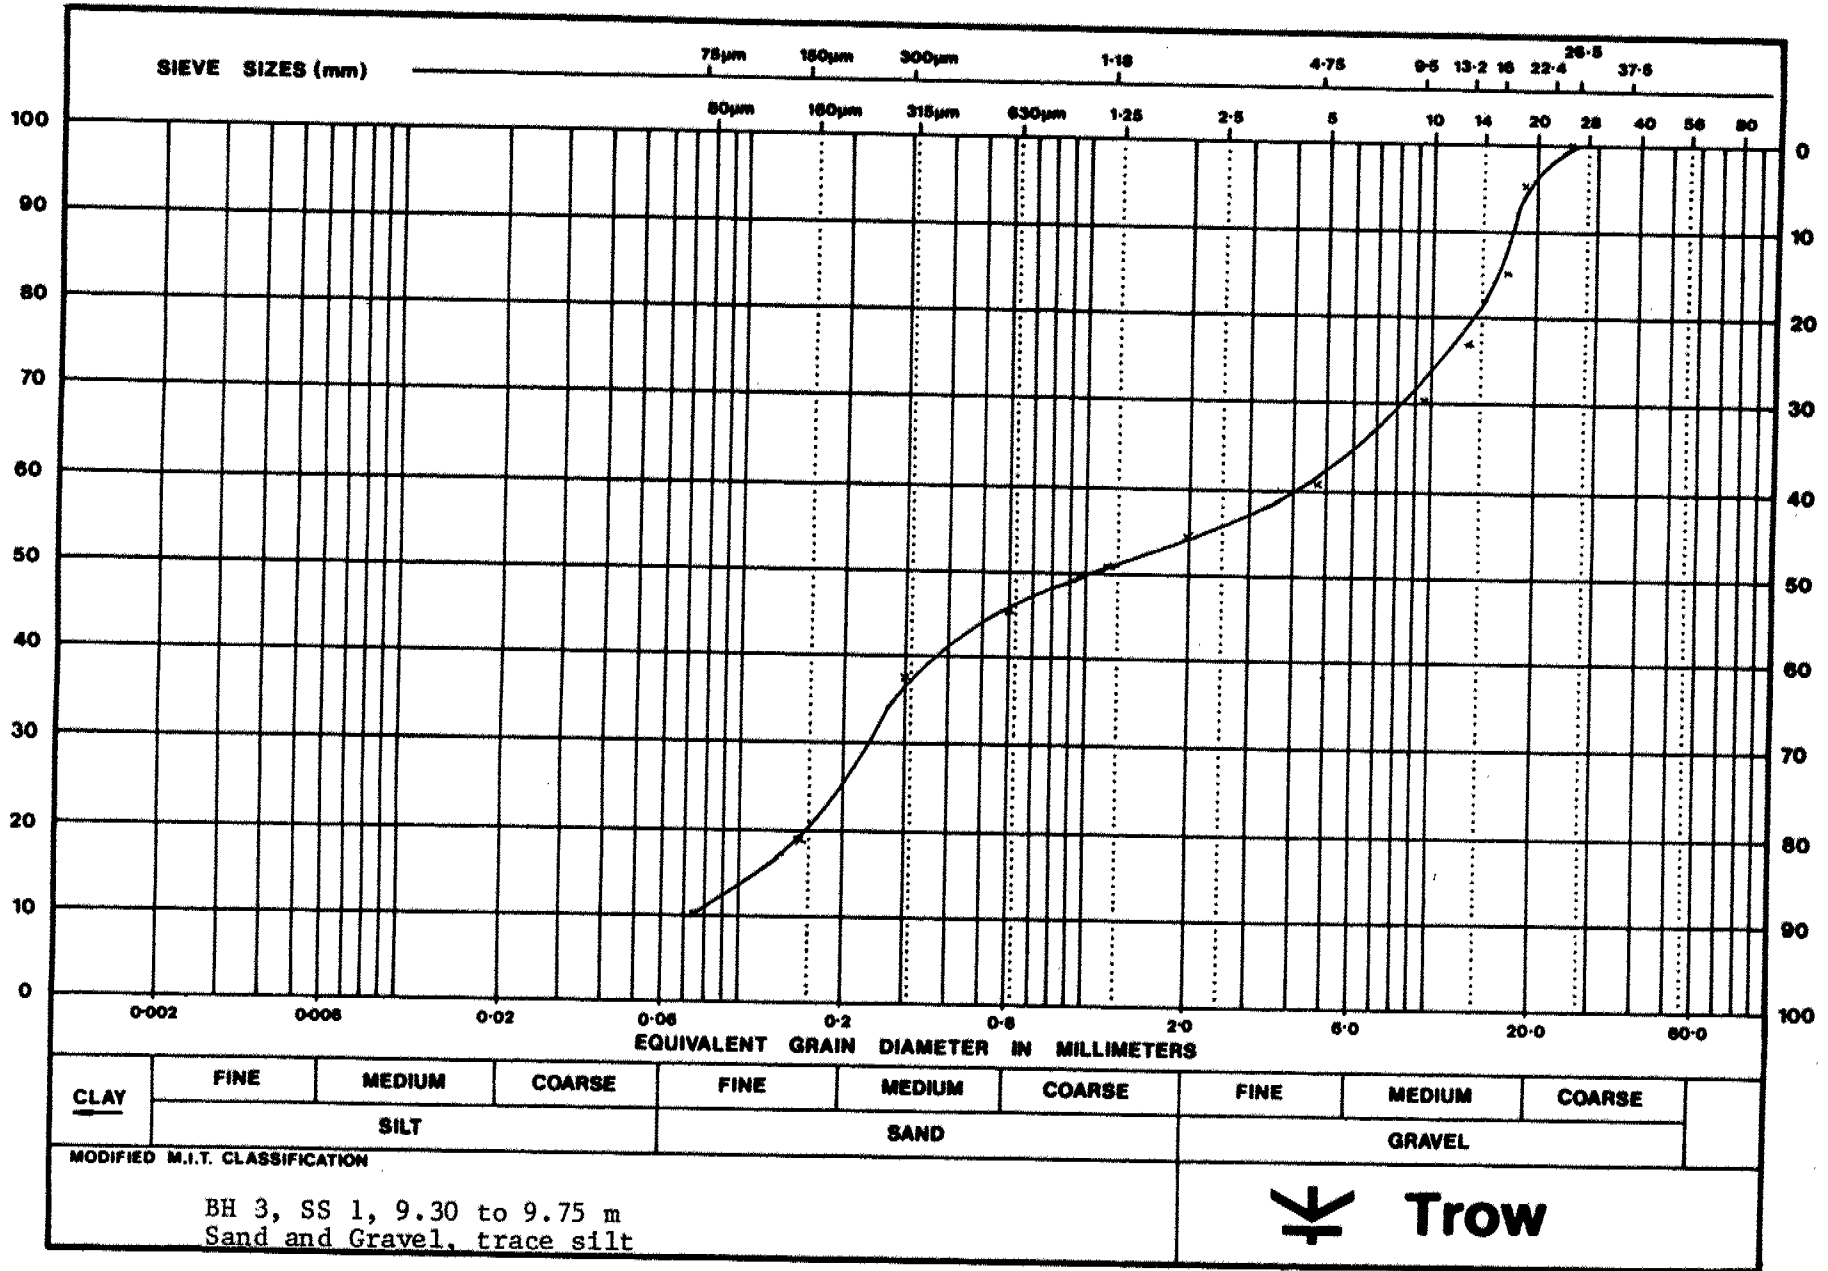
DRAWING 11.

GRAIN SIZE ANALYSIS - ASTM D 422

- natural moisture content tests on all recovered samples, with results presented on the Log of Borehole sheets;
- grain size analysis on two samples, with results presented on Drawings 11 and 12, and;
- point load tests on upper 1.5 m of bedrock with results presented in Table 1.
