**GIFFELS ASSOCIATES LIMITED
HYDROGEOLOGICAL SCREENING
PROPOSED HIGHWAY 28 REALIGNMENT
TOWNSHIP OF DOURO-DUMMER, LAKEFIELD, ONTARIO**

HYDROGEOLOGICAL SCREENING

PROPOSED HIGHWAY 28 REALIGNMENT

TOWNSHIP OF DOURO-DUMMER, LAKEFIELD, ONTARIO

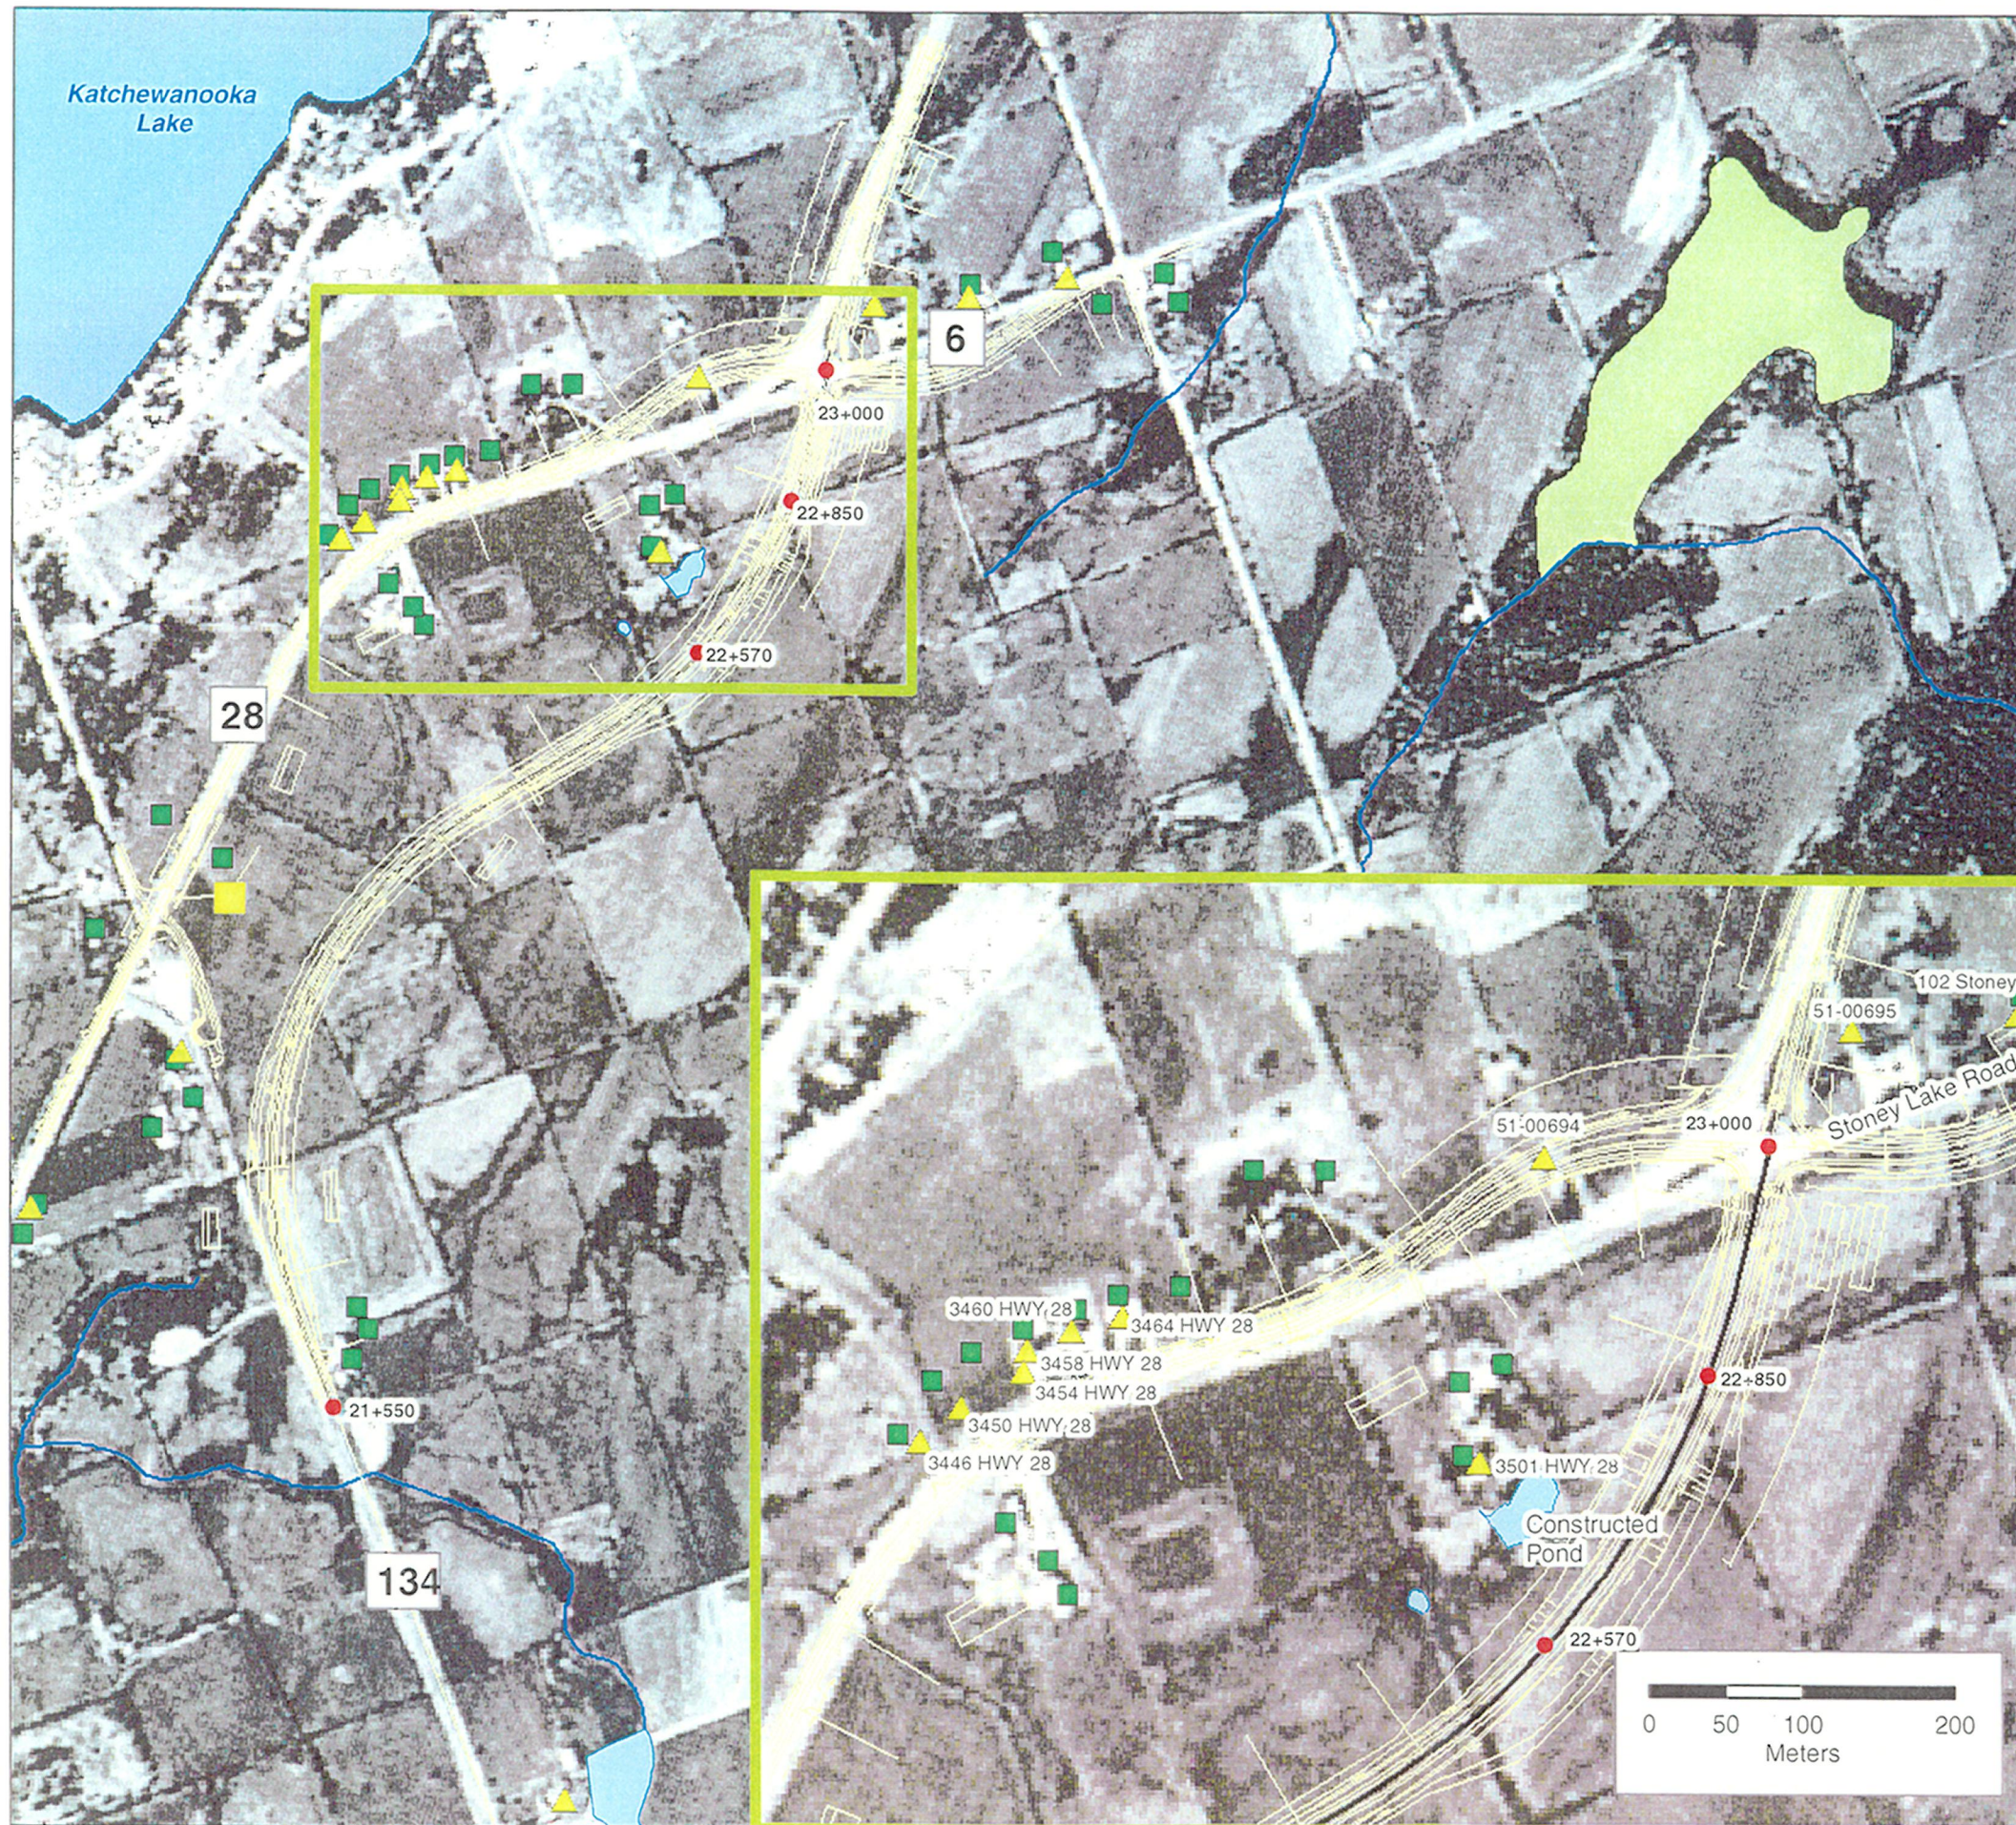
Drawing No.: 2

Water Wells and Surface Water Bodies

Water wells surveyed during the site reconnaissance are shown in Drawing No.2. The water well survey included in this step of the investigation consisted of a visual inspection of the wells to obtain data on physical condition, water levels, current usage of wells within the area of realignment. Depth to groundwater ranged from 2 to 6.4 m below grade surface. Several homeowners also reported bacteriological problem with their wells until they raised the well standpipe at least 30 centimetres (cm) above the ground surface. Almost all of the wells are drilled and bedrock wells, except the dug well at 3501 Highway 28. Groundwater elevations from many of the water wells could not be measured due to the presence of pumps, pipes, sealed well covers, and other obstructions. Locations of water wells currently in use were measured using a Magellan[®] Global Positioning System receiver with sub-centimetre accuracy.

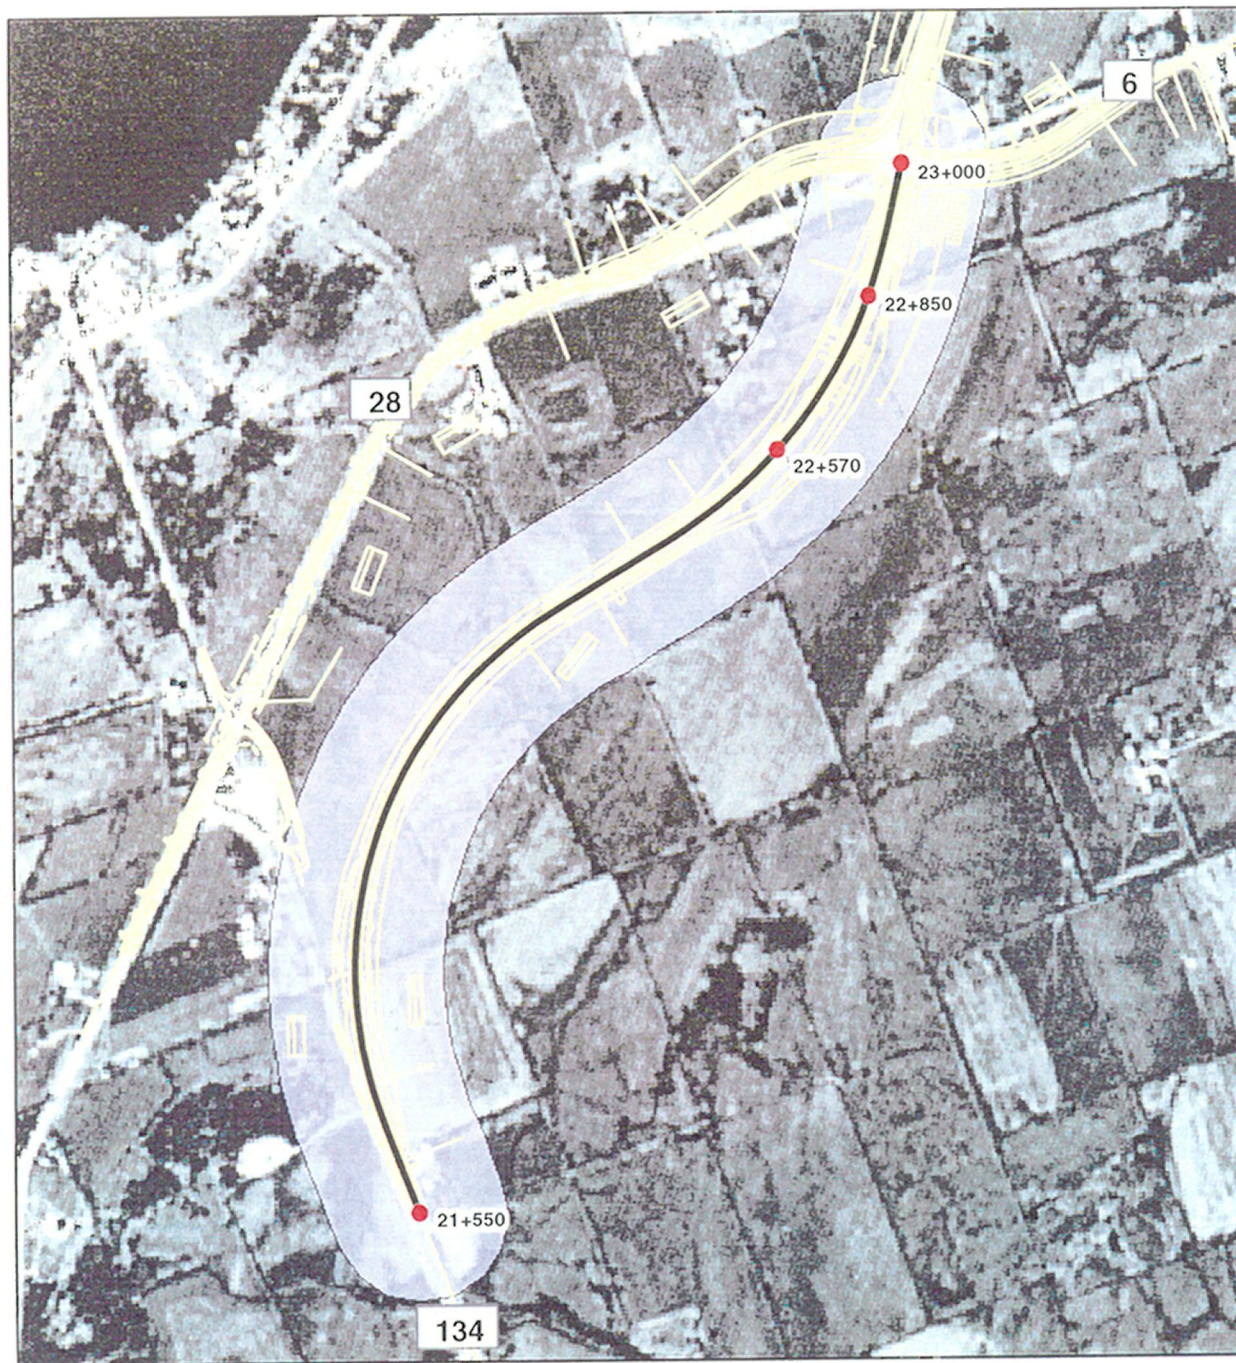
Drawing No.: 3

- Station
- HWY 28 Re-alignment
- Centre Line Re-alignment
- Till: Undifferentiated

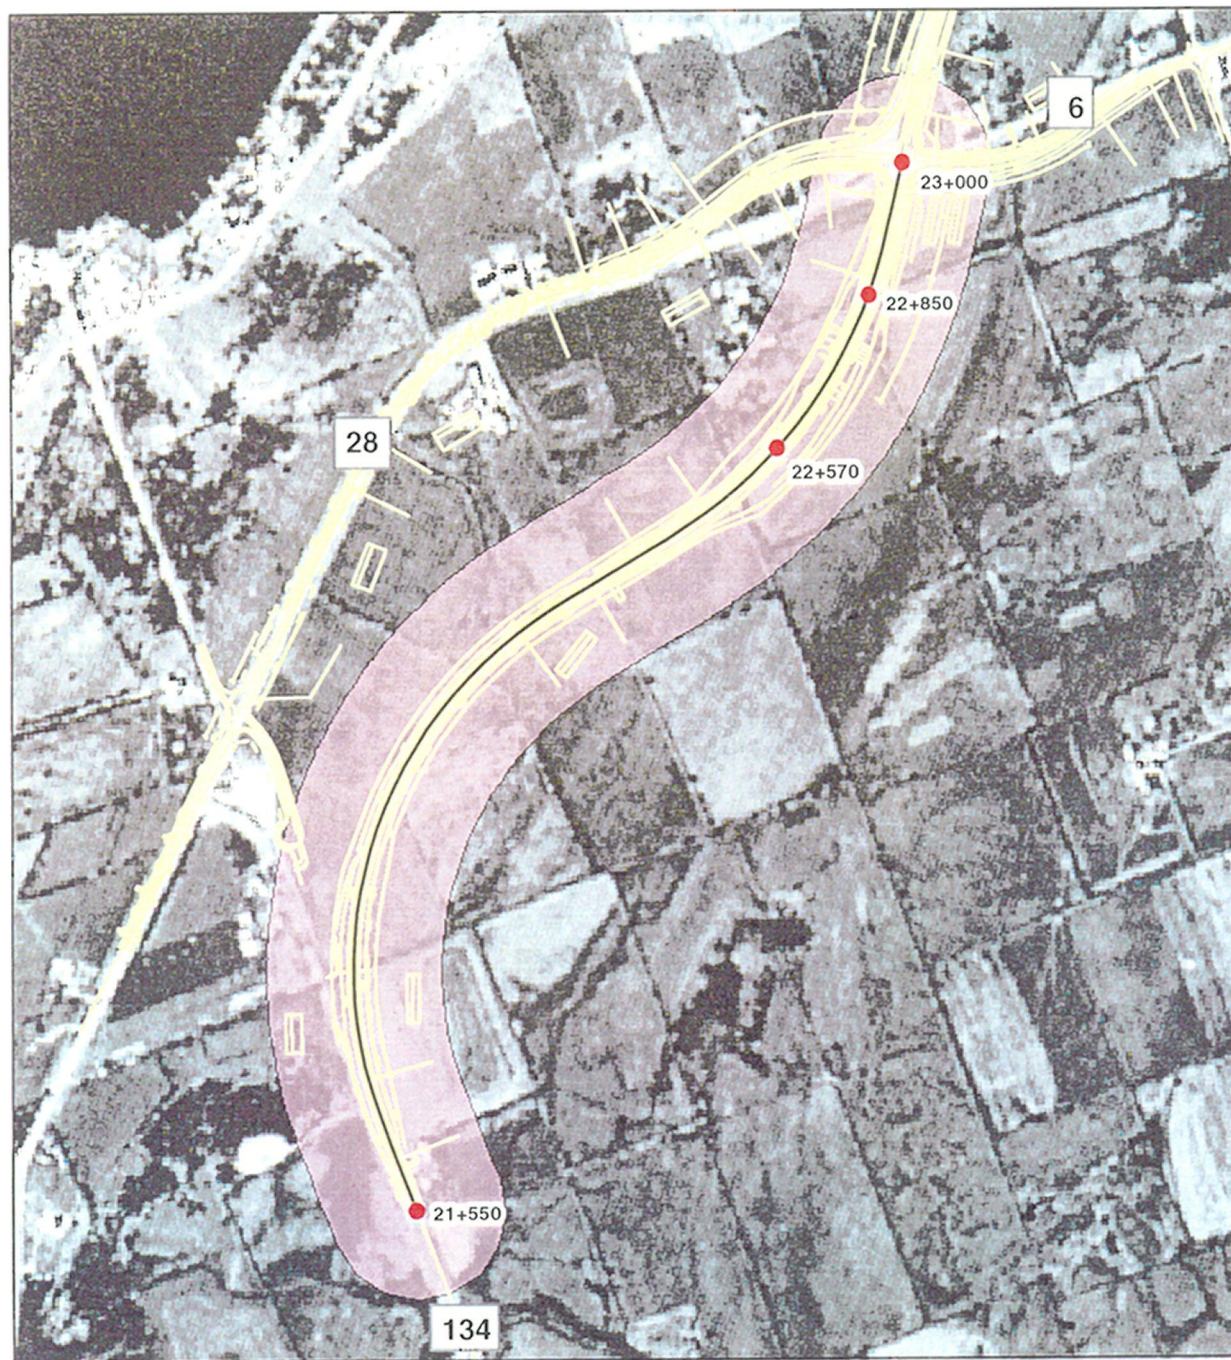
- Station
- Centre Line Re-alignment
- HWY 28 Re-alignment
- Limestone, dolostone
Shale, Arkose, Sandstone

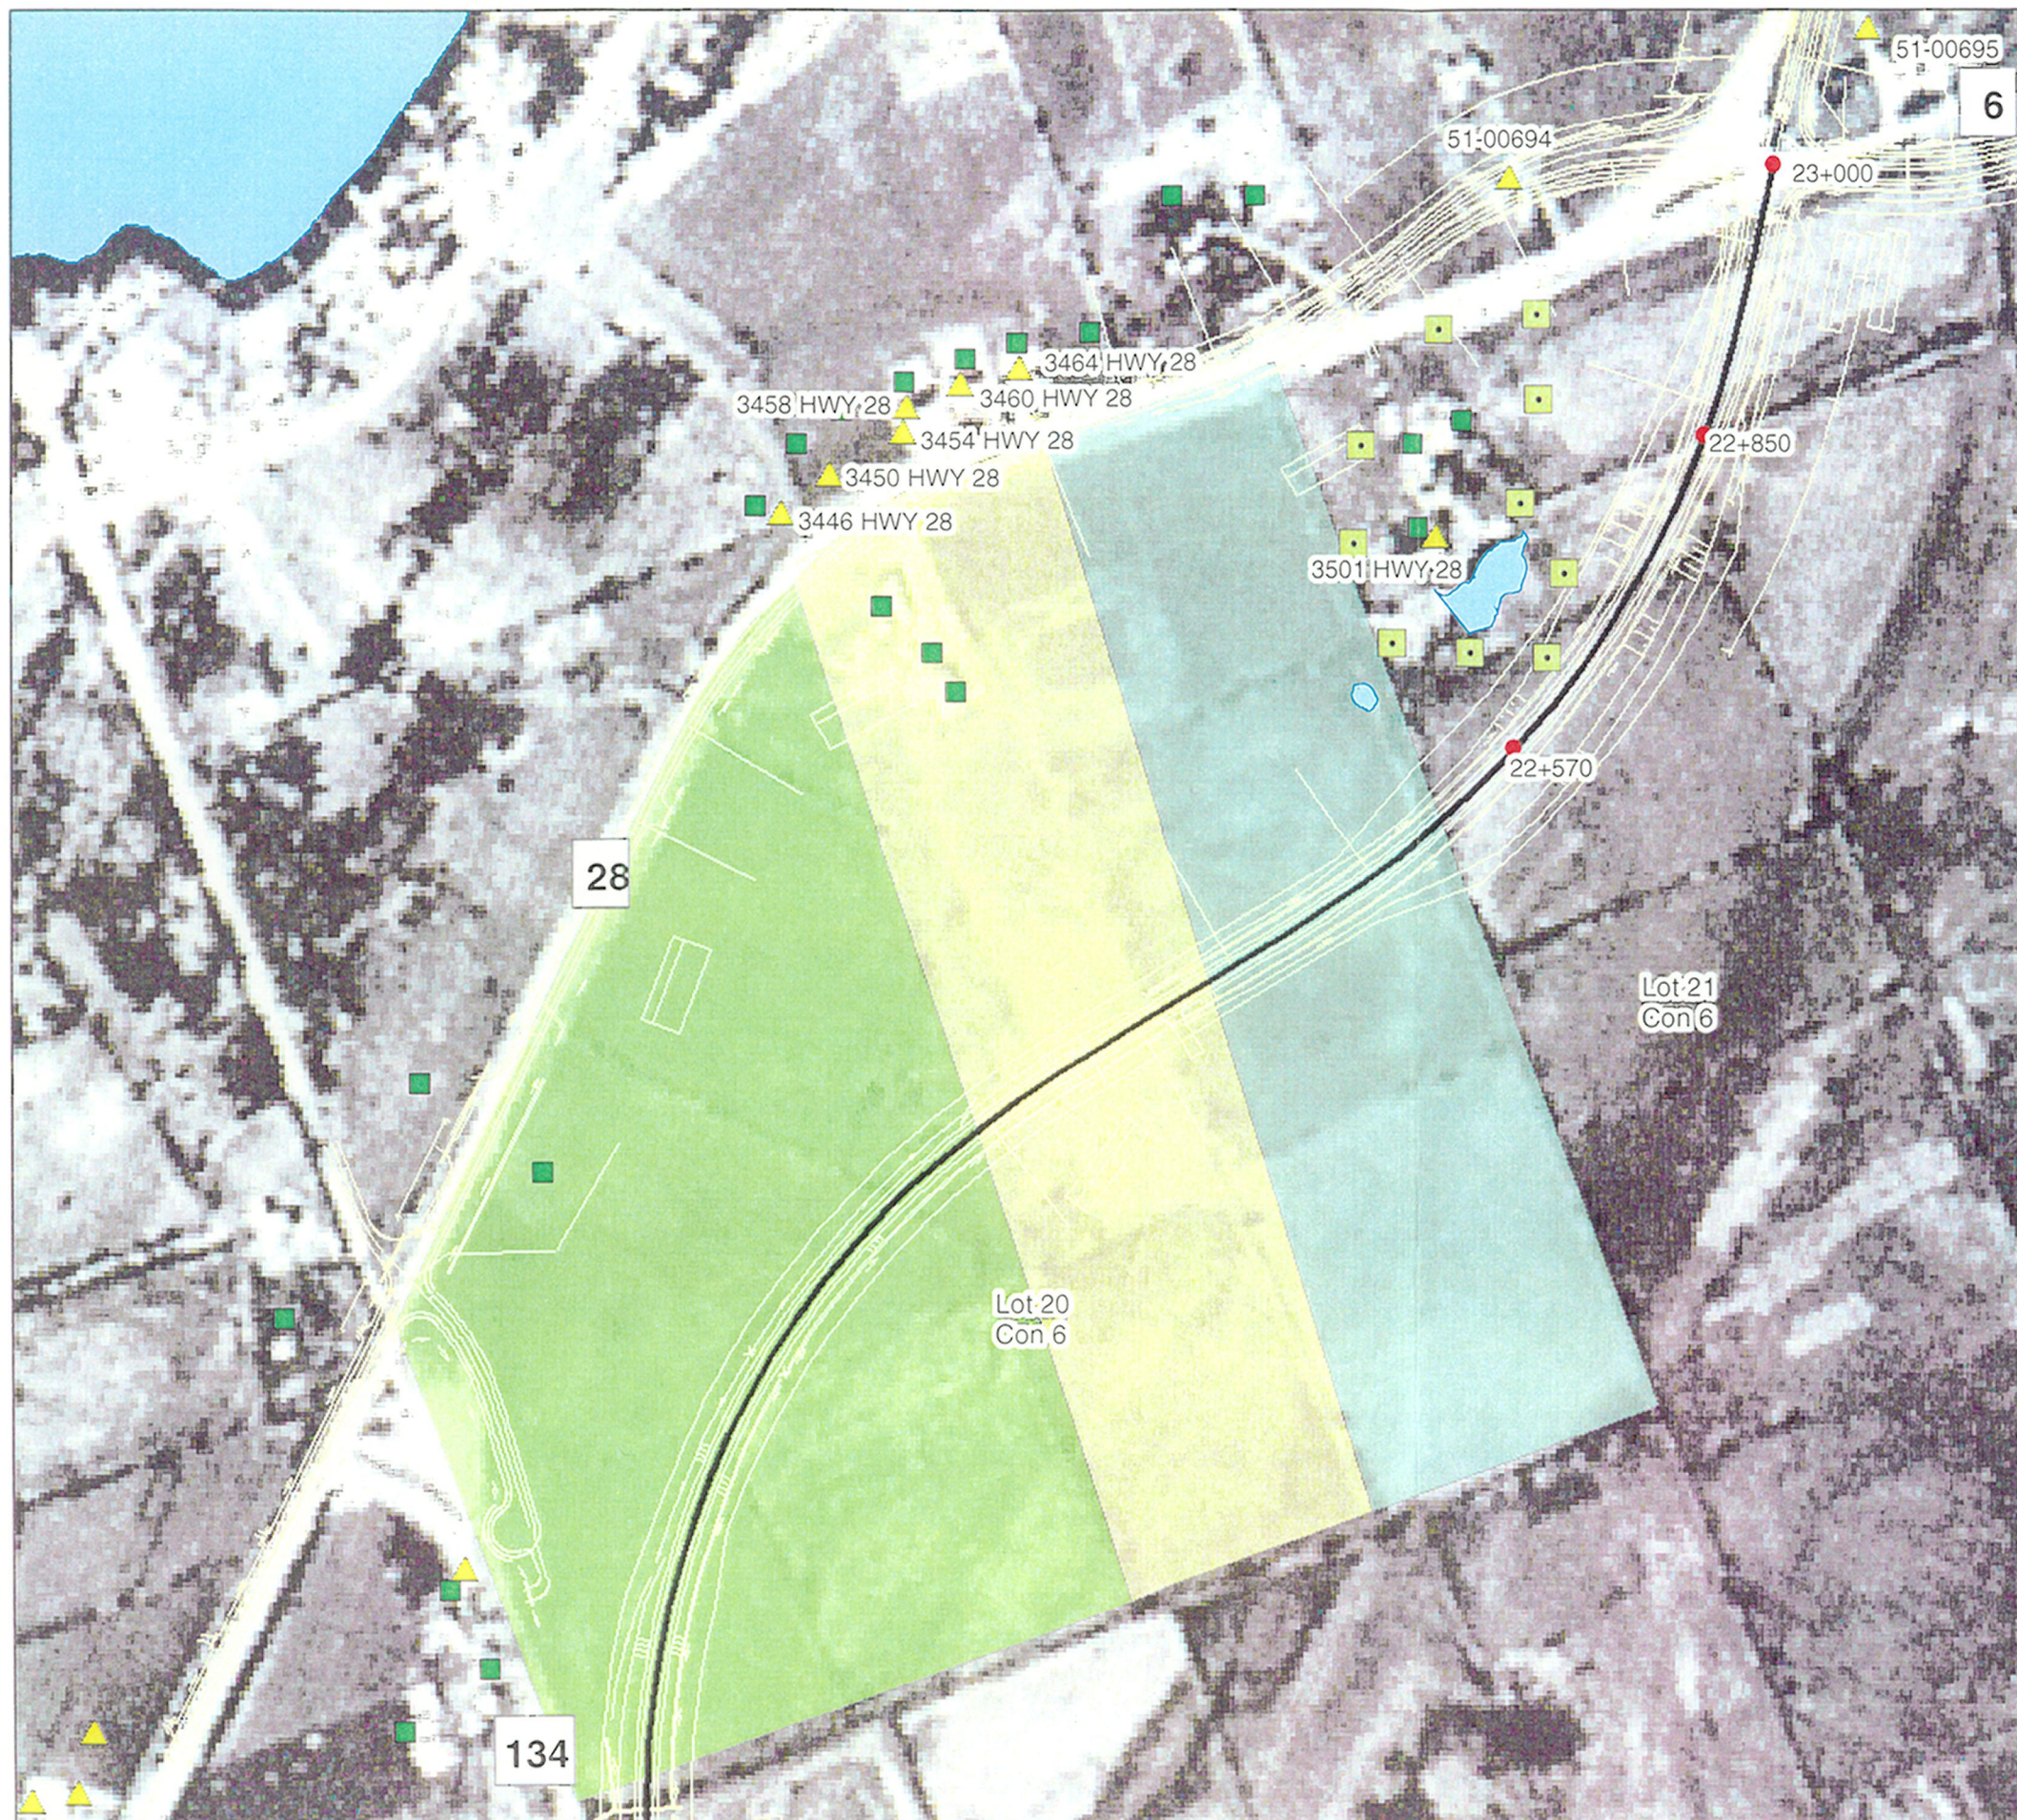
Drawing No.: 5

- Station
- Proposed Monitoring Well Location
- HWY 28 Re-alignment
- Centre Line Re-alignment
