RETAINING WALL AT PORT CARLING
WP 401-64-02, HWY 118
DISTRICT # 11 - HUNTSVILLE

FOUNDATION INVESTIGATION REPORT

FOUNDATION INVESTIGATION REPORT
For
Proposed New Structure and
Related Retaining Walls at the
Crossing of Hwy. #118 (Line 'E') and
Indian River
Village of Port Carling - Dist. of Muskoka
District No. 11 (Huntsville)
W.O. 71-11074 -- W.P. 401-64

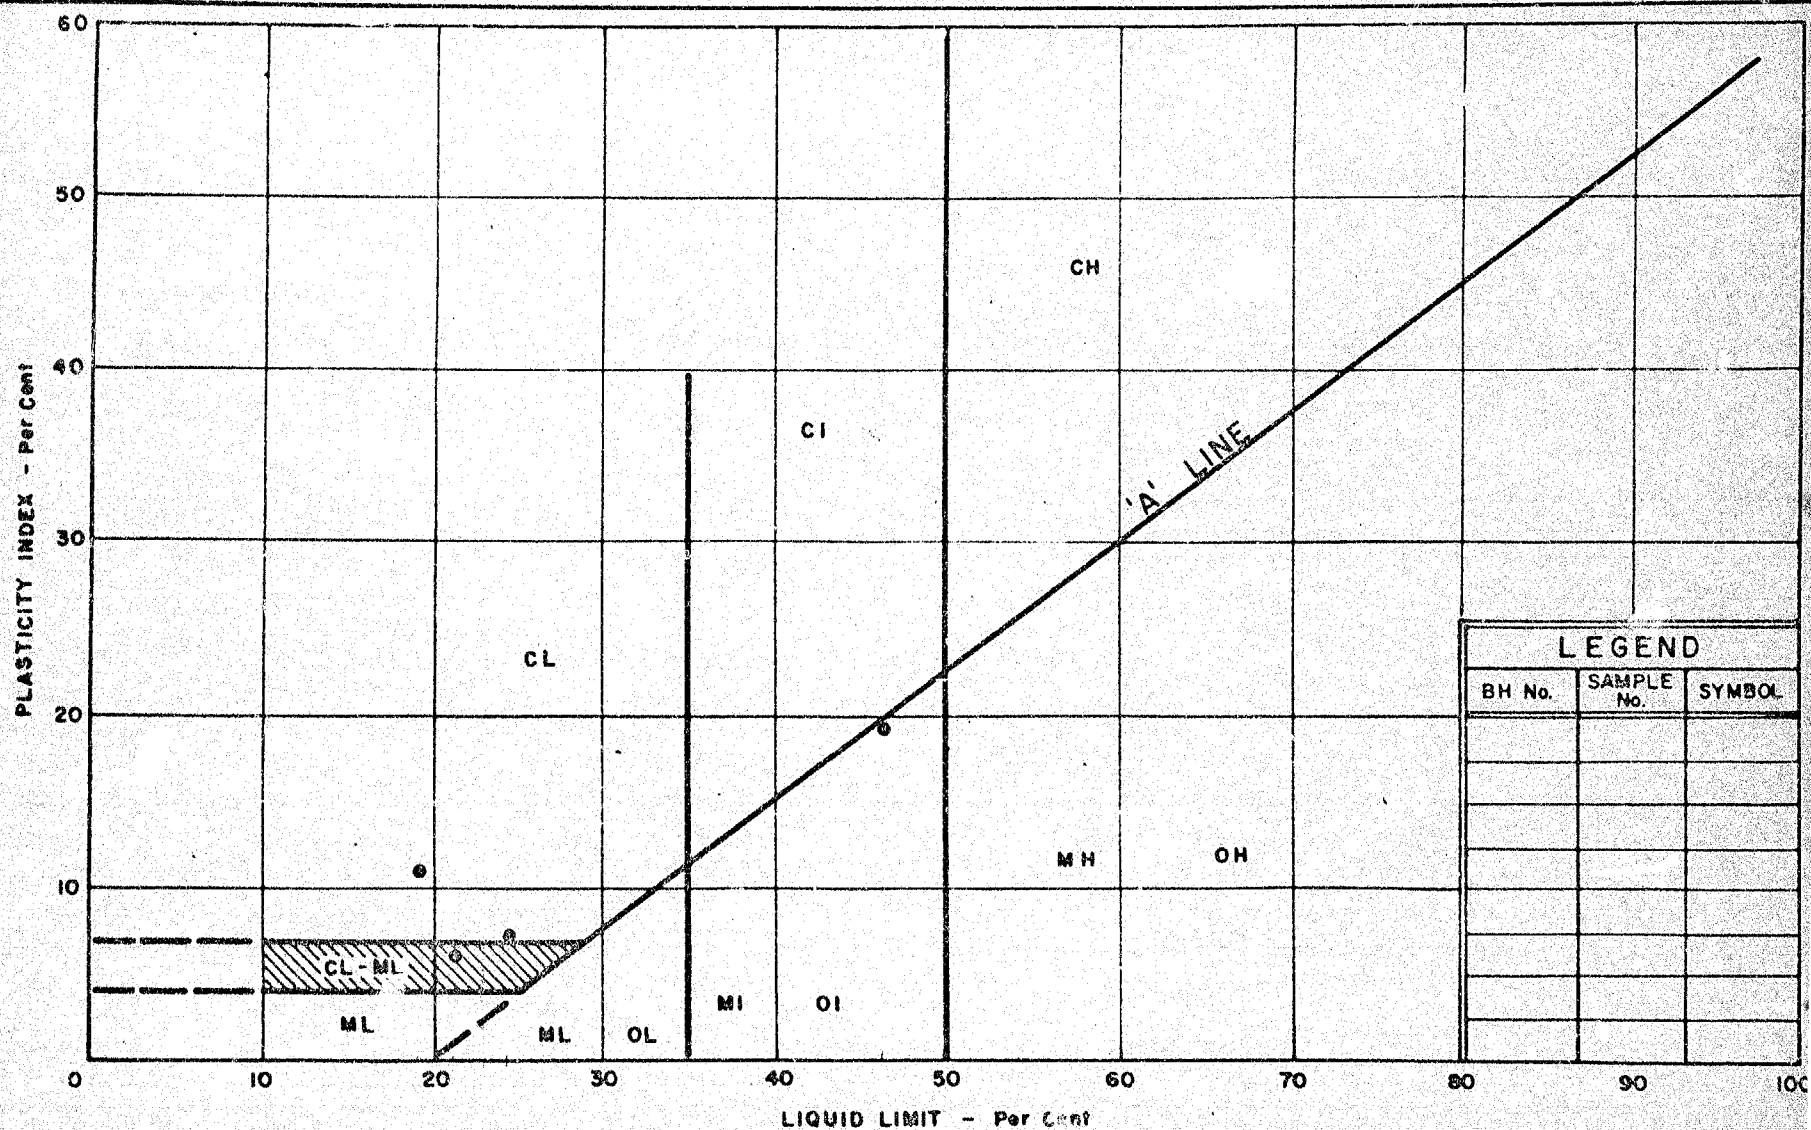
FIG. 2

At B.H.'s #9 and 11 a deposit of firm to hard ('N' values 4 blows/ft. to greater than 100 blows/ft.) clayey silt with sand and gravel is sandwiched within the parent granular deposit, while at B.H. #5 the cohesive material directly overlies bedrock. The thickness of this deposit ranges from 3.5 to 5.5 feet. Numerous sand and silt seams and layers, up to 4 inches thick, are present throughout the deposit. Grain-size distribution curves were obtained for three samples of the cohesive material; these are plotted on Figure #2 in the Appendix.

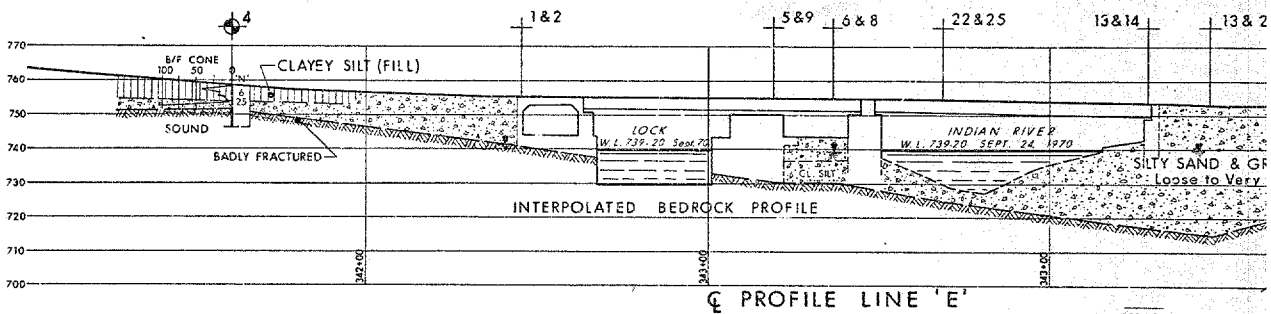
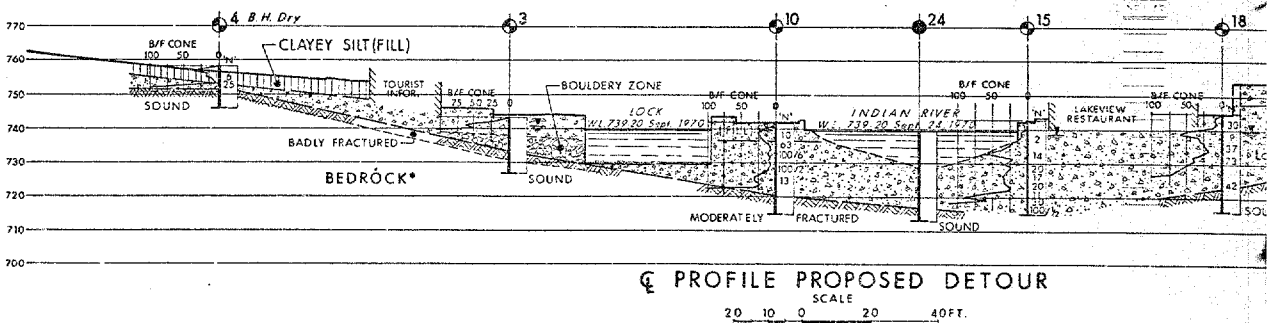
BORE HOLE LOCATIONS & SOIL STRATA

- Bore Hole
- Cone Penetration Test
- Bore Hole & Cone Test
- Water Levels established at time of field investigation
Aug. & Sept. 1971

NO.	ELEVATION	STATION	OFFSET
1	744.5	342+44	26' RT.
2	745.0	342+48	20' LT.
3	743.7	342+47	53' RT.
4	758.4	341+63	28' RT.
5	744.8	343+15	21' LT.
6	743.9	342+33	21' LT.
7	744.4	343+24	26' LT.
8	743.1	343+37	13' RT.
9	743.0	343+20	18' RT.
10	741.7	343+24	50' RT.
11	741.5	343+39	36' RT.
12	741.3	344+51	40' LT.
13	749.2	344+31	28' LT.
14	752.0	344+28	10' RT.
15	742.6	343+97	64' RT.
16	742.5	342+89	92' RT.
17	742.5	343+85	120' RT.
18	744.9	344+57	50' RT.
19	754.8	345+44	12' RT.
20	745.0	342+67	38' LT.
21	743.7	343+51	34' LT.
22	739.5	343+66	20' LT.
23	739.5	343+57	20' RT.
24	739.5	343+66	51' RT.
25	739.5	343+65	20' RT.
26	752.5	344+47	16' RT.

** FOR DETAILS SUCH AS LOCATION & SIZE OF BOULDERS SEE BOREHOLE LOG SHEETS

* FOR DETAILED BEDROCK DESCRIPTION BOREHOLE LOG SHEETS

The soil, bedrock and groundwater conditions, encountered at those borings put down at the proposed site are presented on the Record of Borelog sheets appended to this report. The location and elevation of each of the boreholes were provided by personnel from the Regional Engineering Surveys Section (North Bay). The elevations in this report are referenced to a Geodetic datum.

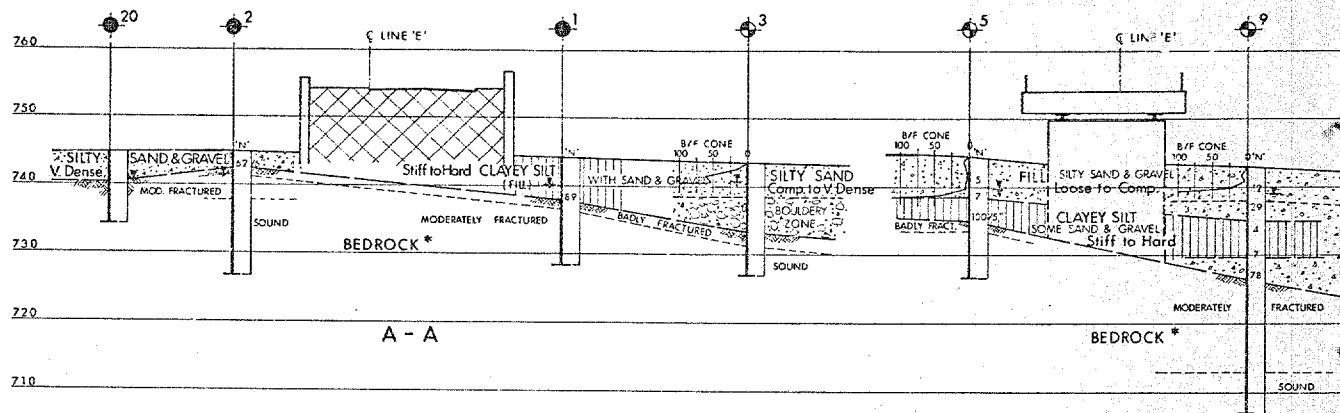
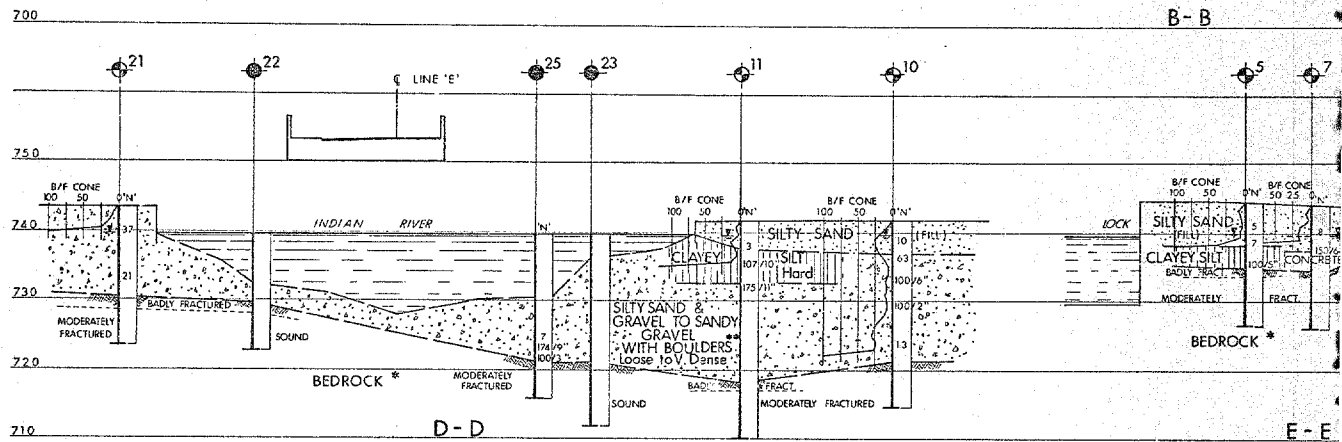
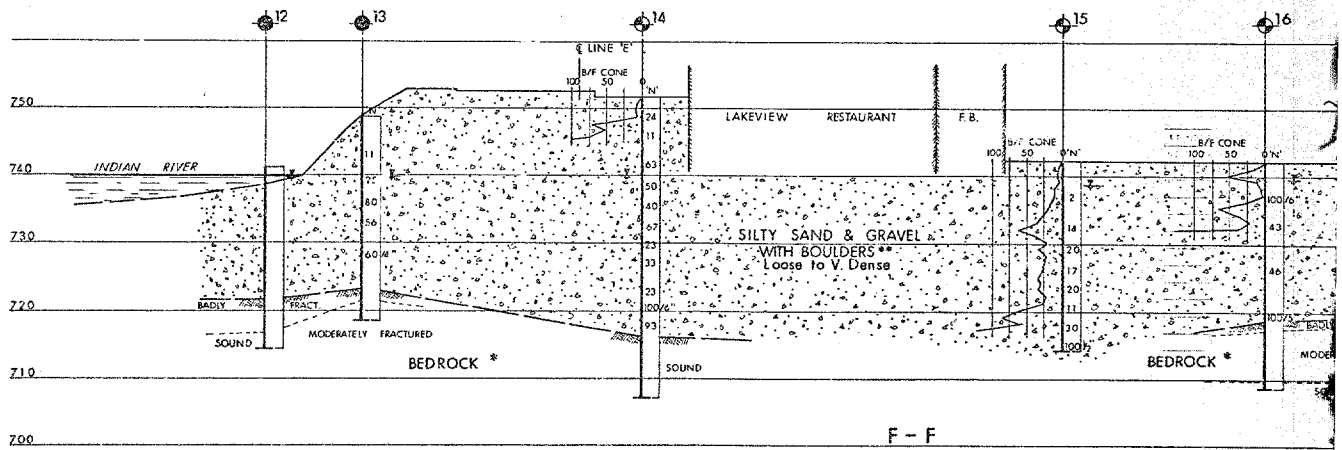
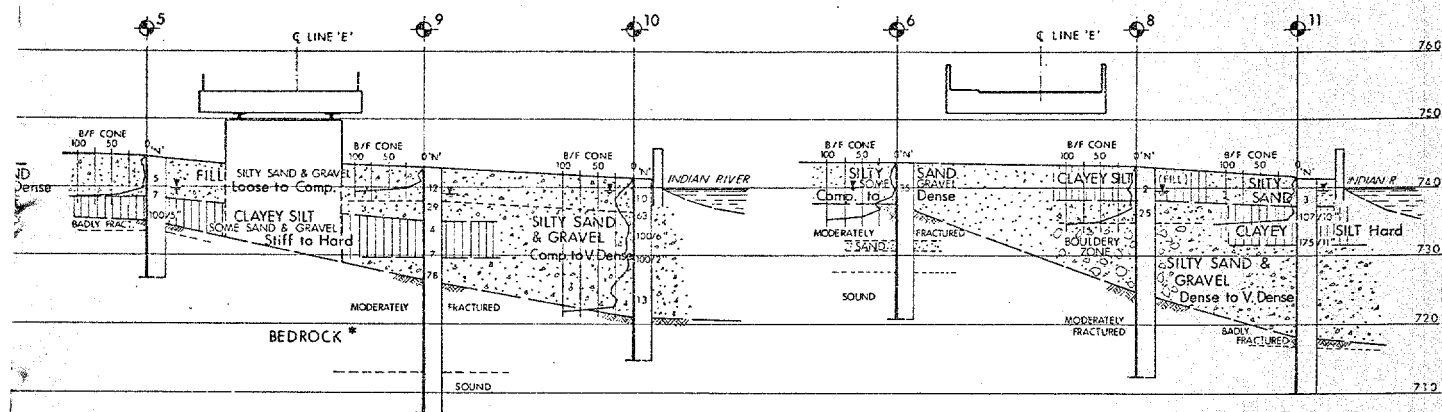
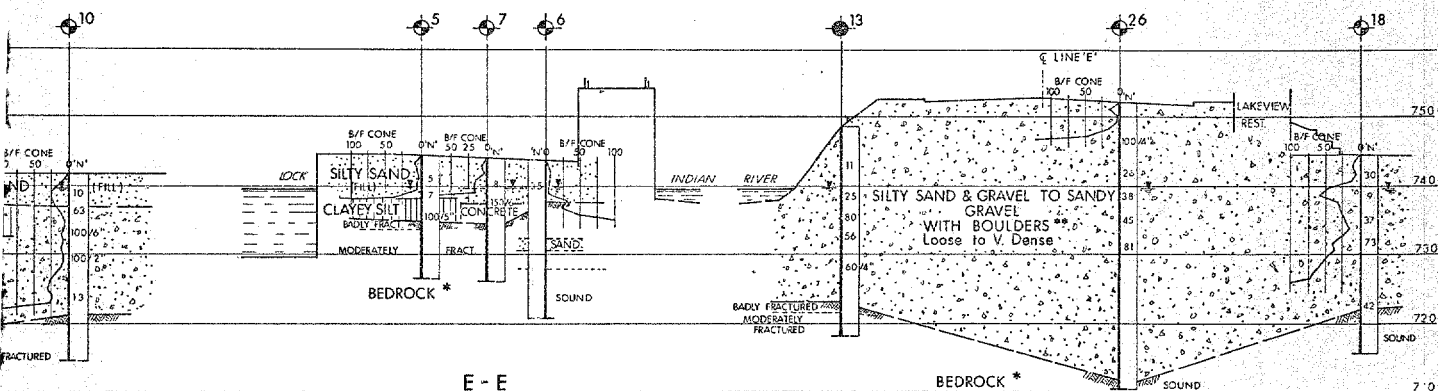
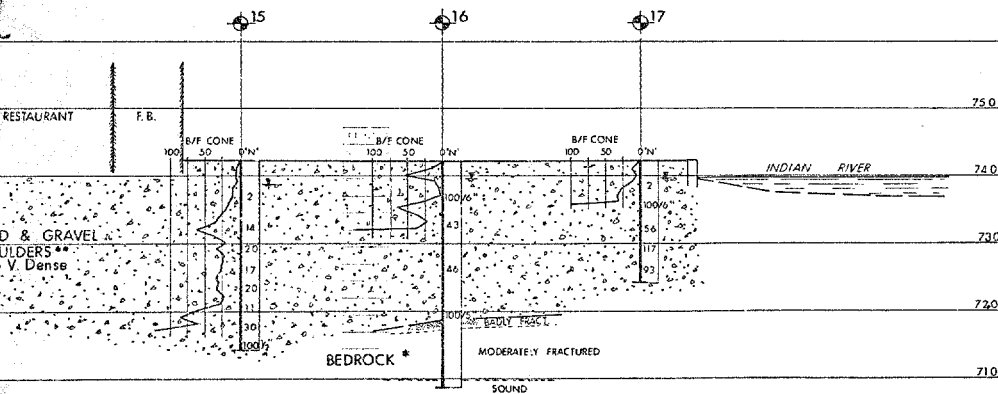
F - F
SECTIONS

B - B

C - C

E - E

G - G

— NOTE —
The boundaries between soil strata have been established only at Bore Hole locations. Between Bore Holes the boundaries are assumed from geological evidence and may be subject to considerable error.
