**FOUNDATION INVESTIGATION AND DESIGN REPORT
STRUCTURAL CULVERT No. 29-242/C1
HIGHWAY 17 DEIL'S CREEK CULVERT
TOWNSHIP OF HORTON, ON
G.W.P. 4076-13-00
AGREEMENT NUMBER: 4016-E-0014**

**JUNE 2018
20479**

HIGHWAY 17
DEIL'S CREEK
CULVERT REHABILITATION
BOREHOLE LOCATIONS AND SOIL STRATA

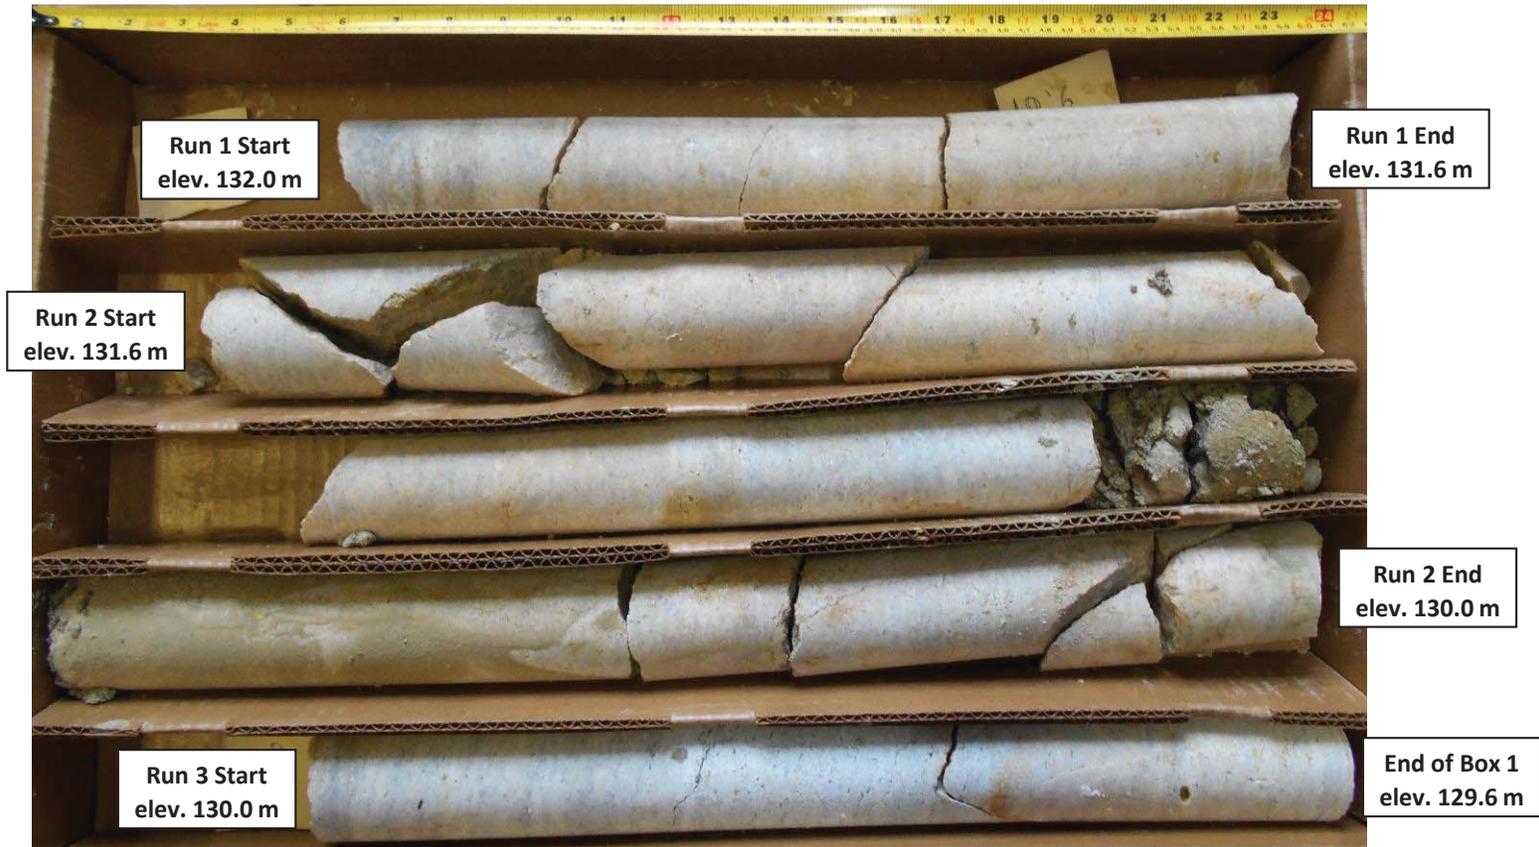
Borehole 17-1
Box 1 (of 2)
Elevation 132.0 m to 129.6 m

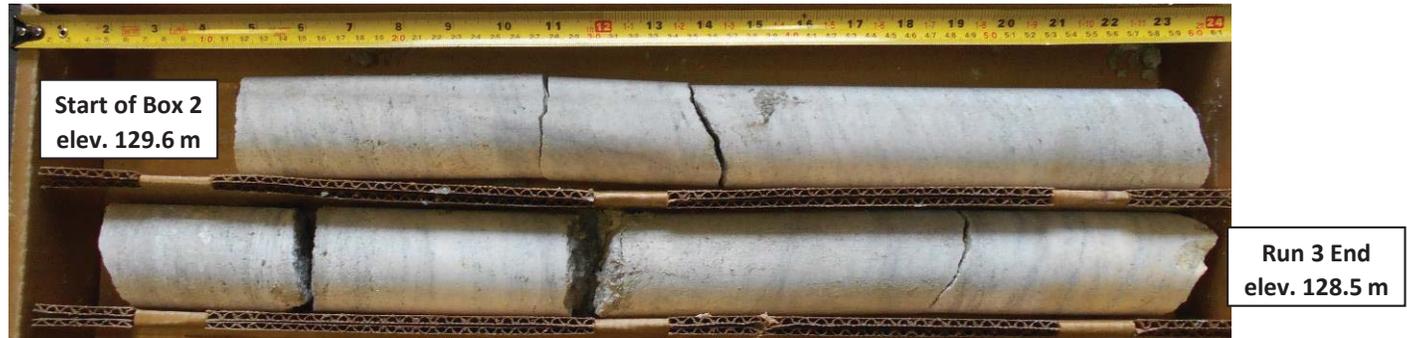
Borehole 17-1
Box 2 (of 2)
Elevation 129.6 m to 128.5 m

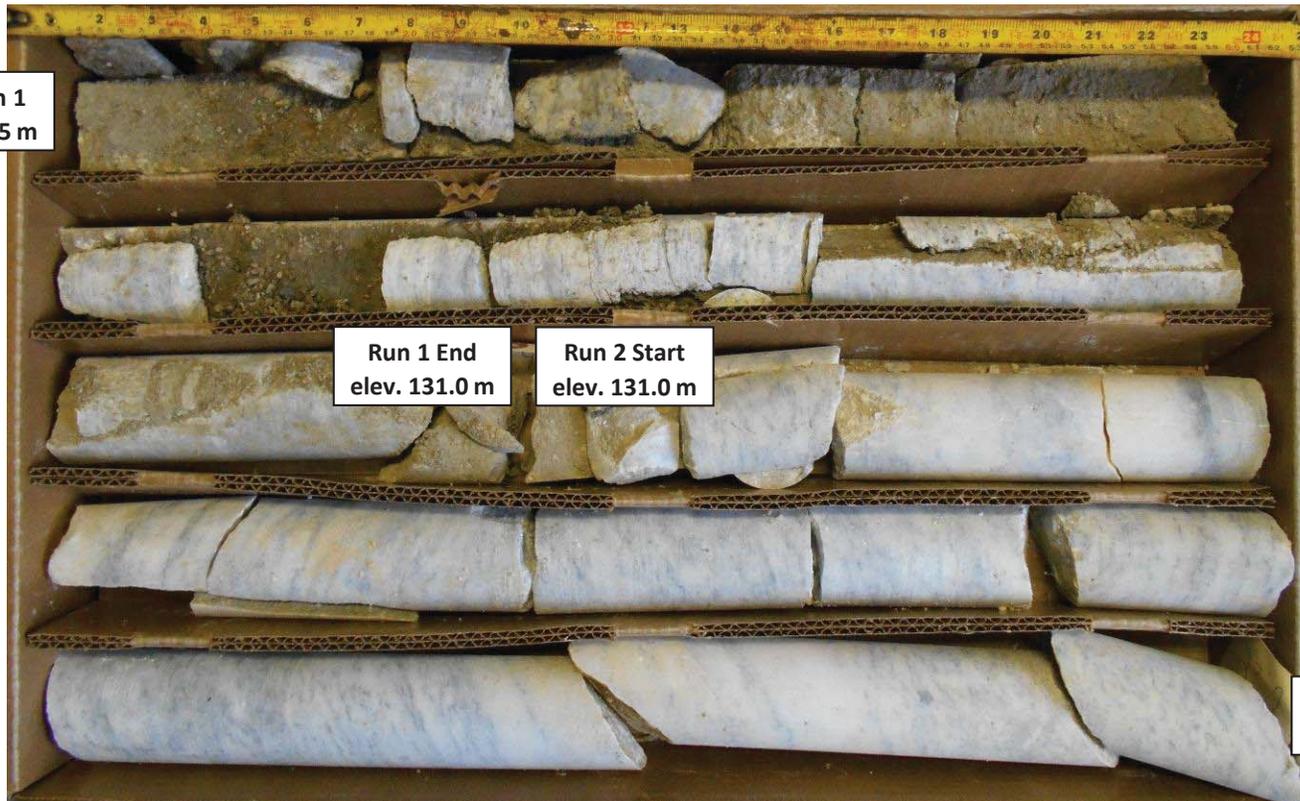
Borehole 17-2
Box 1 (of 1)
Elevation 132.6 m to 129.5 m

Start Run 1
elev. 132.5 m

Run 1 End
elev. 131.0 m

Run 2 Start
elev. 131.0 m

Run 2 End
elev. 129.5 m

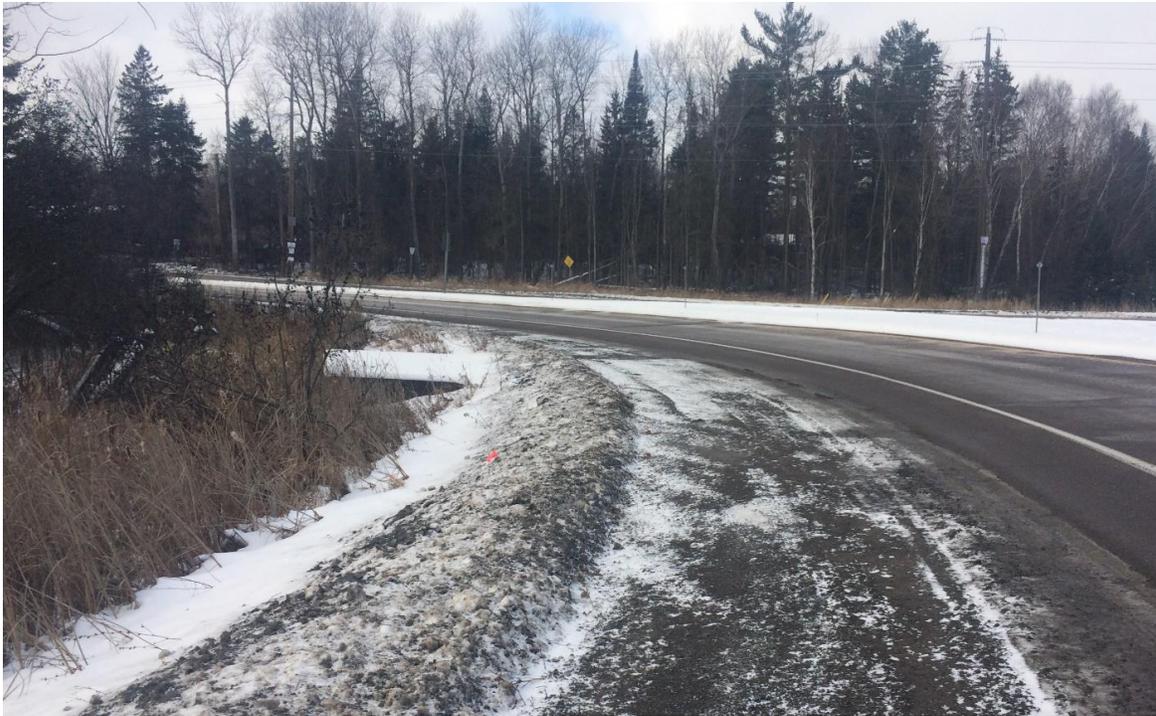
Photograph 1: Roadway platform and embankment at culvert inlet looking southwest

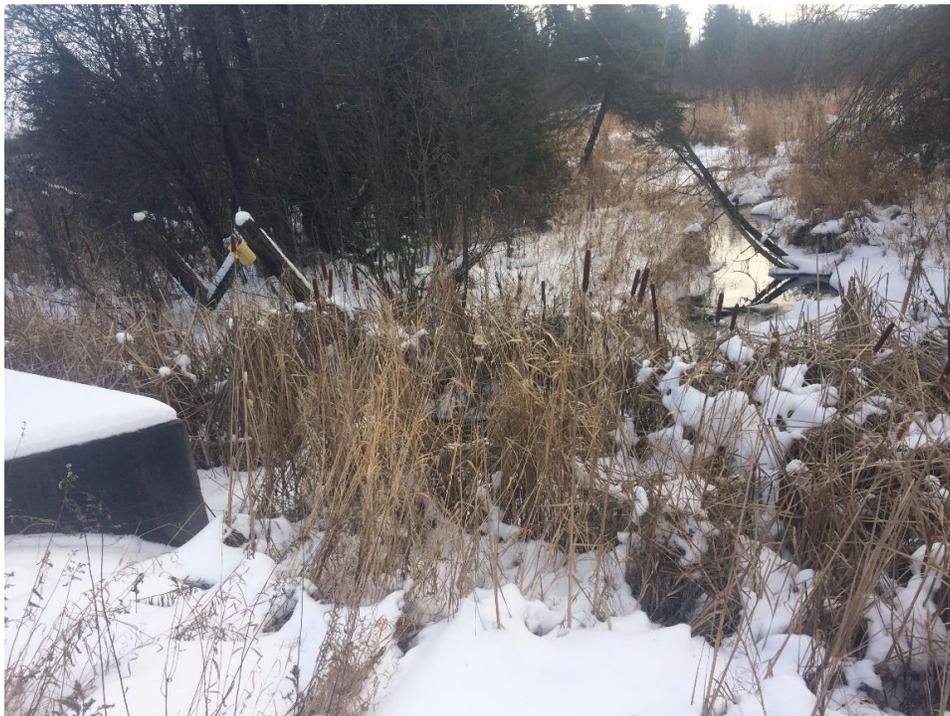
Photograph 2: Looking upstream from culvert inlet

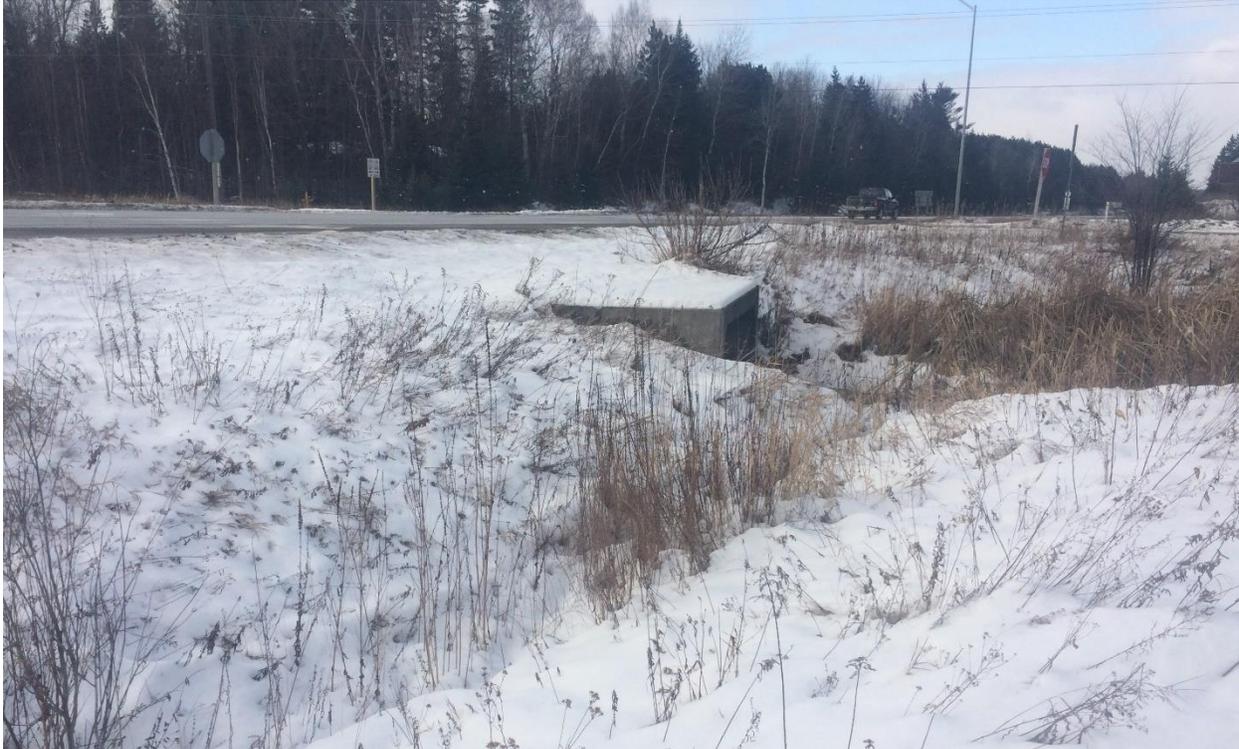
Photograph 3: Looking west along ditchline towards the existing culvert outlet

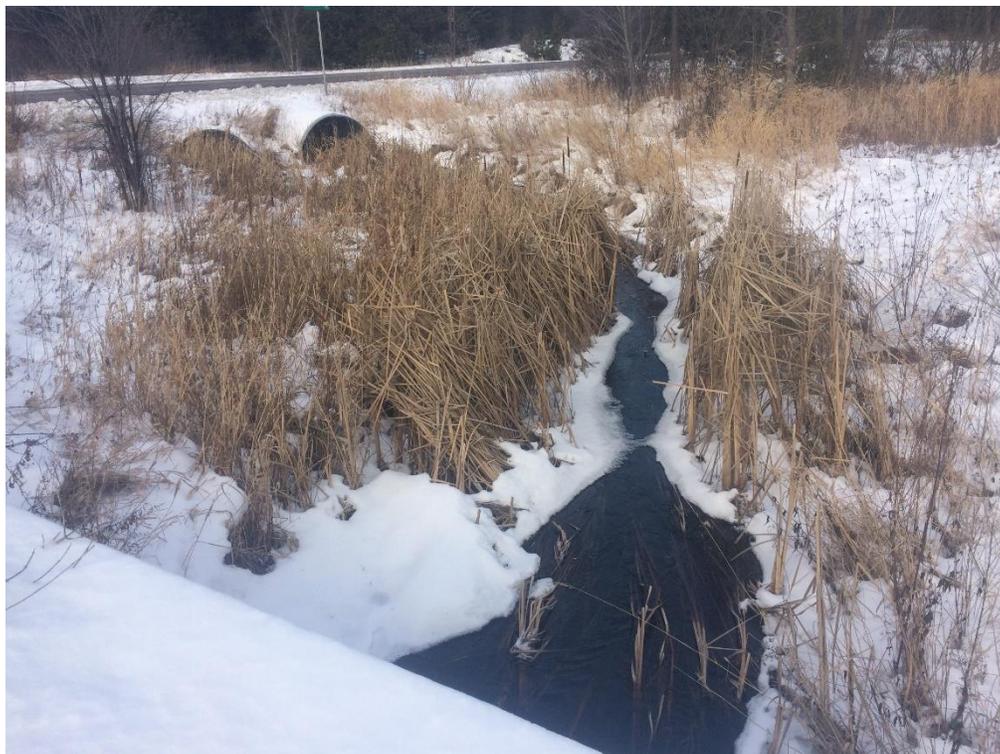
Photograph 4: Looking downstream from culvert outlet

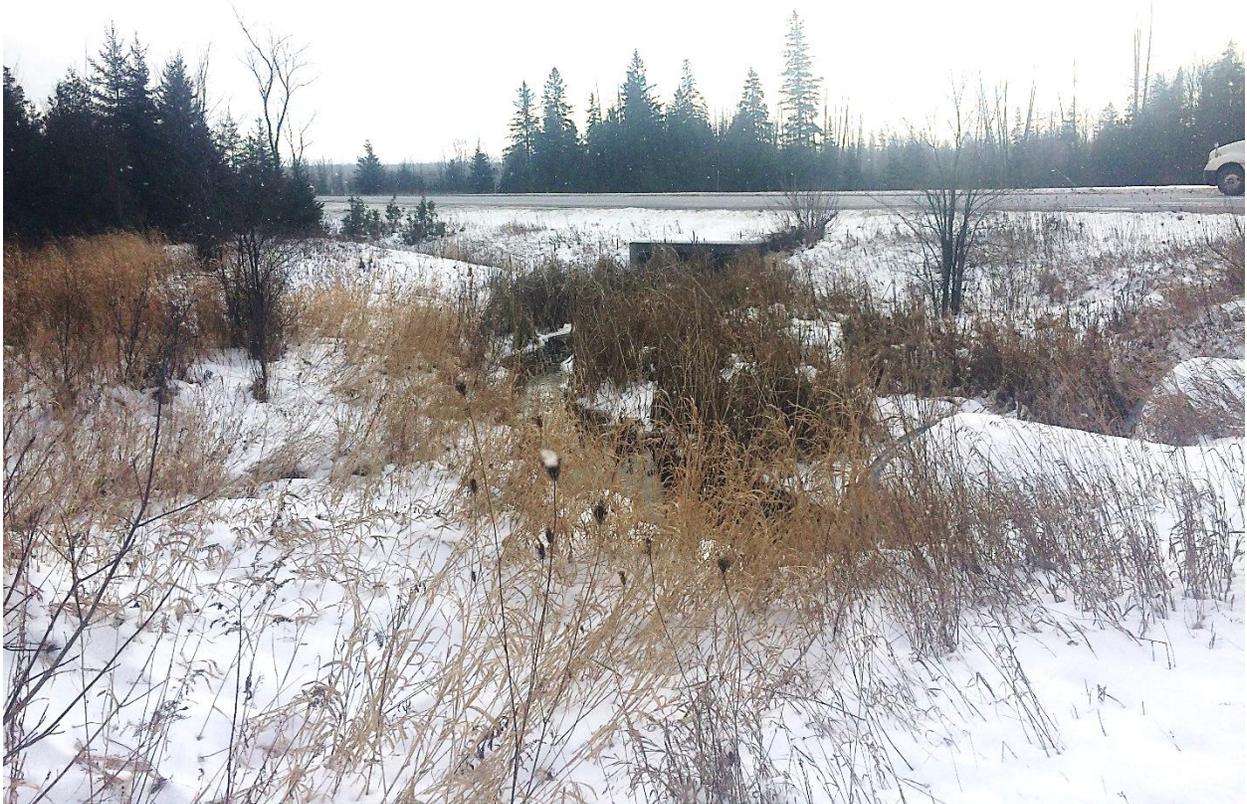
Photograph 5: Looking southeast from County Road 6 towards culvert outlet
