REPORT OF SOIL INVESTIGATION

SITE OF PROPOSED NEW CULVERT AND FILL

STATION 327 + 60

DUNROBIN ROAD

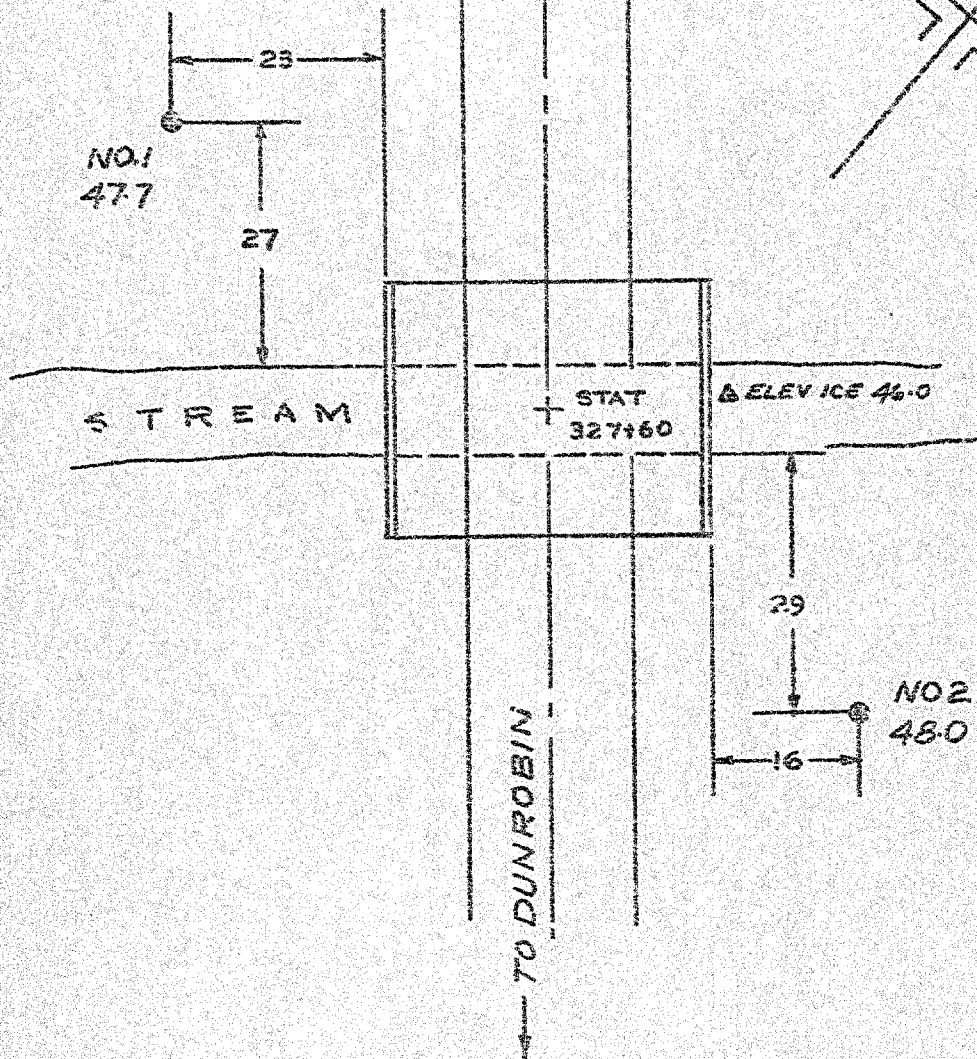
BM. ELEV. 52.92  
NAIL IN HYDRO POLE  
39' LT OF STA 328+03

TEST BORING PLAN  
PROPOSED CULVERT  
LOT 10 CON III  
TORBOLTON TOWNSHIP  
DUNROBIN ROAD

SCALE 1"=20'
