Re: Payne River Bridge - United Counties of
Stormont, Dundas & Glengarry.

TEST BORING PLAN
 PROPOSED BRIDGE
 COUNTY ROAD 12
 LOT 16 CON 9 & 10
 TOWNSHIP FINCH

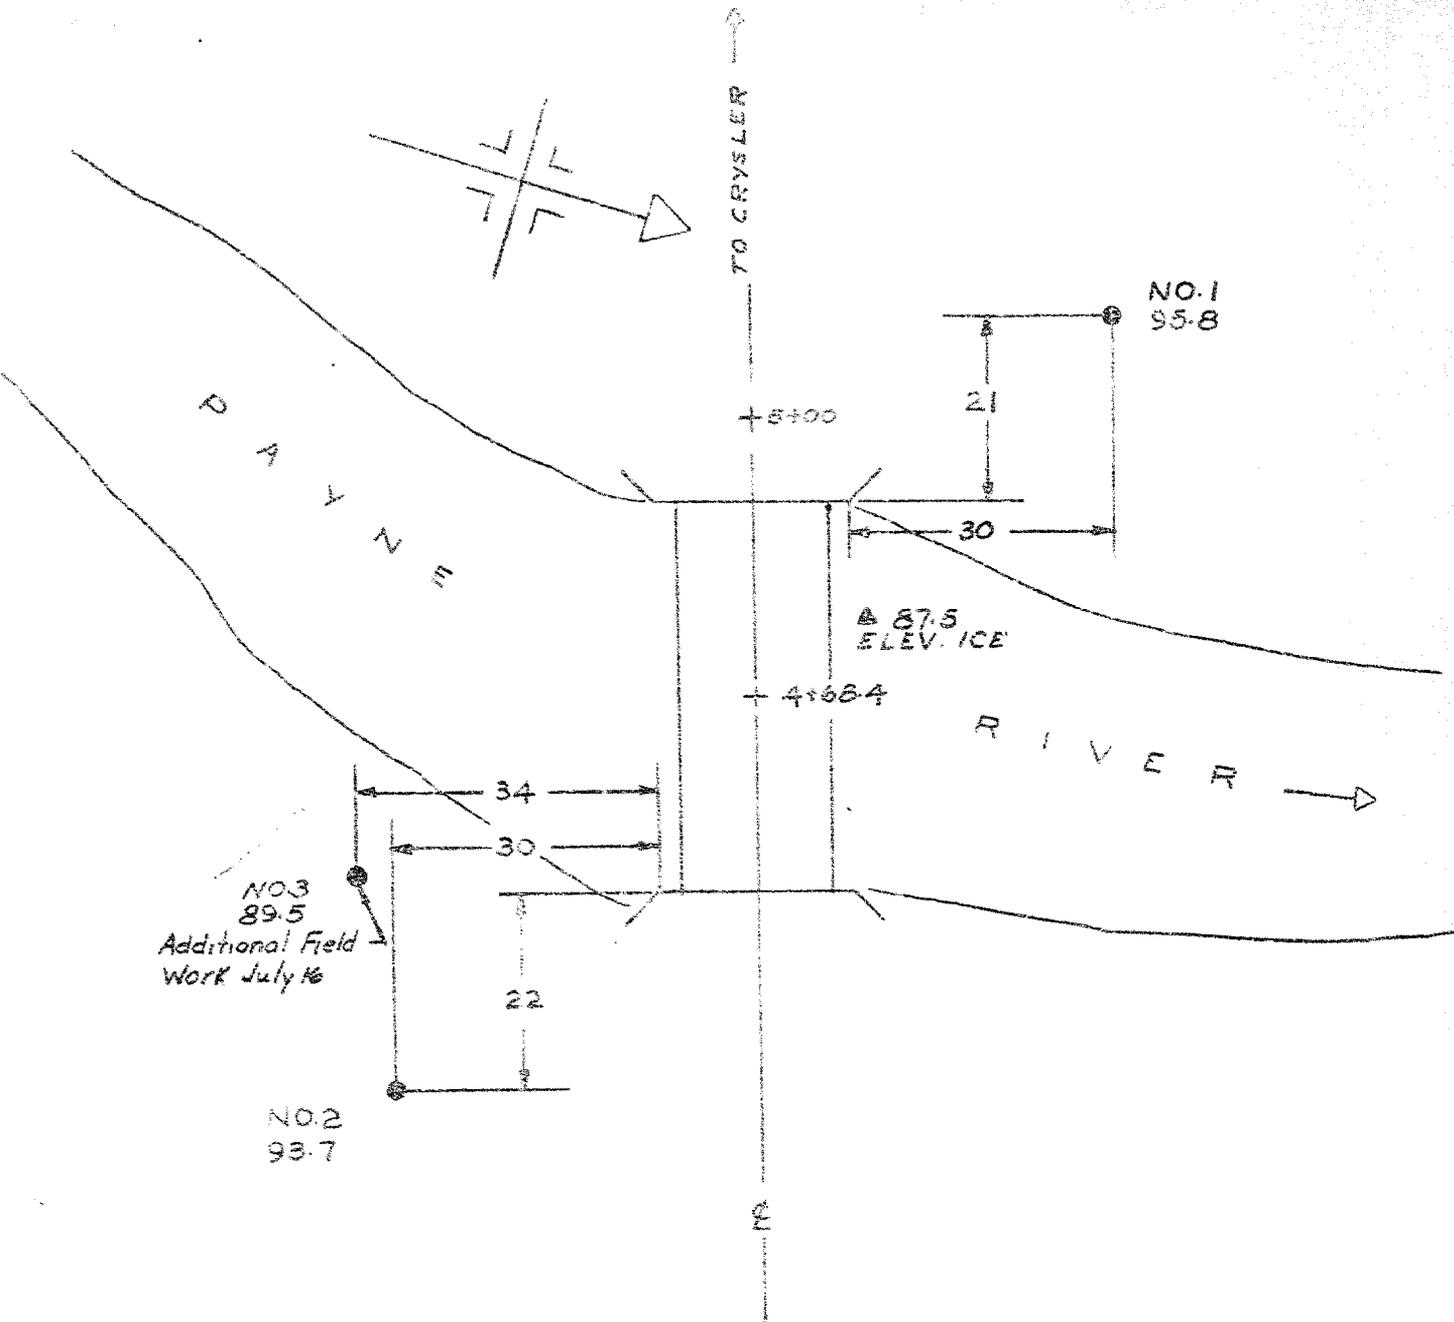
BM ELEV 100.0
 NAIL IN T.P.
 37 LT of STAT 2+94

We have received a letter dated July 31, 1962, from the Soil Consultant, John D. Paterson of Ottawa, with the attached log of the additional borehole that was carried out at the above-mentioned site. Also attached, was a test result summary sheet and a plan showing the location of the boring. Copies of these are attached to this memo.

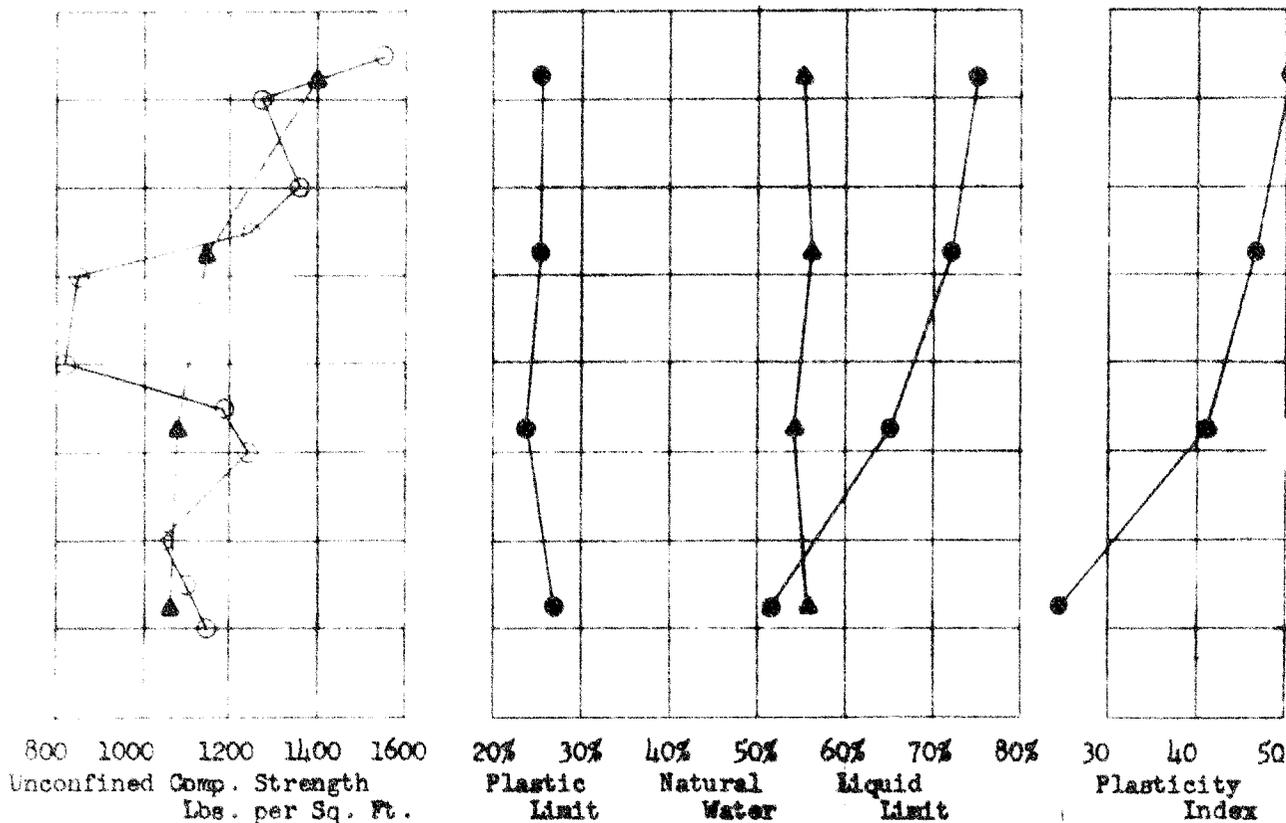
RESULT SUMMARY:

DEPTH IN FEET	ELEV.	SAMPLE
4	84.5	
5		TW 20
7	82.5	
8		TW 21
9	80.5	
10		TW 22
11	78.5	
12		TW 23
13	76.5

Sample No.	Plastic Limit	Liquid Limit	Plasticity Index	Natural Water Content	Average Unconfined Comp. Strength	Average Shear Strength
TW 20	25.4	75 ± 1	50.5 ± 1	55.2	1400	700
TW 21	25.3	72 ± 0.5	46.5 ± 0.5	56.0	1150	575
TW 22	23.8	65 ± 1	41 ± 1	54.1	1000	540
TW 23	26.9	51.5 ± 0.5	24.5 ± 0.5	55.5	1060	530

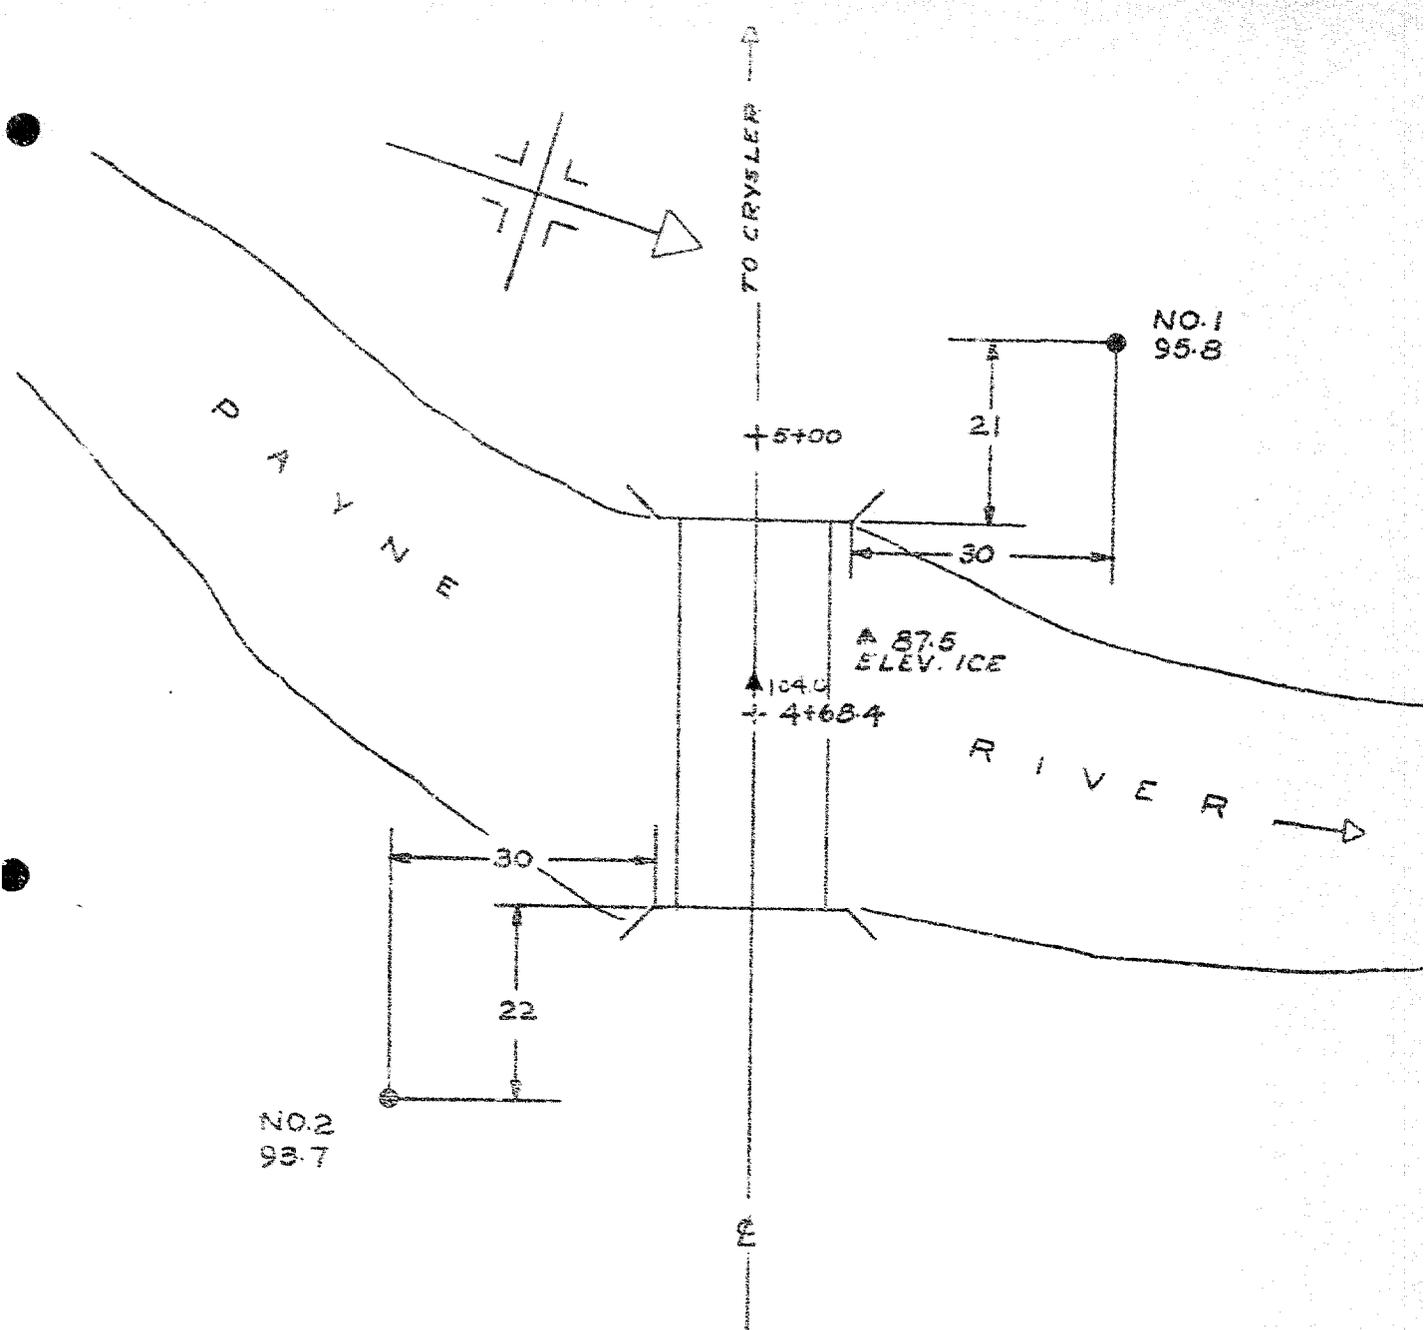
TEST BORING PLAN
 PROPOSED BRIDGE
 COUNTY ROAD 12
 LOT 16 CON 9 & 10
 TOWNSHIP FINCH

BM ELEV. 100.0
 NAIL IN T.P.
 37 LT of STAT 2+94
