e. m. peto associates ltd.

Re: Hwy. 401 - C.N.R. Crossing
W.P. 69-57, Twp. of Charlottensburg

1. We refer to your letter dated December 9th, 1958, in which you requested us to carry out a soils investigation at the proposed site of the above mentioned bridge.
2. Our terms of reference required that we should carry out a complete soils investigation at the site and make a report on our findings together with such recommendations and conclusions as we considered pertinent.
3. We have submitted one copy of this report to your Consultants, Messrs. Laughlin, Wylie and Ufnal, in order to allow them to expedite their design of this bridge.
4. The soil conditions and factors leading to our conclusions are considered in detail in the report attached hereto, together with an Appendix of supporting test results. Here for your convenience is a summary of the conclusions we have reached as a result of these studies:

e.m. peto & associates Ltd.
SOIL SITE INVESTIGATION
HWY. 401 - C.N.R. CROSSING
TOWNSHIP OF CHARLOTTENBURG
FOR
DEPT. OF HIGHWAYS OF ONTARIO.
OUR JOB No. 57-148 DATE FEB. 12, 1988
CLIENTS PLAN No. W.D. 69-578

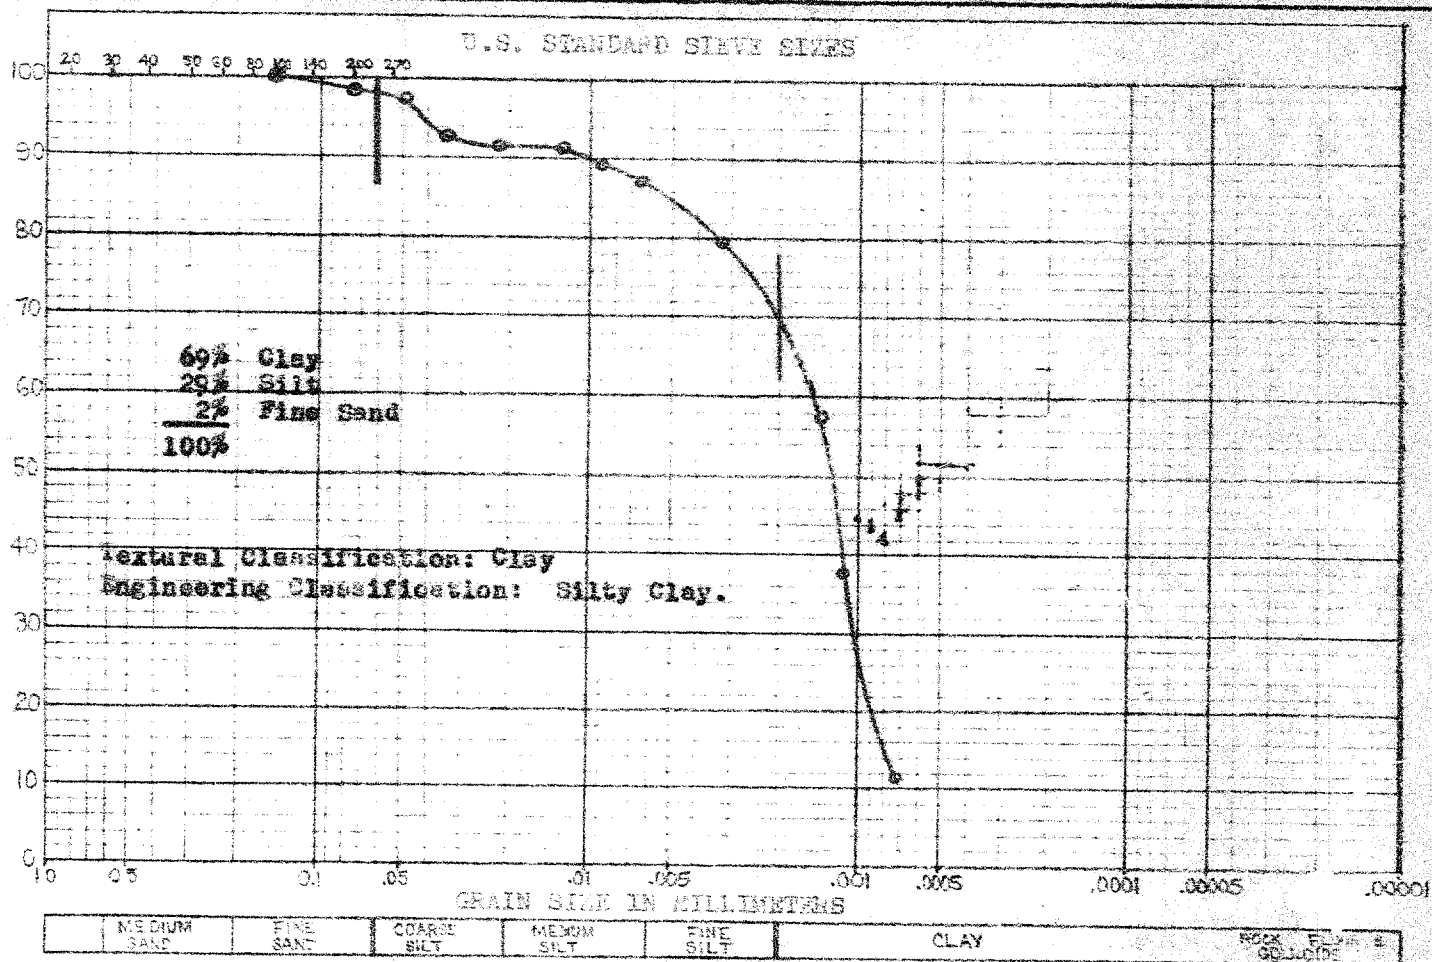
E. M. PETO ASSOCIATES LTD.
HYDROMETER GRAIN SIZE DISTRIBUTION DIAGRAM

M.I.T. CLASSIFICATION

Job Name Hwy. 401 - C.N.R. Crossing Job No. 57149 Borehole No. 5 Sample No. 7
Depth 17-1/2' - 18' Elevation 159.4 Remarks Specific Gravity of this sample = 2.73

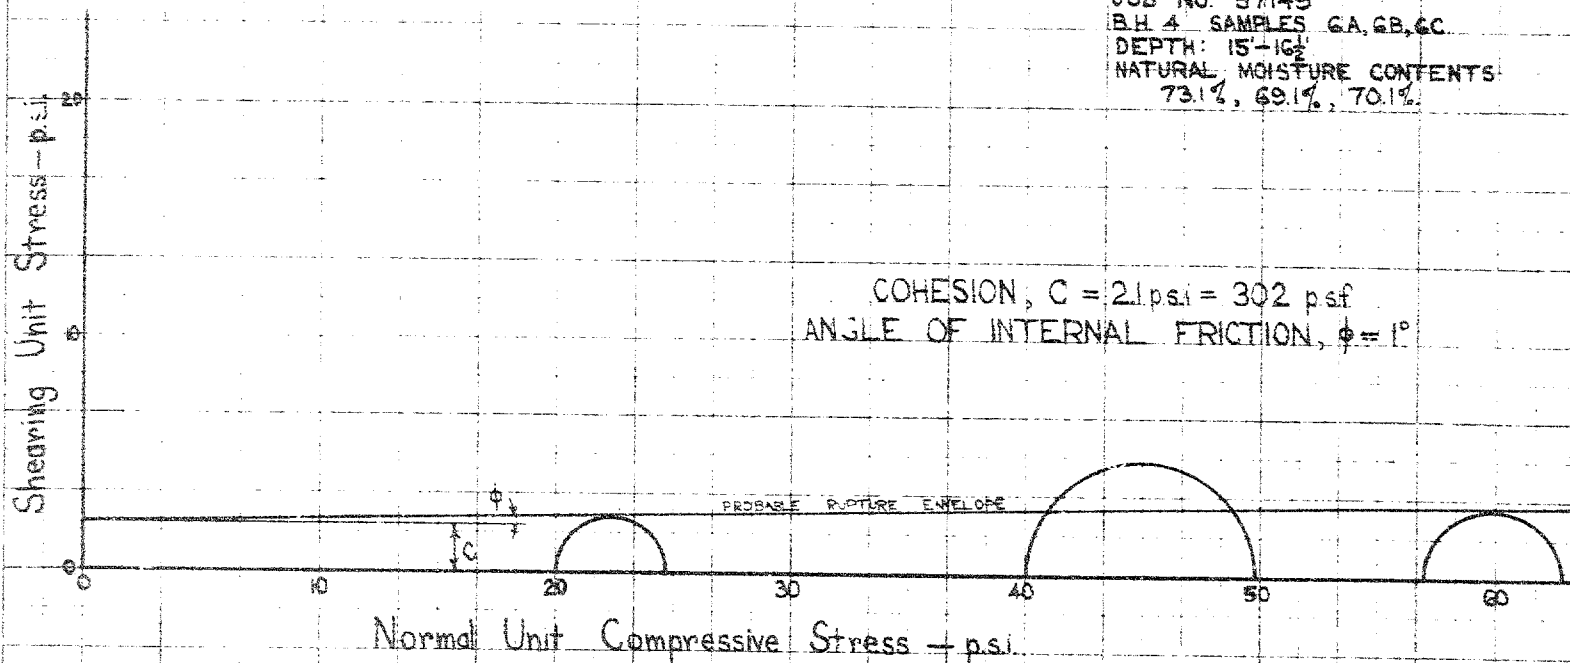
JOB NO. 57149
B.H. 4 SAMPLES GA, GB, GC
DEPTH: 15'-16"
NATURAL MOISTURE CONTENTS:
73.1%, 69.1%, 70.1%

COHESION, $C = 2.1 \text{ psi} = 302 \text{ psf}$
ANGLE OF INTERNAL FRICTION, $\phi = 1^\circ$

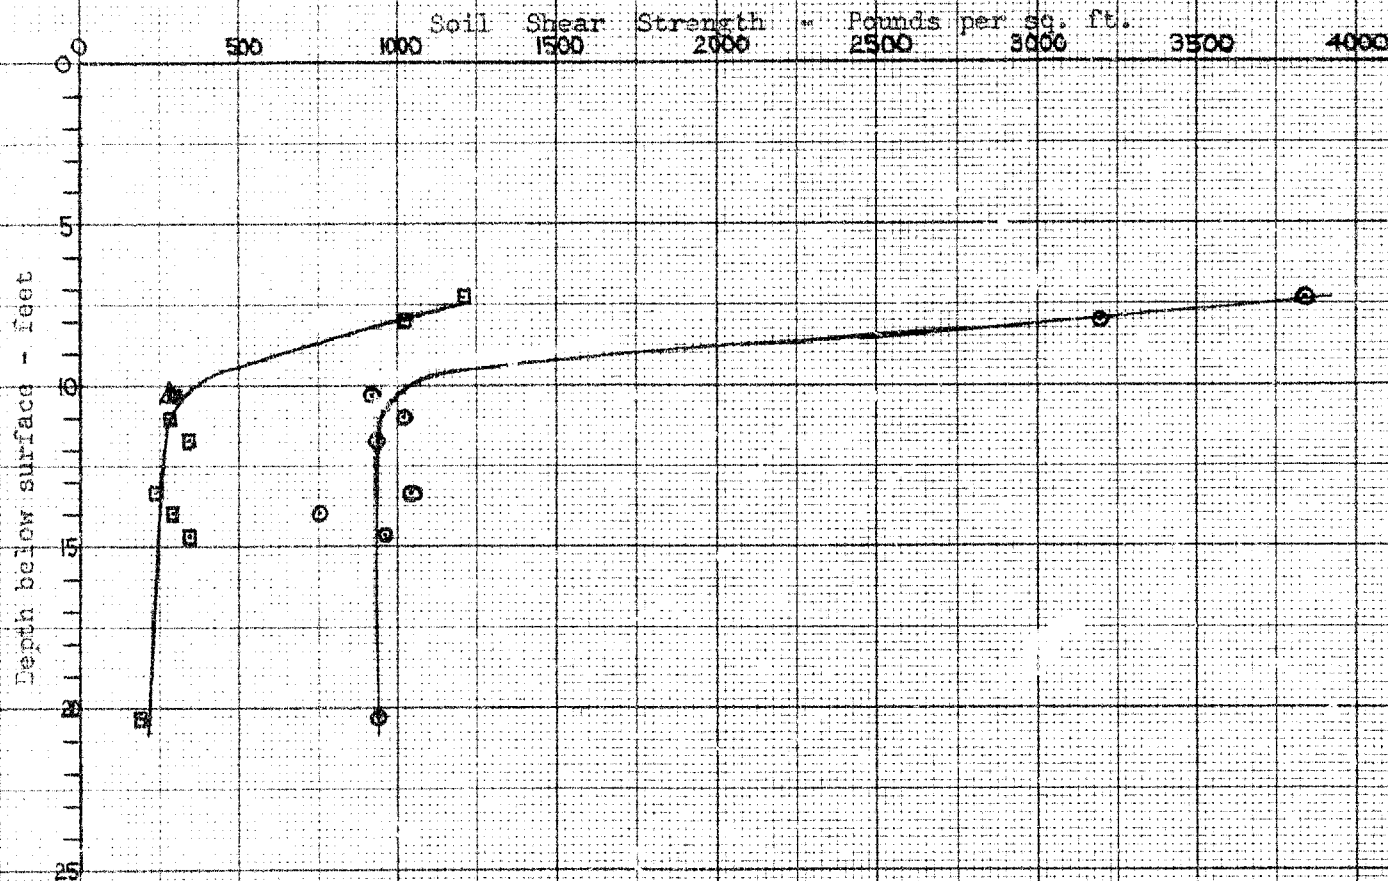
CHART FOR COMPARISON OF IN SITU VANE TESTS AND LABORATORY COMPRESSION TESTS

Job No. 57149A

B.E. 7 and 7A

- △ - 'C' from unconfined compression or triaxial test
- - Shear strength from in situ vane test
- - Remoulded vane test 10 minutes after original test

The "in situ" vane tests on this particular marine clay, having been performed with all due care, appear to give results which are consistently three to five times higher than the laboratory unconfined compression and quick triaxial tests. These results are basically in agreement with data published by the National Research Council on vane tests at Beauharnois on a similar, although thicker, marine clay deposit with almost identical moisture contents and Atterberg limits. However, the discrepancy between the laboratory tests and the vane tests determined by the National Research Council was not quite as large as that indicated by our vane tests.

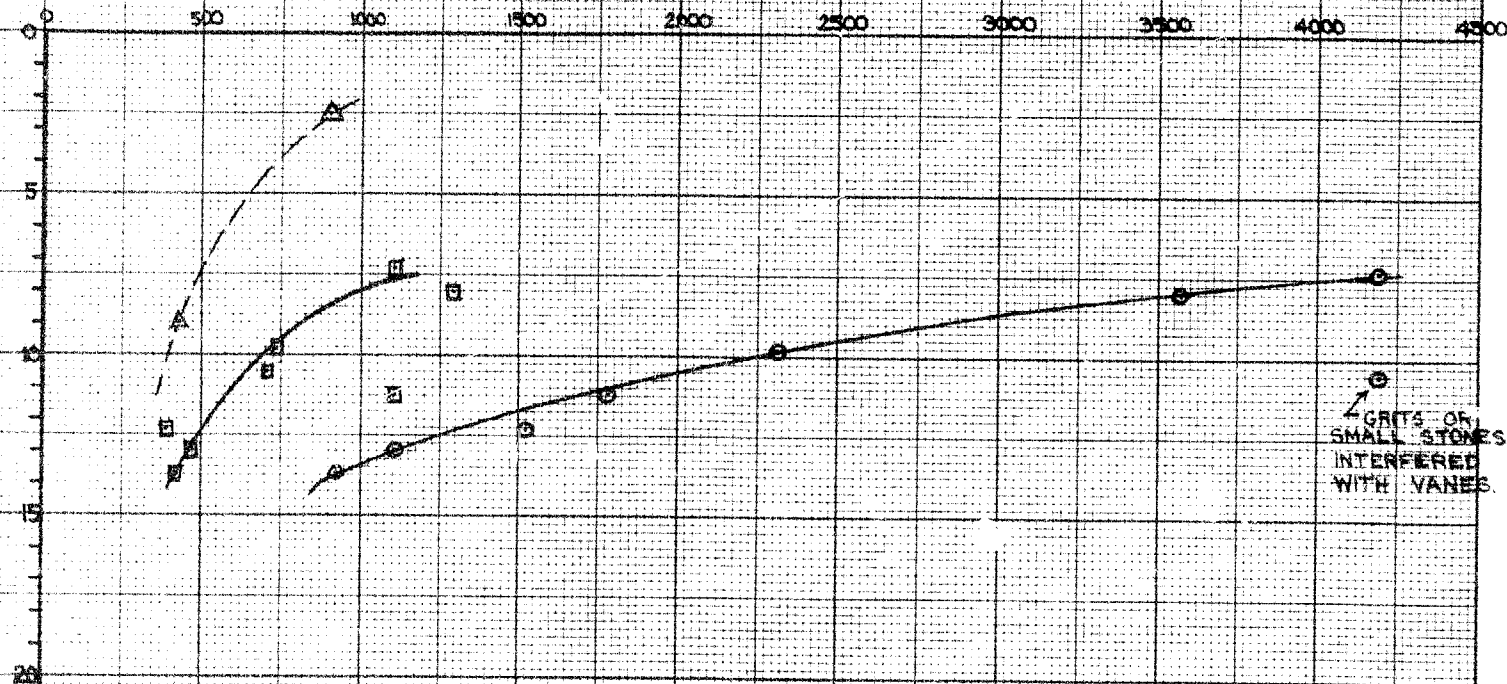
SOIL SHEAR STRENGTH - P.S.F.

DEPTH BELOW SURFACE - FT

GRITS OR SMALL STONES INTERFERED WITH VANES.

- △ - 'C' FROM UNCONFINED COMPRESSION OR QUICK TRIAXIAL TEST
- - SHEAR STRENGTH FROM IN SITU VANE TEST
- - REMOULDED VANE TEST 10 MINUTES AFTER ORIGINAL TEST

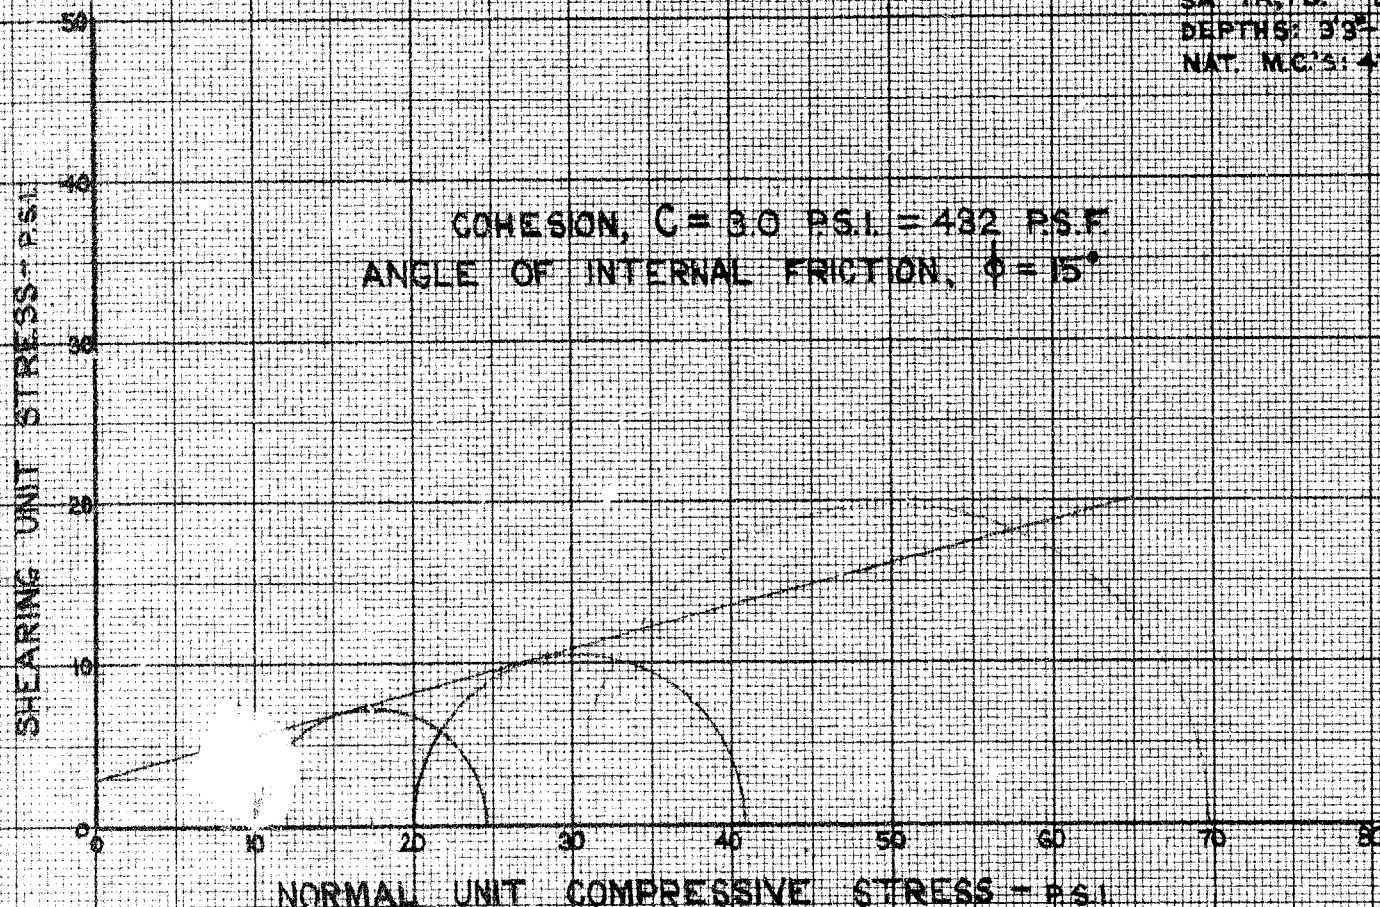
QUICK, UNDRAINED TRIAXIAL TEST

COHESION, $C = 3.0 \text{ PSI} = 432 \text{ PSF}$

ANGLE OF INTERNAL FRICTION, $\phi = 15^\circ$

ON SAMPLE OF VERY SOFT, NUGGETTY, GREY
SILTY CLAY

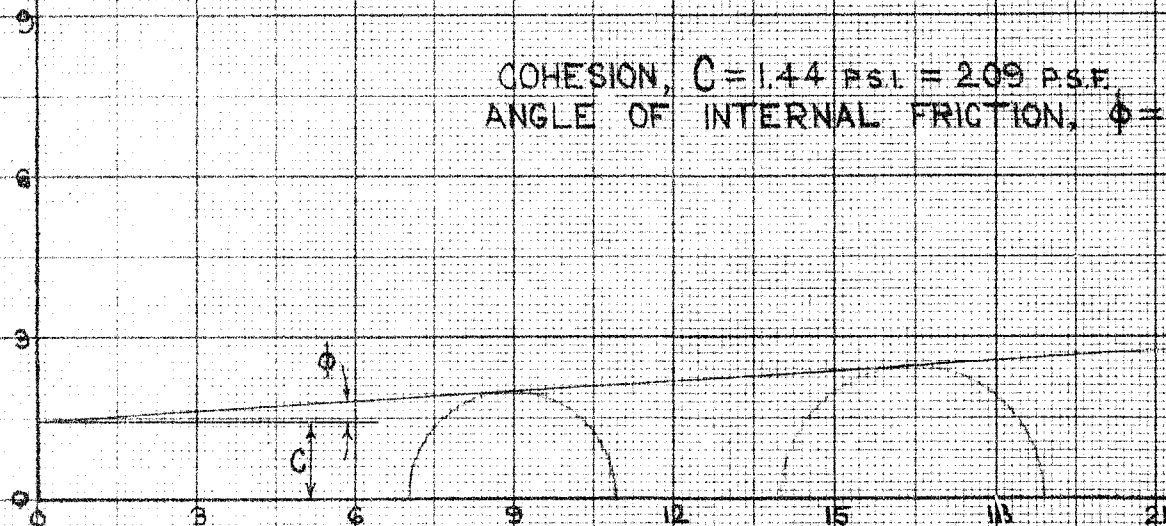
QUICK UNDRAINED TRIAXIAL COMPRESSION TESTS
with
PORE WATER PRESSURE MEASUREMENTS

COHESION, $C = 1.44 \text{ PSI} = 209 \text{ P.S.F.}$
ANGLE OF INTERNAL FRICTION, $\phi = 3\frac{1}{2}^\circ$

SHEARING UNIT STRESS - P.S.I.

NORMAL UNIT COMPRESSIVE STRESS - P.S.I.

5. On the basis of results obtained from slow drained triaxial tests and quick triaxial tests it is possible to arrive at a relationship between critical pore water pressure at failure and applied load.

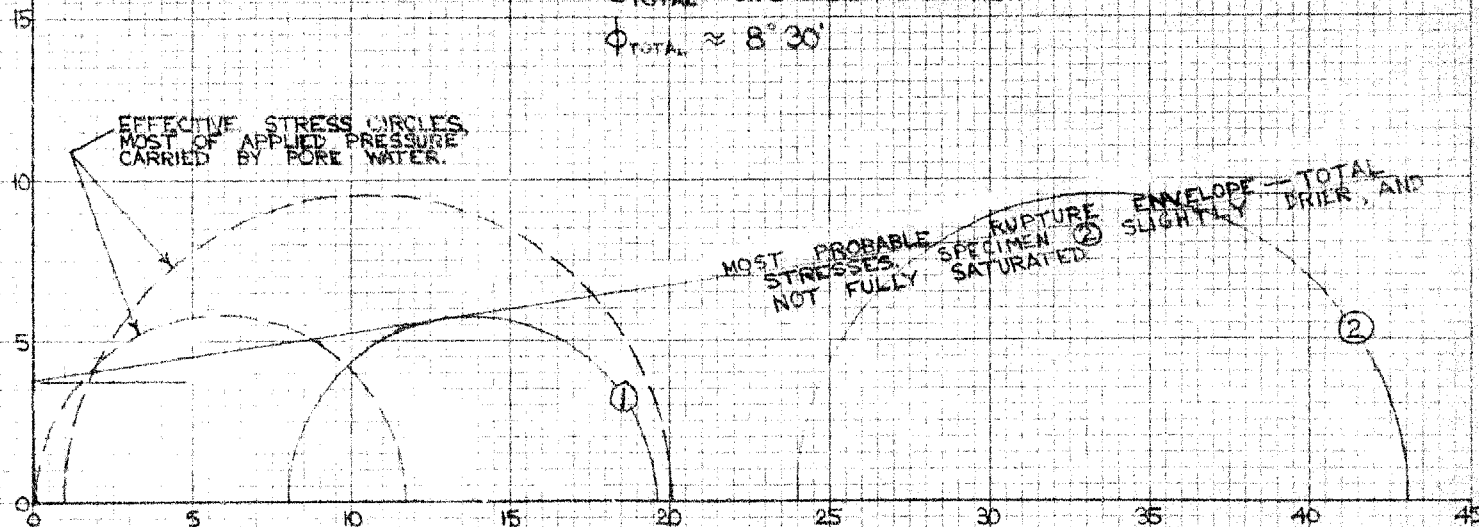
FULLY DRAINED, SLOW TRIAXIAL COMPRESSION TEST
on samples of
CORNWALL MARINE CLAY

ENVELOPE - TOTAL
DRIER, AND
SLIGHTLY

Normal Unit Compressive Stress - p.s.i.

Specimen No.	Depth	Degree of Saturation %	Wet Density p.p.s.f.	Void Ratio	Initial M. C. %	Final M. C. %
B.H. 11A SA. 1B	①	56"-58"	100.0	111.0	1.23	45.0	43.6
B.H. 11A SA. 1B	②	58"-60"	100.0	111.0	1.23	45.0	44.6
B.H. 11A SA. 1C	③	60"-62"	100.0	108.5	1.37	50.4	49.3
B.H. 7 SA. 3B	④	86"-90"	100.0	106.7	1.44	52.3	49.5

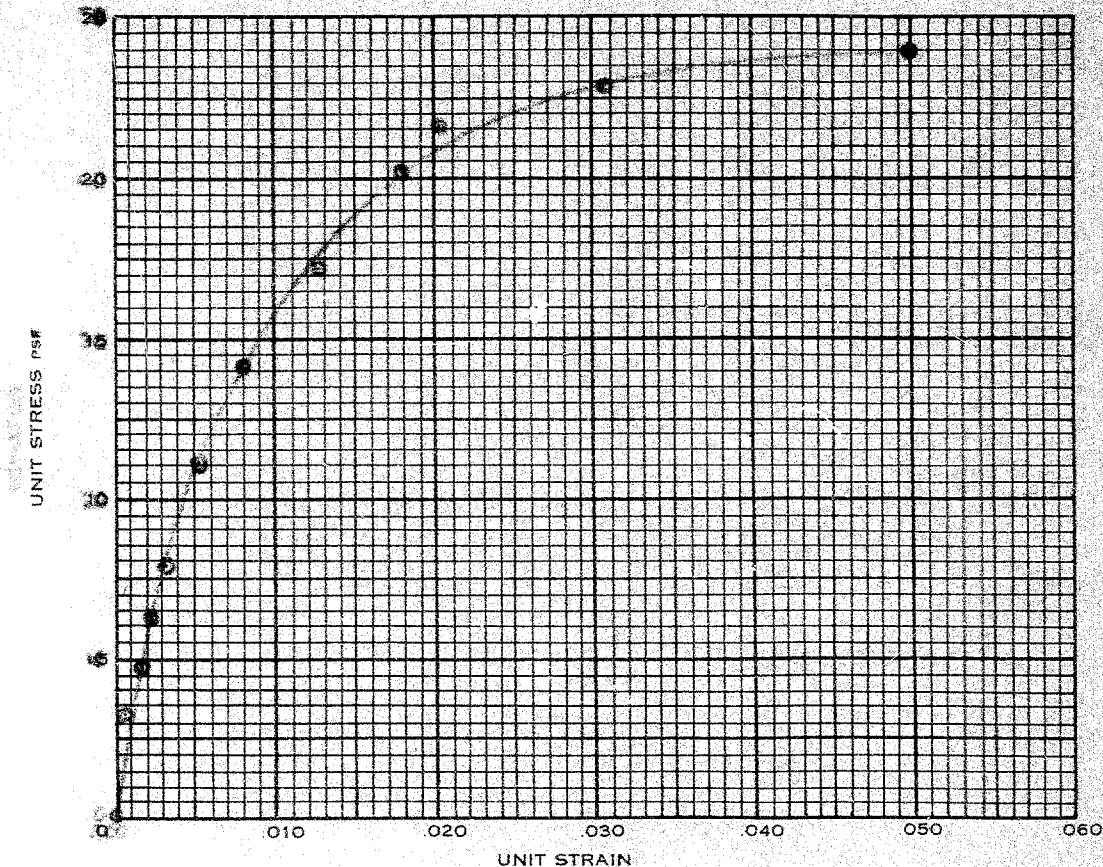
STRESS - STRAIN DIAGRAM

TYPICAL
SLOW TRIAXIAL
STRESS-STRAIN RELATIONSHIP
UNCONFINED COMPRESSION TEST

JOB No. 571428 NAME OF JOB HIGHWAY 401-CNR CONCRETE
HOLE No. 11A SAMPLE No. 13 DEPTH 12'-00"
TYPE OF SAMPLE: ☒ UNDISTURBED ☐ MODIFIED PROCTOR MAXIMUM DENSITY
☐ PROCTOR MAXIMUM DENSITY ☐ REMOULDED AT NATURAL MOISTURE CONTENT
☐ OTHERS DESCRIPTION: _____

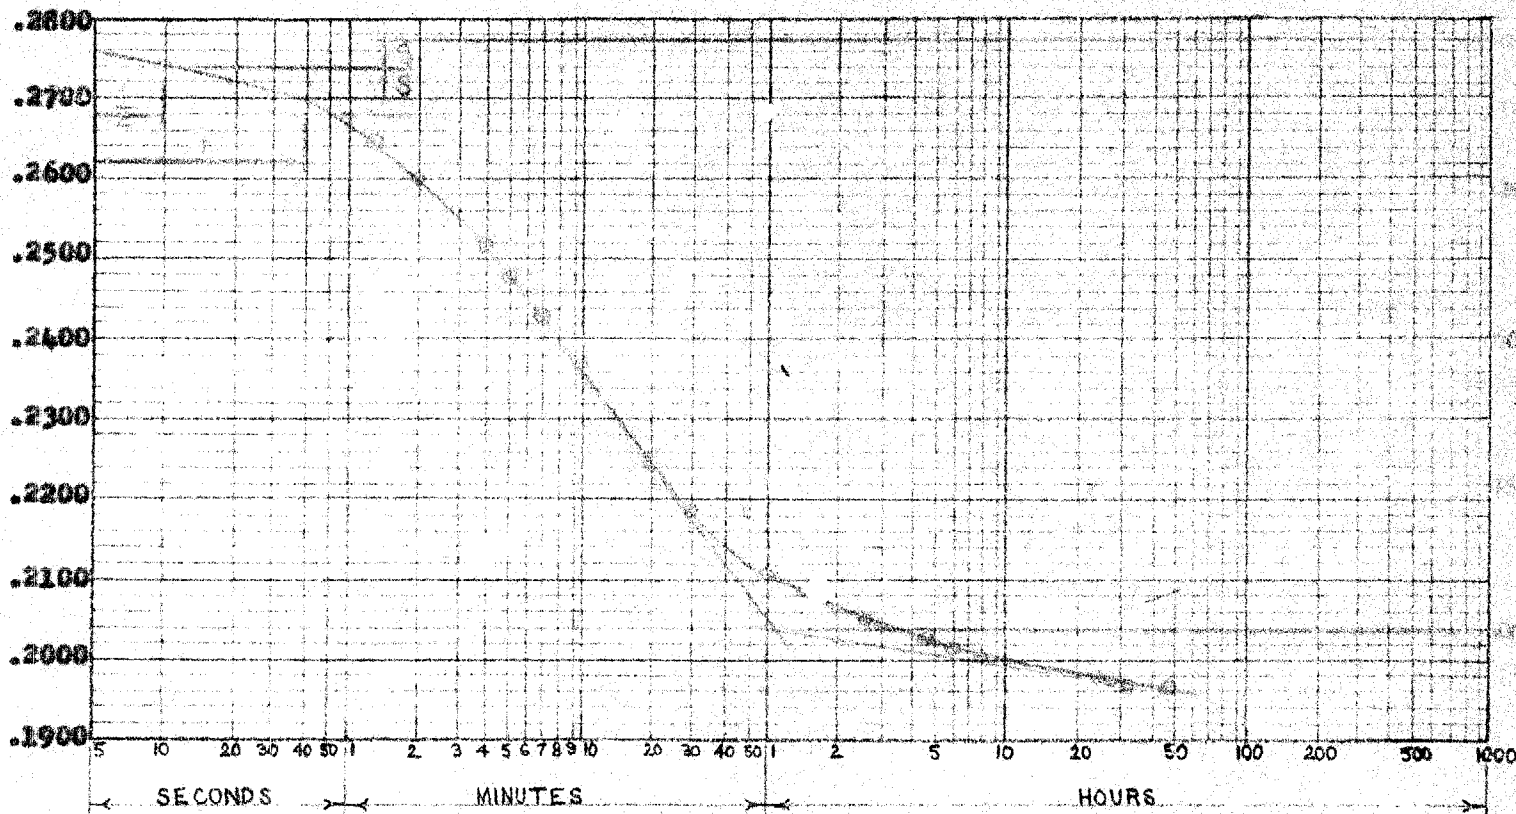
CONSOLIDATION TEST TIME CURVE

Depth from **..11'0" to 11'4".**

DIAL READING

PERCENT CONSOLIDATION

ELAPSED TIME (LOG SCALE)

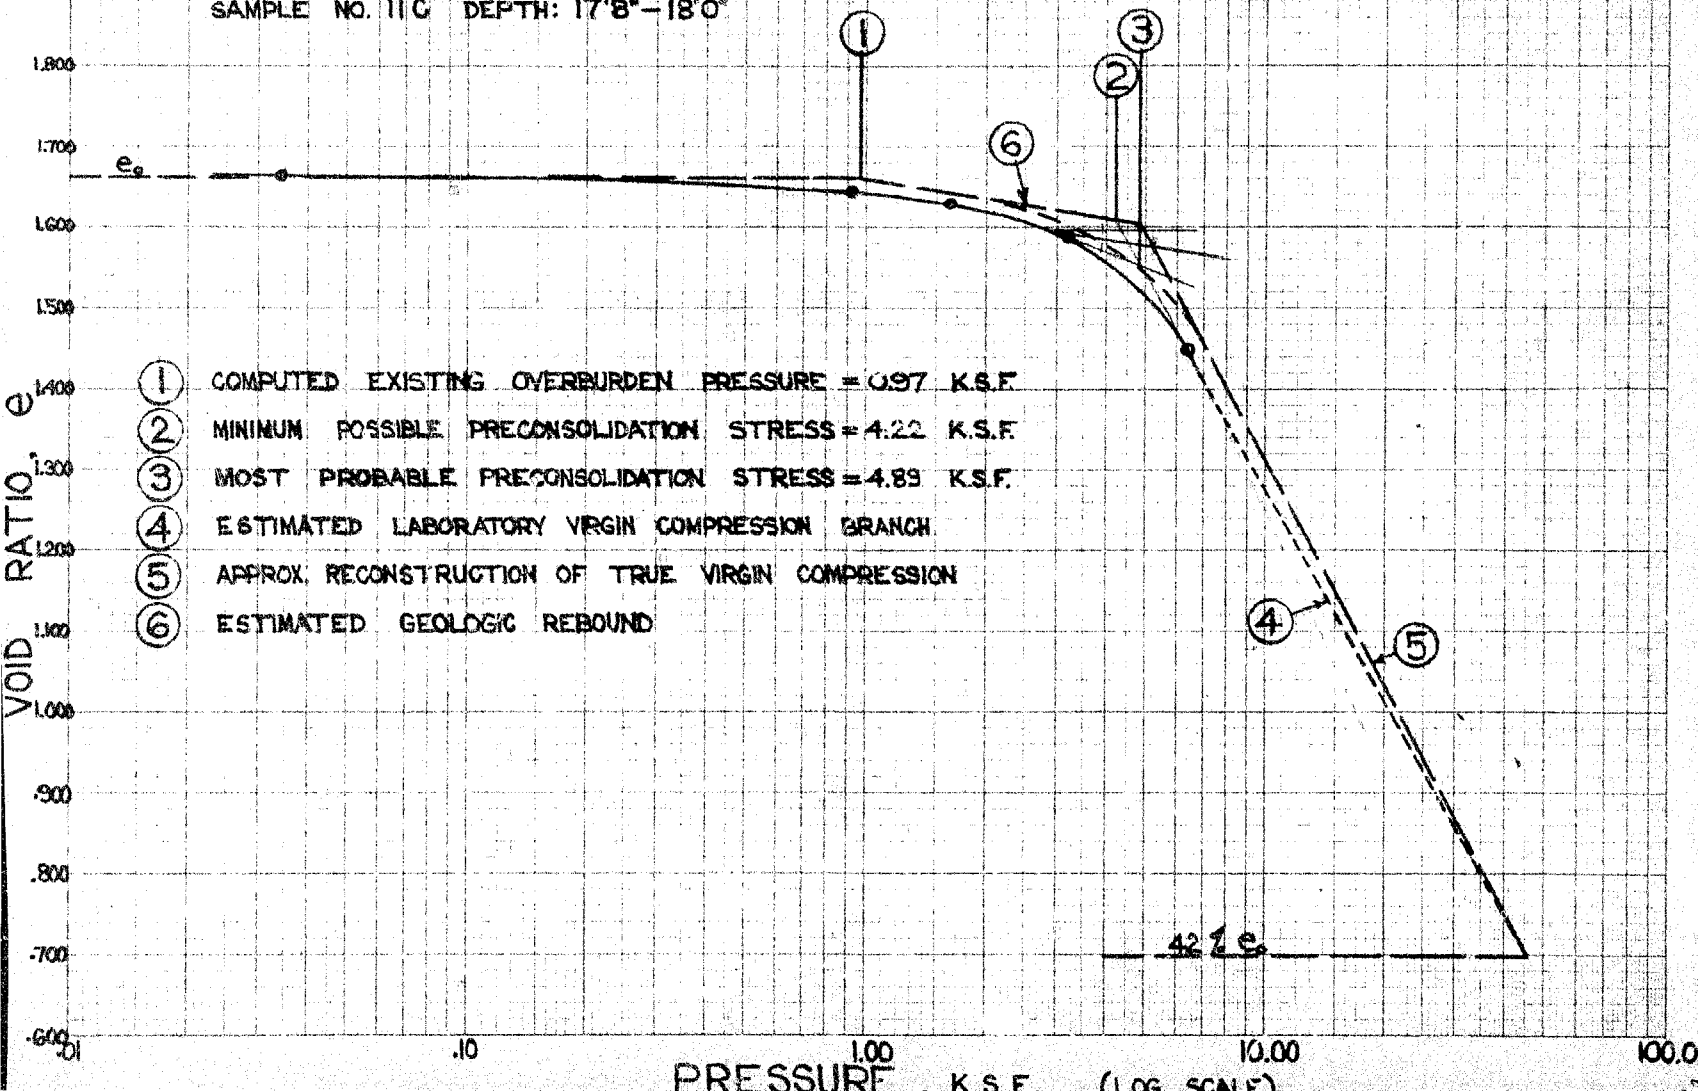
PRESSURE-VOID RATIO CURVE

JOB NO. 57149A BOREHOLE NO. 5A
 SAMPLE NO. 11C DEPTH: 17'8"-18'0"

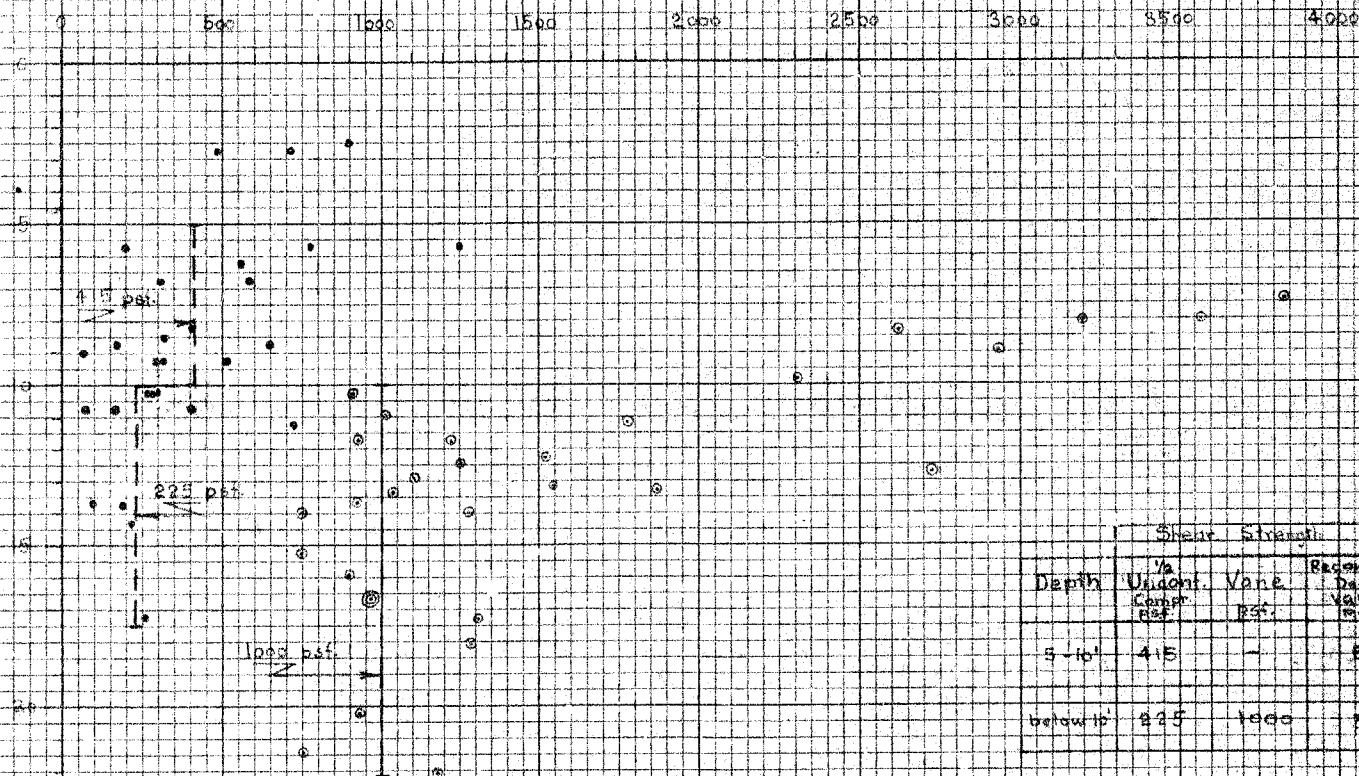
AVERAGE SHEAR PROFILE DETERMINATION

SHEAR STRENGTH in PSF.

DEPTH BELOW THE GROUND SURFACE IN FT.

Depth	Shear Strength		Recommended Design Value in PSF
	1/2 Unconf. Comp. Test	Vane Test	
5-10'	415	-	550
below 10'	825	1000	500

- Shearing Strength determined by unconfined compression test.
- Shearing strength determined by in situ Vane shear test.

The shear strength of the soil profile has been determined in the laboratory by quick unconfined compression tests, and "in situ" by the vane shear test. Plotting the test results on a Shear Strength vs Depth Chart, which appears in Appendix I under the title "Average Shear Profile Determination", a definite grouping of the shear values has been found.

Below the depth of ten feet, and down to the layer of dense glacial till, the average value of cohesion from the unconfined compression test was found to be 225 p.s.f., and from the vane shear test 1,000 p.s.f.

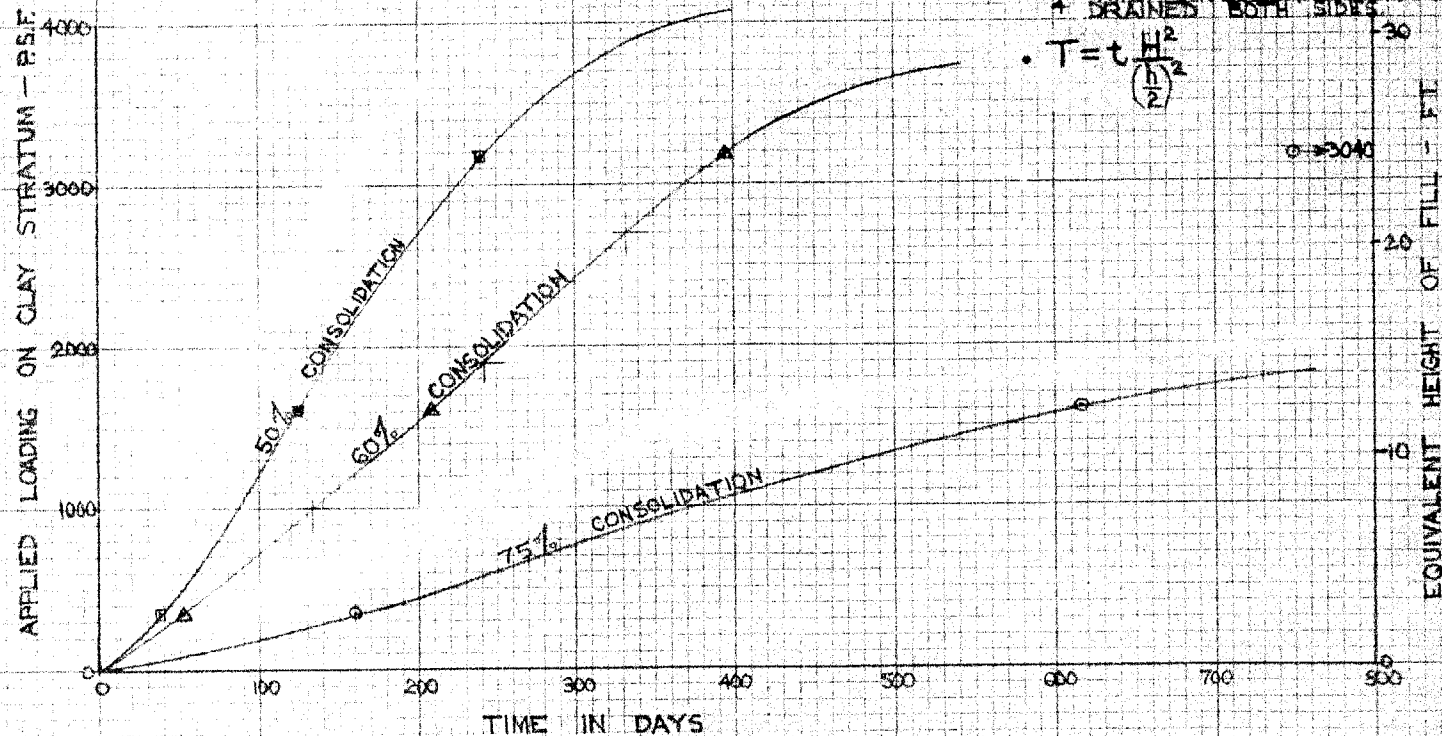
- CLAY LAYER 15 FT THICK.
- OVERLAIN BY PARTLY DESICCATED CLAY UNDERLAIN BY SANDY FILL.
- THE CLAY LAYER DRAINED ONE SIDE ONLY.
- 2" THICK CONSOLIDATION SAMPLE.
- DRAINED BOTH SIDES.

$$T = t \frac{H^2}{\left(\frac{H}{2}\right)^2}$$

3. Practical considerations of the time involved lead us to recommend that the degree of consolidation to be attained in the subsoil should be restricted to between 50% and 60% for each successive lift. This latter form of construction will involve some difficulty in installing piezometers in the field in order to give reliable results, having in mind the sensitivity of the clay. Accordingly we recommend the installation of a number of settlement test plates at suitable cross sections in order that information on settlement and creep could be collected.

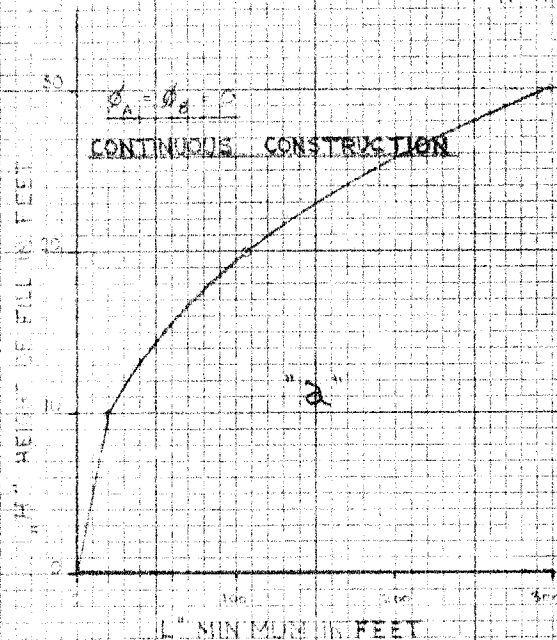
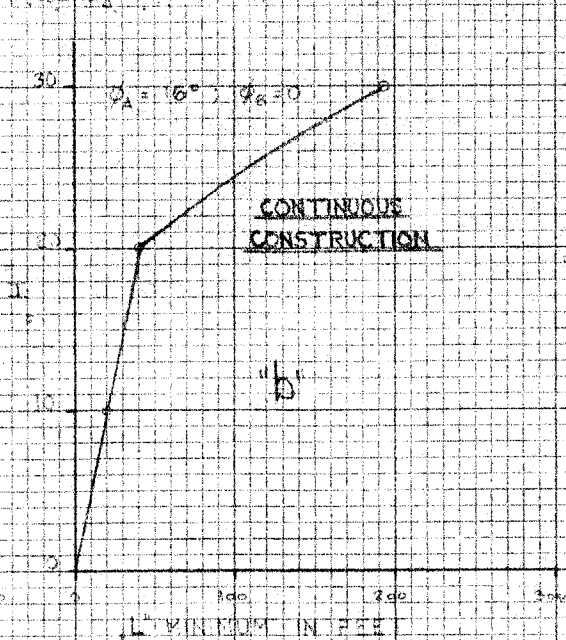
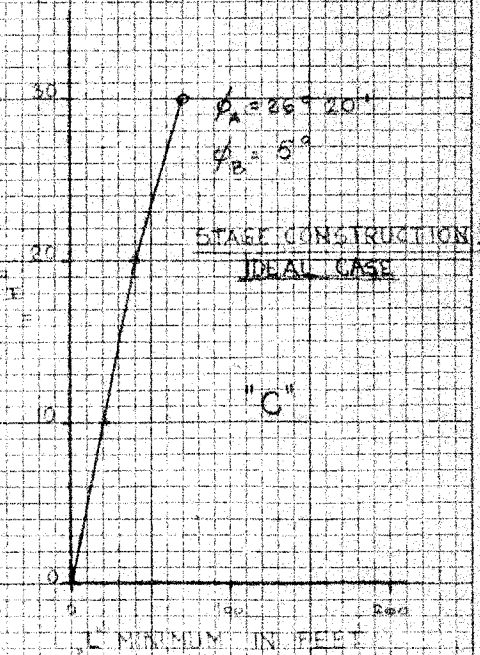
EMBANKMENT STABILITY

$$S_A = 0$$

$$\phi_A = 45^\circ$$

$$\phi_B = \frac{300}{F}$$

FACTOR OF SAFETY = 1.5

Note: Minimum slope 2 horizontal and 1 vertical has been used based upon practical considerations.

2. Even with staged loading we do not recommend the total height of embankment should exceed 32 feet; furthermore the soil stability conditions must be satisfied for each stage where this method of construction is adopted.

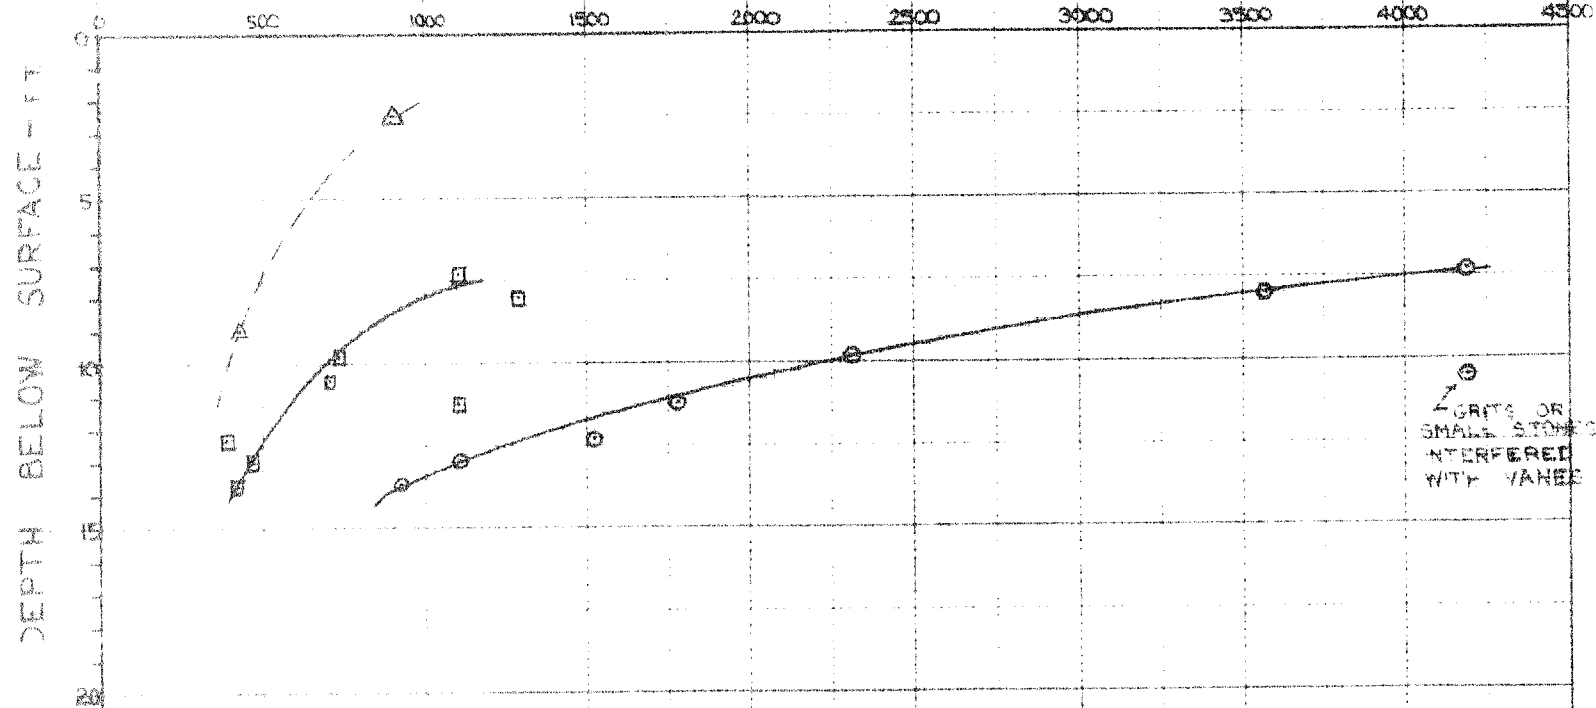
CHART FOR COMPARISON OF IN SITU VANE TESTS AND LABORATORY COMPRESSION TESTS

PLOT OF SOIL SHEAR STRENGTH VERSUS DEPTH

JOB NO 57149B
B.H. II AND B.H. IIA

SOIL SHEAR STRENGTH - P.S.F.

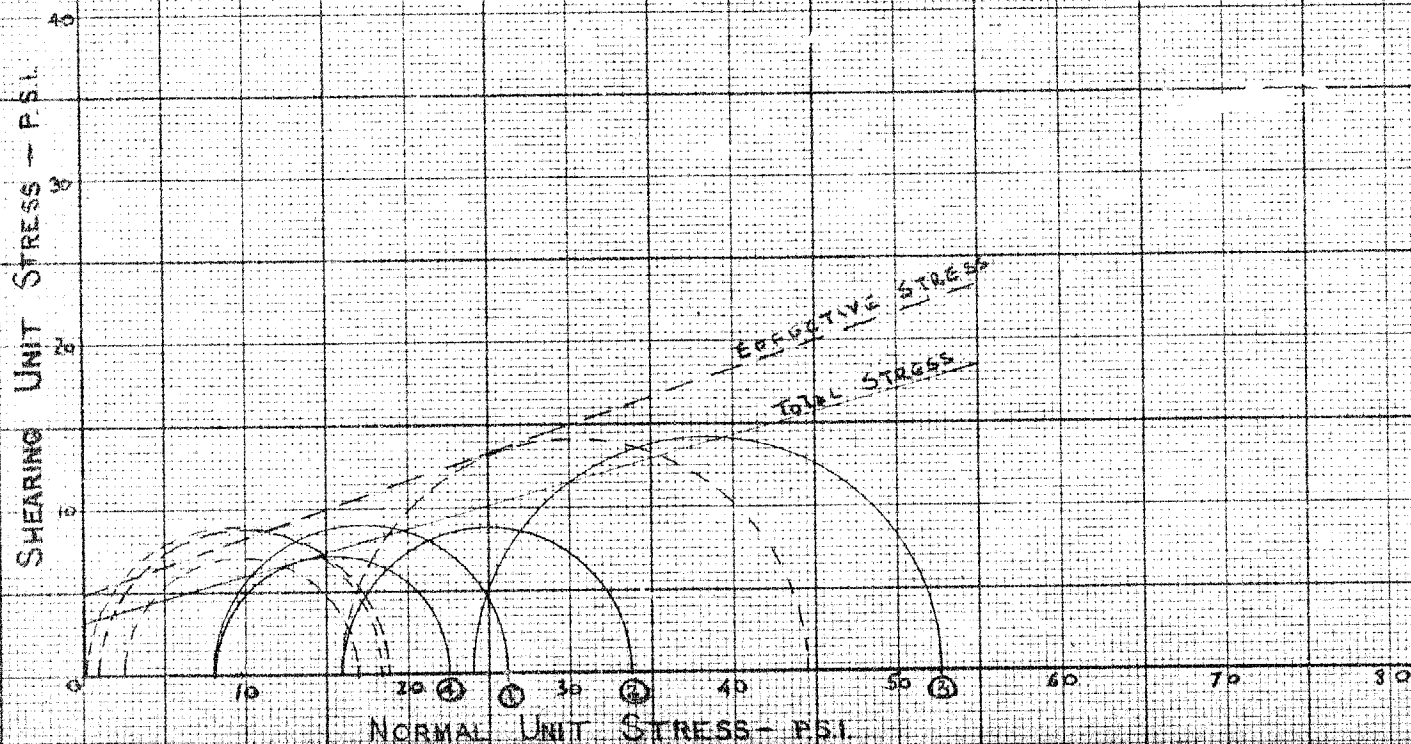
QUICK UNDRAINED TRIAXIAL COMPRESSION TESTS

WITH PORE WATER PRESSURE MEASUREMENTS

C TOTAL = 432 lb/sq ft C EFFECTIVE = 720 lb/sq ft

ϕ TOTAL = 15° 45' ϕ EFFECTIVE = 18° 40'

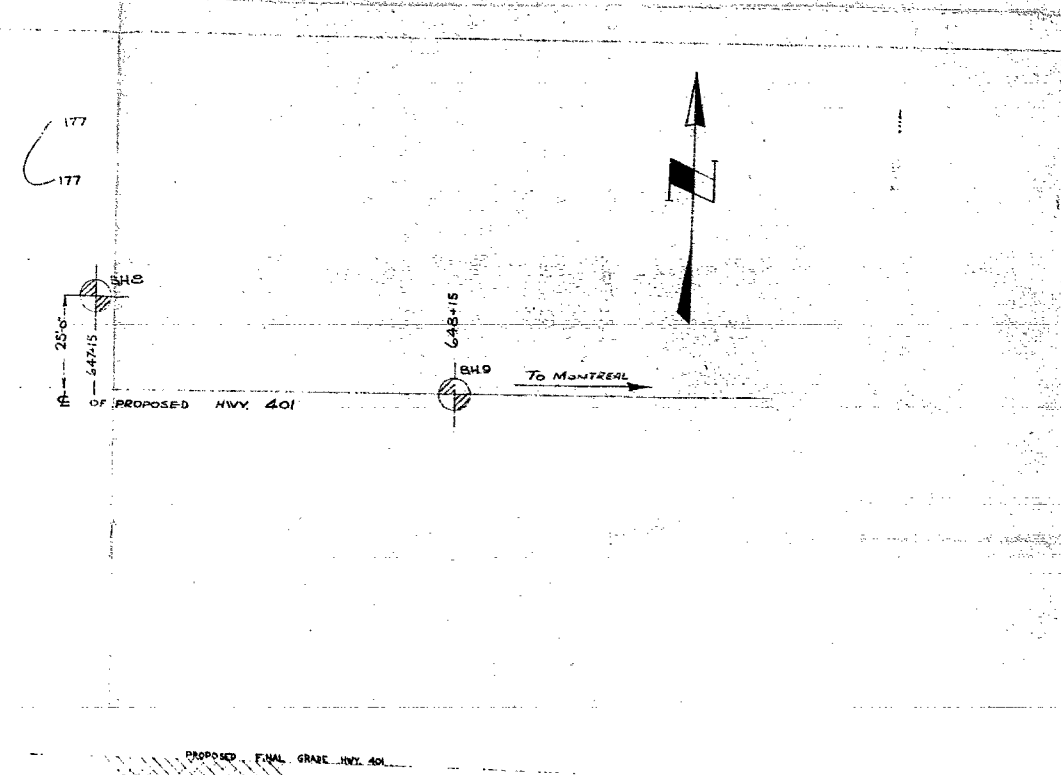
PLAN
SCALE: 1" = 20' F.

PROFILE
SCALE: HOR. 1" = 20'
VERT. 1" = 10'

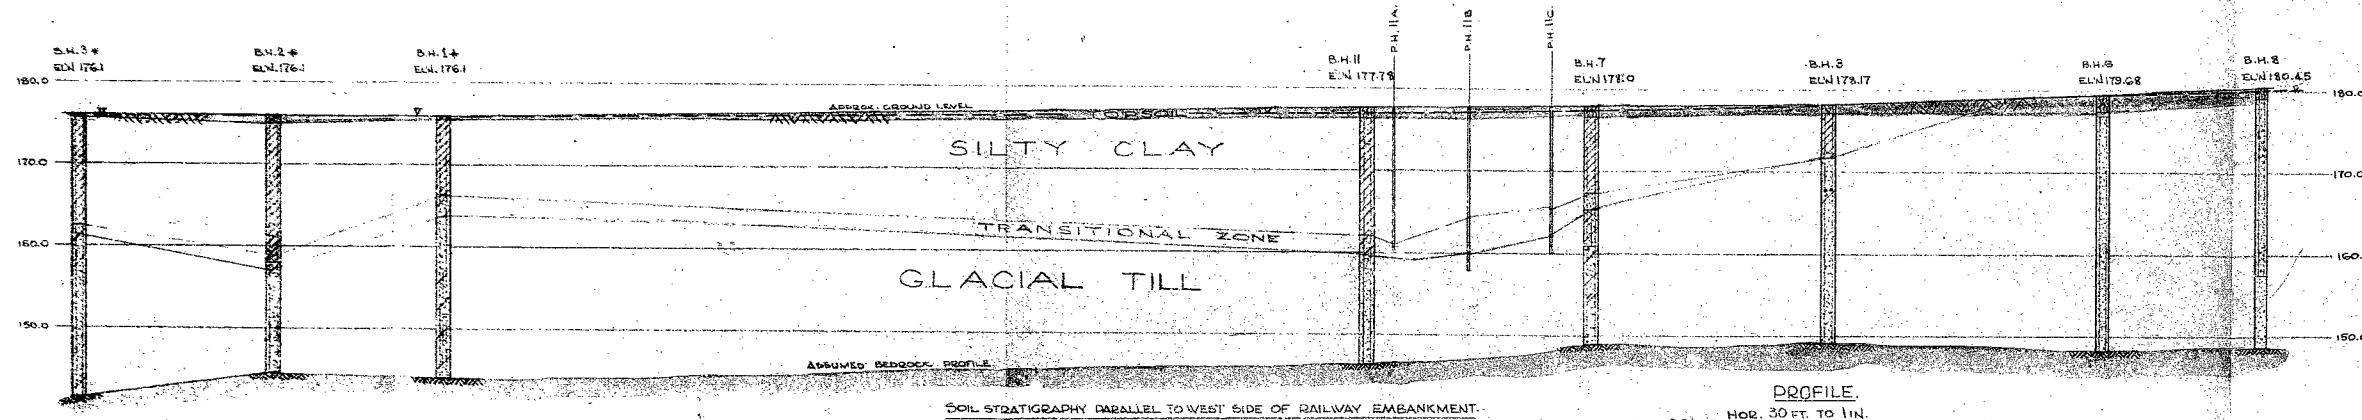
e.m. peto & associates Ltd.
 SOIL SITE INVESTIGATION
 AT
HWY. 40 - C.N.R. CROSSING
 W69-57 TWP. of CHARLOTTENBURG
 FOR
 DEPARTMENT of HIGHWAYS of ONTARIO
 OUR JOB No. 57-1498 DATE MAY 15-58
 CLIENTS PLAN No. F 3165-9 (REVISED) PER G.T.

- LEGEND**
- B.H.* — HOLE DOWN IN PREVIOUS INVESTIGATION AT LINE "G".
 - PROBE HOLE WITH DUTCH CONE.
 - ORGANIC SILTY LOAM.
 - SILTY CLAY.
 - TRANSITIONAL ZONE: SANDY & SILTY CLAY WITH GRITS.
 - TILL: SILTY FINE SAND, GRITS & PEBBLES.
 - FINE TO COARSE SAND, GRITS.
 - LIMESTONE BEDROCK.
 - POSITION OF GROUND WATER TABLE ON MAY 3, 1958.

However, it should be noted that at borehole # 13, 75 feet South along the railway tracks from borehole # 3, the thickness of the silty clay layer decreases, while that of the compact to dense glacial till increases. The top of bedrock profile also was found to dip Southward.
