Re: BA 752- Clyde Ave., Br. # 4.
Ottawa Queensway, Dist. # 9.

Re: Bridge No. 4 at Clyde Ave. W.P. No. 931-58
Queensway Ottawa, District 9

FOUNDATION REPORT - BRIDGE No. 41. FIELD WORK

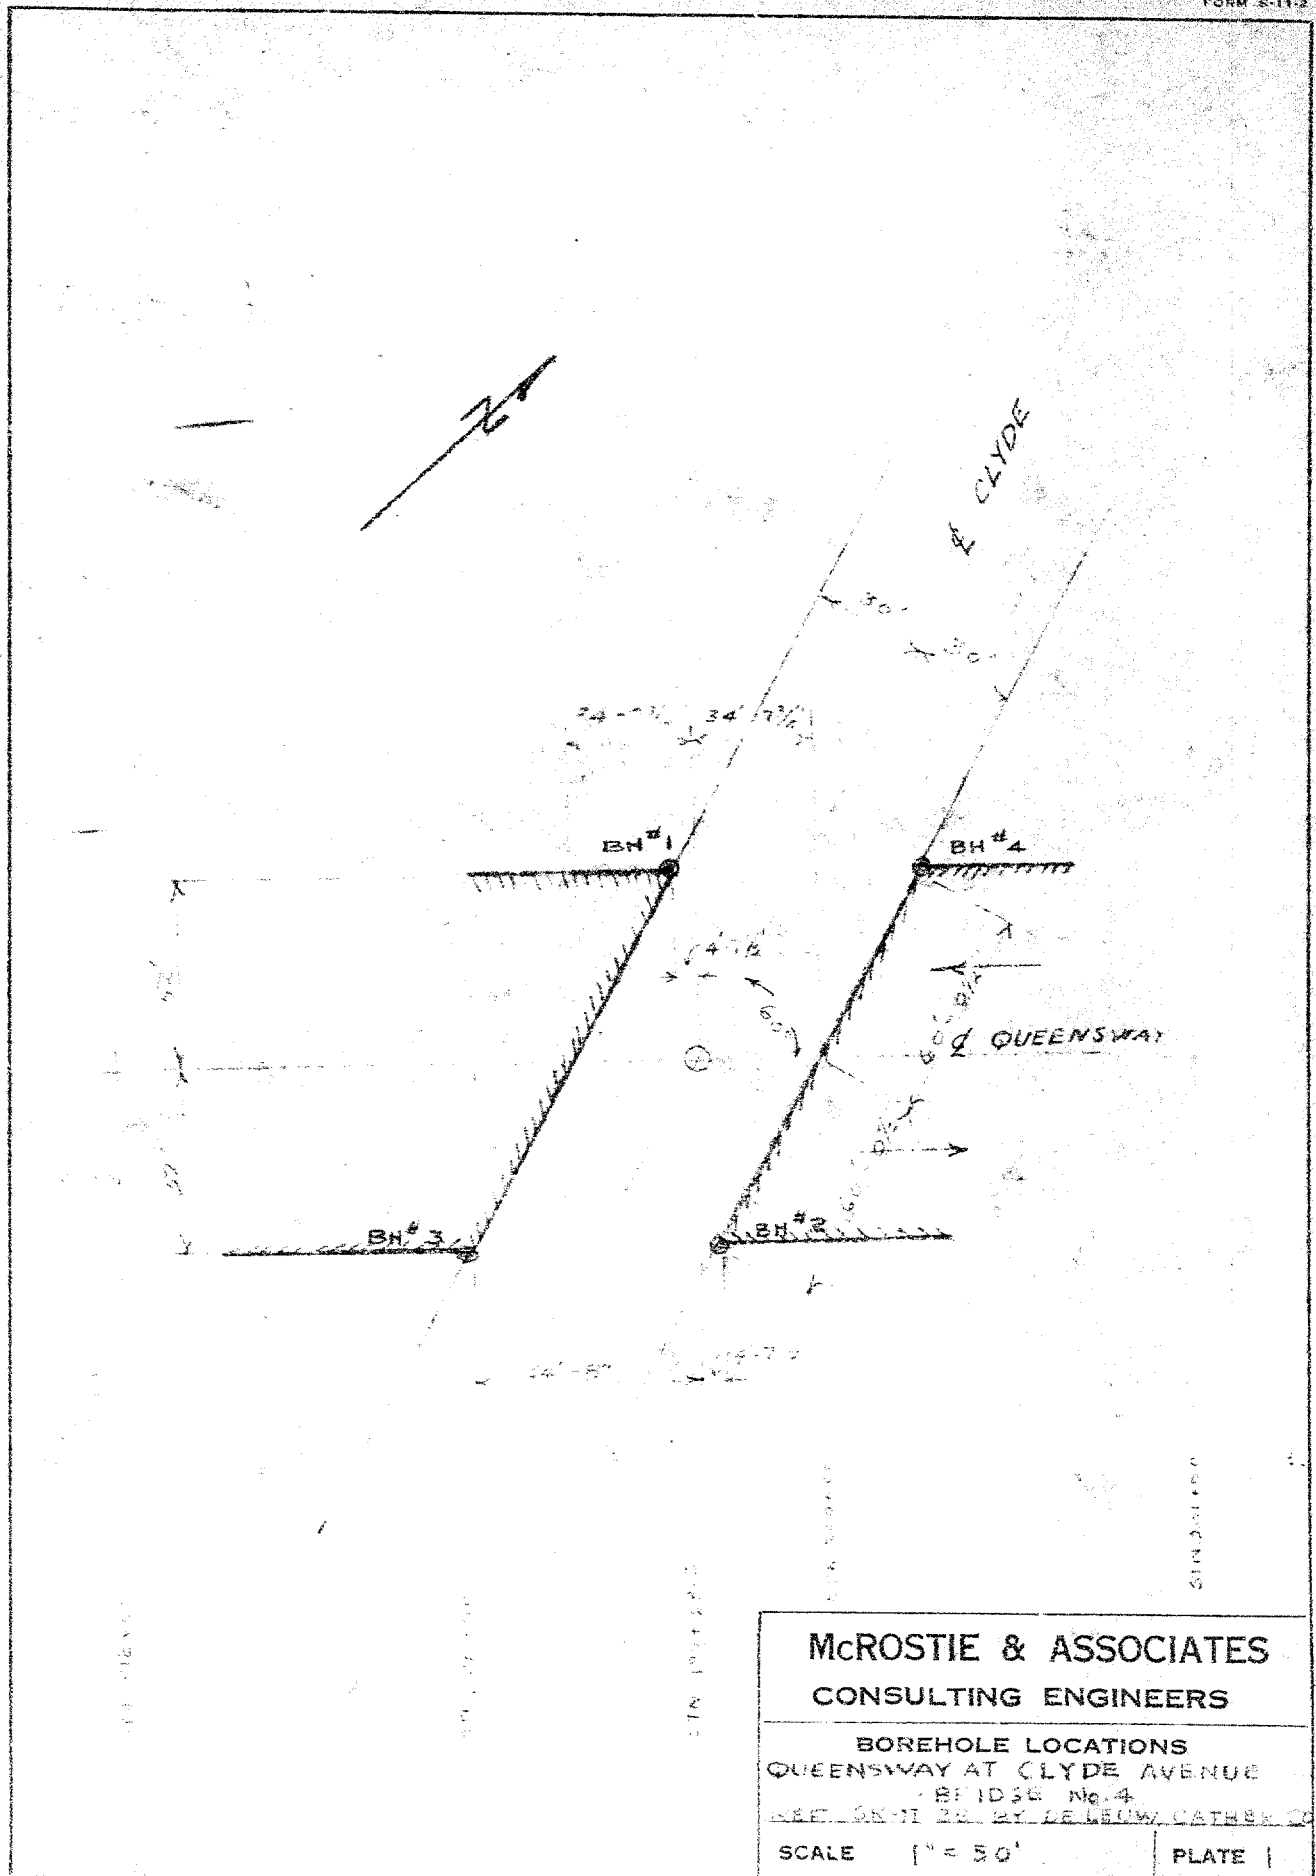
PLATE I

SOIL PROFILE AND SUMMARY OF LABORATORY TESTS

Limestone rock occurs at elevation 249 to 250. At the northerly limit of the Queenway right-of-way, the limestone is overlain with from 3 to 5 feet of loose to dense till. At the southerly limit the limestone is covered by one foot of loose sandy to dense till; above this is 2 to 3 feet of clay. Fill varying from 3 to 60 feet is the covering material to the ground surface over the site except at borhole No. 4, where there is no fill. The Ottawa Formation limestone has "shaly" characteristics, containing partings and layers which have a considerable shale content. Core recovery percentages were

generally high (above 75%) indicating a fairly sound rock broken only by bedding planes and vertical joints.
