59-F-218C
W.P. # 903-59
BRIDGE # 9
HARMER AVE.
QUEENSWAY
OTTAWA

Re: Bridge No. 9 at Harmer Avenue W.P. No. 903-5/
Queensway Ottawa, District 9

Enclosed are three copies of John D. Patterson's soils investigation report No. S107-59 for the above structure.

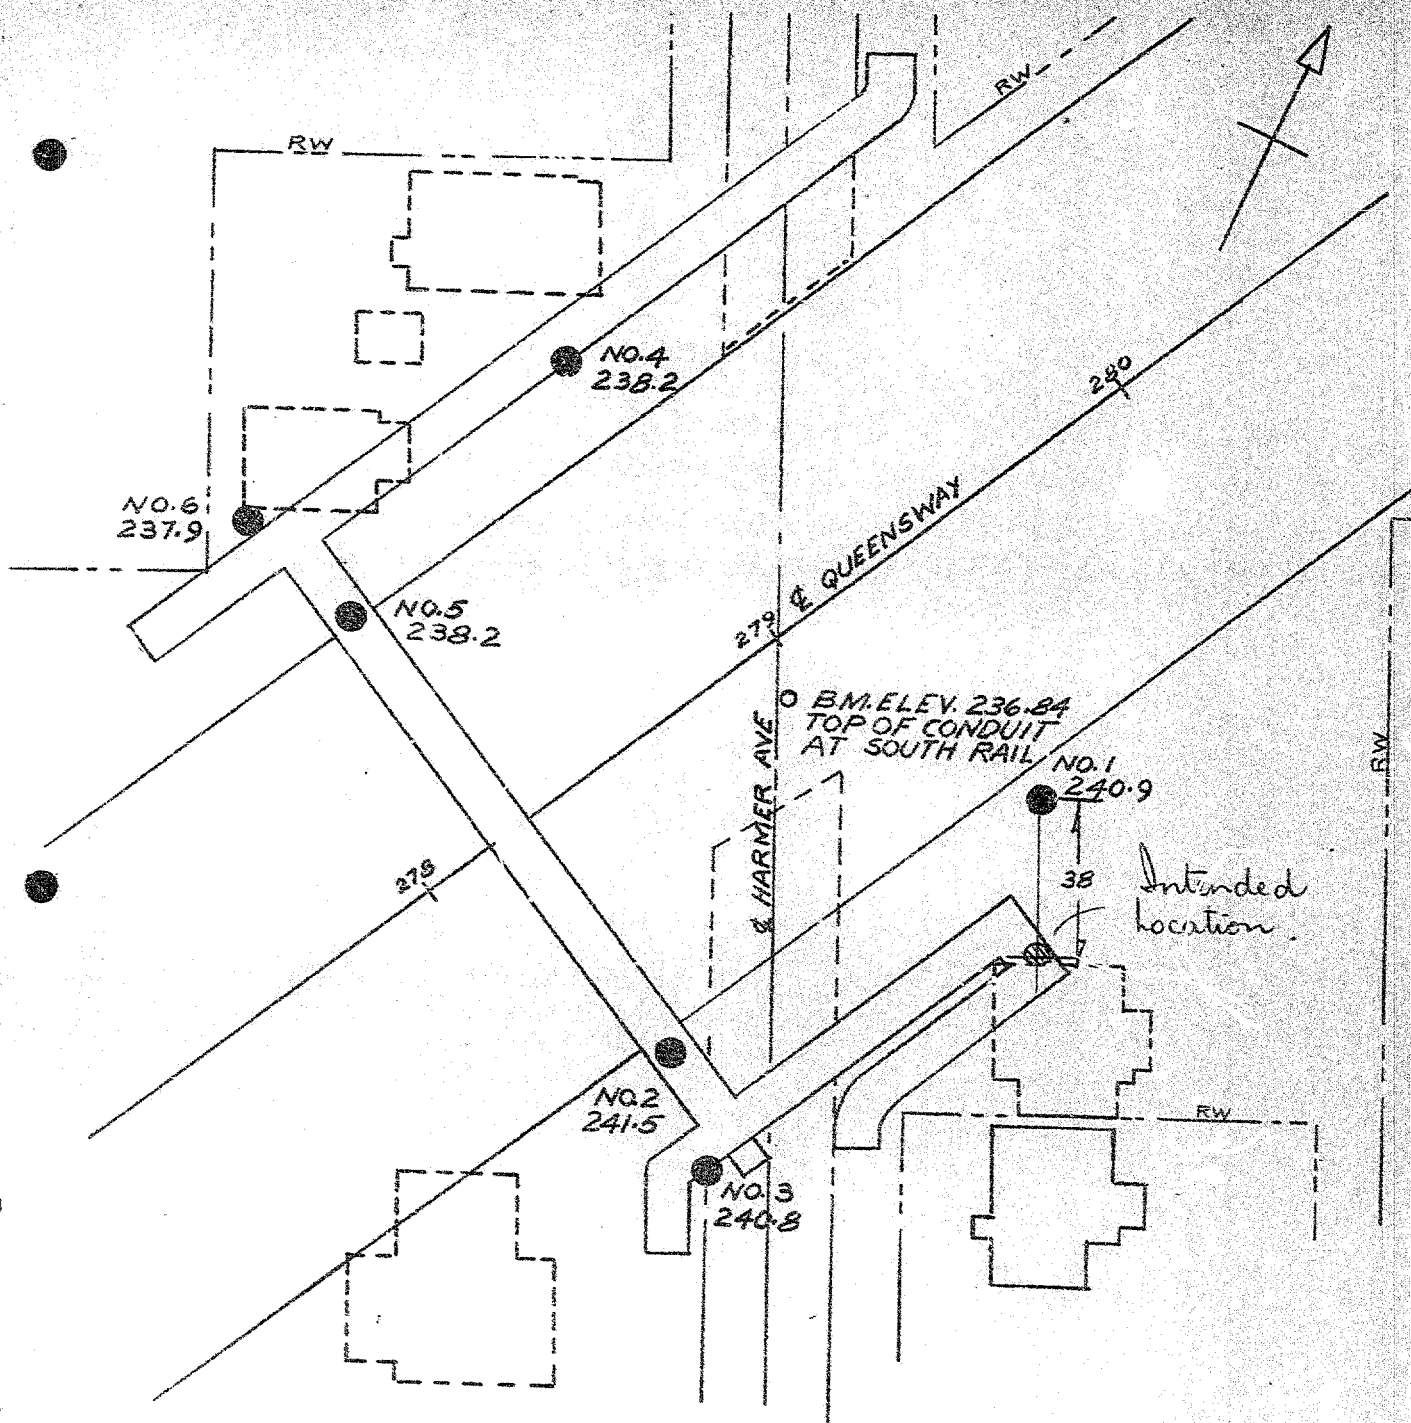
TEST BORING PLAN
BRIDGE NO. 9 JOB NO. C-44-C
HARMER AVE., OTTAWA.

SCALE 1"=40' AUGUST, 1959.

The uniformity of soil conditions at this site did not warrant the drilling of a further hole.

The soil profile was found to be quite uniform over the entire area investigated and summarizing the results obtained in five of the boreholes the profile is as follows: Below the top soil there is from 4 to 7 feet of a brown, sandy clay. This overlies a grey boulder till of medium density containing boulders up to 2 feet in diameter which is approximately 15 feet thick and extends to the bedrock.
