RE: Foundation Investigation
Proposed Crossing at Marten River at Hwy. 64
Township of Sisk
District of Nipissing
W.P. 68-68 (North Bay)

FOUNDATION INVESTIGATION
PROPOSED CROSSING AT MARTEN RIVER AT HWY. 64
TOWNSHIP OF SISK
DISTRICT OF NIPISSING
W.P. 68-68 (NORTH BAY)

71-11-138 (L)
Cont 76-80

WILLIAM TROW ASSOCIATES LIMITED
Toronto, Hamilton, Sudbury
Sarnia & London

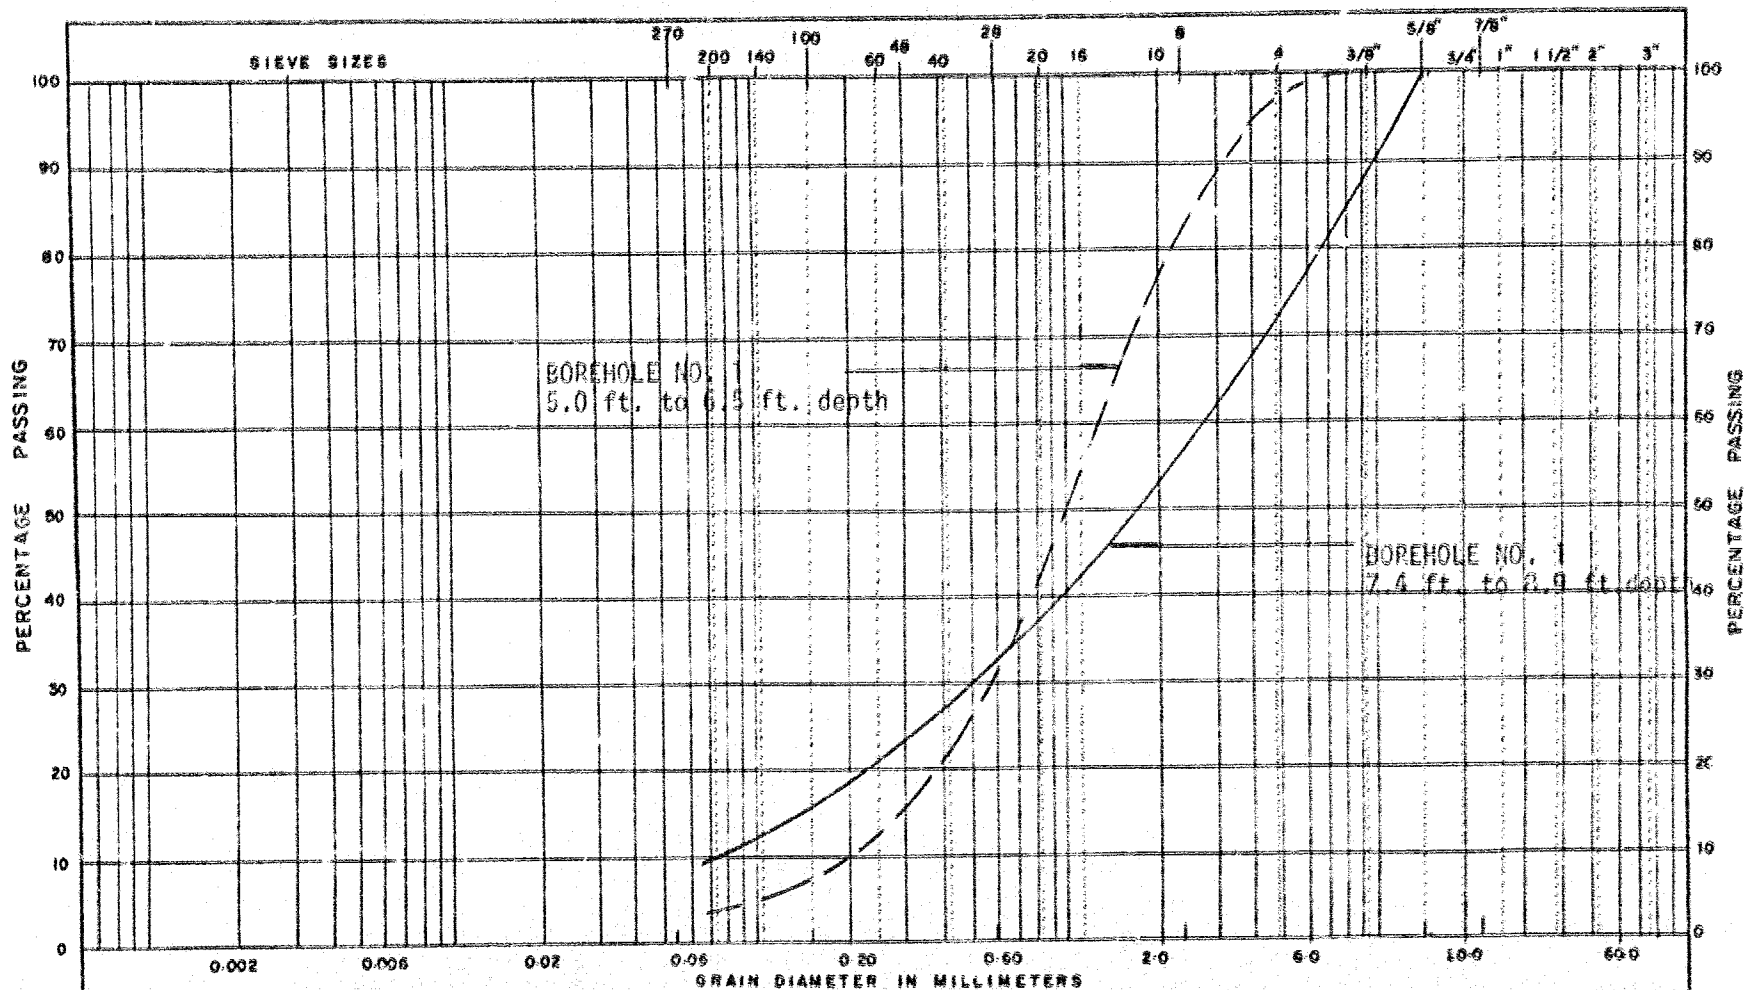
MECHANICAL ANALYSIS

MODIFIED M.I.T. CLASSIFICATION
GRADINGS OF SAND AND GRAVEL FROM UPPER LEVELS OF BOREHOLE NO. 1

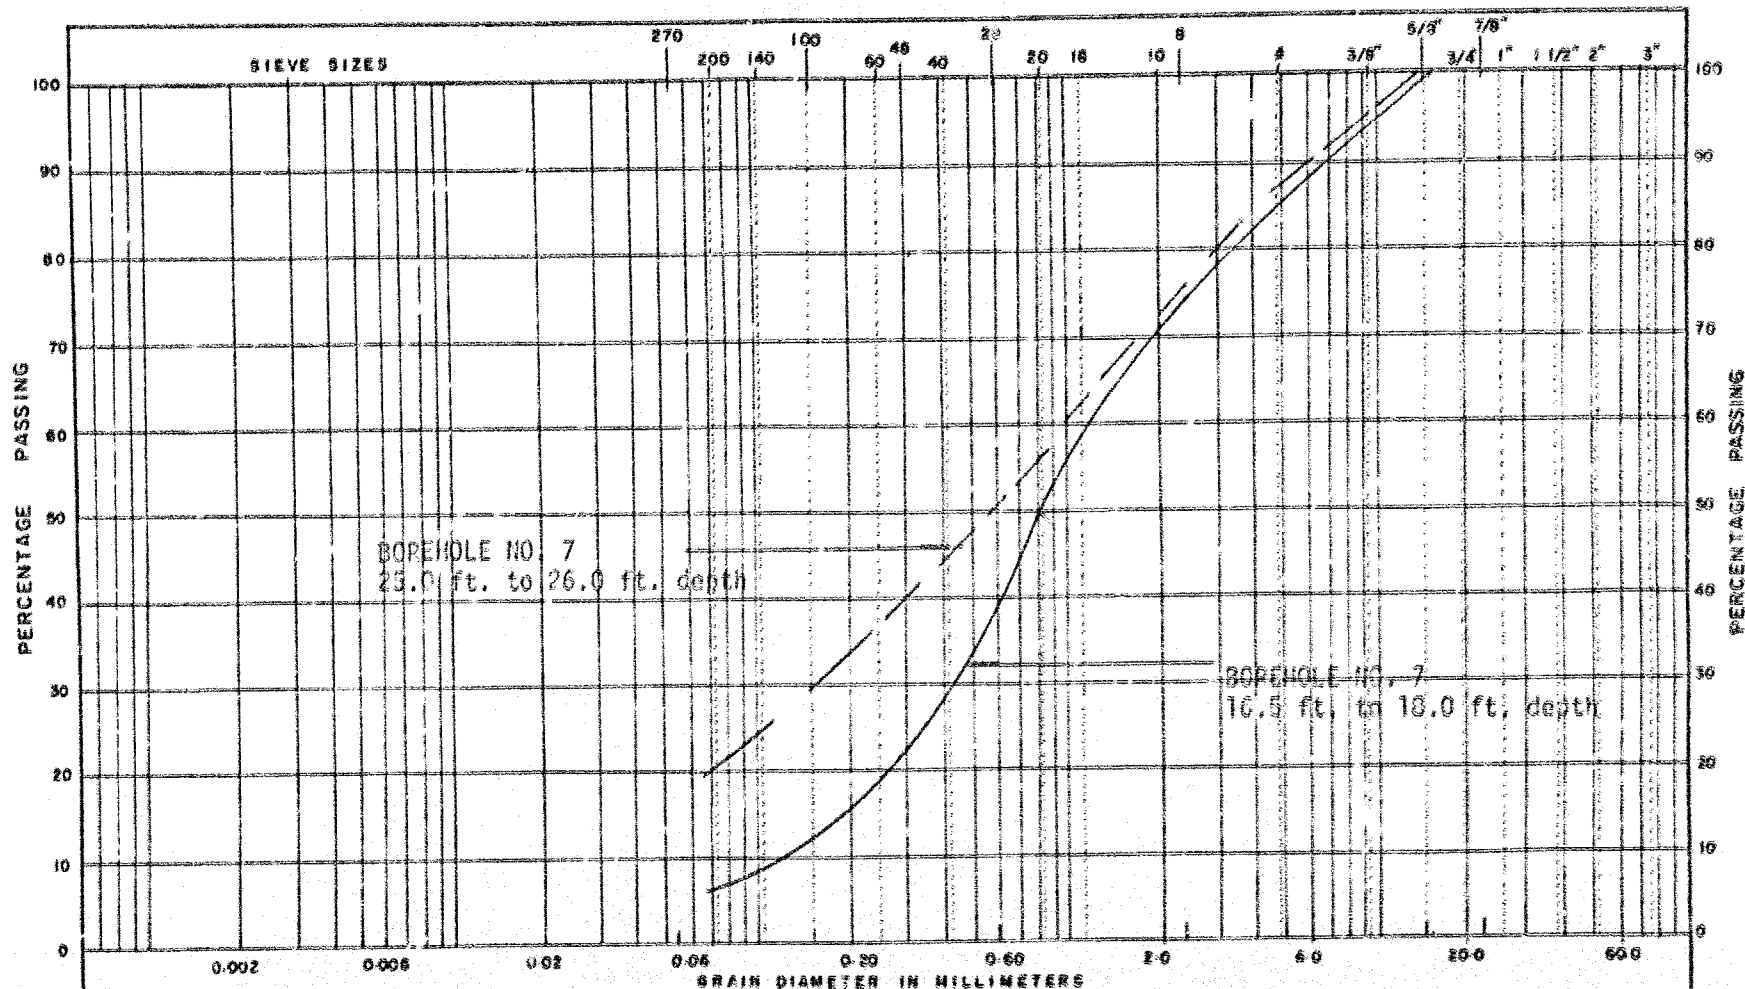
MECHANICAL ANALYSIS

CLAY	FINE	MEDIUM	COARSE	FINE	MEDIUM	COARSE	FINE	MEDIUM	COARSE
	SILT			SAND			GRAVEL		
MODIFIED M.I.T. CLASSIFICATION GRADING OF UPPER SAND AND GRAVEL AND UNDERLYING SILTY SAND TILL FROM BOREHOLE NO. 7						BRIDGE SITE WILLIAM TROW
