Project: C108/J194

Foundation Investigation  
Ontario Northland Railway Overpass  
King Kirkland, Ont.

FOUNDATION INVESTIGATION  
ONTARIO NORTHLAND RAILWAY OVERPASS  
KING KIRKLAND, ONT.

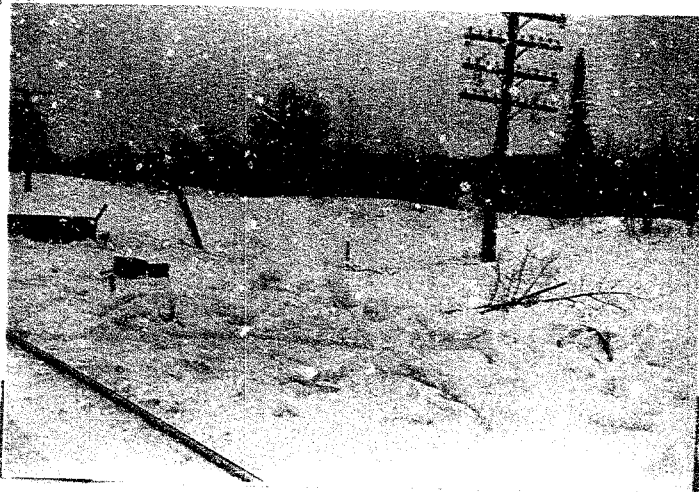
1. South Abutment location  
and view of south  
approach.

The abutment footings for the overpass will undoubtedly rest directly on the bedrock since the depth to the rock is under 10 feet. The construction of the south abutment will offer little or no problem since the 3 to 4 feet of sand on top of the rock is easily removable. Little trouble with water is to be expected since no ground water was encountered in this area during the investigation. Therefore, at the south abutment location, footings can be founded directly on the underlying bedrock at an elevation of approximately 1119.0 ft. The north abutment footings can also be founded on the bedrock, but problems associated with ground water are to be expected. At this location, the ground water is near the surface at elevation approximately 1118.0 ft. Precise bedrock elevation beneath the north abutment will vary slightly with the abutment positioning since in this area the bedrock dips to the north at a slope approximating 6:1. The bedrock at both abutment locations is capable of supporting considerable loads, but in view of the cleavage in the vertical direction, it is recommended that the allowable bearing value does not exceed 10 tons per square foot.

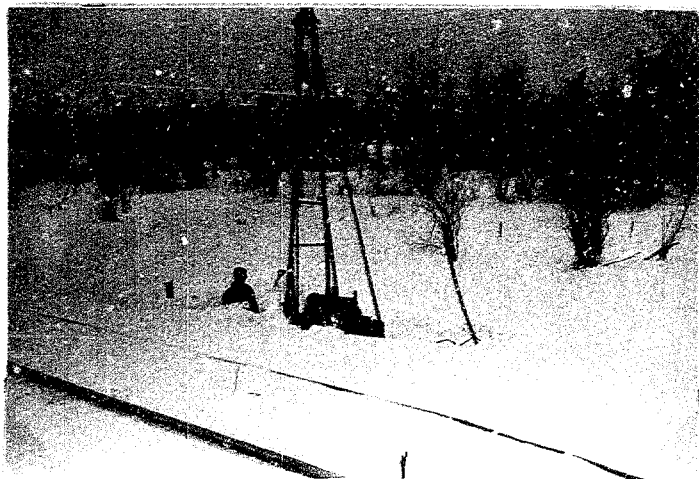
3. North abutment location  
and view of north  
approach.

The construction of the south approach embankment offers no difficulty, but removal of the top layer of muskeg, where present, is recommended. In the case of the north approach, the 3 to 5 foot layer of muskeg must be removed or large and unequal settlements will result. This removal may best be carried out using drag-line excavators sitting on pads. If fill is placed to the water level as the excavation proceeds any possibility of the sides slipping in will be prevented.
