**REVISED FINAL FOUNDATION  
INVESTIGATION REPORT  
HIGHWAY 15/COUNTY ROAD 42 SIGNS  
(44.65345, -76.25741)  
Geocres No. 31C09-001**

Ministry of Transportation Ontario, Eastern Region

Agreement 4021-E-0027 (Assignment #5)/GWP 4342-23-00

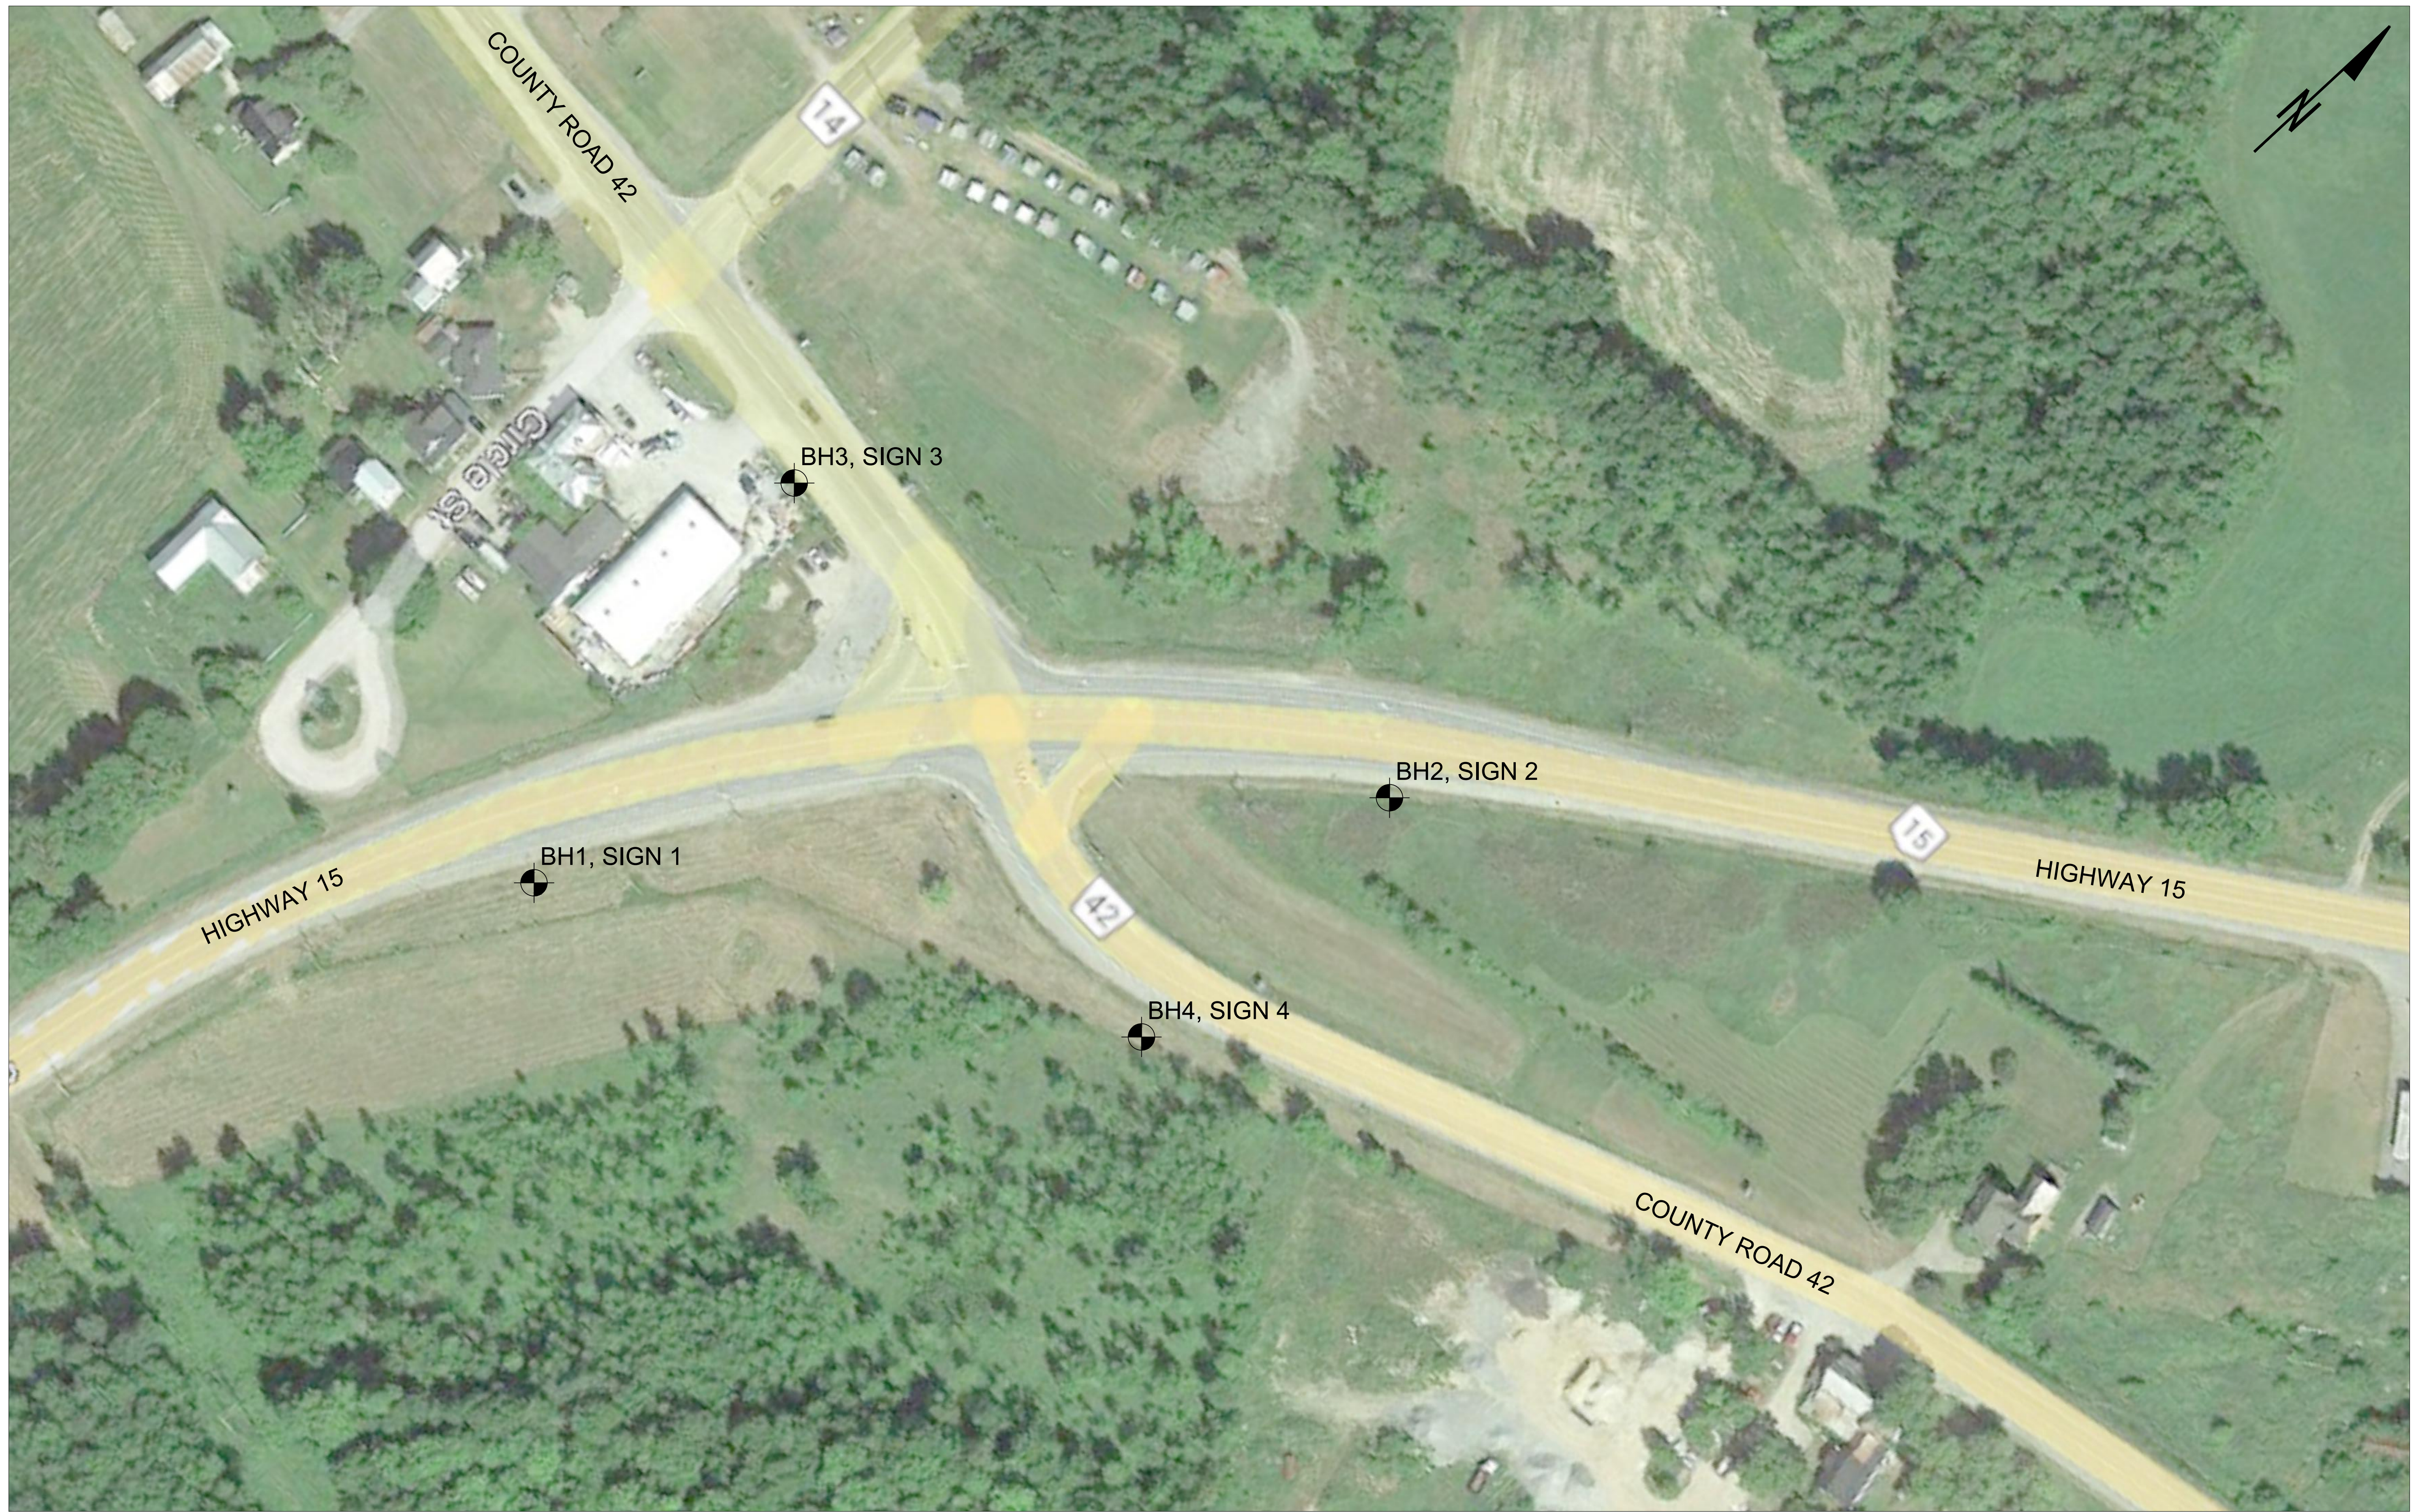
## **Figure No. 1**

### Borehole Location Plan

The Ministry of Transportation Ontario (MTO), Eastern Region retained Ainley Group (AGA) to provide supplemental geotechnical and foundation engineering services for the intended intersection improvements planned for the intersection of Highway 15 at County Road 42 located in the Village of Crosby, within the Township of Rideau Lakes and United Counties of Leeds and Grenville at four (4) proposed sign locations. The locations of the proposed signs is detailed in **Figure No. 1** appended to this report.

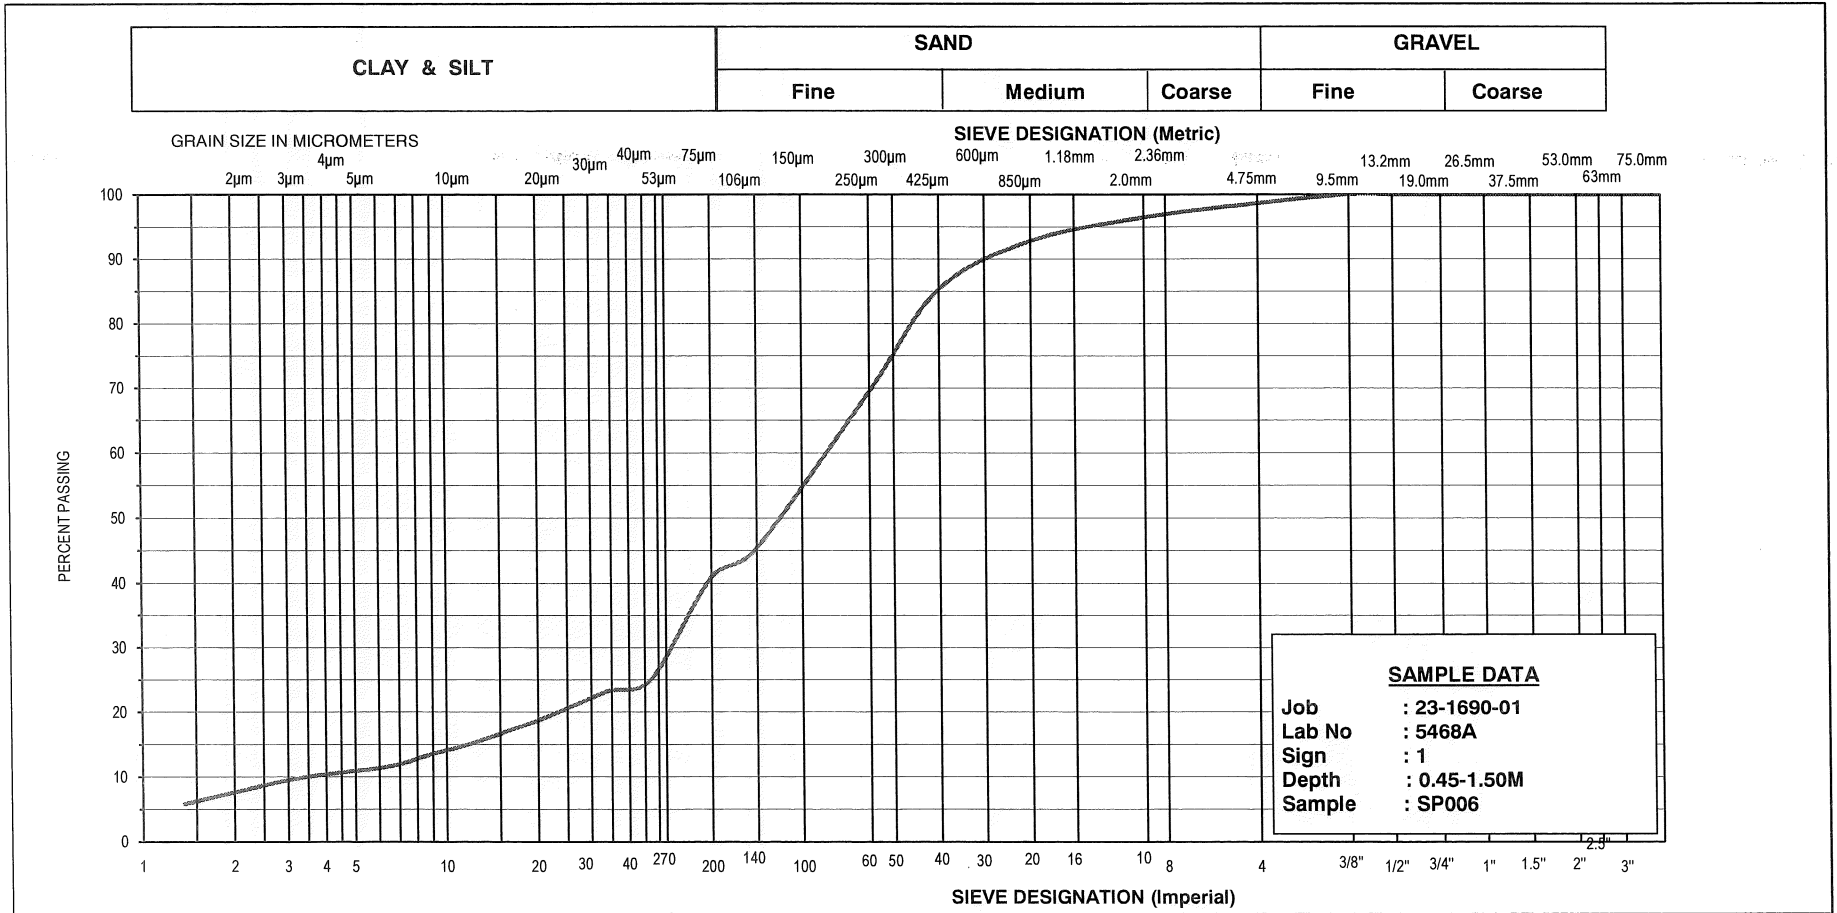
% +3"	% Gravel		% Sand			% Fines	
	Course	Fine	Course	Medium	Fine	Silt	Clay
	0	1	2	11	44	33	8

<b>Atkins Realis</b> 1164 Clyde Court Kingston, Ontario K7P 2E4	<b>GRAIN SIZE DISTRIBUTION</b>		Client: Ainley	
	<b>SILTY SAND</b>		Project: 23-1690-01	
	Trace Clay, Trace Gravel		22589-5 Highway #15 Roundabout Signs	
	Date: July 22, 2024			Moisture Content is 20.2%

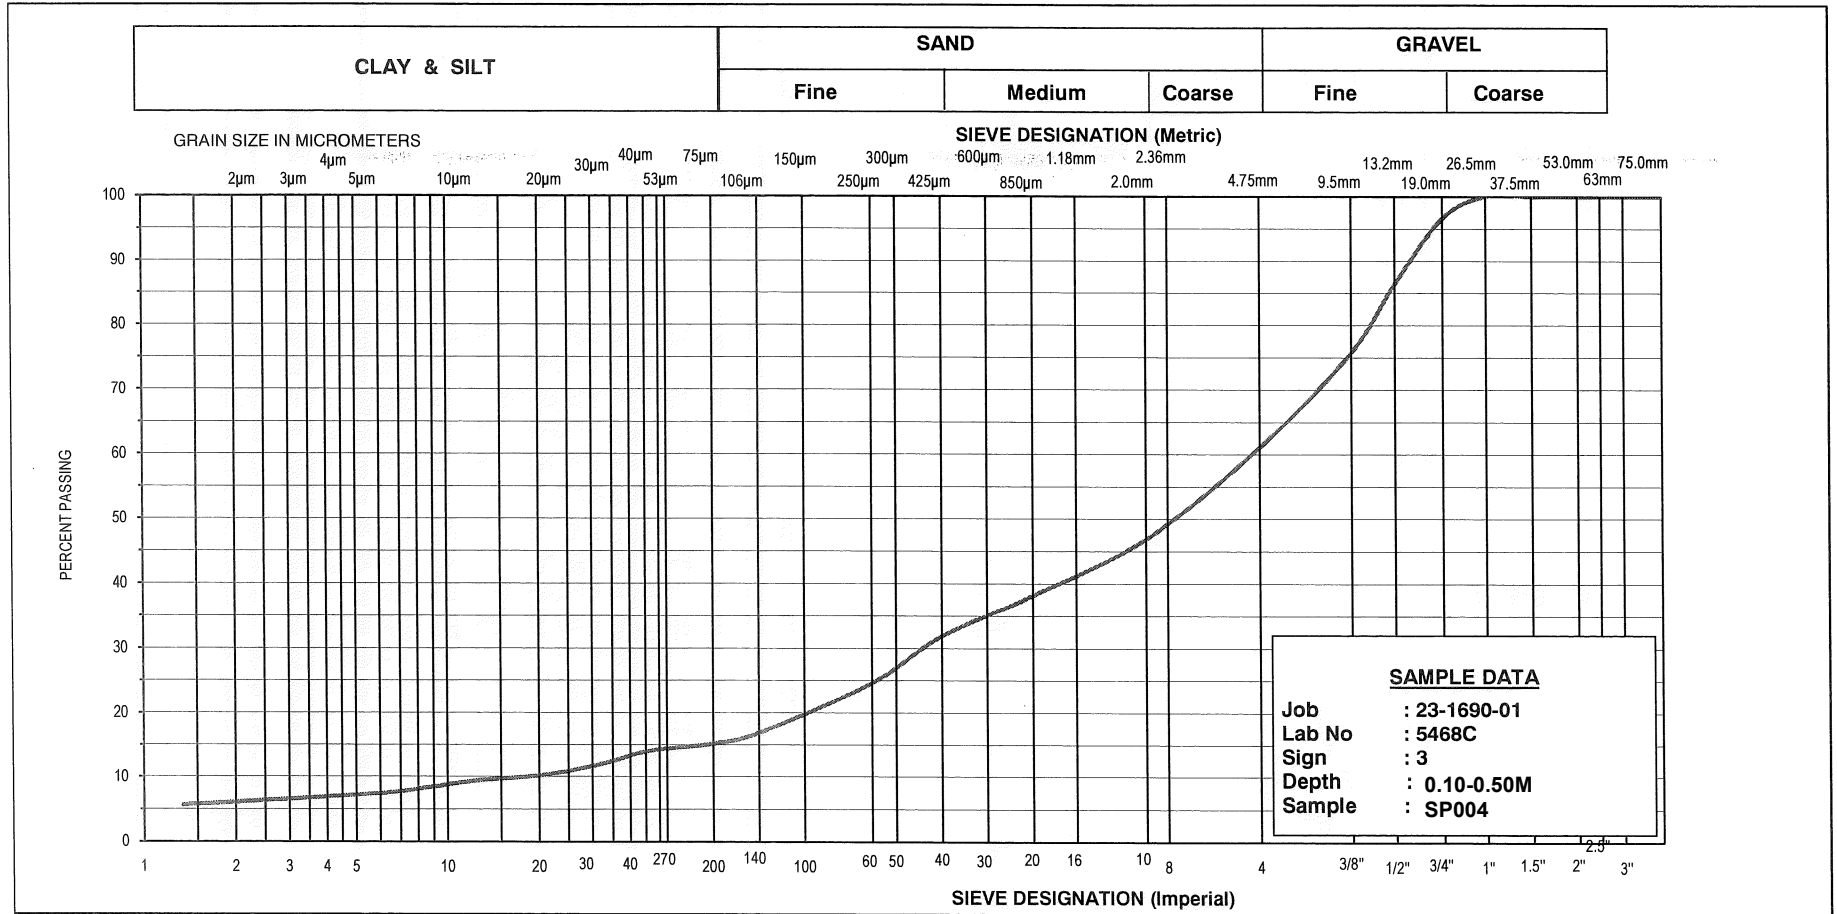
% +3"	% Gravel		% Sand			% Fines	
	Course	Fine	Course	Medium	Fine	Silt	Clay
	3	36	14	15	17	9	6

<b>Atkins Realis</b> 1164 Clyde Court Kingston, Ontario K7P 2E4	<b>GRAIN SIZE DISTRIBUTION</b>		Client: Ainley
	<b>GRAVELLY SAND</b>		Project: 23-1690-01
	Trace Silt, Trace Clay		22589-5 Highway #15 Roundabout Signs
			Date: July 22, 2024
			Moisture Content is 4.1%

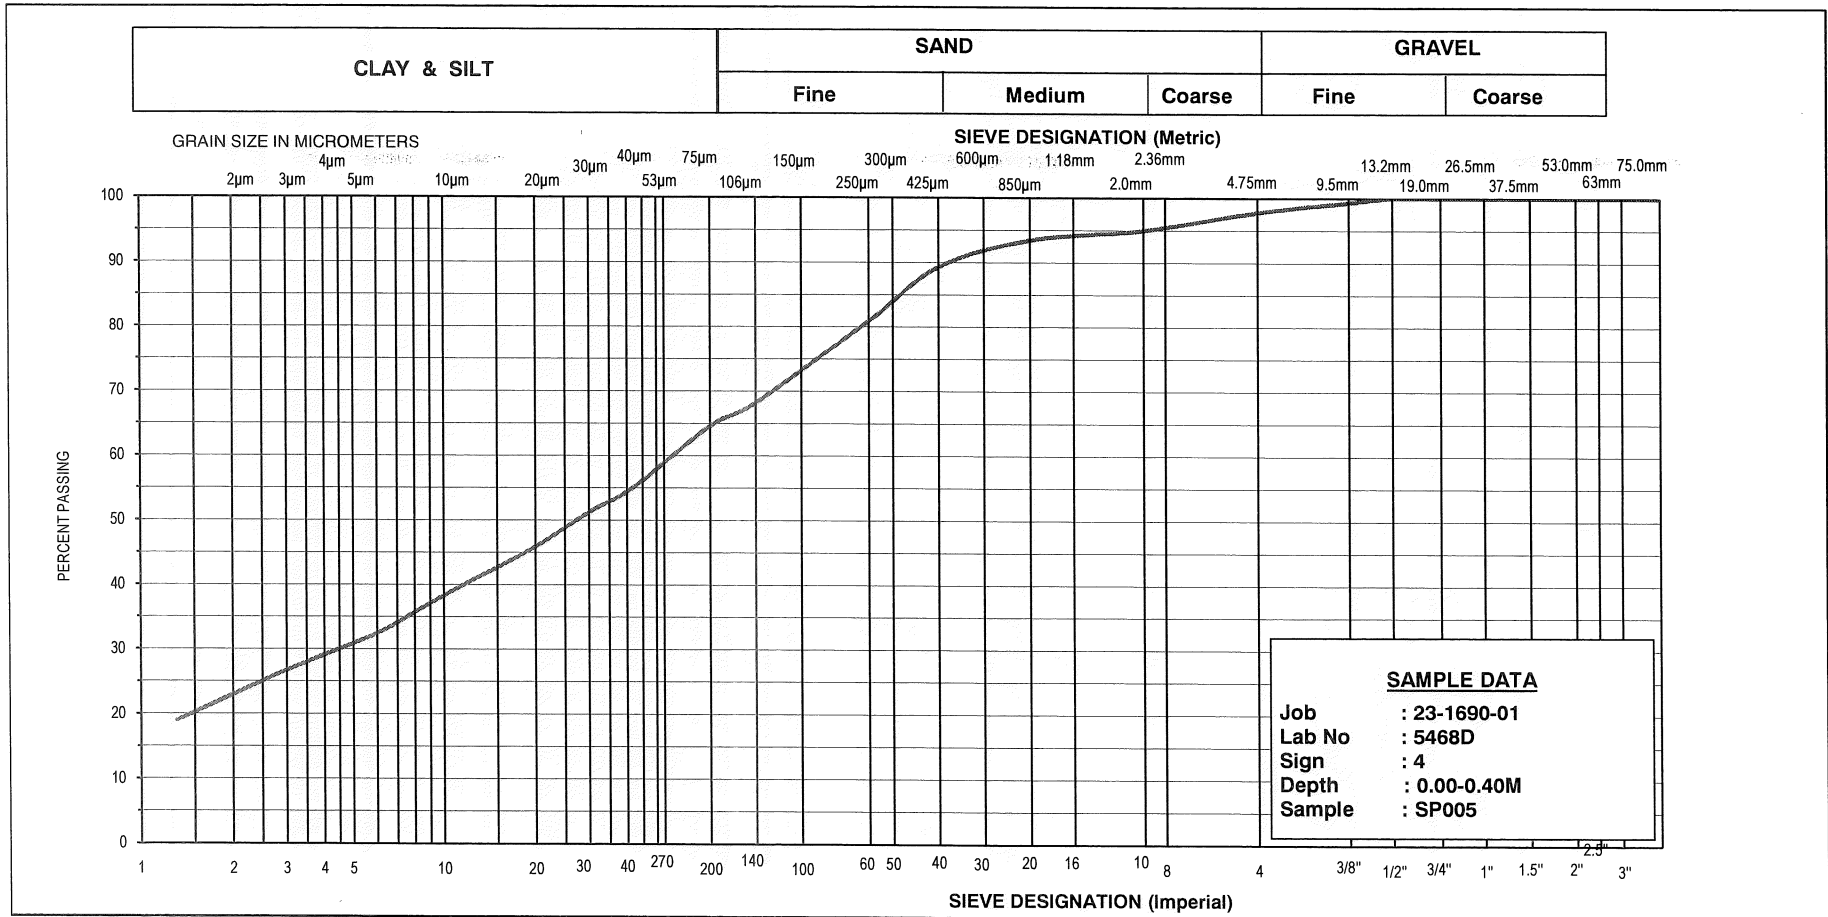
% +3"	% Gravel		% Sand			% Fines	
	Course	Fine	Course	Medium	Fine	Silt	Clay
	0	2	3	6	25	42	23

<b>Atkins Realis</b> 1164 Clyde Court Kingston, Ontario K7P 2E4	<b>GRAIN SIZE DISTRIBUTION</b>		Client: Ainley	
			Project: 23-1690-01	
	<b>CLAYEY SANDY SILT</b>		22589-5 Highway #15 Roundabout Signs	
	<b>Trace Gravel</b>		Date: July 22,2024	Moisture Content is 30.8%
