FOUNDATION DESIGN REPORT

PROPOSED THREE POLE-MOUNTED VARIABLE MESSAGE SIGNS, HIGHWAY 401 AND 417, ONTARIO

MINISTRY OF TRANSPORTATION ONTARIO

MARCH 11, 2021

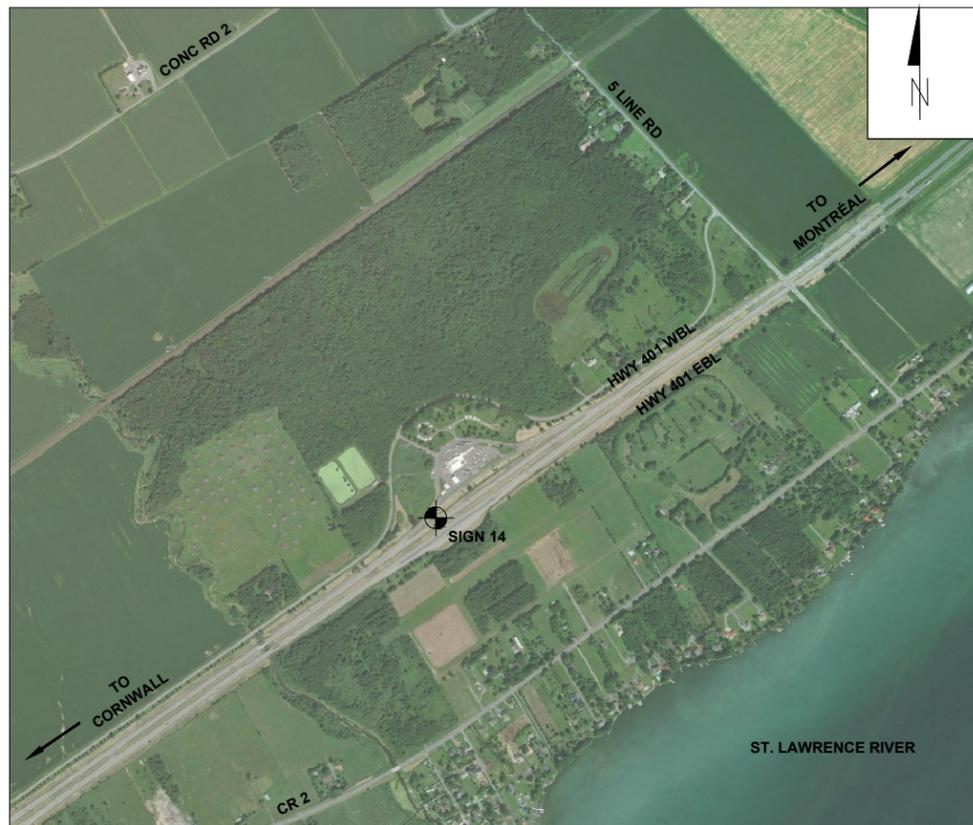
KEY MAP
N.T.S.

ID	TOP OF GRADE ELEVATION (masl)	BEDROCK ELEVATION (masl)	GROUNDWATER ELEVATION (masl)
SIGN 14	48.763	NE	47.563

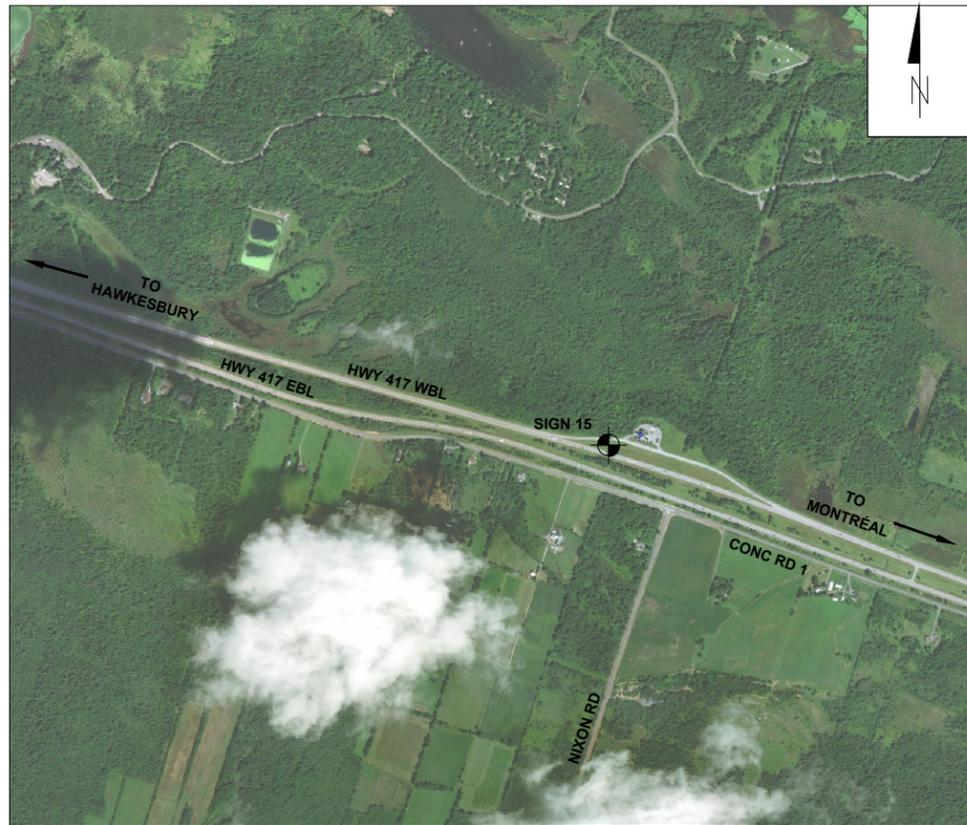
KEY MAP
N.T.S.

ID	TOP OF GRADE ELEVATION (masl)	BEDROCK ELEVATION (masl)	GROUNDWATER ELEVATION (masl)
SIGN 15	52.670	NE	NE
