Soils Report by E. M. Peto Assoc., Ltd.,  
Township Bridge #18, County of Lambton,  
Bridge Office Ref. #BA 1512.

#  
62-F-281M  
TWP BRIDGE 18  
BROOKE-WARWICK

TOWNLINE  
WARWICK  
TWP

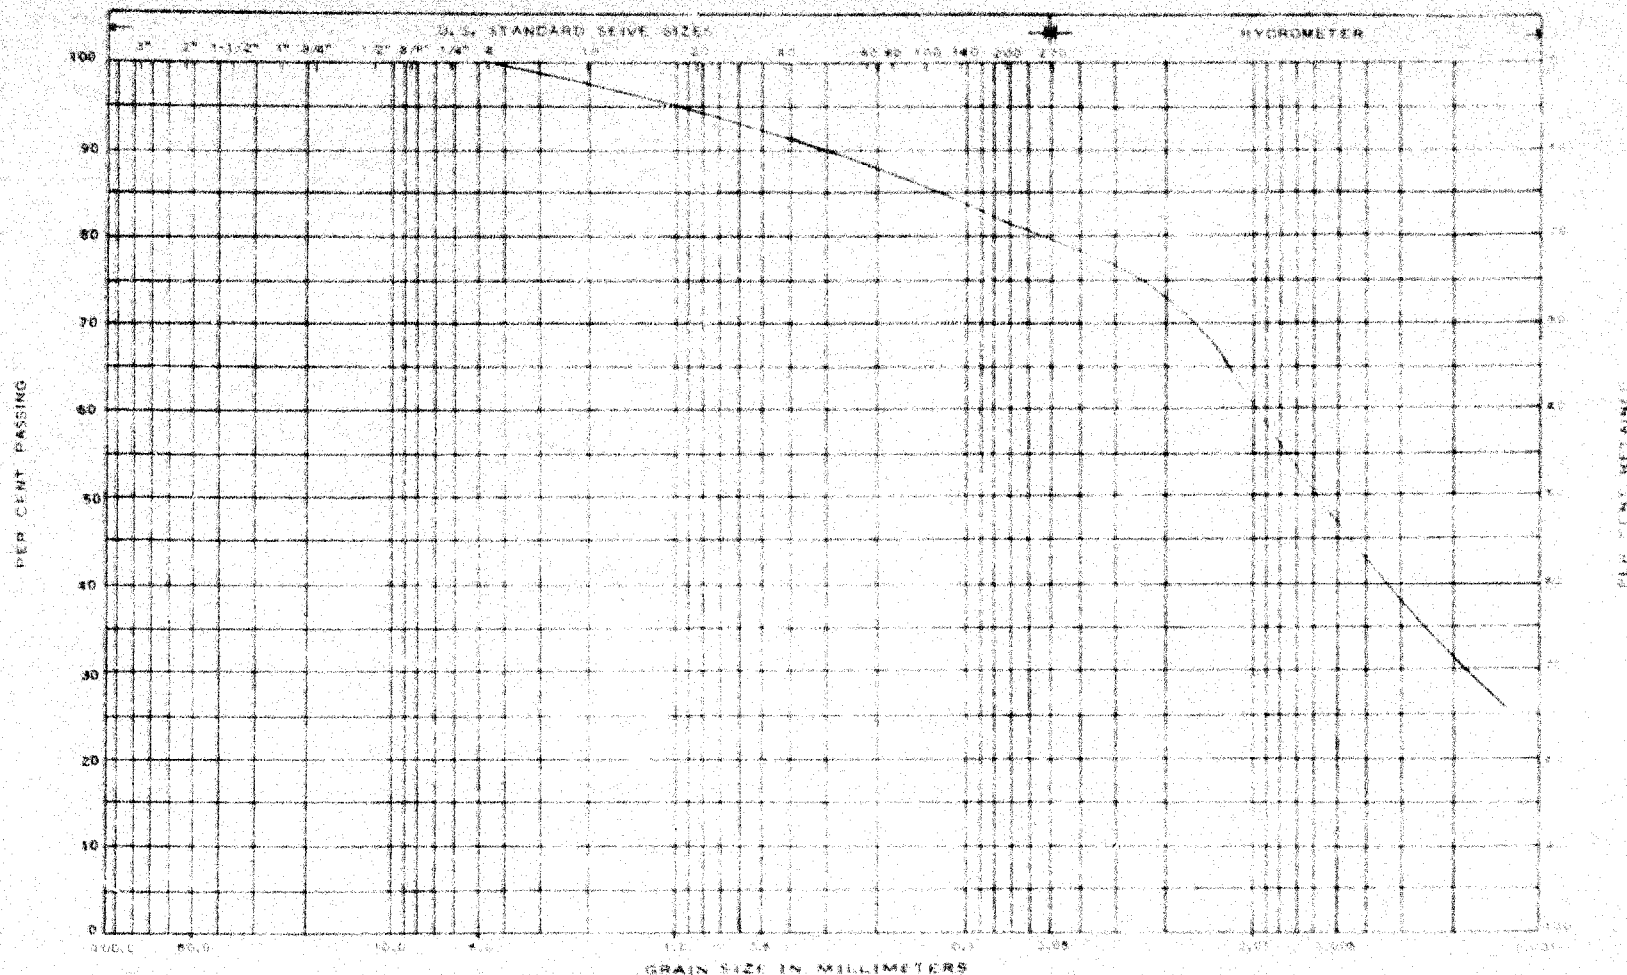
STONES	GRAVEL	COARSE SAND	MED. SAND	FINE SAND	COARSE SILT	MED. SILT	FINE SILT	CLAY
--------	--------	-------------	-----------	-----------	-------------	-----------	-----------	------

MASS. INST. OF TECH. CLASSIFICATION

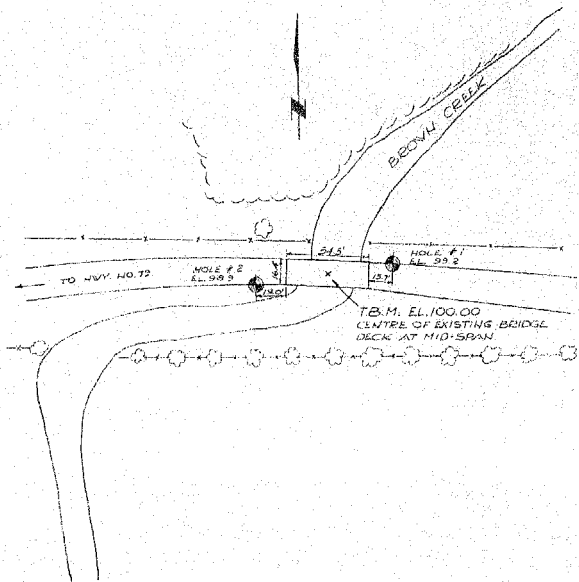
SITE PLAN

SCALE: 50' TO 1"

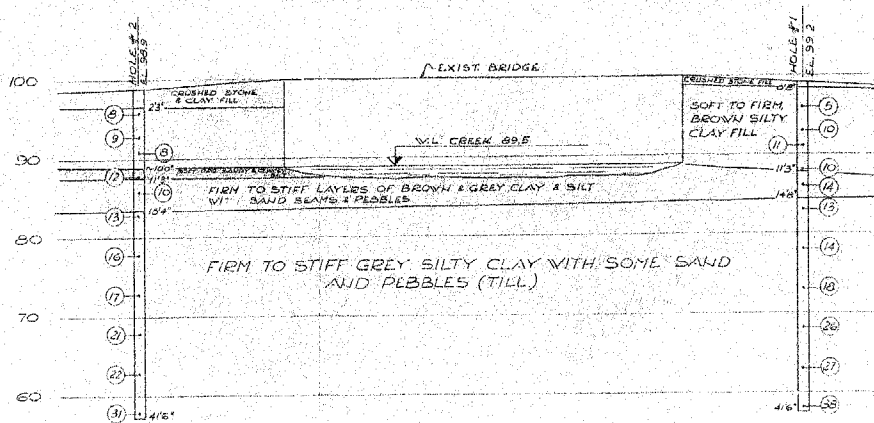
SOIL SECTION THROUGH HOLES 2 & 1

PROFILE SCALE: HOR. & VERT. 10' TO 1"

SEE BOREHOLE LOGS FOR COMPLETE SOIL DATA.

NOTE: The actual soil stratification has been verified from data obtained at the borehole locations only. The inferred contacts shown are based on geological evidence and these may vary from those shown between borings.

Borehole logs are prepared giving details of the soil description and condition as recorded in the field. These logs form the basis of the soil profile, which indicates the general stratigraphy assumed to exist between the boreholes as represented by the borehole logs.

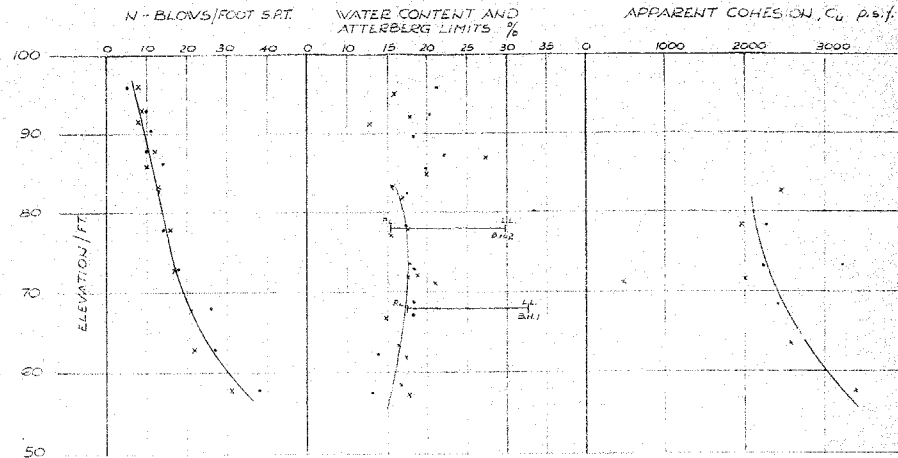
SYMBOLS: ⊕ HOLE #1  
⊖ HOLE #2
