HARDY CREEK BRIDGE

SUBJECT: Township of Brooke  
Hardy Creek Bridge  
Lot 24, Con. X/XI  
County of Lambton  
Structure Site No. 15-160  
Our File No. BA 1712

Re: Subsoil Investigation,  
Hardy Creek Bridge,  
13 miles east of Petrolia, Ontario.

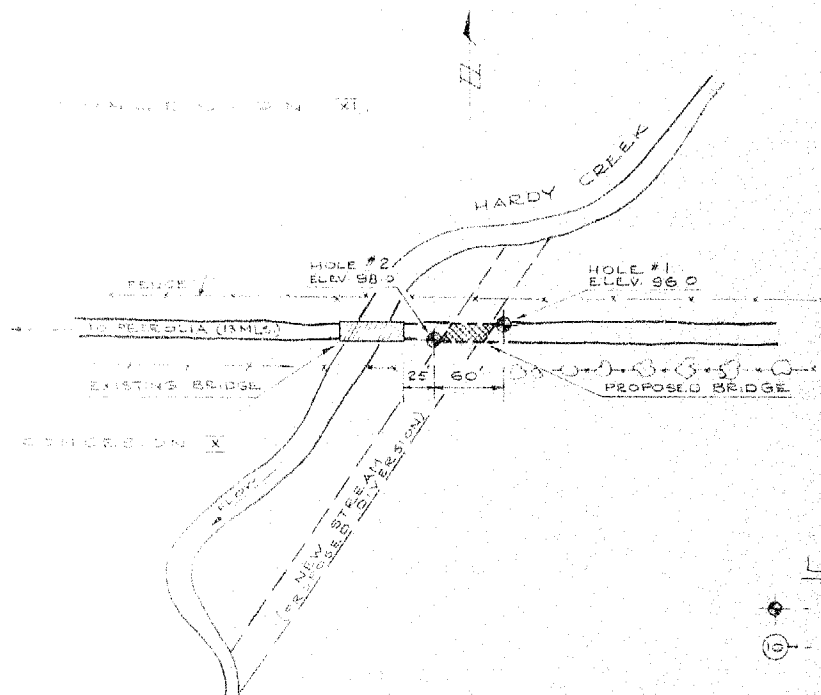
SKETCH SHOWING BOREHOLE  
LOCATIONS

SCALE: 100' TO 1"
