FOUNDATION INVESTIGATION -- by  
William A. Trow & Associates,  
Ltd.

Re: Proposed County Road Underpass,  
Hwy. 401, Twps. Southwold & Delaware,  
W.P. 64-59 -- District No. 2

Foundation Investigation  
Proposed County Road Underpass, Hwy. #401,  
Twps. Southwold and Delaware; WP-64-59.

FOUNDATION INVESTIGATION  
PROPOSED COUNTY ROAD UNDERPASS, HWY. 401,  
TWPS. SOUTHWOLD AND DELAWARE: WP- 64-59.

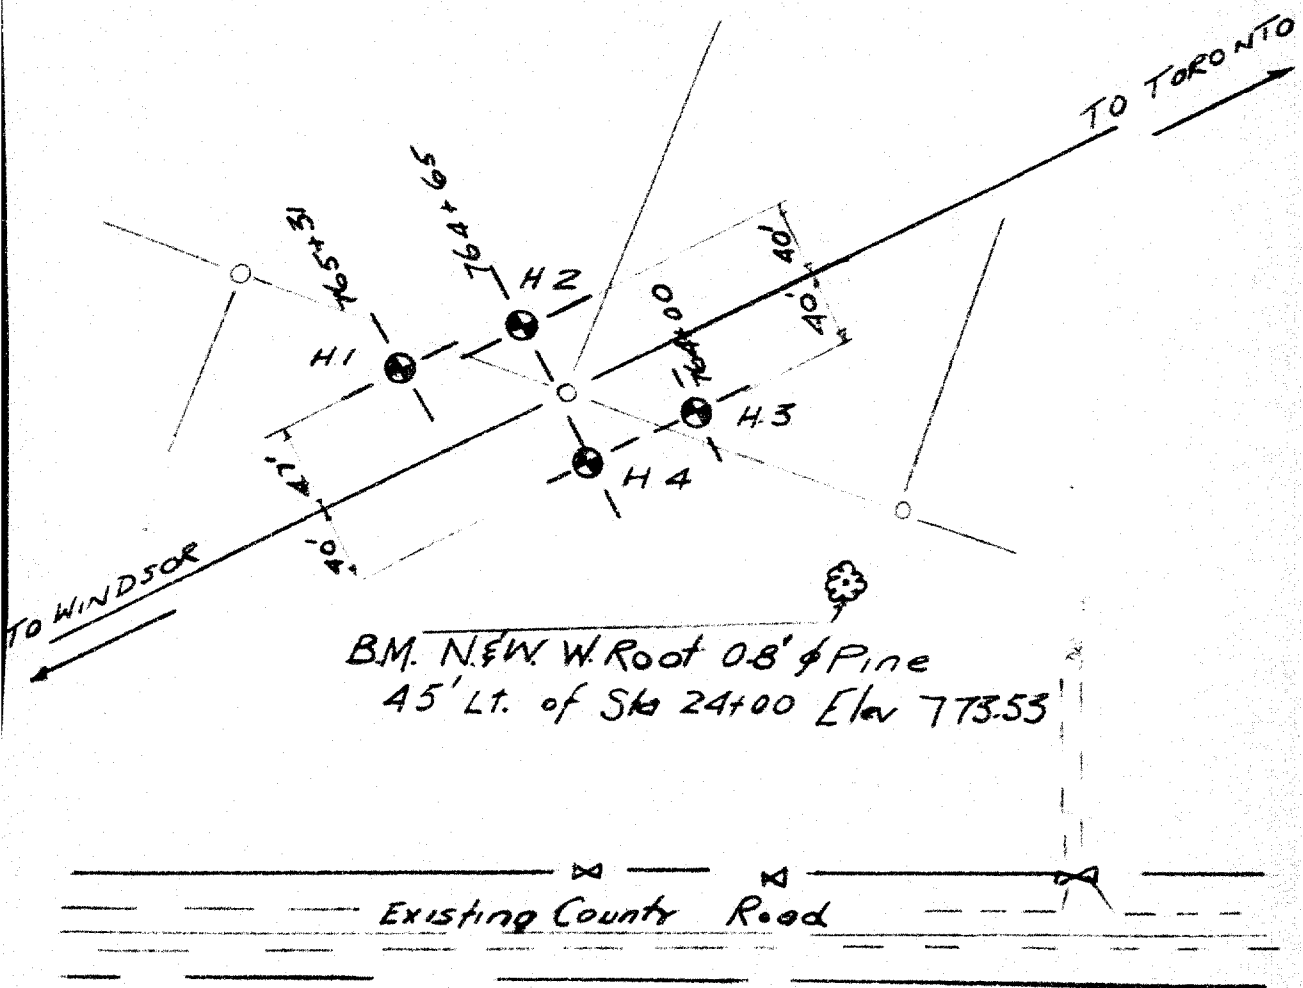
Sketch showing correct position  
of borings WP 64-59 HWY 401  
underpass.

The attached self-explanatory letter  
and accompanying sketch, submitted by the Consultants,  
W. A. Trow & Associates, Ltd., are being forwarded  
for insertion in the above-mentioned Foundation report  
previously distributed.

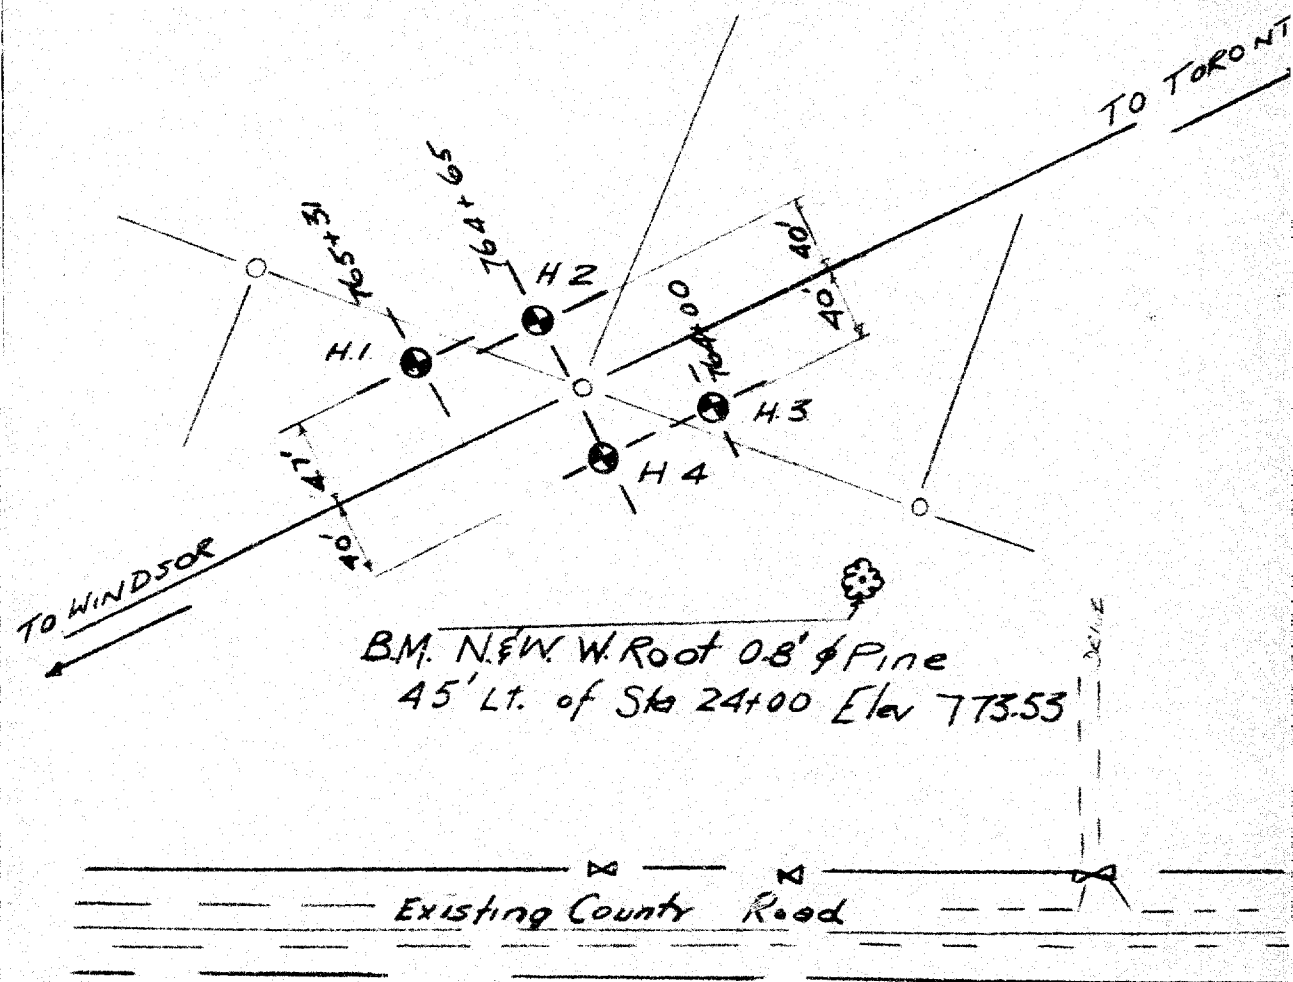
Sketch showing correct position  
of borings WP 64-59 HWY 401  
underpass.

The attached self-explanatory letter and accompanying sketch, submitted by the Consultants, W. A. Trow & Associates, Ltd., are being forwarded for insertion in the above-mentioned Foundation report previously distributed.

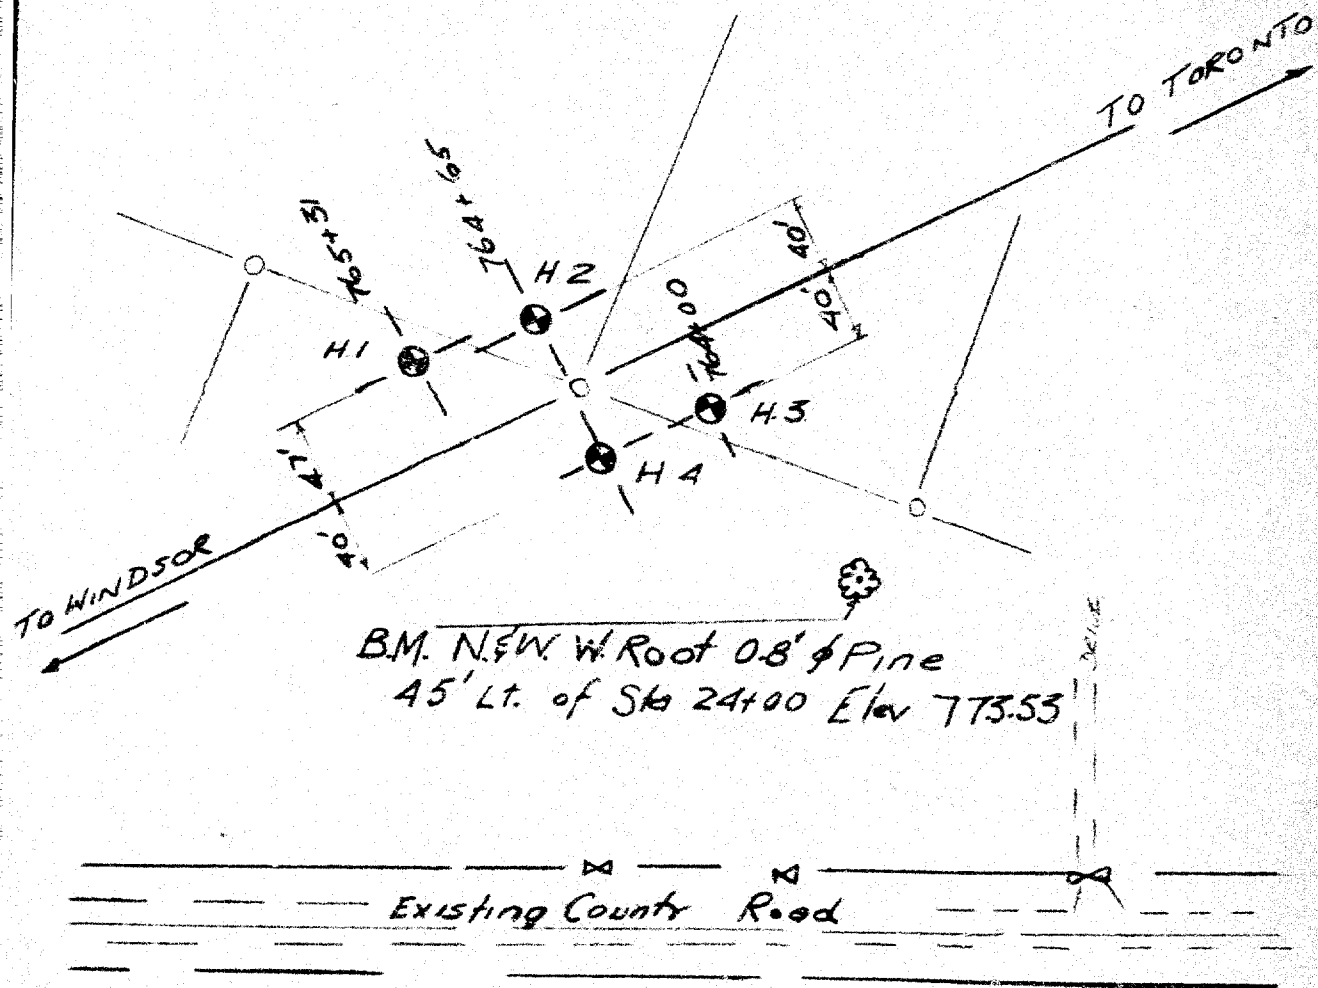
Sketch showing correct position  
of borings WP 64-59 HWY 401  
underpass.

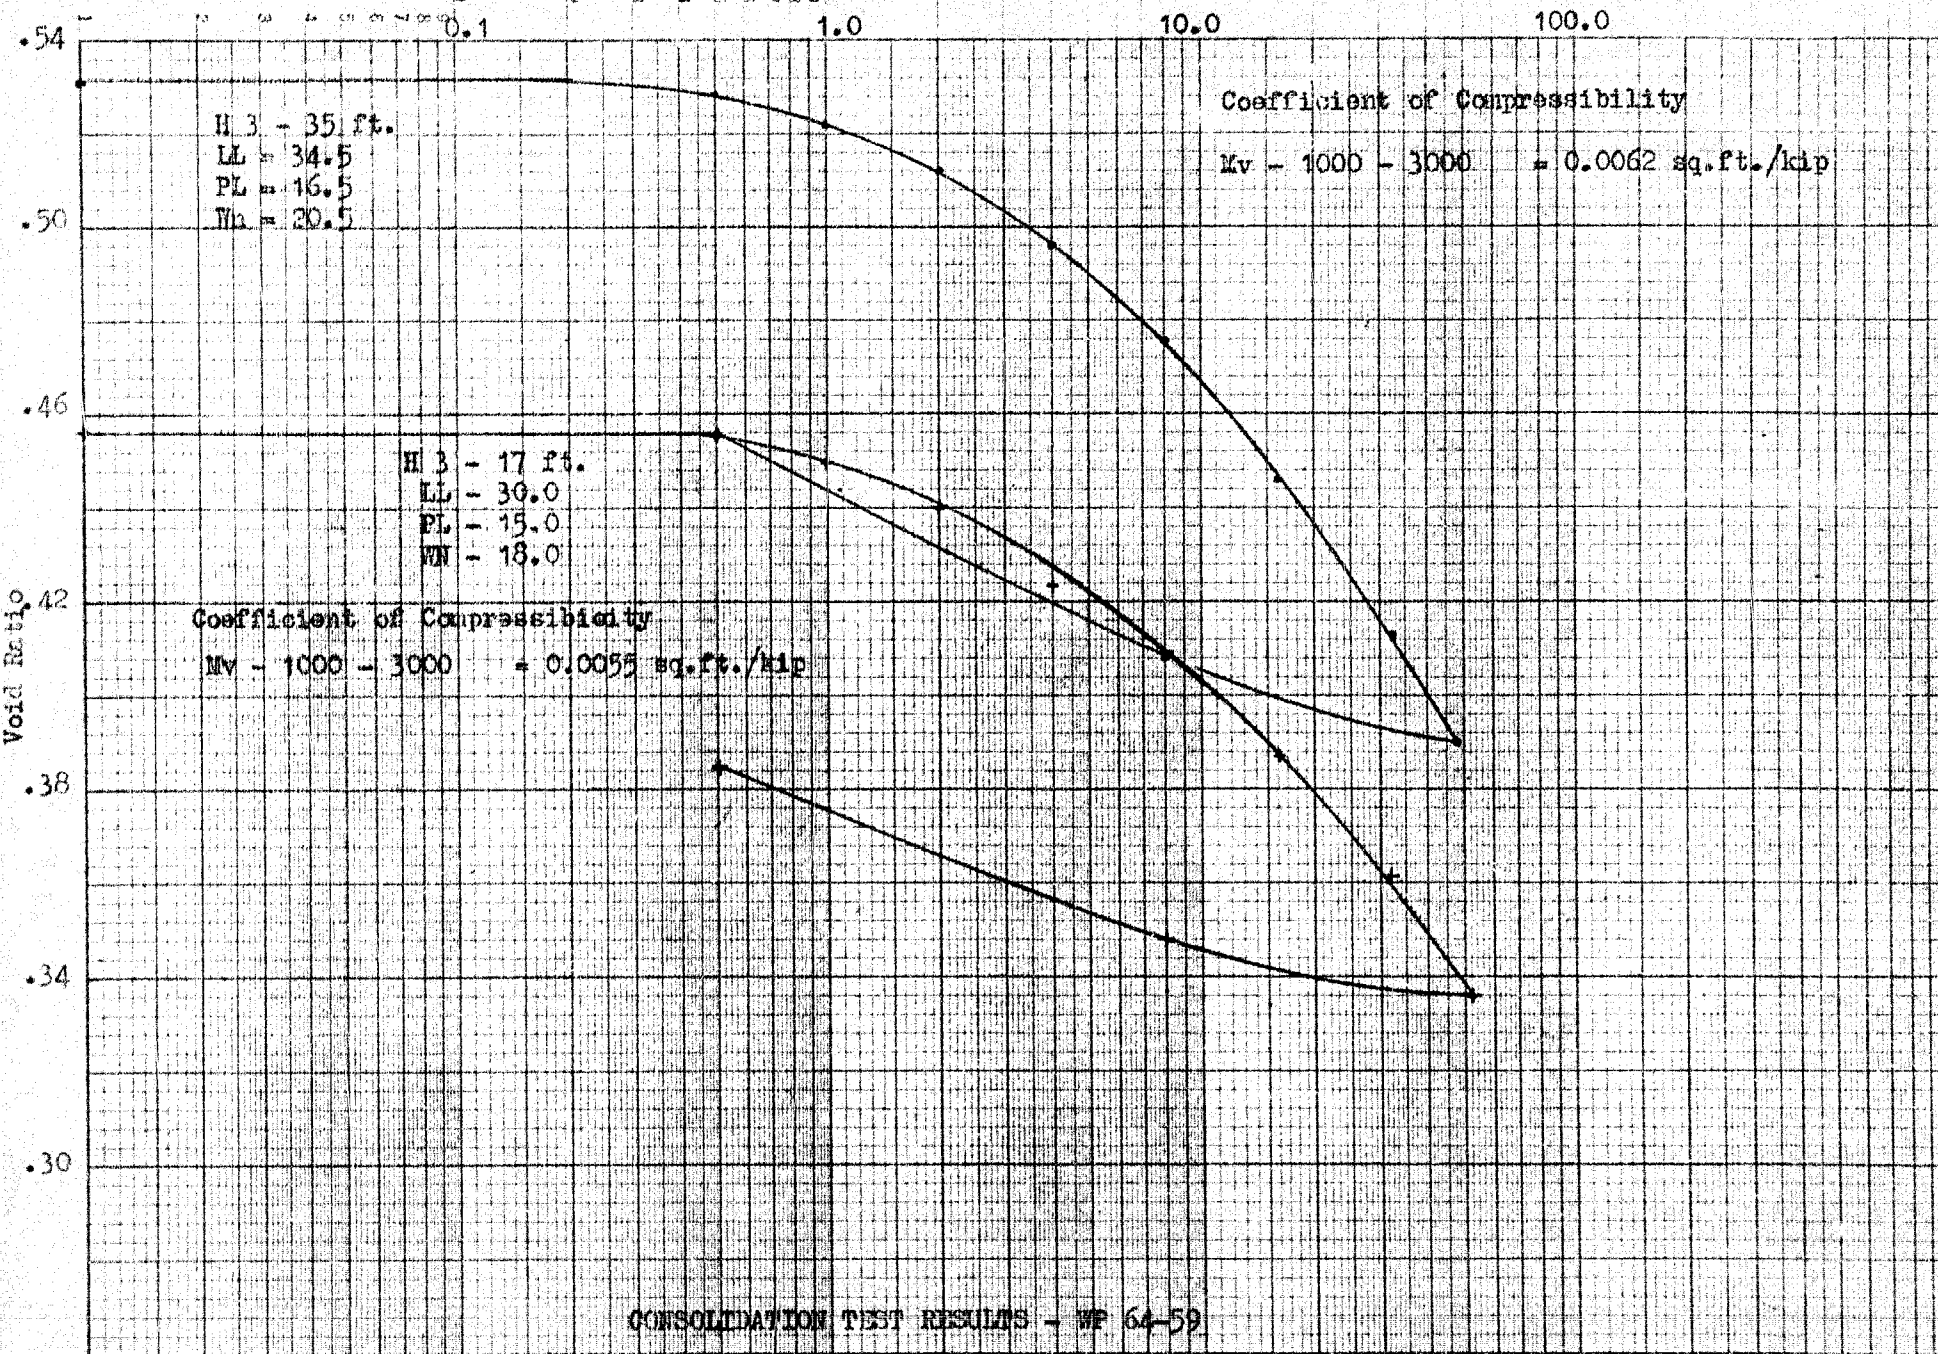
CONSOLIDATION TEST RESULTS - WF 64-59

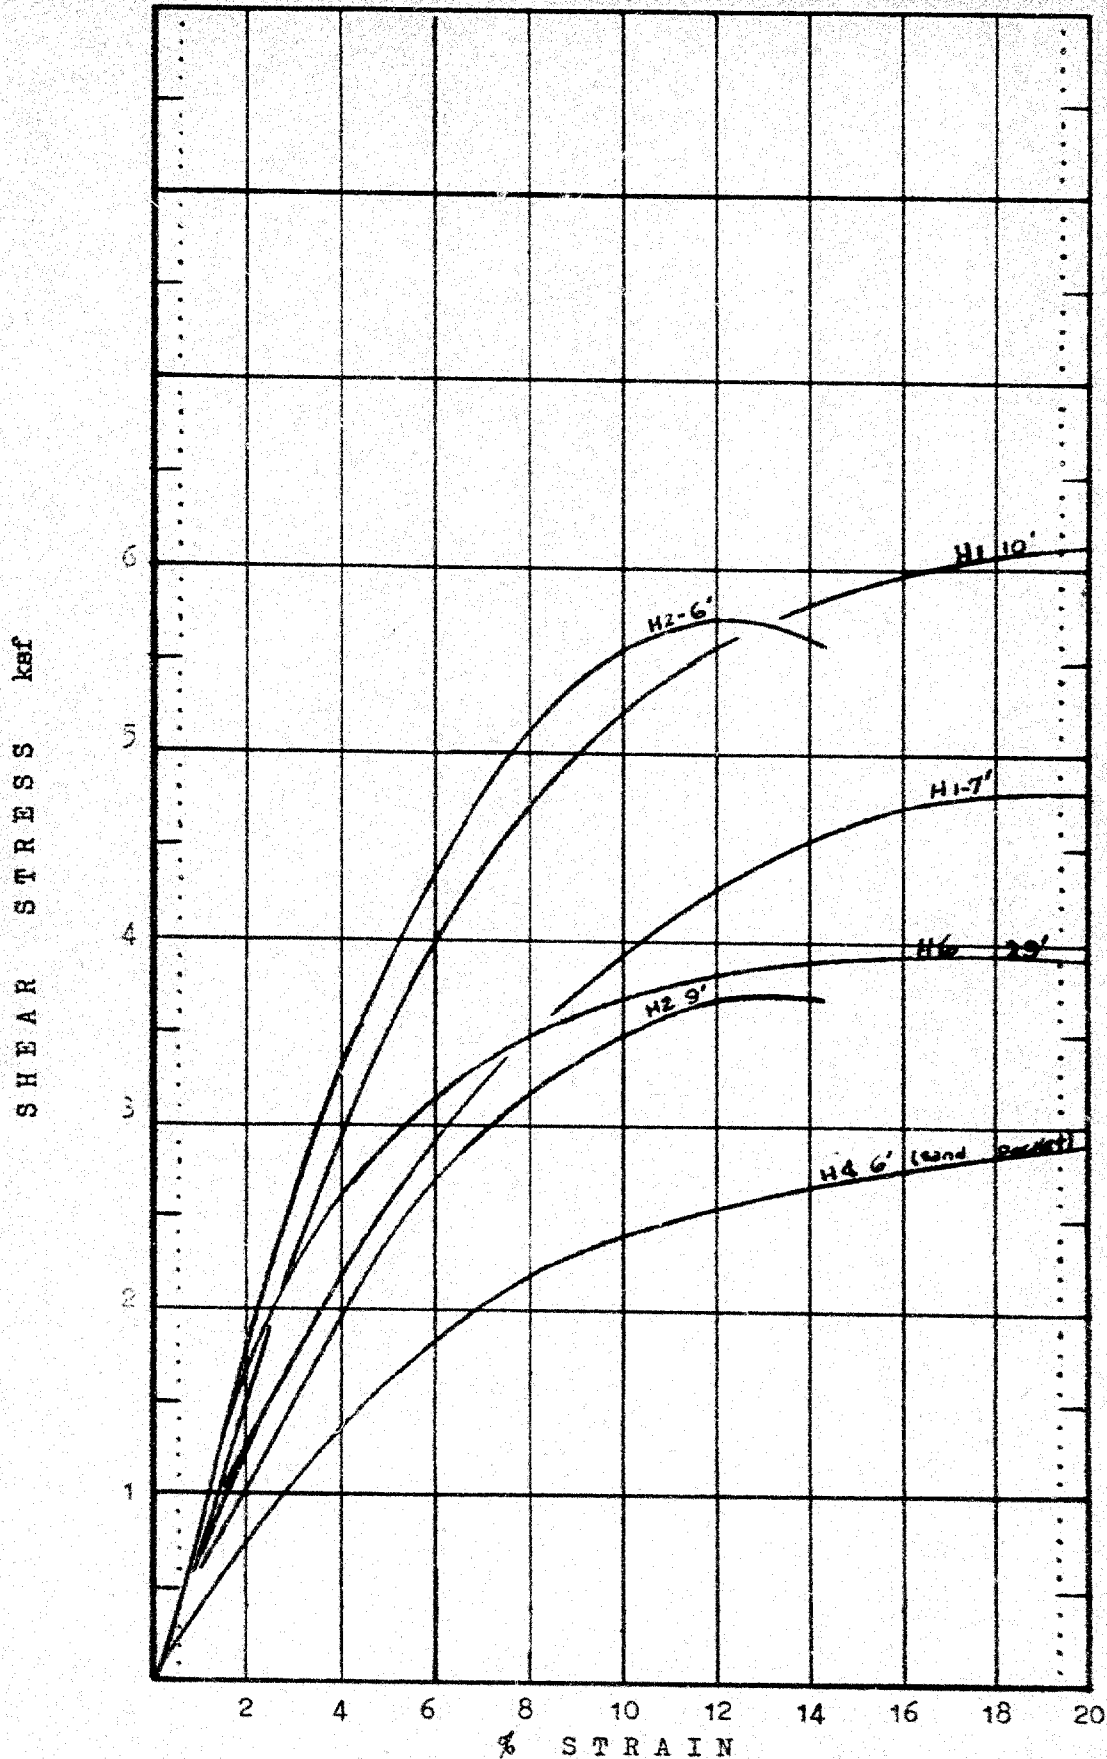
STRESS STRAIN CURVES - UNDRAINED TRIAXIAL TEST RESULTS  
All tests at total overburden pressure.

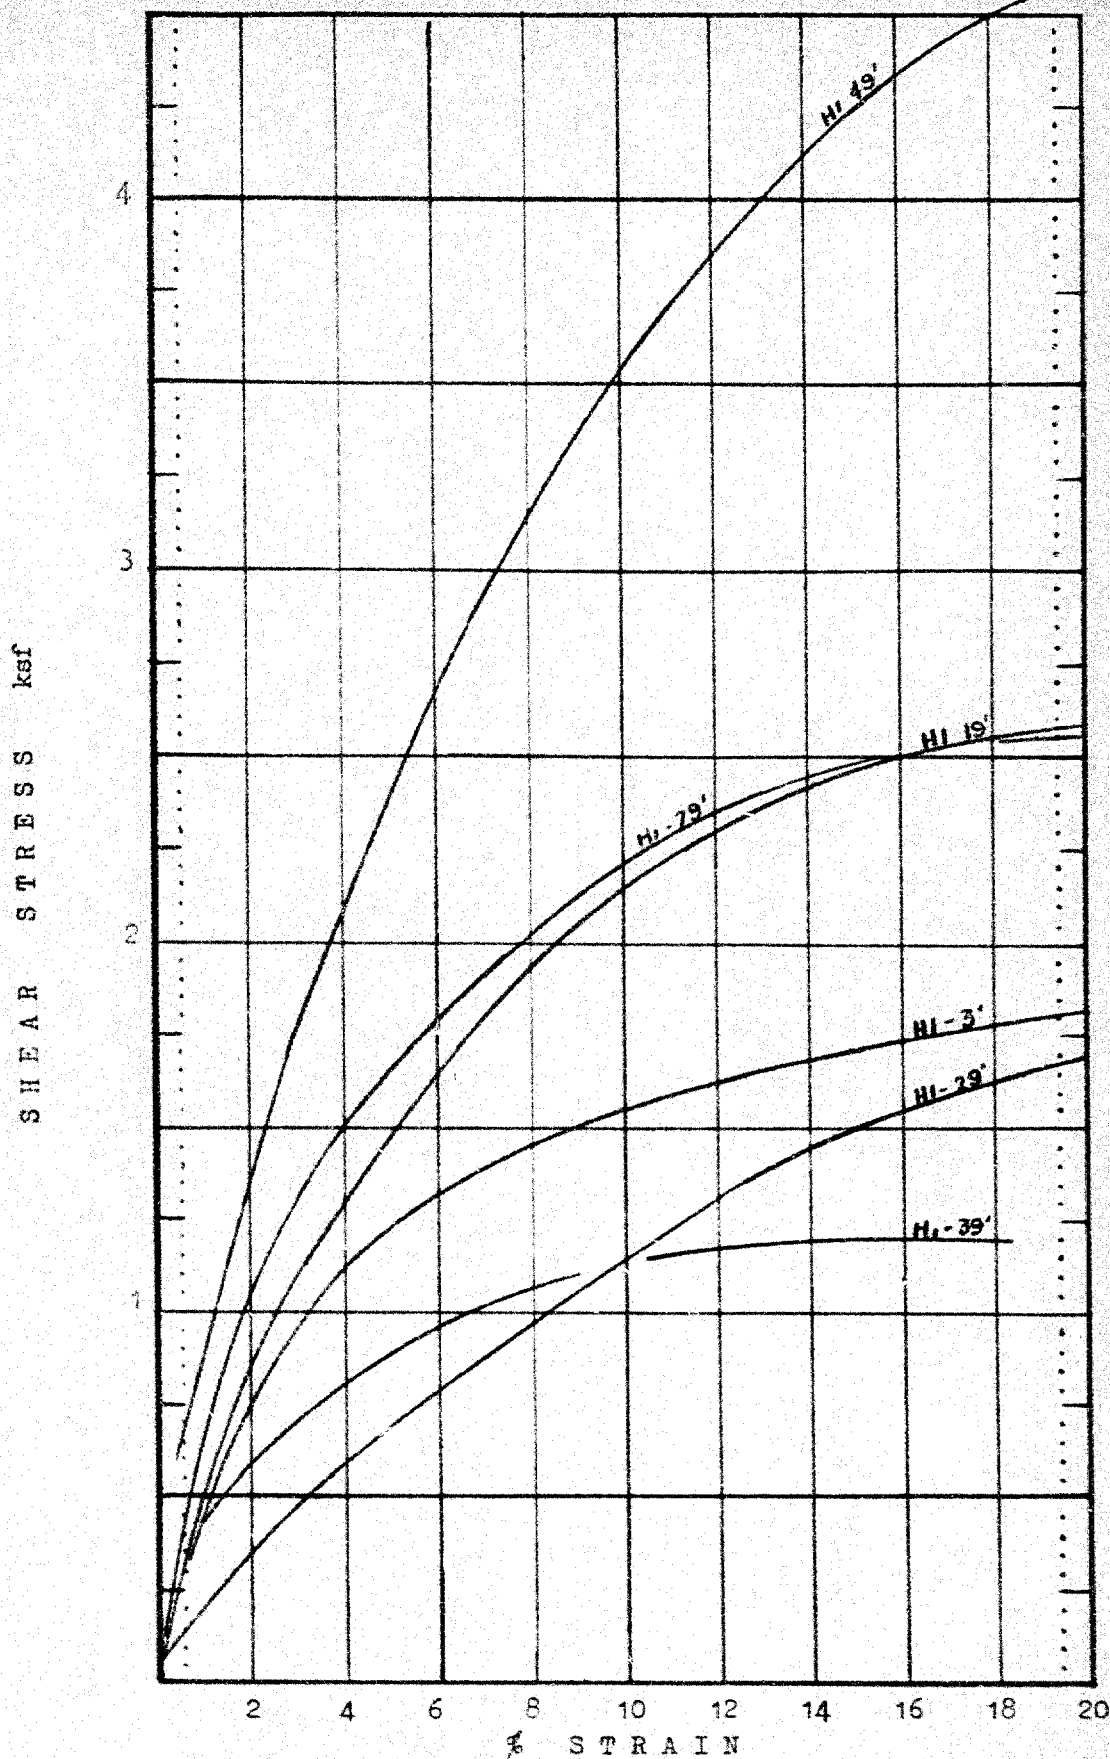
STRESS STRAIN CURVES - UNDRAINED TRIAXIAL TEST RESULTS  
ALL TESTS ON 2 OVERLAPED SPECIMENS.
