59-F-11
W.P. # 159-58
Hwy. # 401
REV. CROSSING
Hwy. # 2
1 MILE W. OF
TILBURY

DEPARTMENT OF HIGHWAYS - ONTARIO			
MATERIALS & RESEARCH SECTION			
HWY 2 PROP. REV'N. PROPOSED CROSSING			
SHOWING POSITIONS & ELEVATIONS OF HOLES			
HWY 401	DISTRICT 1	COUNTY ESSEX	
TOWNSHIP TILBURY NORTH	LOT 19	CON IV	
LOCATION	MATERIALS & RESEARCH SECTION		
DRAWN BY: T. MELLOR	CHECKED BY:	W.P. 159-58	
DATE: APR. 3, 1955	APPROVED BY:	DRAWING NO.	
SCALE: 1" = 20'		F59-11A

Re: Foundation Report -
W.J. F-59-11 -- W.P. 159-58,
Hwy. 401 Line 'B' & Hwy. 2 Revision
Crossing, Lot 19, Con. IV, Twp. of
Tilbury North.

FOUNDATION REPORT --

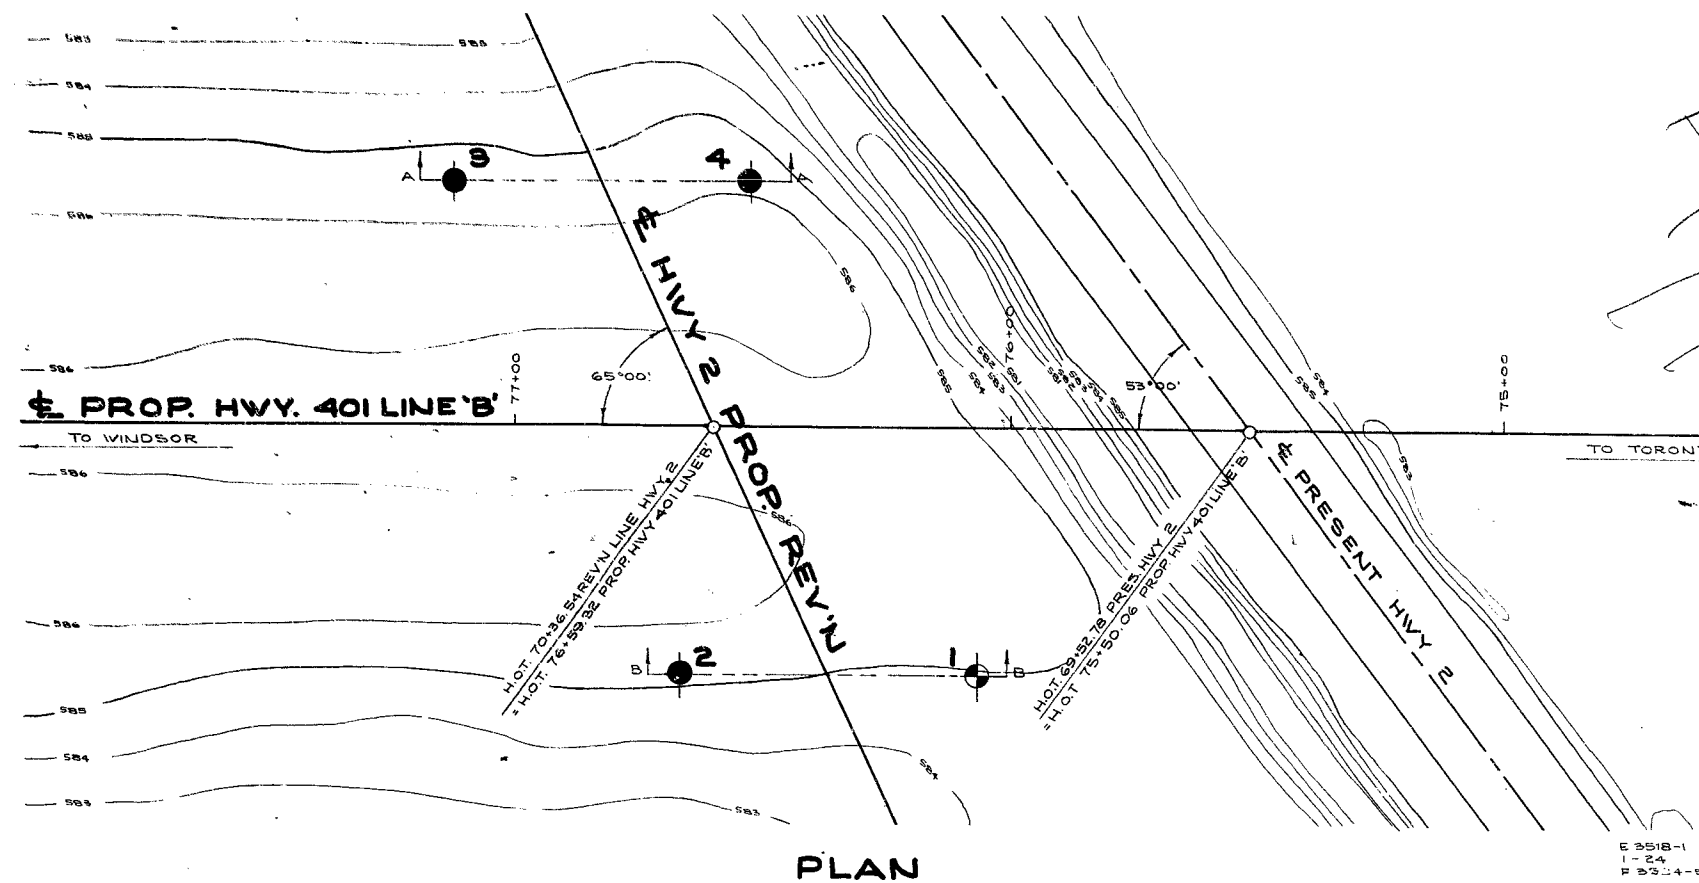
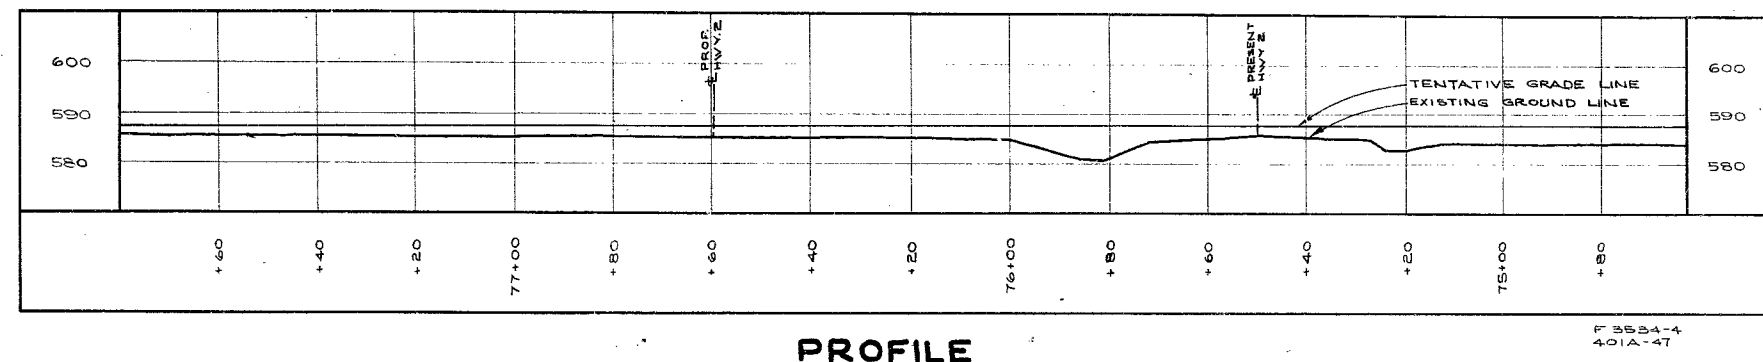
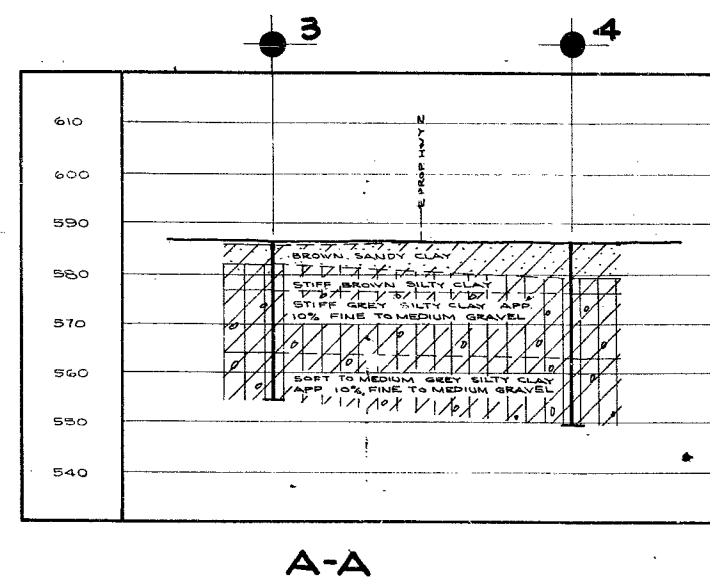
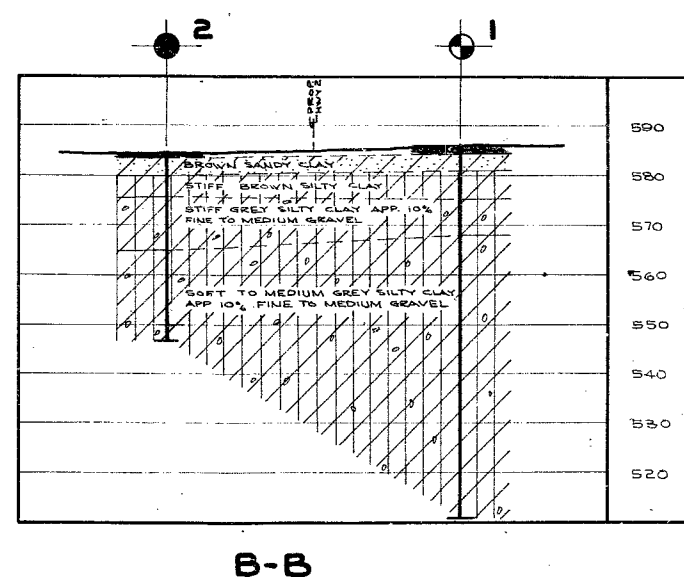
LEGEND			
BORE HOLE			
PENETRATION HOLE			
BORE & PENETRATION HOLE			
HOLE NO.	ELEVATION	STATION	DISTANCE FROM E.
1	585.75'	76+07	50' LT.
2	584.50'	76+46	50' LT.
3	586.50'	77+12	50' RT.
4	586.28'	76+52	50' RT.

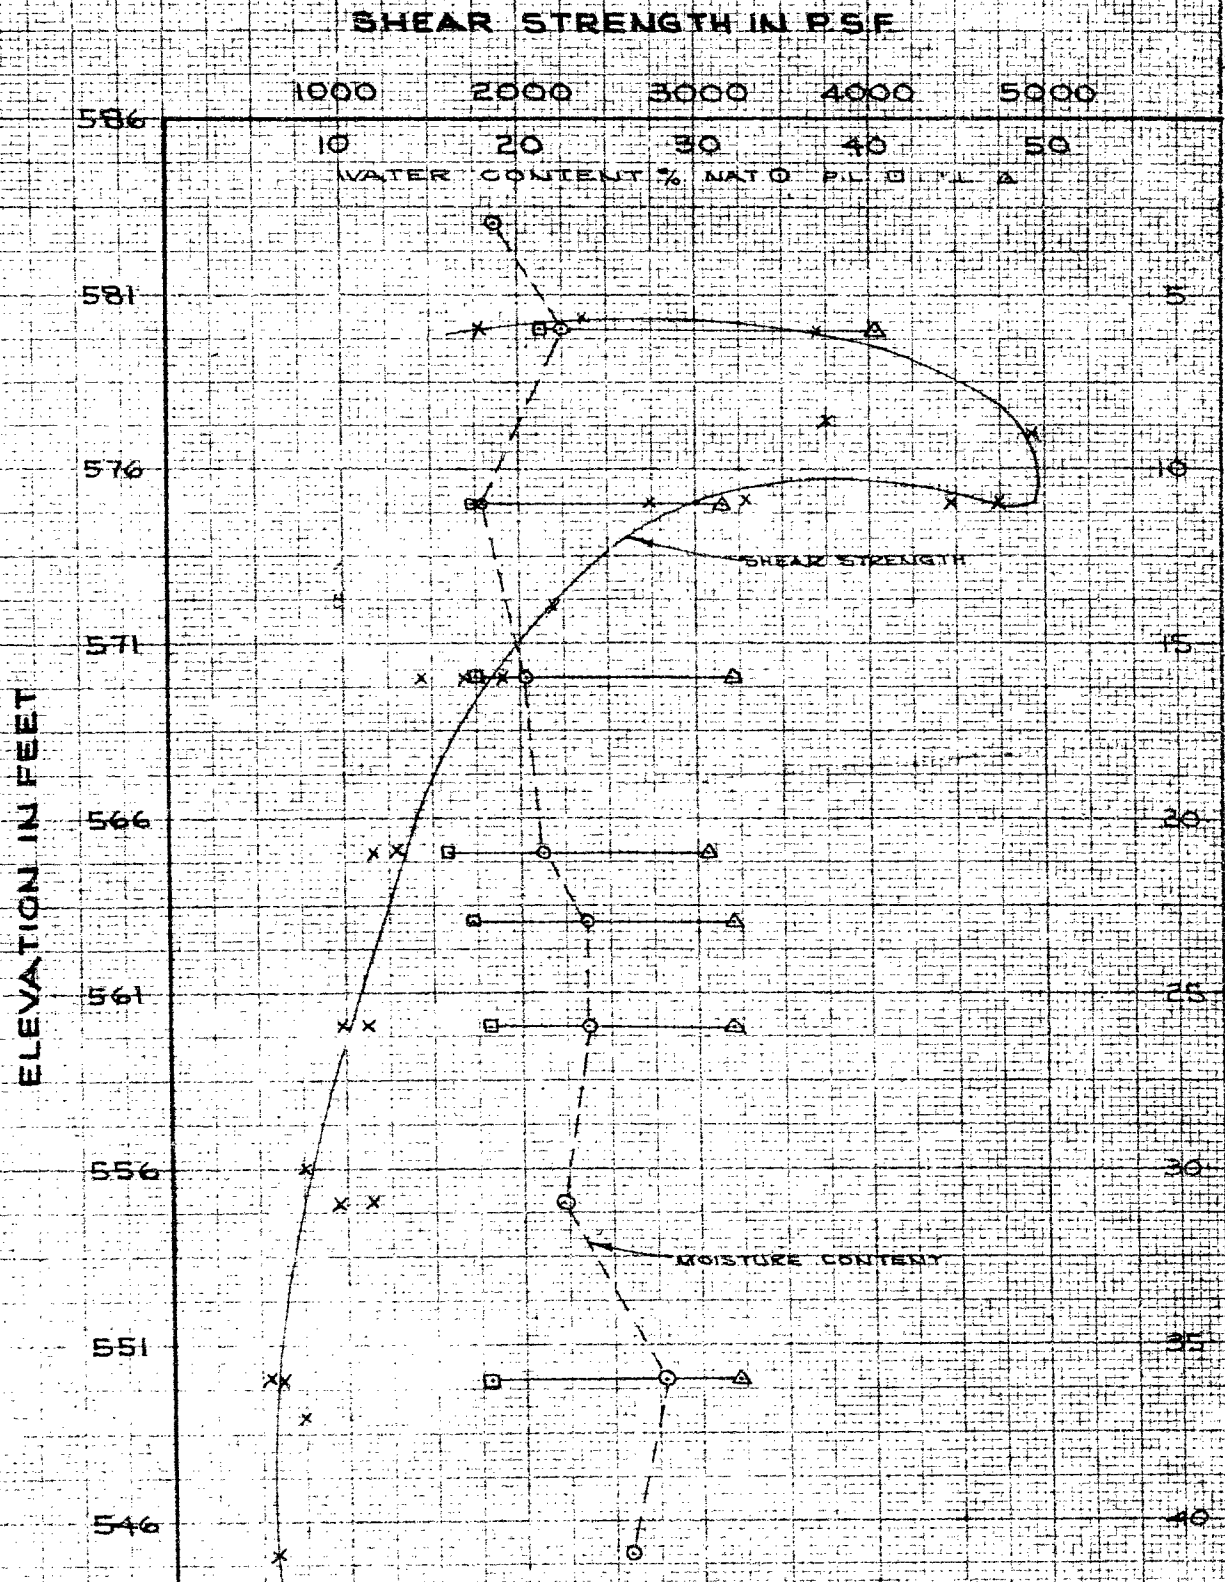
OFFICE REPORT ON SOIL EXPLORATION

SYMBOL	DESCRIPTION	ELEV. FEET	DEPTH FEET	STRENGTH AND PENETRATION RESISTANCE			
				2000	4000	6000	8000
	Ground Level	586.3		50	100	150	200
	Brown sandy clay	579.8					
	Stiff brown silty clay	576.3					
	Stiff grey silty clay - approx. 10% fine to medium gravel.	563.3	20				
	Soft to med. grey silty clay - approx. 10% fine to medium gravel.	549.8	40				
	End of Borehole		60

CONSISTENCY			SAMPLE	NATURAL UNIT WT. P.C.F.
MOIST. CONTENT - % DRY WT.				
10	20	30		
			TW 1	
			TW 1A	131.5
			TW 2	131.5
			TW 3	129.1
			TW 4	126.5
			TW 5	120.2
