H. G. ACRES & COMPANY LIMITED CONSULTING ENGINEERS NIAGARA FALLS, CANADA		
DEPARTMENT OF HIGHWAYS OF ONTARIO		
HIGHWAY 2 CROSSING HIGHWAY 401 (WP 165-58)		
EXPLORATORY HOLES PLAN AND SECTION		
APPROVED	DATE: JAN. 29, 1960	
<i>D. H. MacDonald</i>	SCALE 1 IN. = 20 FT.	JOB No. 849
H. G. ACRES & COMPANY LIMITED	PLATE - I

Re: Hwy. #2 Interchange with Hwy. #401 -
E. of Tilbury - Dist. #1 - Chatham.
W.P. 165-58.

FOUNDATION CONDITIONS AT THE HIGHWAY 2 CROSSING
OF HIGHWAY 401 AT TILBURY EAST
(WP 165-58)

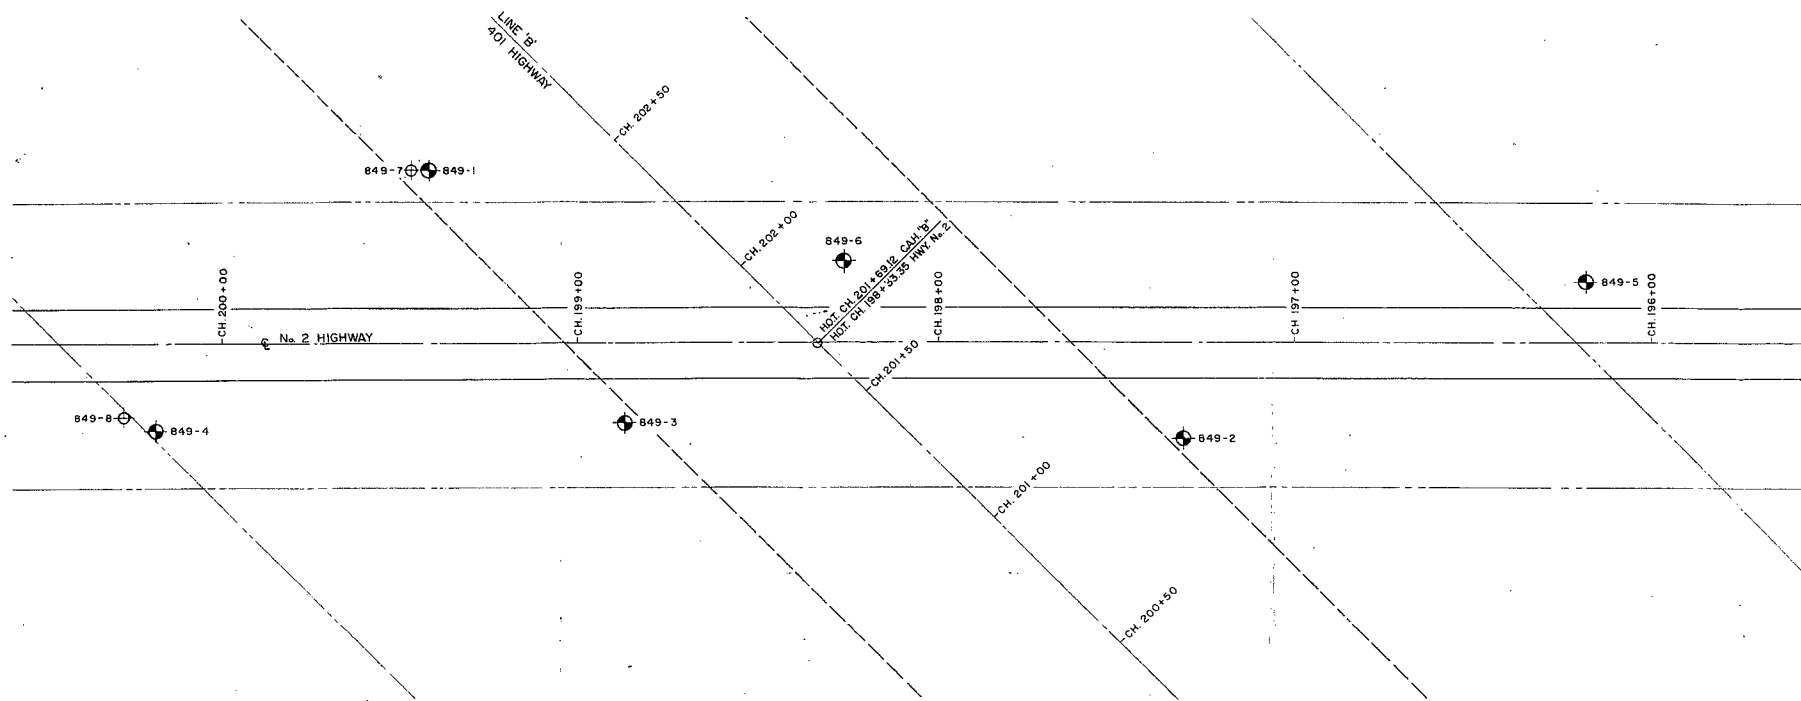
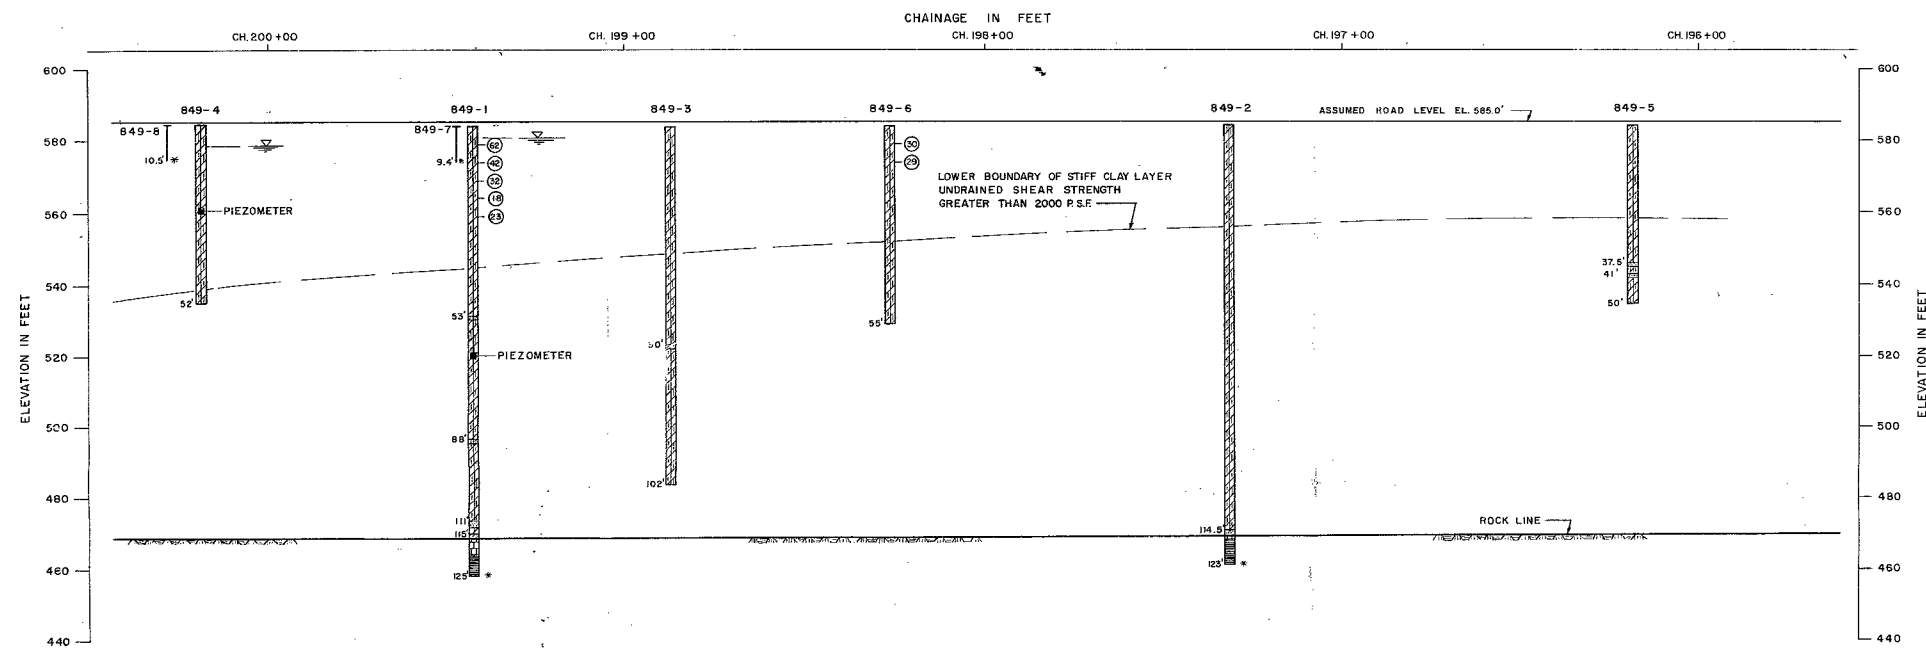
PLAN

SECTION ALONG C OF No. 2 HIGHWAY

STANDARD PENETRATION TESTS AND CONE PENETRATION TESTS WERE PERFORMED USING A 140 POUND WEIGHT DRIPPING 30 INCHES.

Soil explorations were carried out by H.G. Acres & Company Limited to determine the foundation conditions for a structure to be built to carry Highway 2 over Highway 401 at Tilbury East. A plan of the site is shown on Plate I in this report.

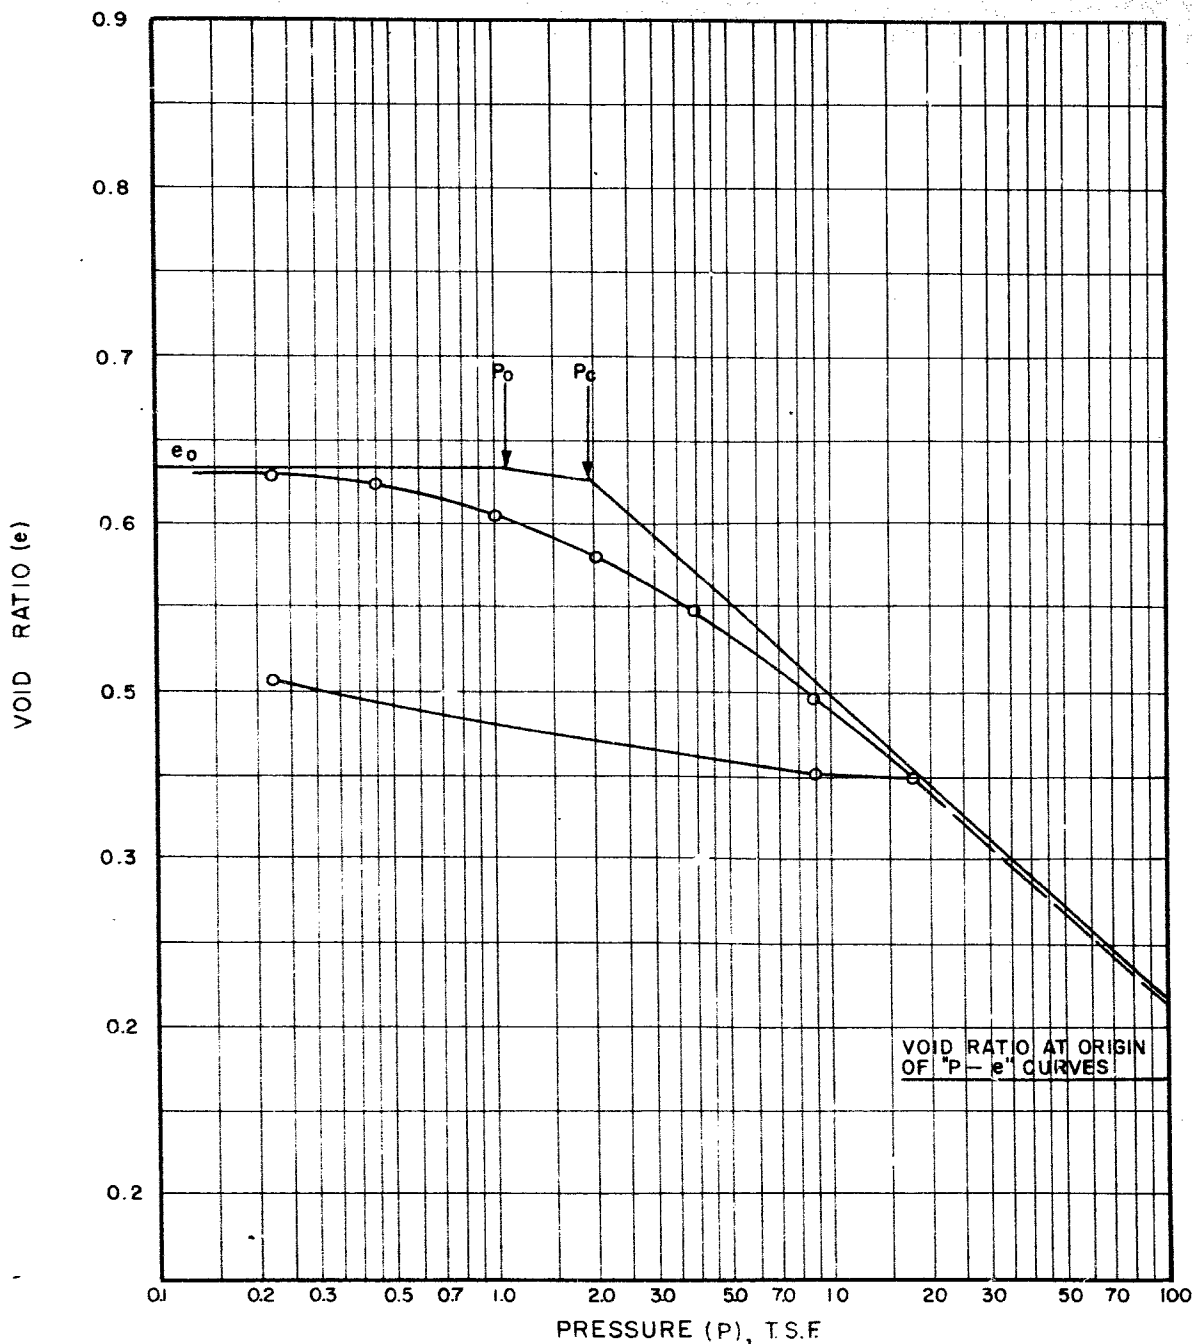
OVERBURDEN PRESSURE - $P_o = 1.09$ T.S.F.
 PRECONSOLIDATION PRESSURE - $P_c = 1.90$ T.S.F.

NATURAL WATER CONTENT - $w_o = 21.1\%$
 LOADING INTERVAL - 25 MIN.

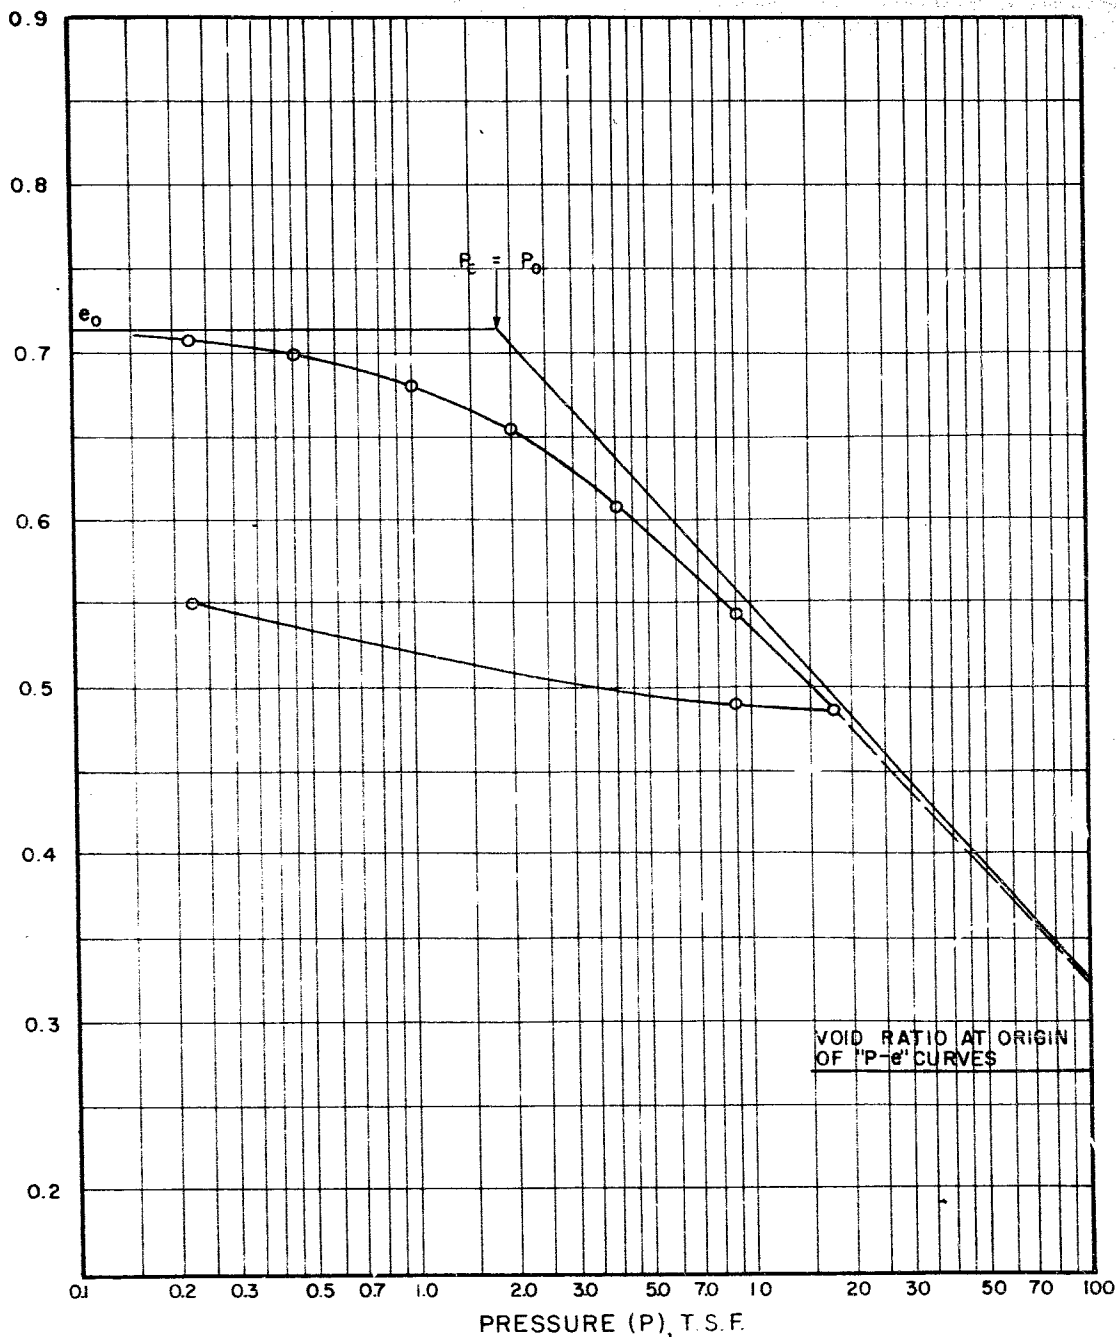
OVERBURDEN PRESSURE — $P_0 = 1.75$ T.S.F. NATURAL WATER CONTENT — $w_o = 24.9\%$
 PRECONSOLIDATION PRESSURE — $P_c = 1.75$ T.S.F. LOADING INTERVAL — 25 MIN.

SAMPLE No. 849-B0-27 TEST DATE JAN. 13, 1960
 TEST No. 849-9-2 TESTED BY R. G.

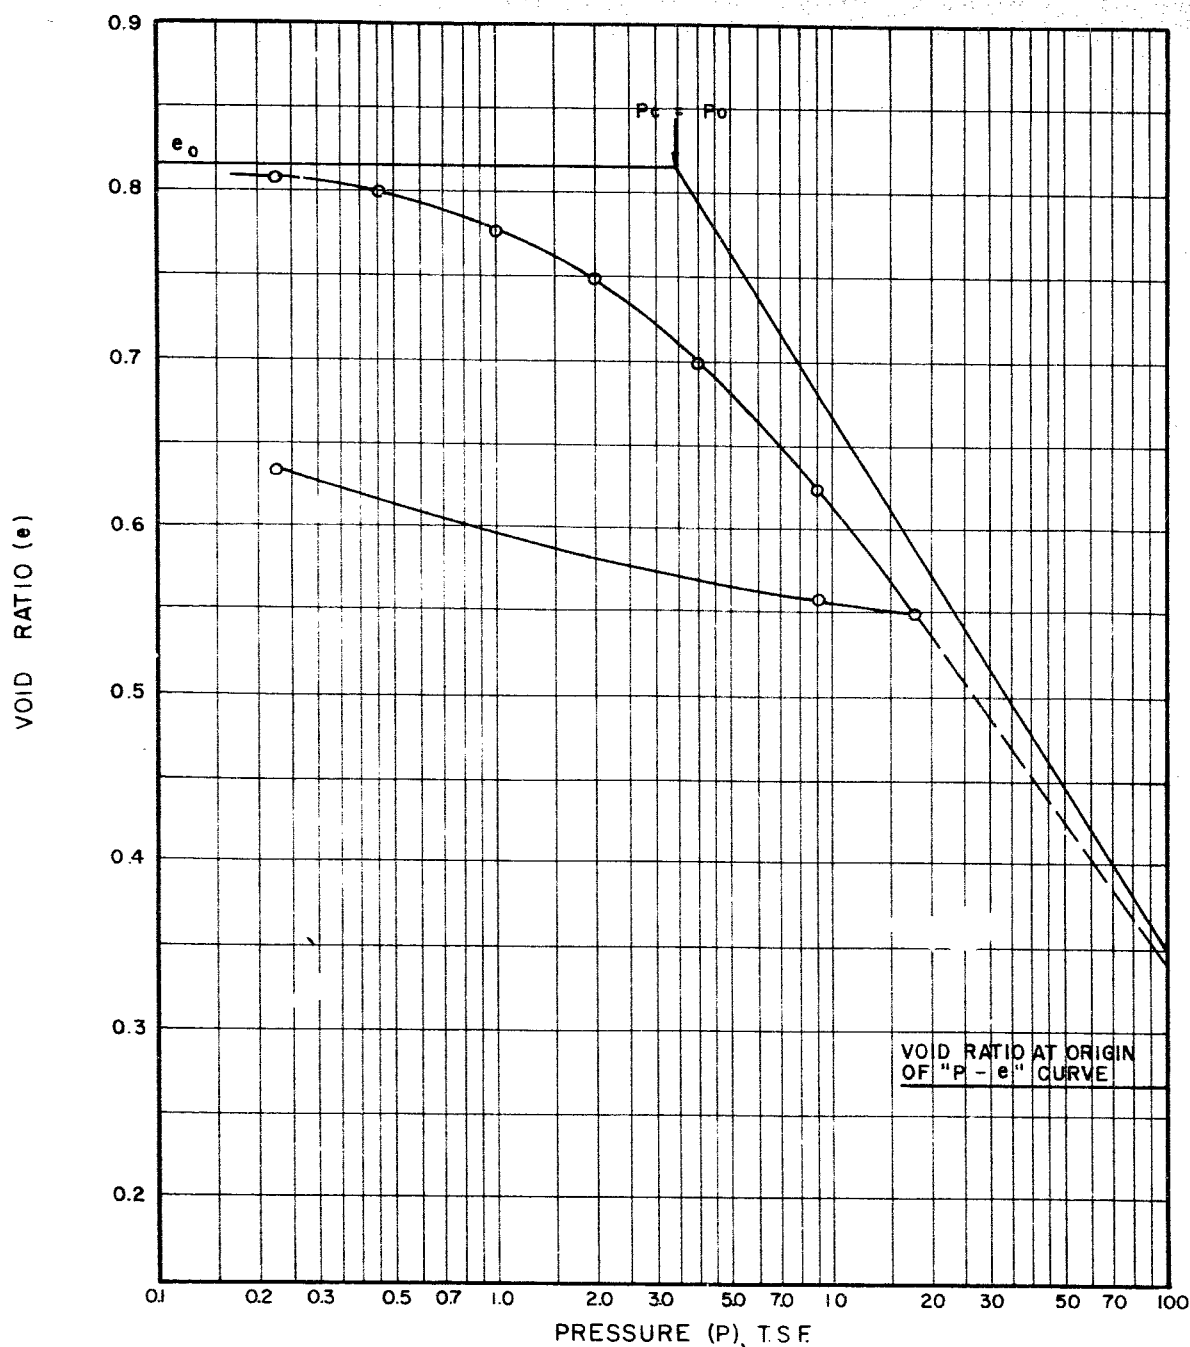
OVERBURDEN PRESSURE - $P_0 = 3.40$ T.S.F.
PRECONSOLIDATION PRESSURE - $P_c = 3.40$ T.S.F.

NATURAL WATER CONTENT - $w_0 = 29.0$ %
LOADING INTERVAL - 25 MIN.
