ENGINEERING MATERIALS OFFICE
SOIL MECHANICS SECTION

Vehicle Inspection Stations
Located on Hwy. #402
2.4 Miles East of Lambton Co. Rd. #26

FOUNDATION INVESTIGATION REPORT

Vehicle Inspection Stations
Located on Hwy. #402
2.4 Miles East of Lambton Co. Rd. #26
W.P. 2517-75-01/02 (North Side)
W.P. 2518-75-01/02 (South Side)
District 1, Chatham

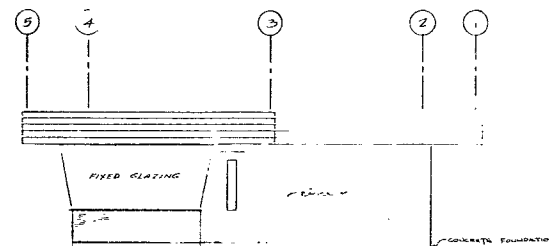
NORTH ELEV

BRICK - "GOLDEN BLEND" D918
TUCONTO BRICK CO.
FACIA - METRO BROWN OC 228
SUPPORT - BONE WHITE OC 213
GLAZING - SOLAR GRAY HYPERULITE
DOORS - AC-578 GLIDDEN
DOOR FRAMES - AC-578 GLIDDEN
ALUMINUM WINDOW FRAMING - STATNEY
BRONZE #42 (KAWNEER)
WINDOW SILL - AC-578 GLIDDEN
BASE - NATURAL CONCRETE

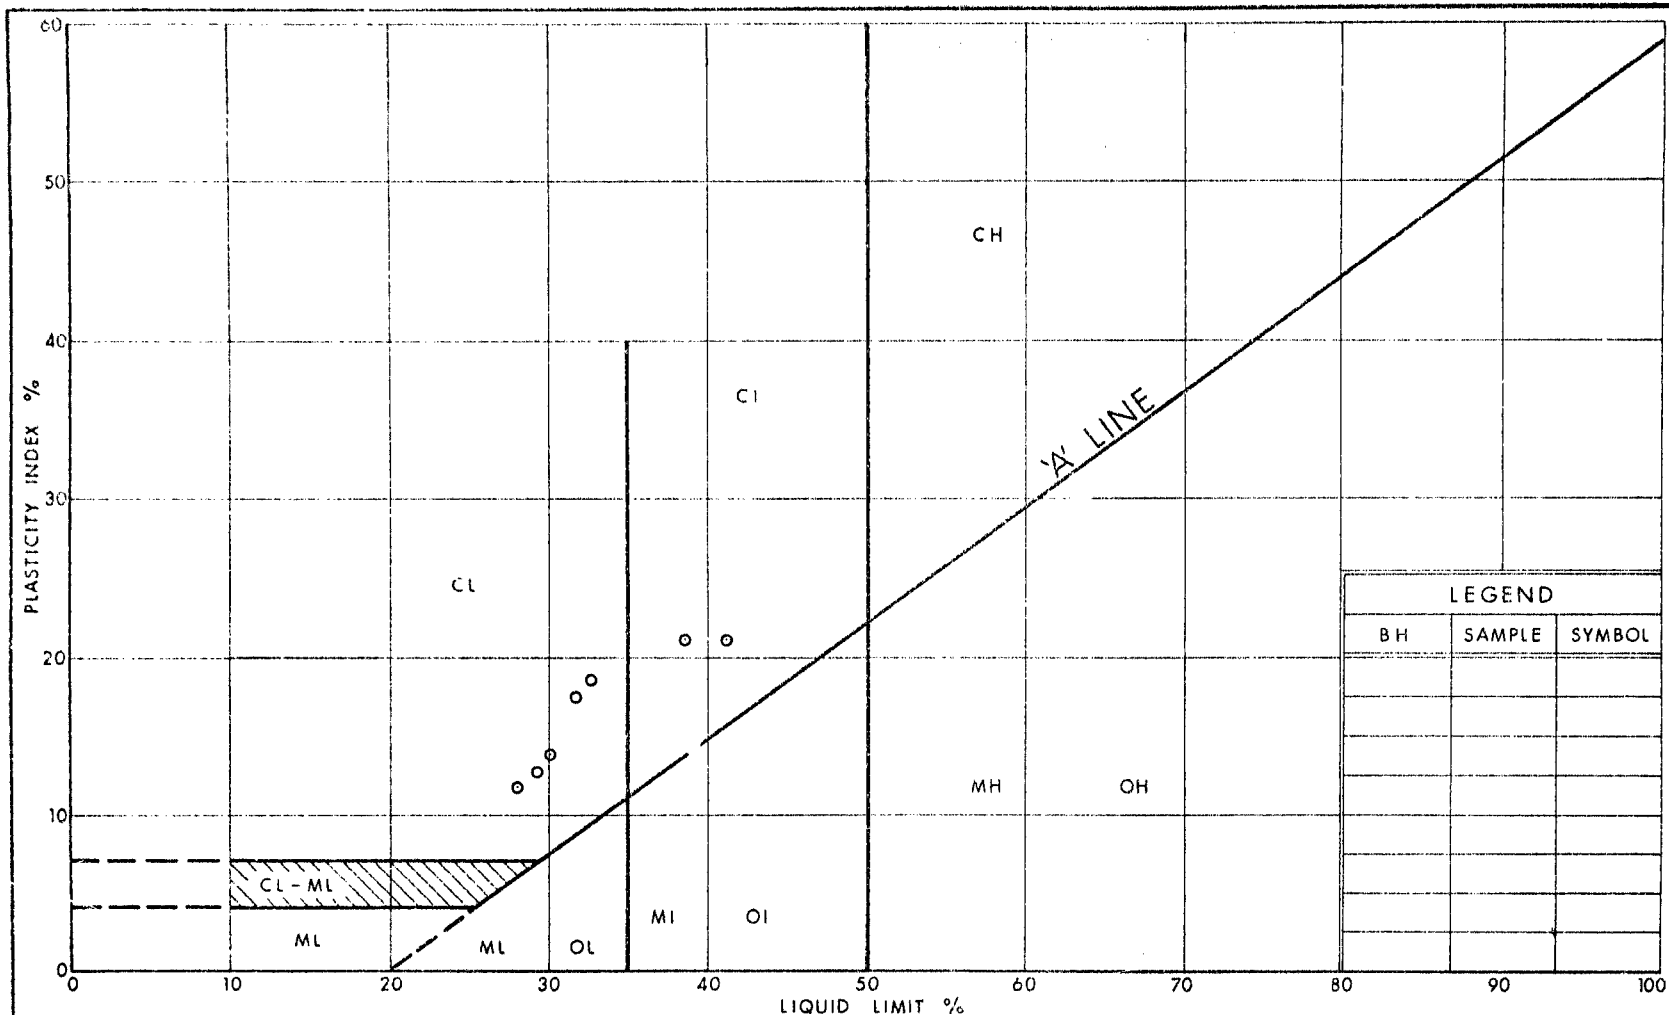
OFFICE REPORT ON SOIL EXPLORATION

SOIL PROFILE			SAMPLES			GROUND WATER ELEV	DYNAMIC CONE PENETRATION RESISTANCE PLOT				LIQUID LIMIT w_L PLASTIC LIMIT w_p WATER CONTENT w			UNIT WEIGHT γ	REMARKS
ELEV DEPTH	DESCRIPTION	STRAT. PLT	NUMBER	TYPE	'N' VALUES		20	40	60	80	100	w_p	w	w_L	
665.0	Ground Level														
0.0	Some Organics		1	SS	17	Borehole Dry									
			2	SS	39										
			3	SS	35										
			4	SS	30										
			5	SS	30										
	Clayey Silt		6	TW	PH										
	Some Sand		7	SS	28										
	Trace of Gravel		8	SS	22										
	Very Stiff to Hard		9	SS	22										
			10	TW	PH										
			11	SS	23										
			12	SS	21										
			13	SS	16										
			14	TW	PH										
592.5			15	TW	PH										
71.5	End of Borehole		16	TW	PH										
						590

The results of the field and laboratory tests carried out within the overburden are plotted on the Record of Borehole Sheets attached to the Appendix.

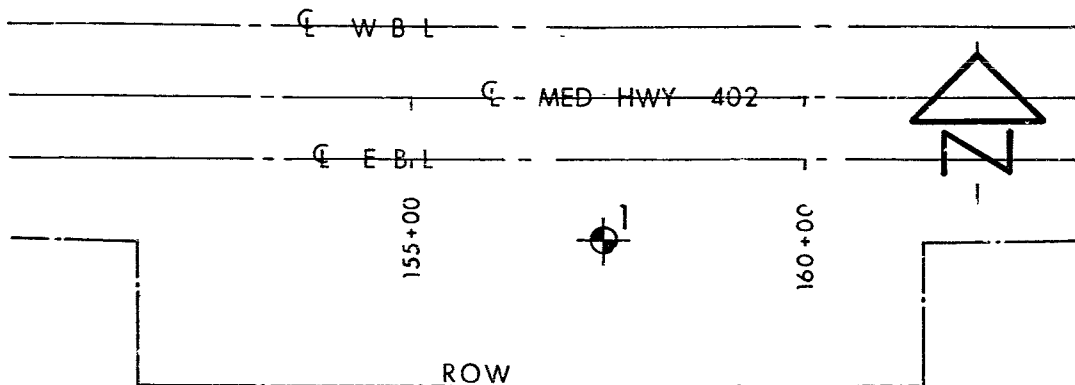
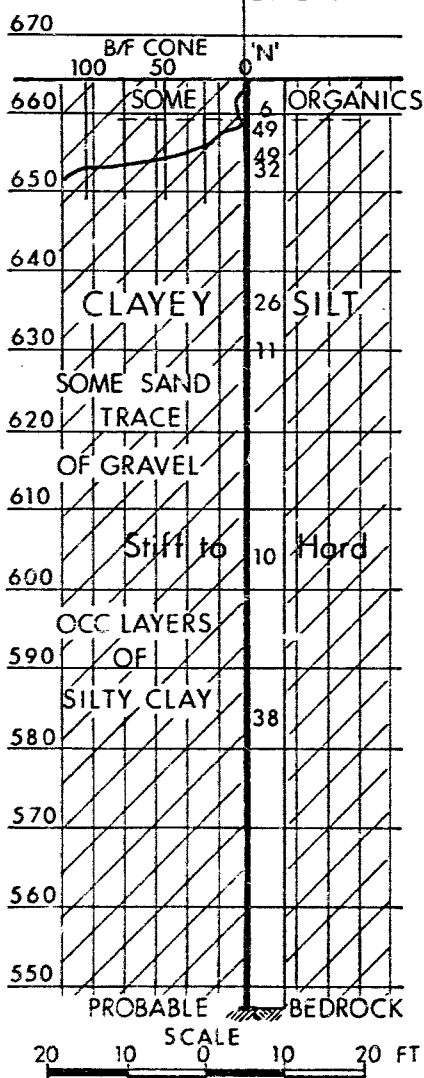
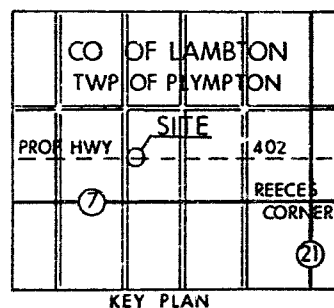
BH	ELEV	STA	OFFSET
1	664.8	157+42	100' RT EBL

VEHICLE INSPECTION STATION
SOUTH SIDE OF HWY 402
