SOIL INVESTIGATION REPORT

DEPARTMENT OF HIGHWAYS OF ONTARIO

HIGHWAYS 2 and 401, EAST OF WOODSTOCK

As requested, we carried out a soil investigation at the site of a proposed Overhead Crossing of Highway 2 by Highway 401 east of Woodstock.

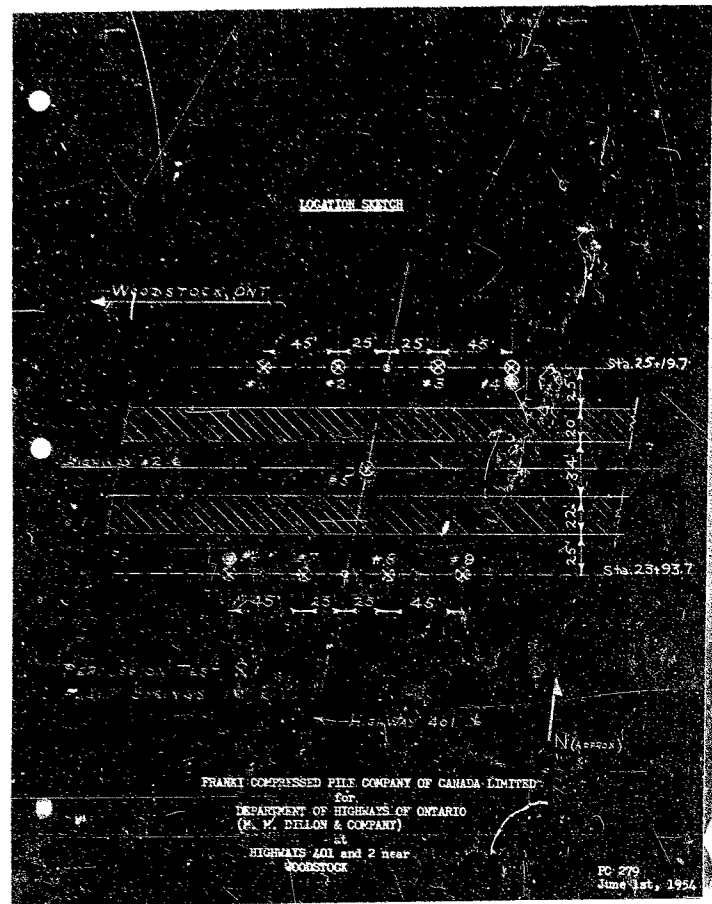
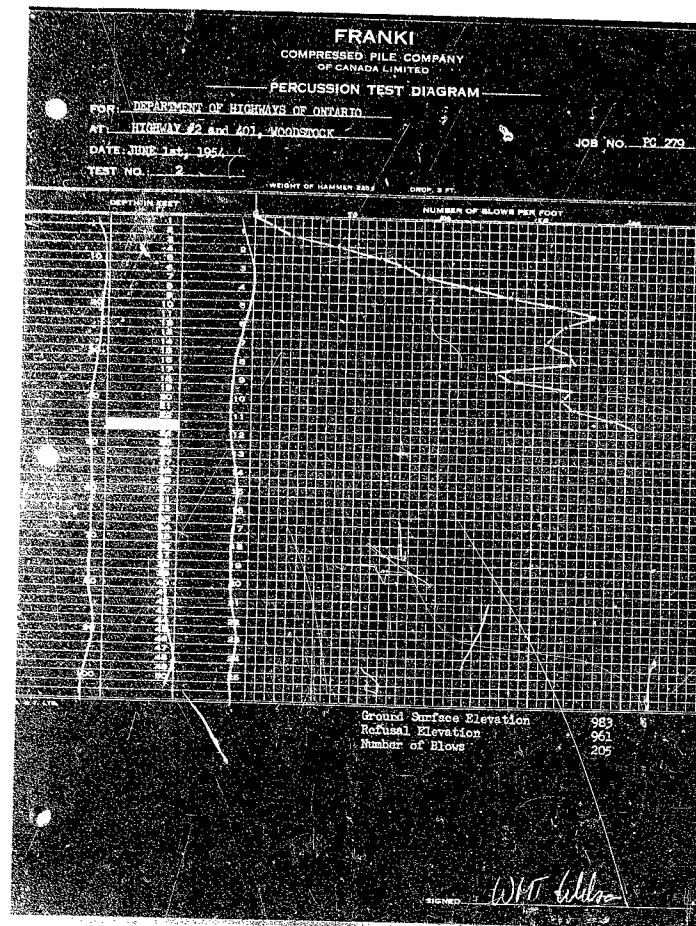
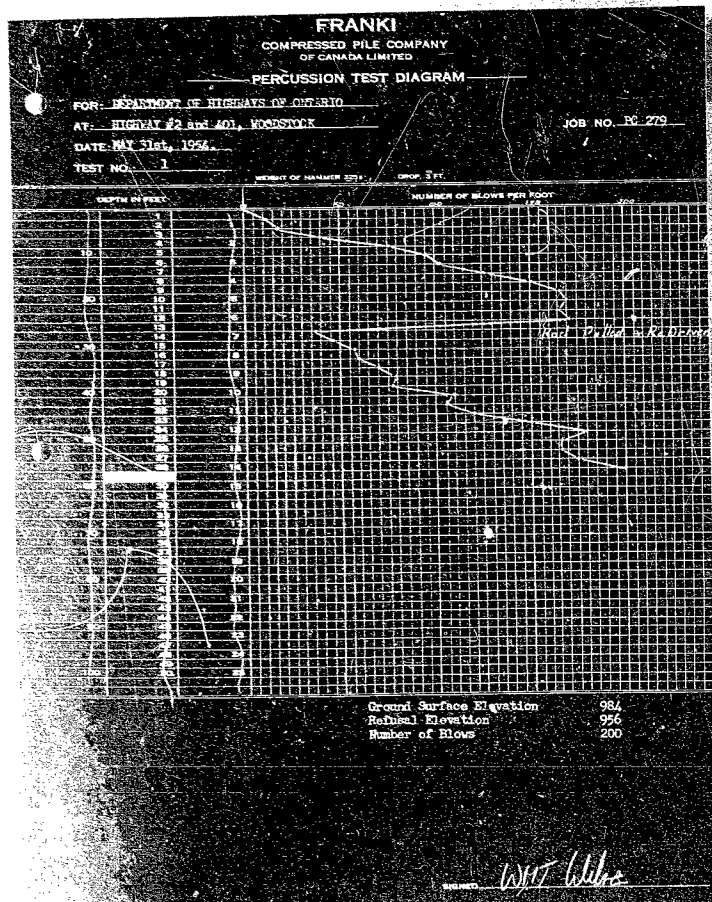
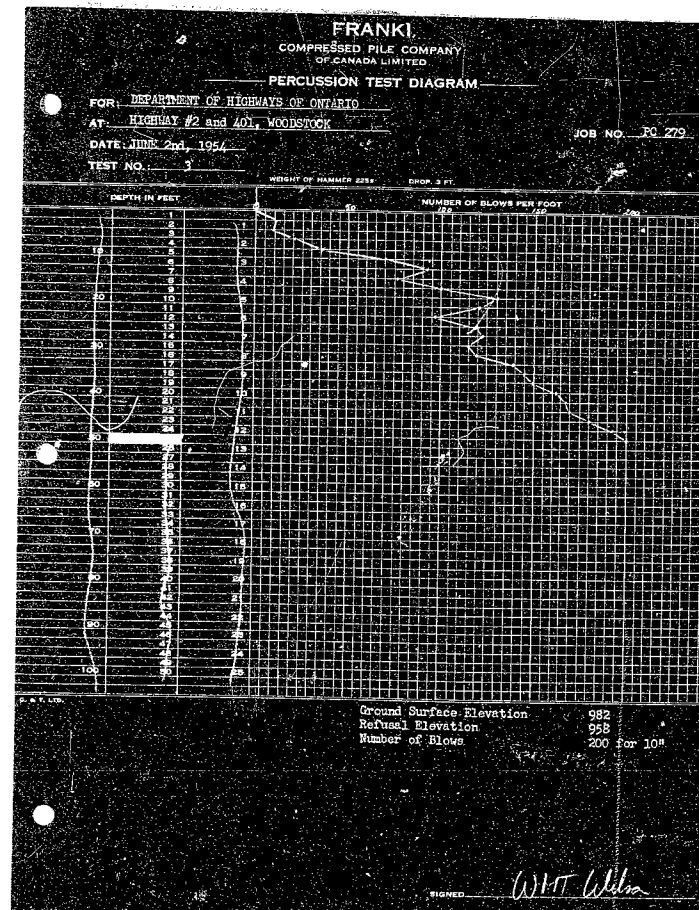
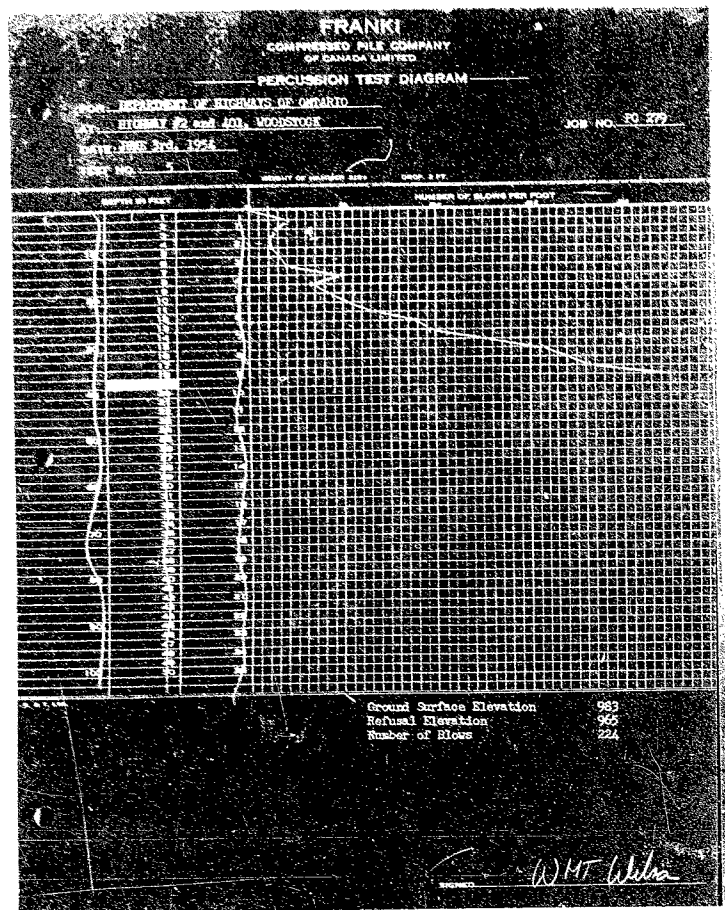
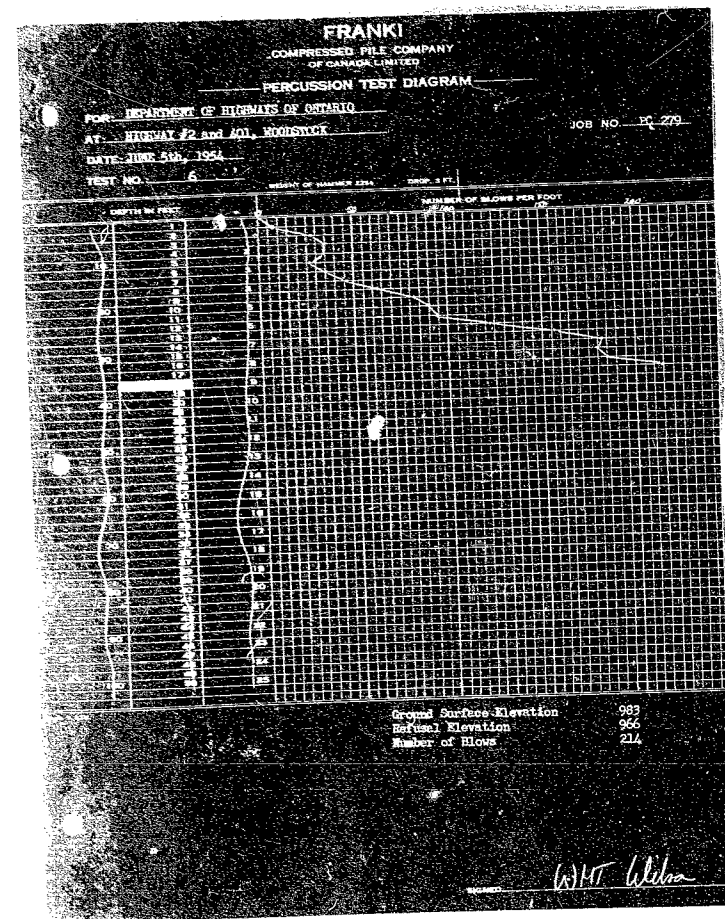
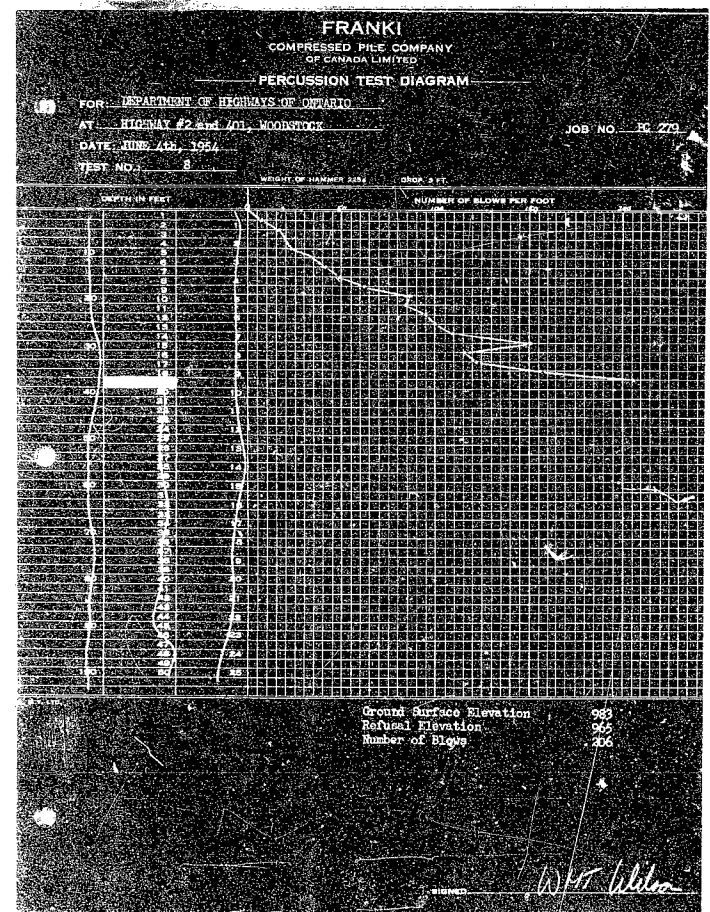
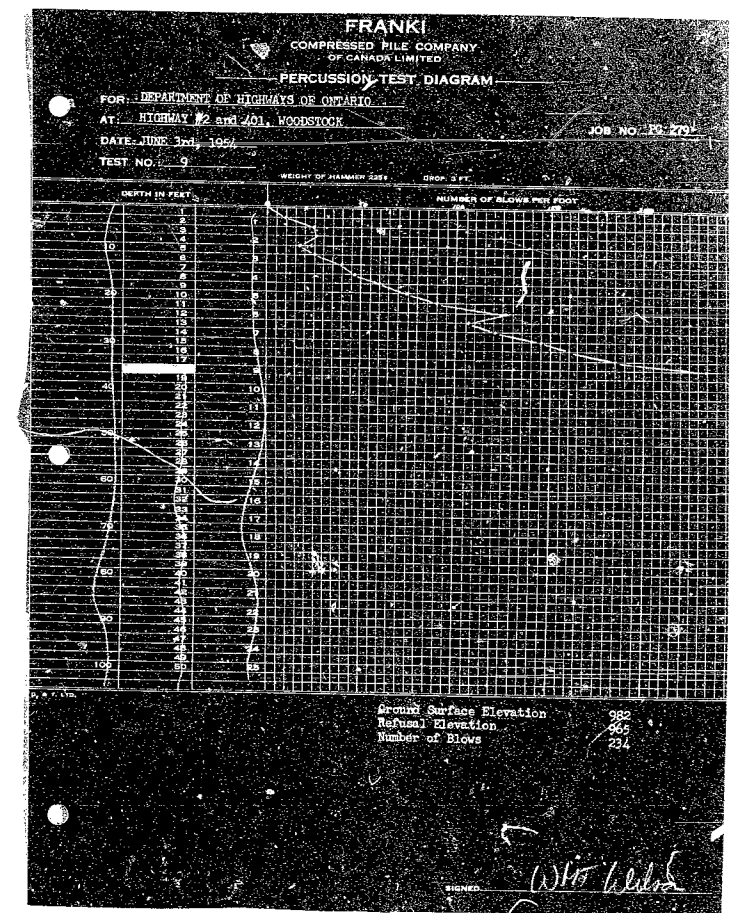
Nine percussion tests were made at the locations shown on the attached Location Sketch. The results of these tests are shown on the attached diagrams and are summarized as follows.

Hole No.	E L E V A T I O N S				Refusal
	Ground Surface	Water Level	2,000 lbs. per sq.ft.	4,000 lbs. per sq.ft.	
1	984	972	982	981	956
2	983	-	980	979	961
3	982	-	978	977	958
4	983	-	980	979	970
5	983	-	976	973	965
6	983	979	980	975	966
7	983	975	979	977	960
8	983	976	979	976	965
9	982	972	977	974	965
