62-F-272 M
C-12-17 CULVERT
SHASHAWANDAM
CREEK
BOSANQUET
TWP

Soils Report by E. M. Peto Assoc., Ltd.
County of Lambton,
Proposed Pipe Culvert,
Township of Bosanquet,
Lot 62, Rd. between L.F.E. & L.R.W. Cons.,
Structure Site #15-287.
Bridge Office Ref. #BA 1516.

A new culvert is to be constructed on County Road 12, near Ravenswood, Ontario, where this road crosses the Shawana Creek. A site investigation was required to determine the subsoil conditions.

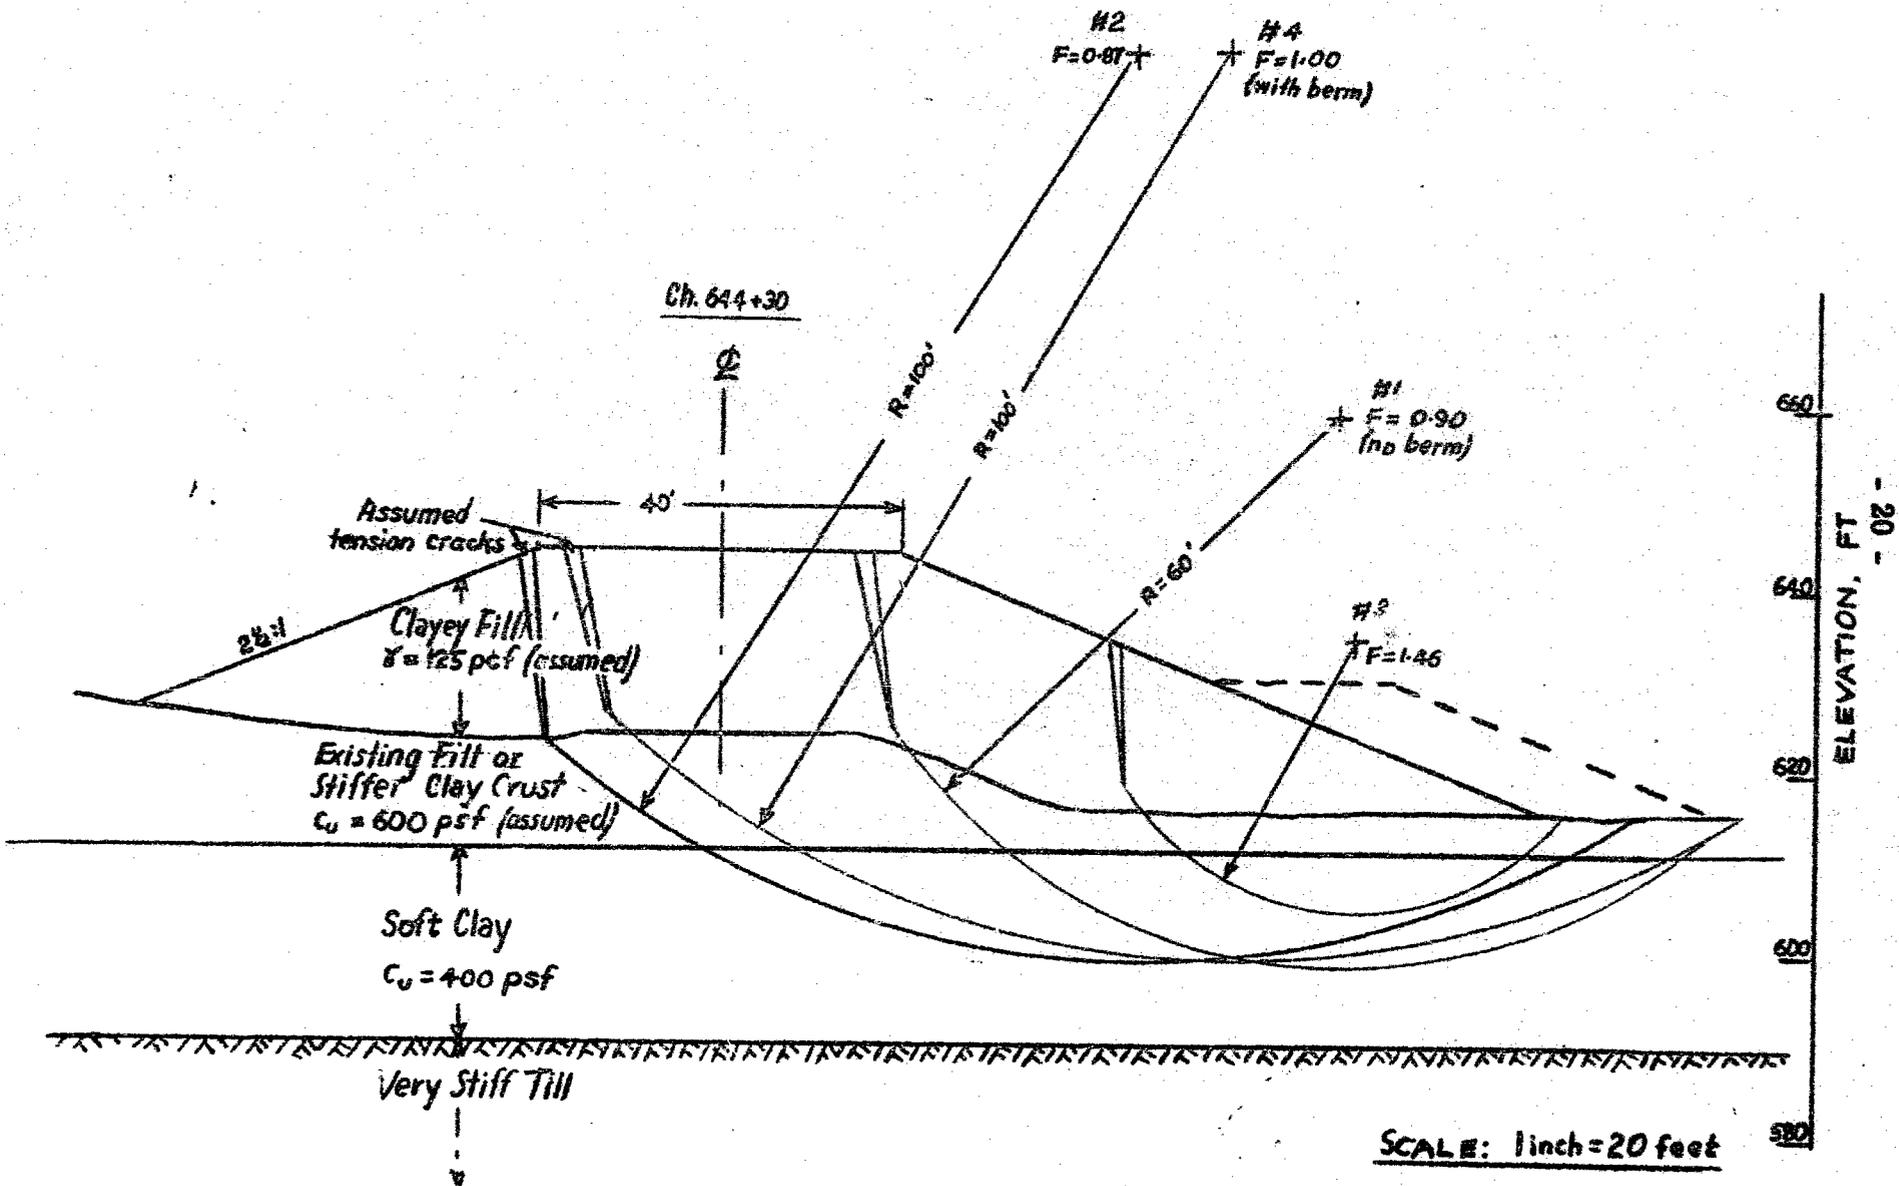
ILLUSTRATION OF STABILITY ANALYSIS

3. In the stability analysis, the most critical conditions based on results of the two test holes were considered. Only a small increase of strength in the top, drier portion of the topsoil was assumed, and the shear strength of the embankment material was neglected completely, assuming a tension crack penetrating to the virgin soil.

Provision of berms, which, designed on the basis of the above stability analysis, would ensure a substantial increase in the factor of safety of the embankment, would involve a considerable quantity of additional fill and a large width of acquired property. Because of the uncertainties involved in the stability analysis and its consequent limited reliability, such more expensive measures cannot be justifiably recommended on the basis of the presently available information.
