DEPARTMENT OF HIGHWAYS - ONTARIO			
MATERIALS & RESEARCH DIVISION - FOUNDATION SECTION			
AUSABLE RIVER			
KING'S HIGHWAY NO. 81		DIST. NO. 2	
CO. MIDDLESEX			
TWP. WILLIAMS E. & W.		LOT 1 & 2, CON. E.C.R. & W.C.R.	
MEASUREMENT POINT LOCATIONS			
SUBM'D G.C.	CHECKED	W.P. NO. 6-61	M.B.R. DRAWING NO.
DRAWN To	CHECKED	JOB NO. 63-F-64	63-F-64A
DATE JULY 4, 1963	SITE NO.	BRIDGE DRAWING NO.	
APPROVED <i>A. J. Thomas</i>	CONT. NO.

INSTRUMENTATION INVESTIGATION

Ausable River Bridge on Hwy. No. 81,  
Dist. No. 2, W.J. 63-F-64, W.P. 6-61.  
Contract 61-92 & 61-118

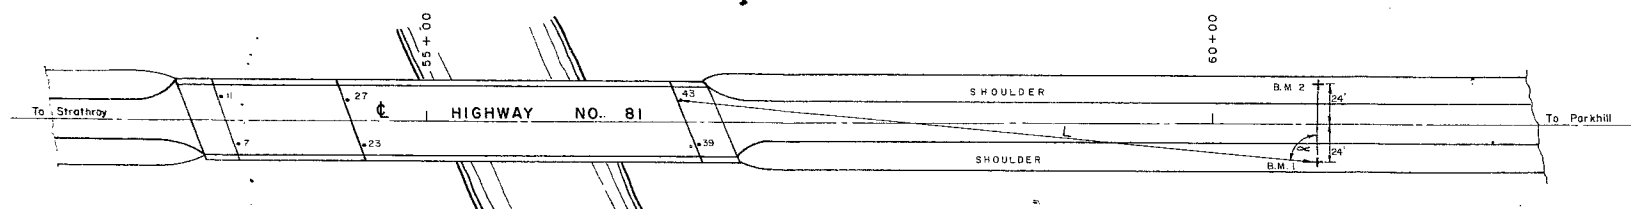
NOTE: VIEWS A, B, C, D, E & F INDICATE  
INSIDE EDGE OF CURBS.

A field instrumentation programme was carried out by this Section at the above-noted site from June 10 to June 12, 1963. The purpose of this instrumentation programme was to determine the magnitude and extent of any bridge movements, with the main emphasis on accurate determination of movements in a horizontal plane.
