RE. SUBSOIL INVESTIGATION FOR
THE PROPOSED HEYROCK CREEK BRIDGE
REPLACEMENT NEAR GODERICH, ONTARIO

Dominion Soil Investigation Ltd.

4th June, 1958

FOUNDATION INVESTIGATION FOR PROPOSED HEYROCK CREEK BRIDGE REPLACEMENT NEAR GODERICH, ONTARIO.

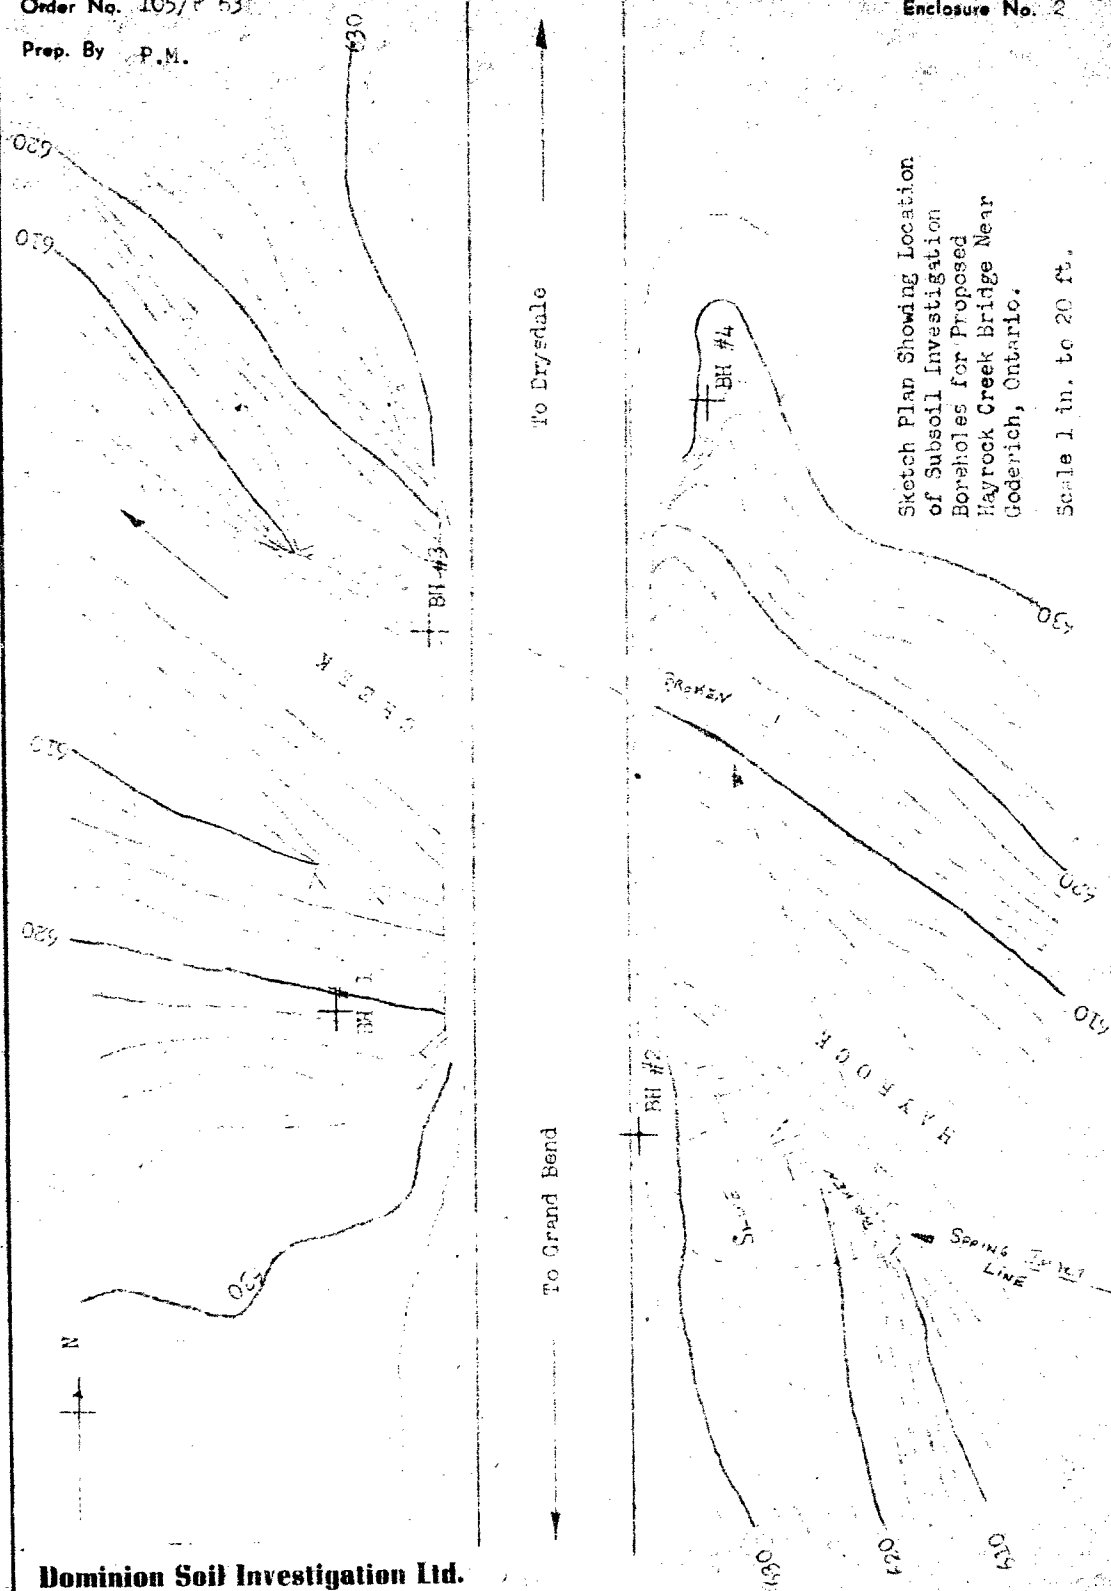
Sketch Plan Showing Location
of Subsoil Investigation
Boreholes for Proposed
Hayrock Creek Bridge Near
Godenrich, Ontario.

Scale 1 in. to 20 ft.

The borehole locations are shown on the plan on Enclosure No. 2.
