PROP. GARAGE

GRAND BEND

D.H.O. FOUNDATION INVESTIGATION
REPORT.

RE: PROPOSED PATROL GARAGE, HWY. 83 & 21, GRAND BEND, DIST. #3.

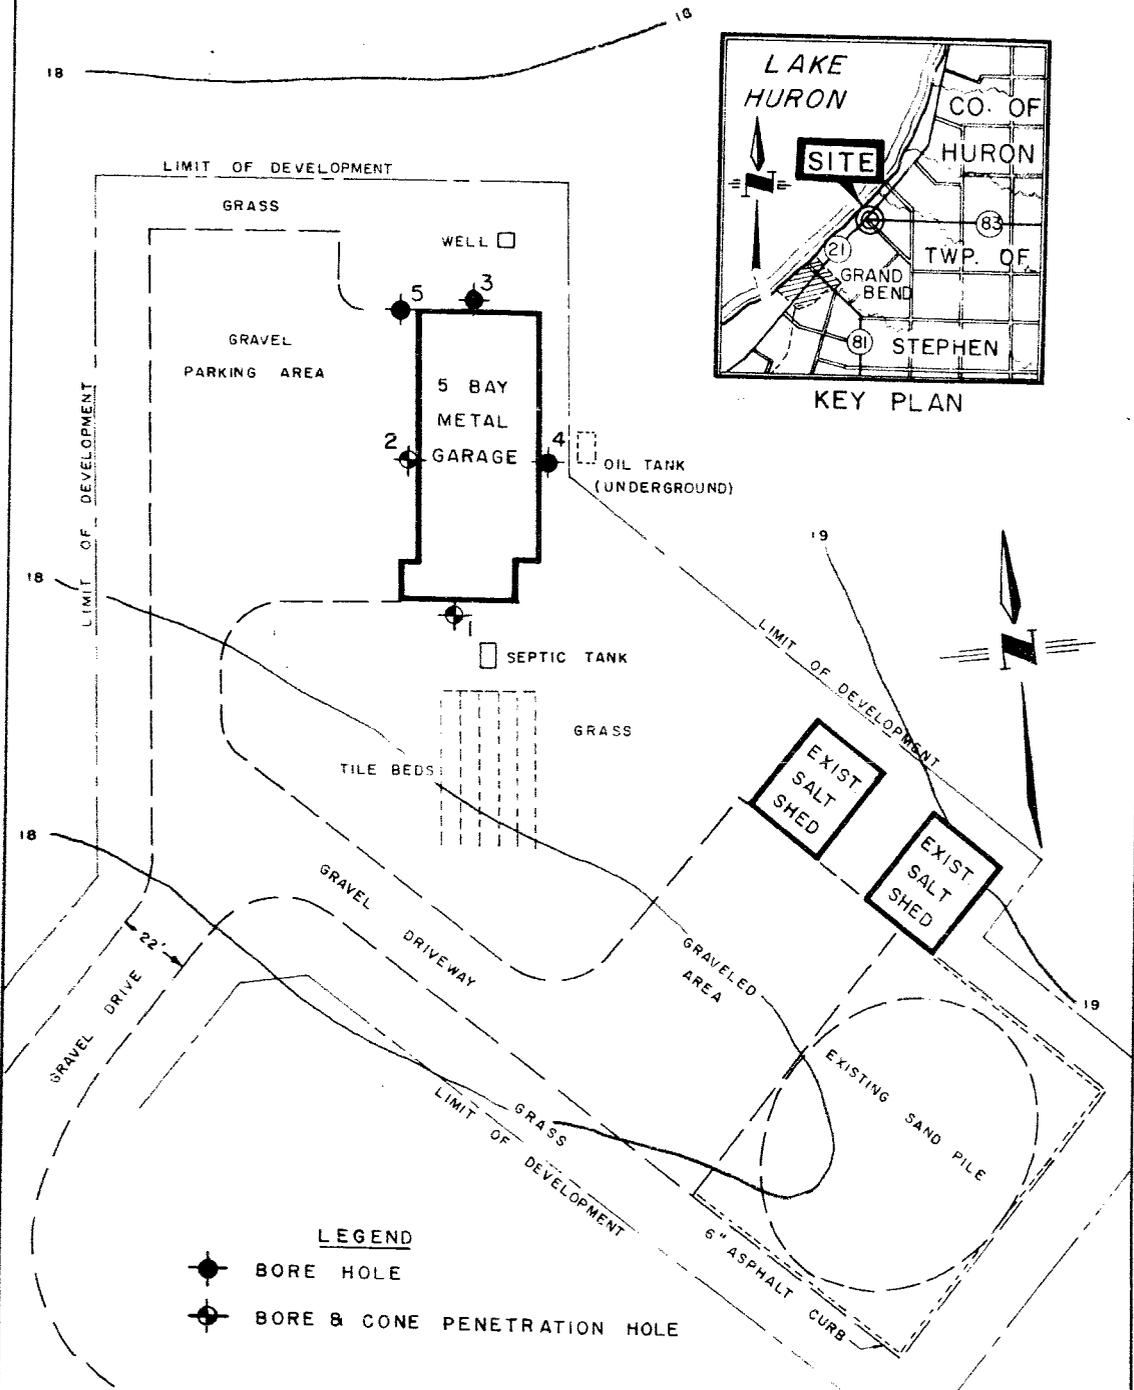
APPENDIX I.

A patrol garage is planned to be rebuilt at the D.H.O. yard near the junction of Hwy. 83 & 21. A foundation investigation was requested by the Special Services Section via a memo dated February 16, 1962. In order to determine the subsoil conditions at this site and decide on the type and elevation of footings to be recommended, an investigation, consisting of five sampled borings and two dynamic cone penetration tests, was carried out. Attached to this report is a sketch showing the boring locations.

and gravel material was encountered. In boring #3 only, a layer of water-bearing sand was encountered between 8'-6" and 11'-0" below the ground level.

Ground water was encountered in boring #3 at a depth of 8', and in boring #2 at 23' below the ground surface. No ground water was observed in any other borings during the investigation.
